A Structural Health Monitoring of a Pitch Catch Active Sensing of PZT Sensors on CFRP Panels: A Preliminary Approach

K.D. Mohd Aris, F. Mustapha, S.M. Sapuan and D.L. Majid

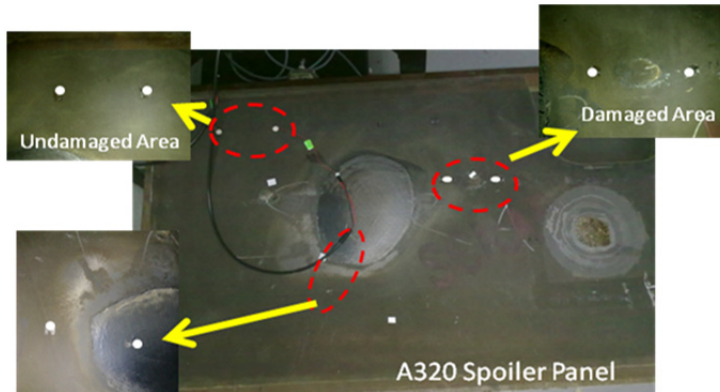
Figure 1. Locations of the structural conditions and PZT sensor placements

An aircraft spoiler was used for this research. The use of the structure is only arbitrary at this stage. It is use to seek the workability of the sensor upon trial on several flat panels. Three conditions were introduced to the panel which is the undamaged/ parent, damaged and repaired area. The undamaged/ parent was the area free from any defects. The undamaged area is the original conditions or controlled area. The damaged area was damage caused by impact that removes the top laminate. It was made by impacting the faced planes with a blunt object and creating damage less than 40mm diameter fracture. The level of impact is not an interest in this particular testing due to the studied conditions is only applicable to small surface damage due to impact. The repaired area was where the

damage plies were removed and replaced in accordance with the SRM [23]. The damaged area was repaired by scarfing method.

The PZT sensors were placed at 100mm apart for the three studied conditions. For damaged condition, the sensors were placed in between the damage area and for the repaired area, the sensors were replace across the actual and the repair doubler surface. This is to ensure

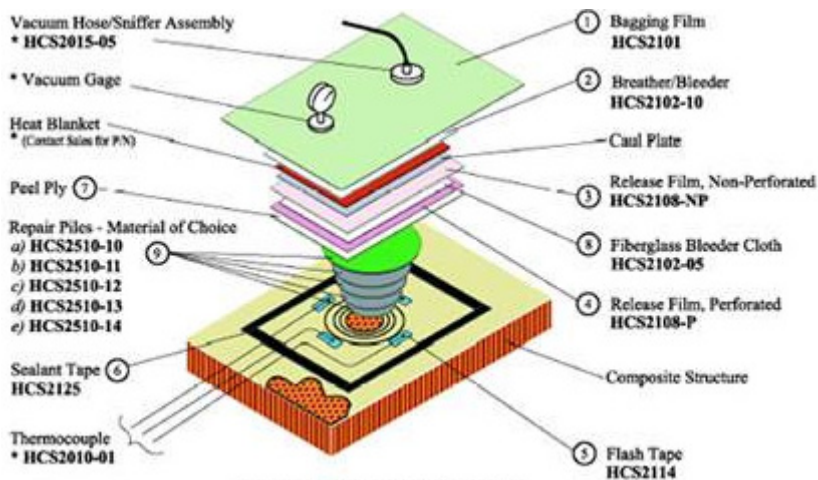
Figure 2. Hot bonder materials sequence for repairing aircraft composite parts. [24]

The repair was conducted by using hot bonder from Heatcon Inc. The Hexply® M10/38%/UD300/CHS/460mm CFRP pre-preg system from Hexcel Corp was used for the repair process. Care and take were observed to ensure similar procedures as per SRM recommendation. All plies were cut according to the sizes required and laid up accordingly. The affected area were vacuum bag as per Figure 2 and cured at 120°C at atmospheric pressure for 120 minutes. All vacuum bag materials were removed once the cycle ended.

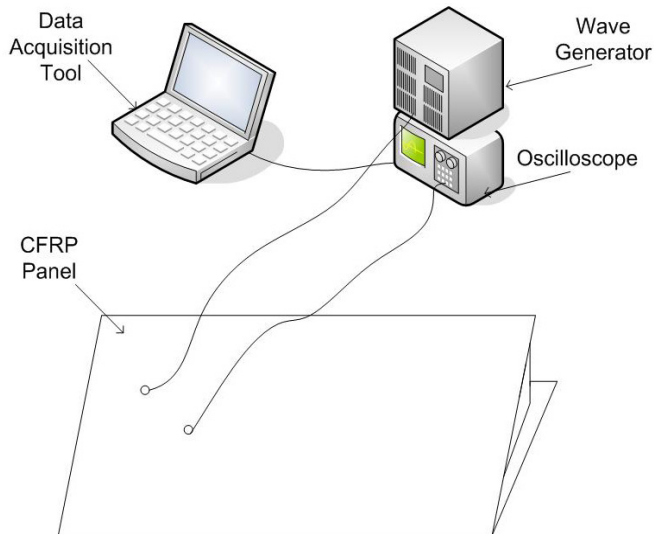
Figure 3. Aircraft spoiler with PZT sensor on specimens set-up.

distance consistency of 100mm between the sensors. One of the sensors acted as an actuator. The actuator controls the surface guided in the form of elastic perturbation through the surface guided wave across the panel. The wave was controlled by a function generator with the setup as per Table 2.

The receiving sensor modulated as the guided wave reached and transmit the energy to electrical signal. The received signals were saved for post processing by using oscilloscope. The arrangement of the equipment is shown in Figure 4.

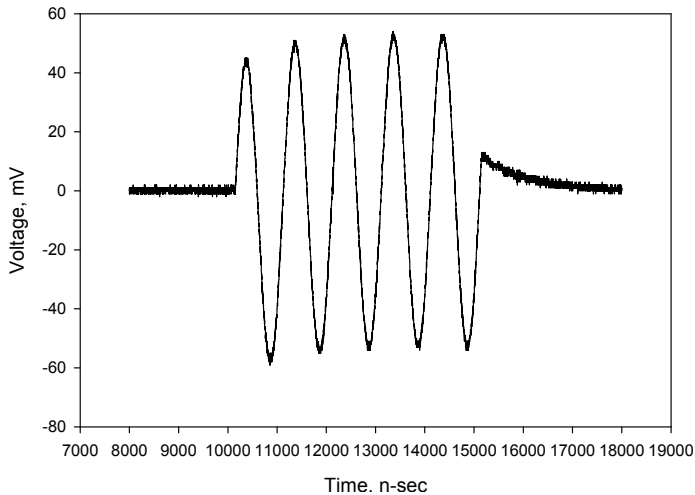
Figure 5. Actuating signals

Parameter	Unit	Parameter	Unit
Frequency	250kHz	Symmetrical	50%
Voltage	+10V	Time Generation	3ms at 333.3 Hz
V_{pp}	50Ω	Burst Count	5
Phase	0°

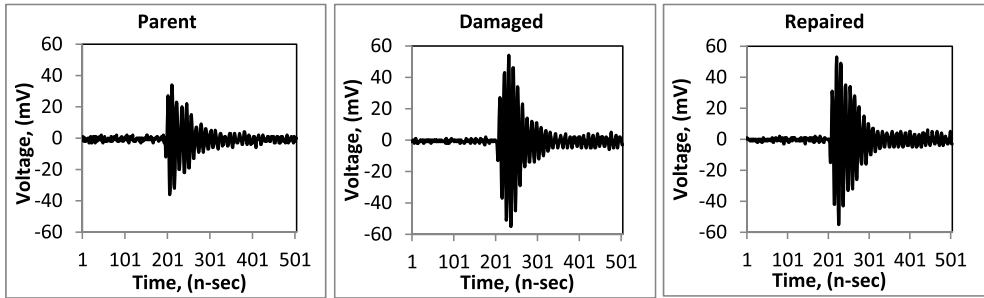
Figure 6. Wave packet samples from a) undamaged, b) damaged and c) repaired structural conditions after synthesized.

Figure 7 shows the results of the receiving wave packet upon synthesized by the points for each condition. Different behavior from the voltage (V_{pp}) and complete time of flight cycle are shown which characterized the evaluated conditions.

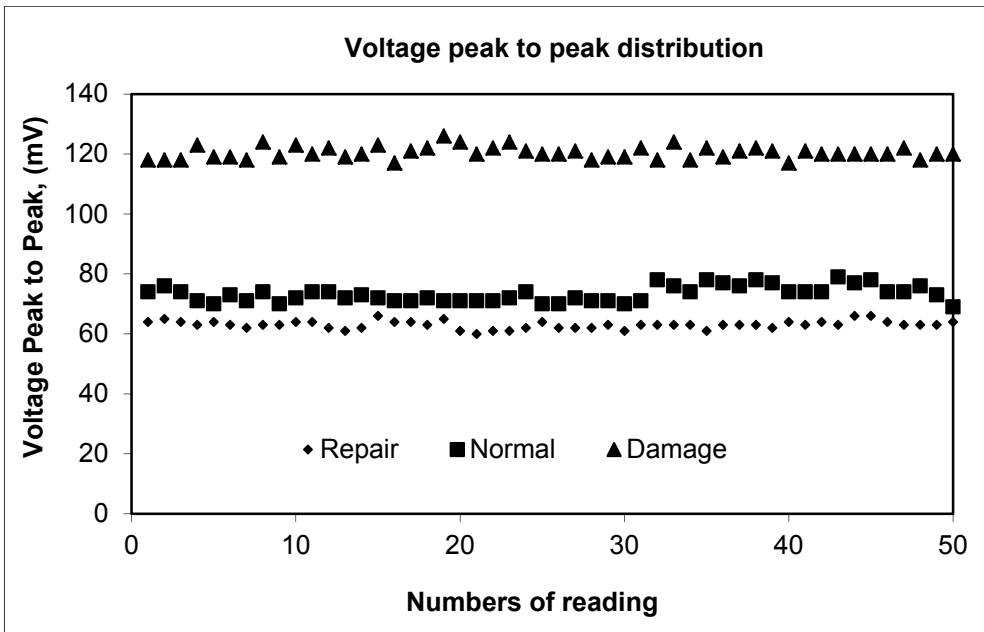
The V_{pp} showed similar values for the undamaged and damaged structure condition. It was assumed that the wave travel without discontinuity due to partial damage at that particular area. However several other types of damage need to be examined before any conclusive evidence can be finalized.

Figure 7. V_{pp} distribution among the structural conditions

Then, each of the receiving structural conditions wavelet data were compared between to ensure the signals was homogeneous to each other on the timeline basis. Since this is the unsupervised learning process the clusters were assigned to separate three conditions as stated in the methodology. The V_{pp} or voltage peak to peak is the attribute to distinguish the conditions. More than 50 V_{pp} values were collected and tabulated. The scattering of the V_{pp} for the three conditions were examined and is shown in Figure 8.

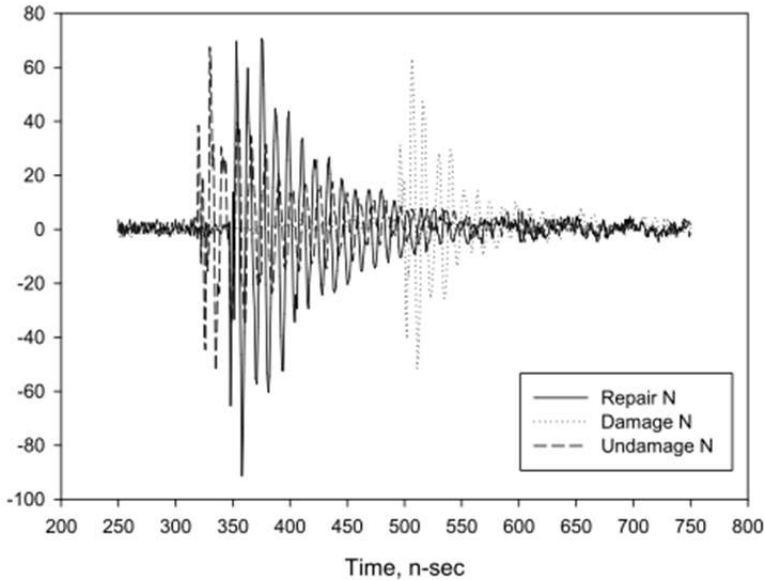
Figure 8. Overlay Outlier Pattern for different structural condition

A further post processing was carried out by overlapping the three conditions in one graph with similar time-domain comparison. The most common interest point lies within points 12250 ~ 12750. This was the first spike seen in the wave packet. In the earlier V_{pp} comparison, the distribution data between the damage and undamaged were identical. Therefore it was difficult to interpret the data for the latter machine learning process.

However, when all three data was overlapped, a significant different can be seen as shown in Figure 9. The undamaged signals appear at the initial time frame indicated that there was a clean surface wave traveling from the actuator to the receiver. However, once the partial damage was introduced, the spike appear later about 200nsec due to the discontinuity of the spoiler surface. The unaffected wave bifurcated to the receiver with delay. For the repair condition, since the surface integrity has been restored by the flush repair, the continuity of the surface wave was preserved again with delay about 50 nsec .

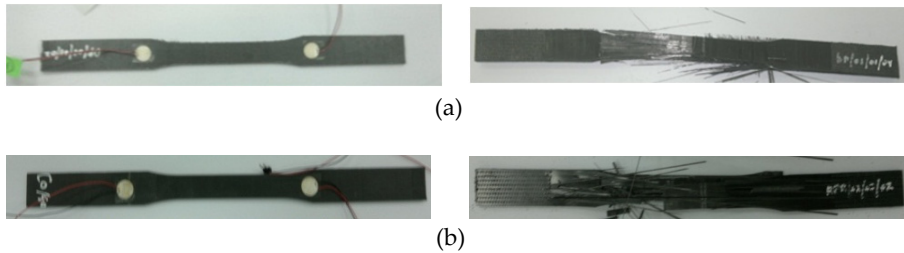
Figure 9. CFRP result before and after tensile test for parent specimens for a) normal and b) repaired specimens

The tensile test results showed a similar behavior towards a brittle stress-strain curve. Below are the results of the tensile test on normal and repaired specimens. All specimens were found to have breakage at center. The fiber breakage for parent specimens occurred at arbitrary layer. However, for the repaired specimens, the breakage occurred at the intermediate bonding layer between the original layers and repair plies. This is due to the fiber discontinuity and the matrix is the only medium to transfer the stress from the parent surface to the repair surface.

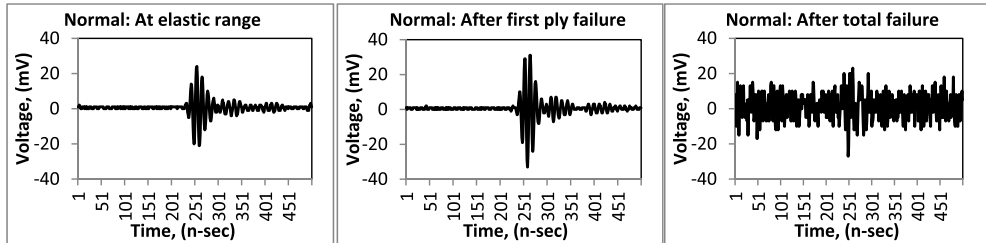
Figure 10. Receiving signals for parent panel with a) at elastic range, b) after first ply failure and c) at failure.

Based of the wavelet analysis from the Sigmaplot software, both conditions showed a significant changes at the investigated stages. At the elastic range, the wavelet shows a significant solid wave at the respective time of flight. However a slight change appeared after the first ply failure occurred. The V_{pp} values were found to be higher and there are also a distinct echo developed after the main wave packets. At the end of the testing, the signal lost its signature due to damage upon breakage of the panels. An online monitoring during the course of the test shown a good unique characteristics for anomalies to be identified.

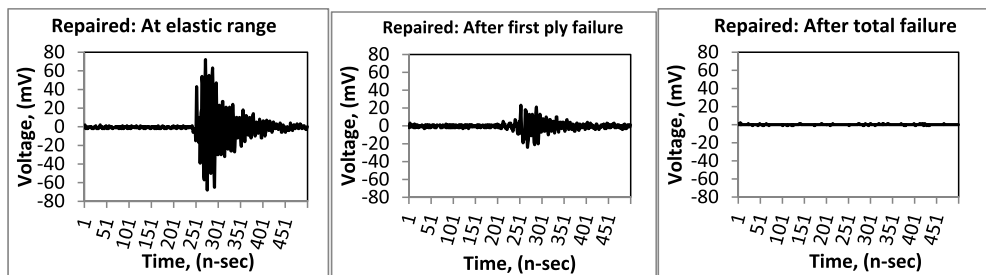
Figure 11. Receiving signals for parent panel with a) at elastic range, b) after first ply failure and c) at failure.

Figure 11 shows the behavior of the full repair panel throughout the testing. The degradation of the signal indicates the lamb wave attenuation has lost due to separation of the repair plies. This can be seen by 50% reduction of the V_{pp} at the initial of the testing. The significant reduction of the signal strength correlates with the structural integrity lost as the test reached the total fractured. Towards the end of the testing, all the specimen failed at the center and disintegration of the sensor due to the failure of the panels.
