ACR Guidance Document on MR Safe Practices: 2013

Key Words: MR safety; MR; MR safe practices
J. Magn. Reson. Imaging 2013;37:501–530.
 © 2013 Wiley Periodicals, Inc.

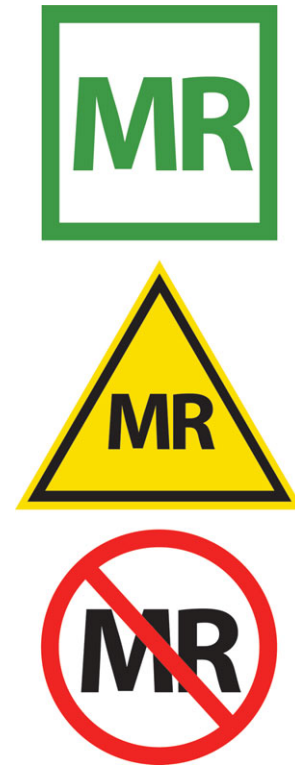
Figure 2. U.S. Food and Drug Administration labeling criteria (developed by ASTM [American Society for Testing and Materials] International) for portable objects taken into Zone IV. Square green “MR safe” label is for wholly nonmetallic objects, triangular yellow label is for objects with “MR conditional” rating, and round red label is for “MR unsafe” objects.

- a. All portable metallic or partially metallic devices that are on or external to the patient (e.g., oxygen cylinders) are to be positively identified in writing as MR Unsafe or, alternatively, MR Safe or MR Conditional in the MR environment before permitting them into Zone III Figure 2. For all device or object screening, verification and positive identification should be in writing. Examples of devices that need to be positively identified include fire extinguishers, oxygen tanks and aneurysm clips.

erly identified and appropriately labeled using the current FDA labeling criteria developed by ASTM International in standard ASTM F2503 (<http://www.astm.org>). Those items which are wholly, nonmetallic should be identified with a square green “MR Safe” label. Items which are clearly ferromagnetic should be identified as “MR Unsafe” and labeled appropriately with the corresponding round red label. Objects with an MR Conditional rating should be affixed with a triangular yellow MR Conditional label before being brought into the scan room/Zone IV.
