# Ancient Machu Picchu Drainage Engineering

**ABSTRACT:** The drainage infrastructure constructed by the Inca at ancient Machu Picchu represents a significant public works achievement. The difficult site constraints associated with the nearly 2,000 mm per year of rainfall, steep slopes, landslides, and inaccessibility posed drainage challenges that were met successfully by the Inca. The technical analysis of the Inca drainage works demonstrates that the drainage criteria used were reasonable and the implementation exceptional, and that the Inca were good engineers even though they labored without the benefit of a written language or the use of a wheel. Proof of the Inca success with drainage rests with the fact that Machu Picchu lay in the rainforest for 400 years without failure. There is no better example of successful ancient civil engineering than Machu Picchu. It was built by Native Americans before the arrival of the Spanish Conquistadors, was essentially abandoned in 1540 A.D., and endured for 4 1/2 centuries under a thick rainforest until the 20th century. Scientists, engineers, and laymen alike continue to marvel at the wonders of Machu Picchu.

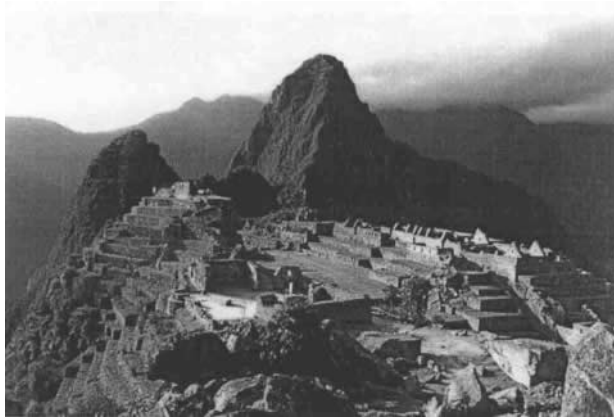
Figure 1. Machu Picchu Was in Good Condition after Four Centuries of Rain Forest Growth When Discovered by Yale Explorer Hiram Bingham in 1911. Its Longevity and Resistance to Landslides and Settlement Are Result of Extensive Drainage Systems Built by Inca in 15th and 16th Centuries.

When Professor Hiram Bingham returned to Yale University after his discovery of Machu Picchu, Peru, in 1911, he stated that "the Inca were good engineers" (Bingham 1913). Recent engineering research at Machu Picchu has demonstrated that Bingham was correct. This paper describes the carefully planned and constructed drainage infrastructure at Machu Picchu, without which it would not have endured to the present (Fig. 1).

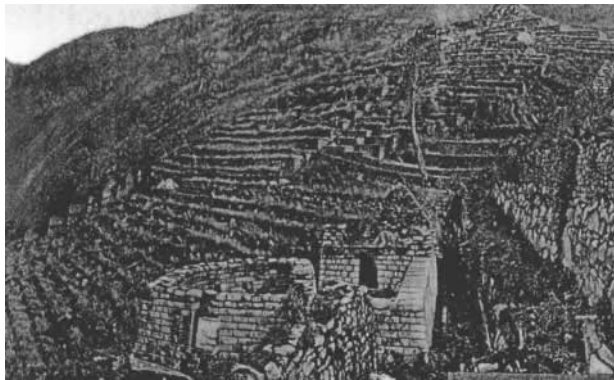
Figure 2. Hiram Bingham's 1912 Photo of Machu Picchu Agricultural Terraces Showing Hundreds of Undamaged Stone Walls That Resisted Landslides and Earthquakes. Surface and Subsurface Drainage Works Were Built to Handle 1,940 mm of Average Annual Rainfall. Temple of the Sun Is Shown in Foreground with Its "Most Beautiful Wall" Intact on Right (Bingham 1930).

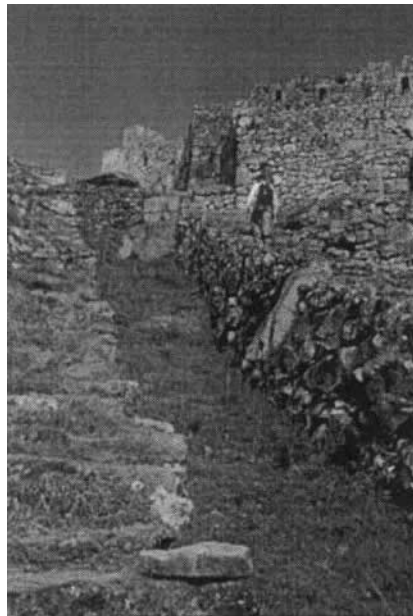
*Figure 8. Main Drain of Machu Picchu, Sometimes called the Dry Moat, this Drain Overlaid Local Geologic Fault. Main Drain Discharges into Rainforest Below. Effective Engineering Layout of Drainage Infrastructure Was Main Element in Longevity of Machu Picchu.*

1. A centralized Main Drain serving to separate the Agricultural Sector from the Urban Sector (Fig. 8).
2. Agricultural terrace surface drainage with good longitudinal slopes to formal surface channels integrated with access stairways or to the main open drain.

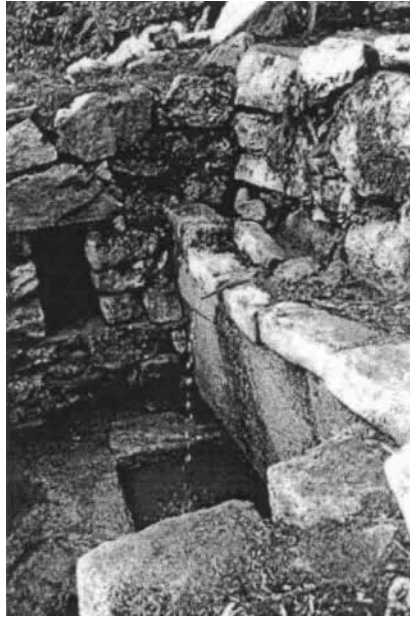
*Figure 13. Fountain 1, Immediately After Excavation. Operational Hydraulics Provided Drinking Water Source for Archaeological Crew.*

A September 1998 excavation permit from the government allowed excavation of the fountains, two of which were ceremonial fountains that were put into operation again after being buried for over four centuries (Fig. 13).

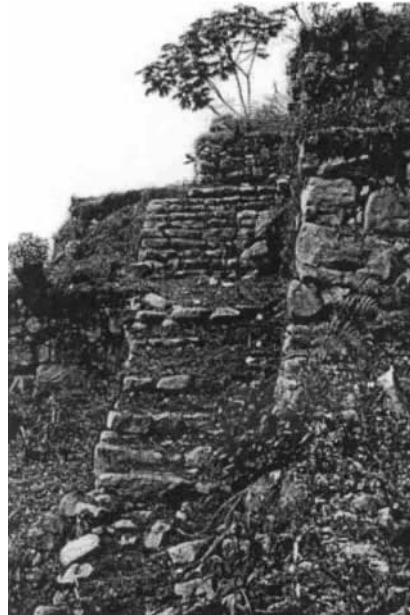
Figure 14. Main Inca Trail from Machu Picchu to Urubamba River Lying Adjacent to Fountains 3, 4, and 5 on Eastern Flank of Ridge.

The 1998 field exploration resulted in more than the excavation of the fountains: a previously unknown Inca trail was discovered. The trail is typically 2 m wide, with many excellent granite staircases ranging up to 3 m wide (Fig. 14). The Inca trail route was followed through the thick rainforest all the way down to the Urubamba River, where the ancient low water crossing was found. The trail is judged by the writers as being the primary trail from Machu Picchu to the easterly Vilcabamba region.
