Application of Ultrasonic C-Scan Techniques for Tracing Defects in Laminated Composite Materials

Theodoros Hasiotis – Efstratios Badogiannis* – Nicolaos Georgios Tsouvalis

School of Naval Architecture and Marine Engineering, National Technical University of Athens, Greece

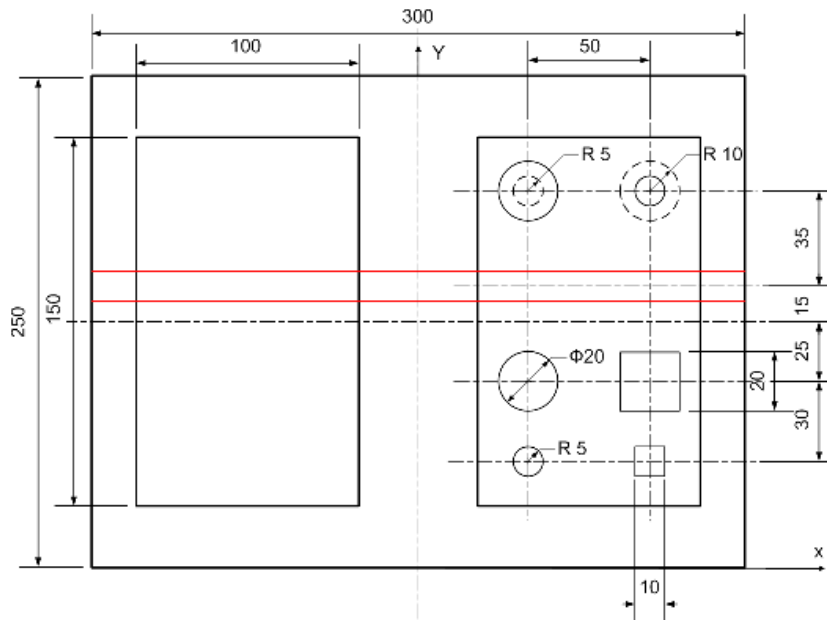
Fig. 1. Layout of specimens with artificial defects

The four test laminates had dimensions 300 × 250 mm, as it is shown in Fig. 1. The average uniform thickness of the test laminates are listed in Table 1, measured by conventional methods (calliper and micrometer). Two specimens were cut from each test laminate, each one with dimensions 100 × 150 mm. The first specimen (on the left in Fig. 1) is a reference specimen without any polyamide artificial defects and the second

(on the right in Fig. 1) included all the embedded polyamide artificial defects. In GFRP laminates, the woven roving fiber reinforcements were layered with their warp direction along y-axis, whereas in CFRP laminates, the unidirectional fiber reinforcements were layered with their warp direction along x-axis.

In total eight separate polyamide artificial defects were embedded in each one of the defected specimens. These defects, designated D1 to D8 (see Fig. 1), had the specific dimensions and were placed at the specific x-y positions shown in Fig. 1. The distances between these defects were chosen so that their presence does not influence the detection of their neighbour ones. More specifically, the detailed characteristics of all these defects are as follows:

- D1: circular shape, radius is 5 mm, embedded between layers No. 4 and 5 (layers numbering starts from the mould side of the test laminate).
- D2: square shape, side is 10 mm, embedded between layers No. 4 and 5.
- D3: circular shape, radius is 10 mm, embedded between layers No. 4 and 5.
- D4: square shape, side is 20 mm, embedded between layers No. 4 and 5.
- D5: circular shape, radius is 10 mm, embedded between layers No. 3 and 4 (solid line in Fig. 1).
- D6: circular shape, radius is 5 mm, embedded between layers No. 7 and 8 (dashed line in Fig. 1).
- D7: circular shape, radius is 5 mm, embedded between layers No. 3 and 4 (solid line in Fig. 1).
- D8: circular shape, radius is 10 mm, embedded between layers No. 7 and 8 (dashed line in Fig. 1).

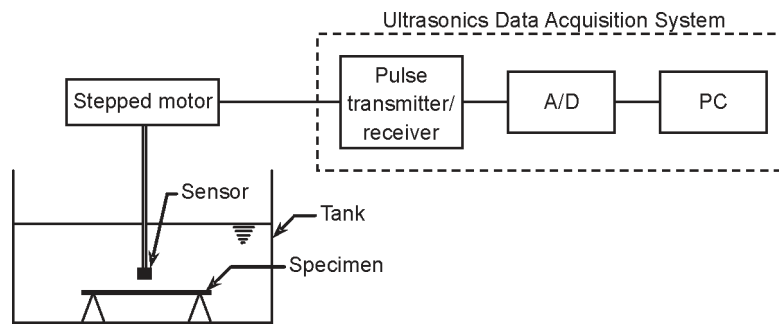
Fig. 2. Schematic view of the ultrasonics system

The ultrasonic inspection of the specimens was made by applying the Pulse – Echo method. A ¼" diameter single crystal pulse-receiver flat transducer of 5 MHz from PANAMETRICS was used and the inspection was made with the specimens immersed in distilled water. The ultrasonic device used is ULTRAPAC II system (automated immersion system), in association with ULTRAWIN software for data acquisition, control and imaging. It is an automated immersion system, equipped with high speed computer-controlled stepped motor drivers. X-Y axis scanning speed exceeds 20 in/s (500 mm/s), with a resolution of 0.0027 in (0.07 mm). The direct vertical axis driver has a maximum speed of 1 in/s (25 mm/s) and a resolution better than 0.001 in (<0.025 mm). ULTRAPAC II system uses a heavy duty Plexiglas tank supported by an also heavy duty aluminium framing system. A classic PC controls ULTRAPAC II system, which employs a Pulse/Receiver card for the generation and receiving of the ultrasonic waves. A different card is also used for the analog to digital conversion of

the incoming signal (A/D). A schematic view of the whole ultrasonics system can be seen in Fig. 2.

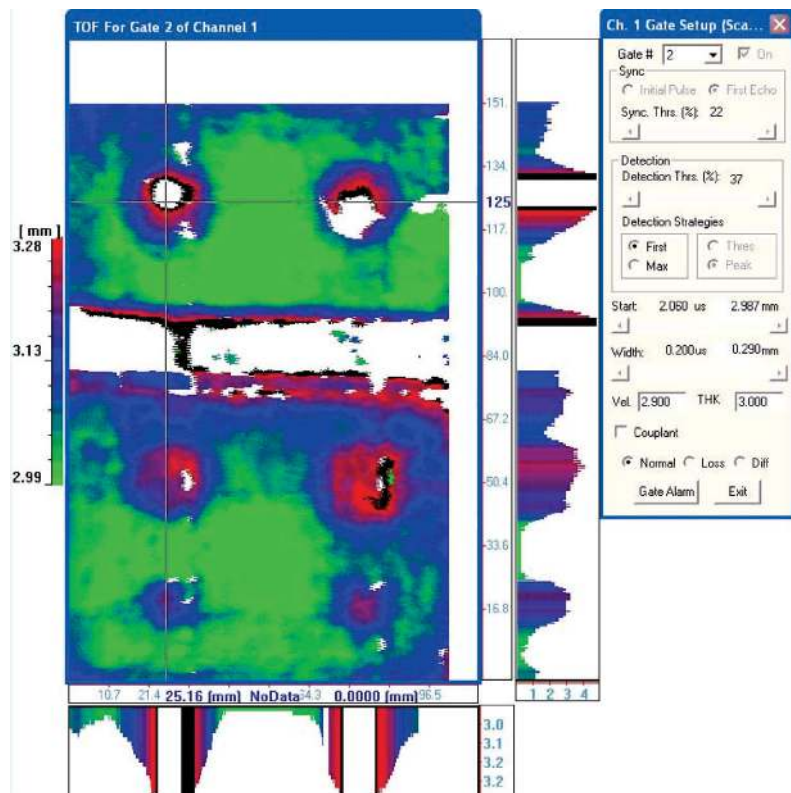
Fig. 3. TOF C-scan of CFRP-VI specimen focused at backwall

Fig. 3 presents the Time of Flight (TOF) C-scan of the CFRP specimen with defects. The gate was placed at backwall echo and the first-peak strategy was used in order to measure the thickness of the specimen. The thickness variation is presented in Fig. 3 with different colours. The gate width was properly adjusted in order to monitor the maximum thickness value of the wrinkle (see Table 1). Fig. 3 shows that the majority of the specimen thickness is around the average value of 3 mm, however there are areas where thickness is larger, like those around and on the artificial defects and at the wrinkle. The horizontal orthogonal white colour zone indicates that the wrinkle area has thickness greater than 3.28 mm.

B and B'-scans shown in the horizontal (below) and the vertical (on the right side) axis of the image, respectively, present the variation of the TOF parameter (thickness variation) within the thickness range illustrated at the legend on the left side of Fig. 3 (2.99 to 3.28 mm). B-scan displays the thickness variation along the horizontal cross-section of the specimen where the crosshair is placed and, similarly, B'-scan displays the thickness variation along the corresponding vertical cross-section. It is clearly shown that the existence of the artificial defects affect the local thickness of the specimen in the areas where the defects are located. This is recorded by an increase in TOF. It also becomes clear from B and B'-scans that defects D6 and D7 which overlap defects D5 and D8 cause high attenuation of the ultrasonic beam. Evidential of this high attenuation is the existence of white areas (no data points), which are present and clearly shown in the C-scan image. These white areas are also shown in the B and B'-scans as areas with no thickness.

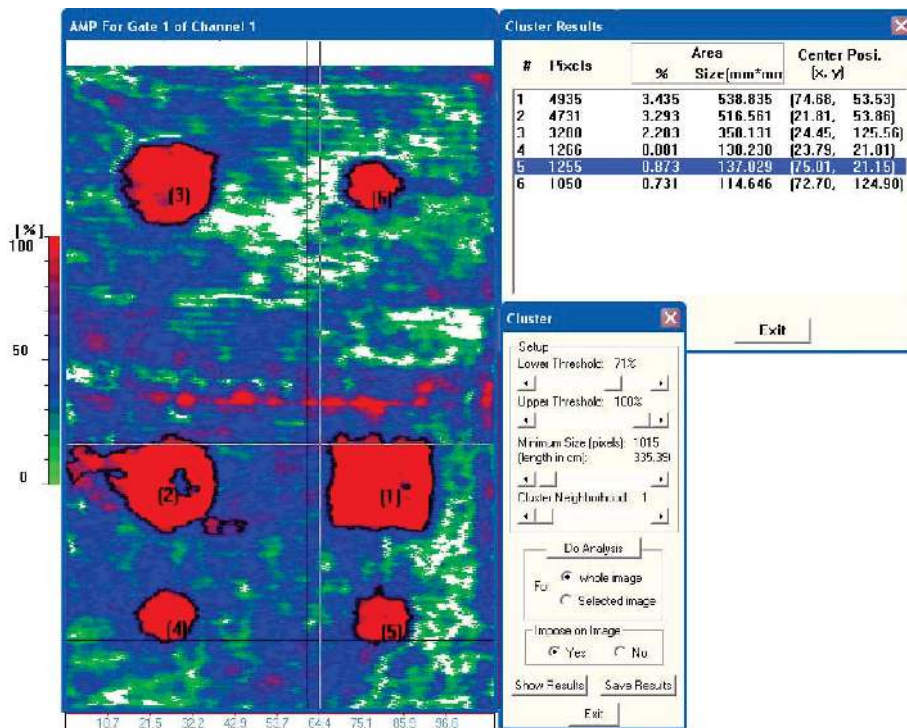
Fig. 4. Amplitude C-scan of CFRP-VI specimen focused between the 3rd and the 5th layer

In Fig. 4 the amplitude C-scan of the CFRP specimen with defects is shown. The gate was properly adjusted in order to inspect the area from the top of the 3rd layer to the bottom of the 5th layer. The max-peak strategy has been applied in order to monitor all defects which have initially been placed between the 3rd and the 4th layer that is all defects except D6 and D8. These six defects are clearly shown in Fig. 4. The same figure also clearly shows the direction of the fibers, which is parallel to the short side of the specimen (x-axis of the test laminate, see Fig. 1).

In the sequence, the cluster analysis utility of the software was used, in order to determine the dimensions and the position of each defect and compare these values to the initially defined ones before the construction (Fig. 1). The clustering procedure was applied to isolate the group of data with amplitude greater than 70% of FSH, which correspond to defects. The aim of this analysis is to conclude on whether the applied procedure is able to accurately estimate the defects dimensions, as well as to define if the manufacturing procedures influenced the final position of the defects.

The last two columns of the "Cluster Results" window in Fig. 4 present the monitored data for the co-ordinates of the center of each defect (defects numbering is shown in the figure), where x- and y-axis origin is at the lower left corner of the picture. The comparison of these data to the corresponding initial values shown in Fig. 1 leads to the conclusion that the location of the defects was very accurately identified. Moreover, it is shown that the applied method scanned accurately the shape of each defect. The "Cluster Results" window in Fig. 4 presents also the ultrasonically monitored area of each defect (fourth column). By comparing these values to the original defect areas that can be calculated from Fig. 1, it can be seen that the ultrasonic method significantly overestimates the area of all defects, from 14 to 73%. These differences may be due to the fact that all layers above the artificial defects exhibit a small bending over the defects. As a result, echoes from the areas adjacent to the defects are amplified up to 70% of FSH and they are recognized as defect areas.

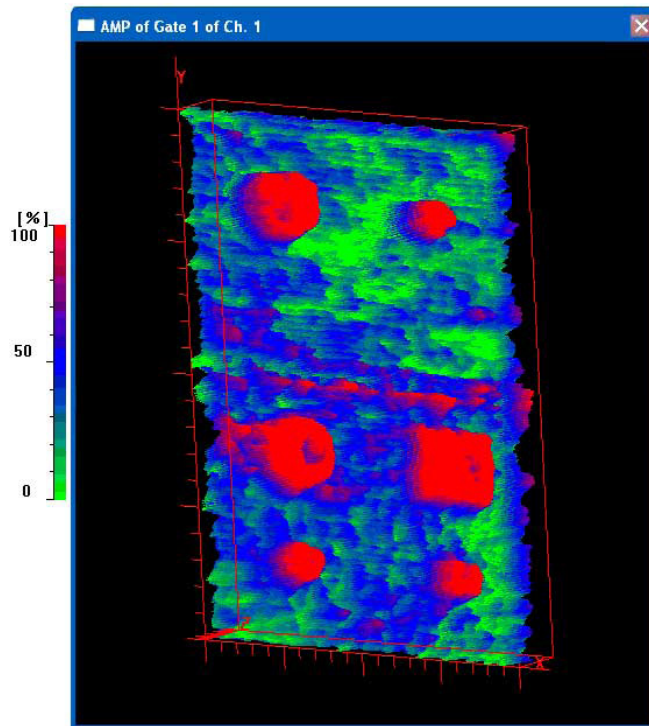
Fig. 5. 3-D amplitude C-scan of CFRP-VI specimen focused between the 3rd and the 5th layer

In Fig. 5, a 3-D amplitude C-scan of the CFRP specimen is given, focused from the 3rd down to the 5th layer. The six defects of the specimen D1 to D5 and D7 are clearly shown in this figure. They are coloured in red, since these areas are highly reflective to the acoustic energy.

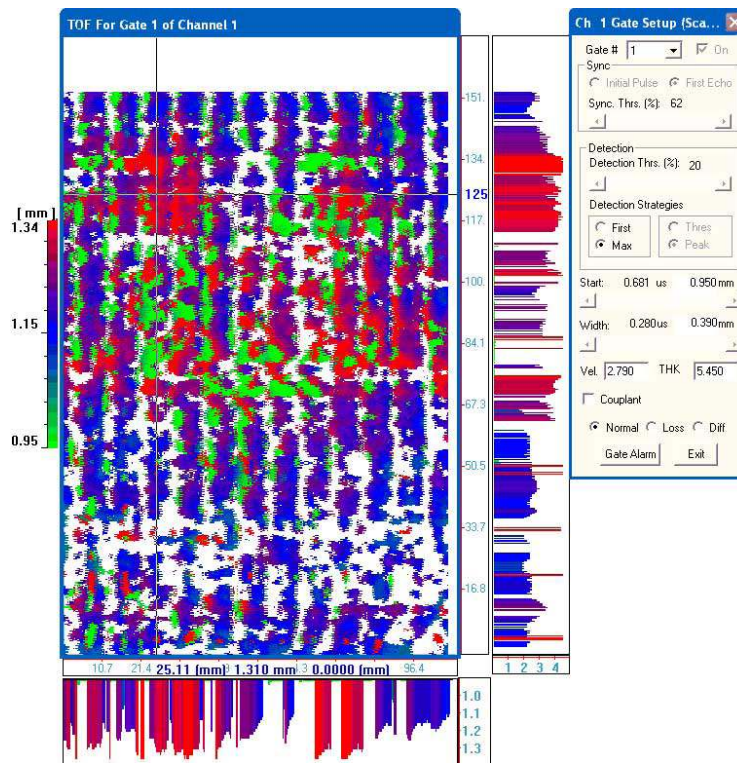
Fig. 6. TOF C-scan of GFRP-VI specimen focused at the 3rd layer

Fig. 6 shows the TOF C-scan of the GFRP specimen, focused at the 3rd layer in order to detect defects D5 and D7. Similarly to Fig. 3, the histograms in the horizontal (below) and the vertical (on the right side) axis of the image show the B and B'-scans along the two corresponding axes of the crosshair, presenting the variation of the TOF parameter (thickness variation) within

the thickness range illustrated at the legend on the left side of Fig. 6 (0.95 to 1.34 mm). The echoes coming from the glass fibers result in a more or less uniform colour motive of the inspected surface. In this respect, Fig. 6 clearly shows the general pattern of the glass yarns, constituting the woven roving reinforcement. The orientation of the fibers is clearly shown. The echoes coming from the defects have the same TOF and, therefore, are much more concentrated and correspond to a single colour (red areas in the figure). In order to better define these areas, it has been also taken into account that their size must be considerably larger than the size of the repeated square crossings of the fibers in the warp and fill directions, whose dimension is approximately 4 mm. However, in the B and B'-scan images it is shown that these red areas are not clearly defined, but they are mixed together with the echoes coming from the glass fibers. Therefore, these areas do not have a specific shape and well defined borders, as it is evident from Fig. 6.

The echoes generated from the woven roving fabrics are more intense at the intersection of the glass yarns in the fill and warp directions. That is why spots of different colour are displayed in GFRP C-scans. The different colour spots correspond to echoes coming from different depths of the material. The green spots mask the blue areas and the blue spots mask the red areas as shown in Figs. 6 and 7.

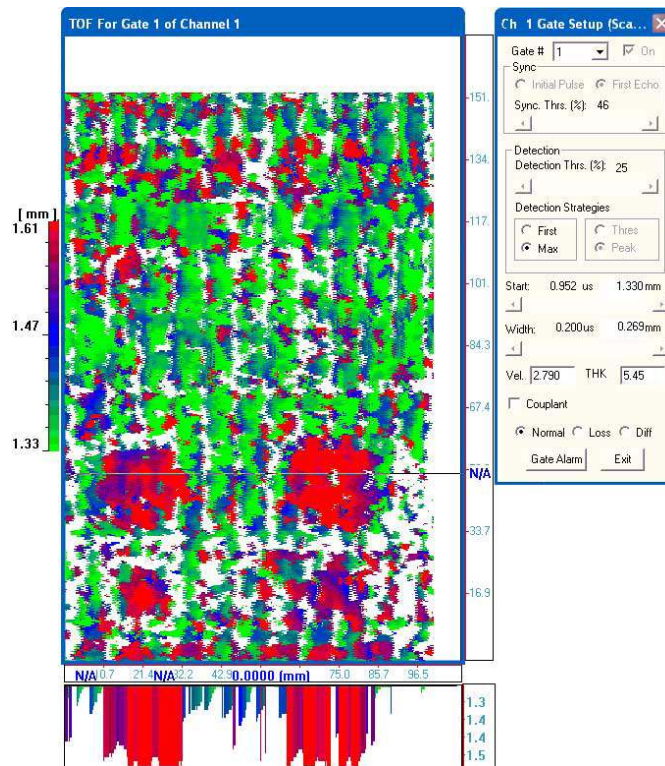
Fig. 7. TOF C-scan of GFRP-VI specimen focused between the 4th and the 5th layer

Fig. 7 shows the TOF C-scan of the GFRP specimen, focused at the area between the 4th and the 5th layer, in order to detect defects D1 to D4,

together with the corresponding B-scan along the horizontal crosshair. The red coloured areas, which correspond to the two aforementioned defects, are reported to a depth of approximately 1.6 mm, which is very close to the actual through thickness position of these defects. Although the existence of the defects is indicated in Fig. 7, their geometry is once more not clearly defined, as was also the case in Fig. 6. This was due to the high attenuation that the glass fibers demonstrate, masking the reflections from the artificial defects. It is clearly illustrated in Fig. 7 that the reflections coming from the fibers are superimposed to the reflections coming from the defects. Spots of different colour and no data areas can also be observed in the area of the defects. This phenomenon is more severe at the boundaries of the defects.

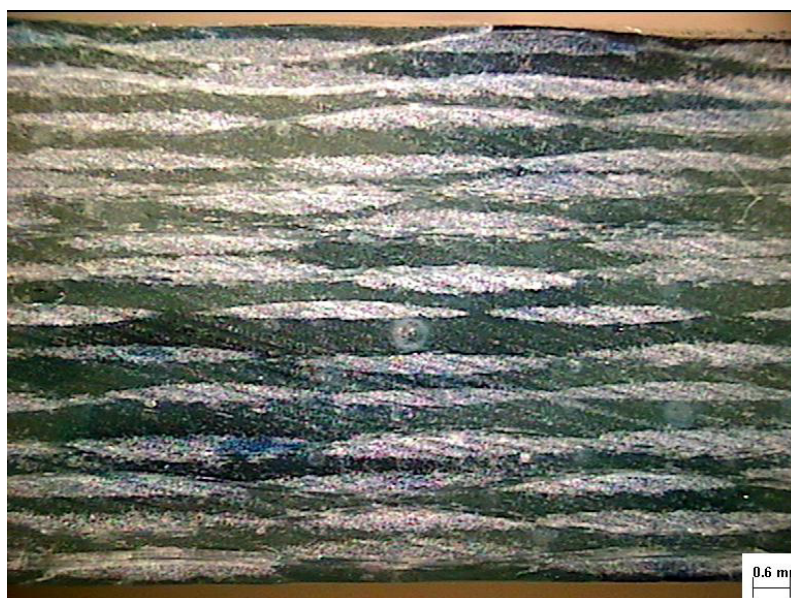
Fig. 8. Cross section ($\times 100$) of GFRP specimen showing the elliptic shape of the fiber yarns

It must be noted that, in general, the echoes coming from the fibers are more intense compared to the echoes coming from the defects or other areas. This is due to the reported elliptic shape of the glass yarns' cross section (see Fig. 8). As [7] mention, a convex or a concave shape reflects a big portion of ultrasonic energy.

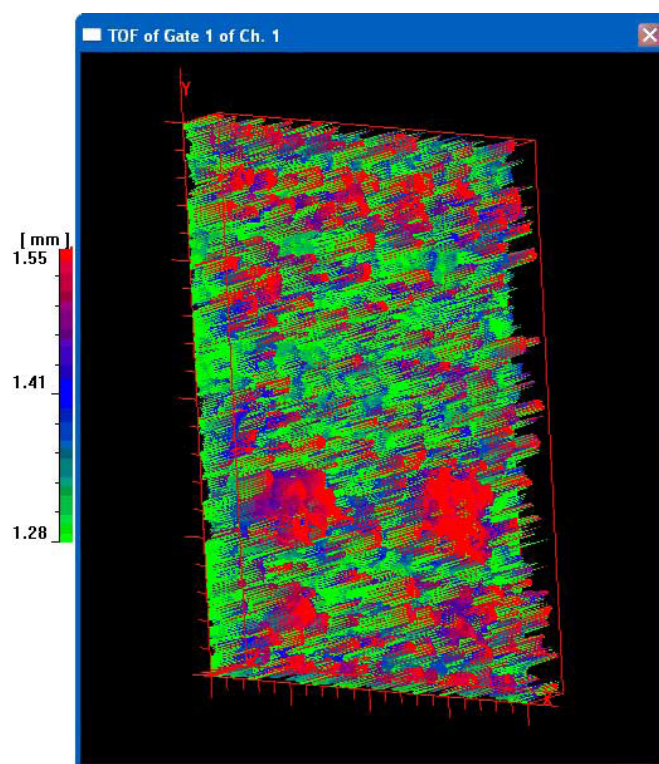
Fig. 9. 3-D TOF C-scan of GFRP-VI specimen focused between the 4th and the 5th layer

A 3-D TOF C-scan of the GFRP specimen is given in Fig. 9, focused from the 4th down to the 5th layer. Contrary to the CFRP specimen case, the four defects D1 to D4 are not clearly defined
