Bank erosion and protection on the Brahmaputra (Jamuna) River

A.B.M. Faruquzzaman Bhuiyan¹, M M Hossain² & Richard Hey¹

Abstract

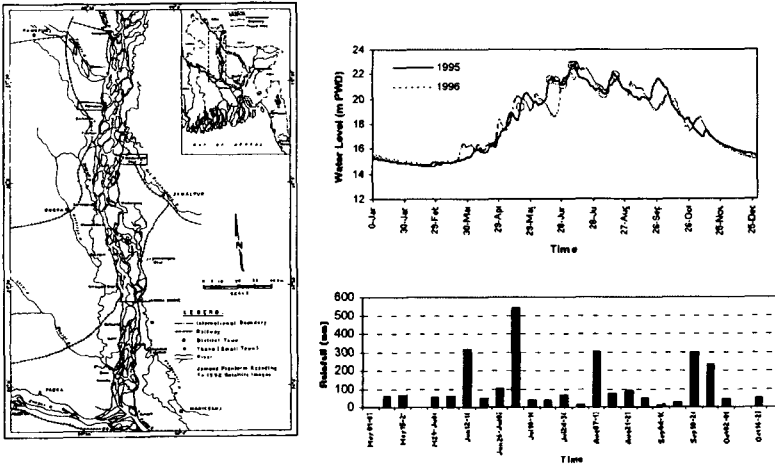
Figure 1: Brahmaputra river, typical flood hydrograph (1995-96) and weekly rainfall (1995).

The Brahmaputra-Jamuna river system is one of the largest braided rivers in the world with an overall braid belt width of some 5 to 17 km (Fig. 1) and with individual channels up to 2 km wide. The average flood discharge is about

The critical height changes progressively in response to simultaneous changes in river or groundwater levels (Fig. 3, h_{cgr}). When the groundwater level increases relative to a low river flow (h_{crg}) or when the river water level changes against a fully saturated bank (h_{cgr}), the critical bank height changes rapidly. The flood hydrograph of the Jamuna is characterised by rapid rises and falls (Fig. 1). The rise and fall may be 0.2 to 0.8 m/day compared to coefficient of permeability of the soil of the order of 10^{-5} - 10^{-7} m/s. Consequently, widespread erosion of the banks occur in either drained or undrained condition, facilitated by rapid removal of the failed debris and the changing geometry of the banks due to the strong currents in the river. During the rising stage, the river water level may show a stabilising effect by increasing H_c . However this may be over-ridden by higher toe erosion rates, changes in the shape of bank profiles and change in seepage condition by heavy rainfall (Fig.1).
