# Bioinspired self-healing of advanced composite structures using hollow glass fibres

R. S. Trask, G. J. Williams and I. P. Bond\*

*Department of Aerospace Engineering, University of Bristol, Queen's Building,  
University Walk, Bristol BS8 1TR, UK*

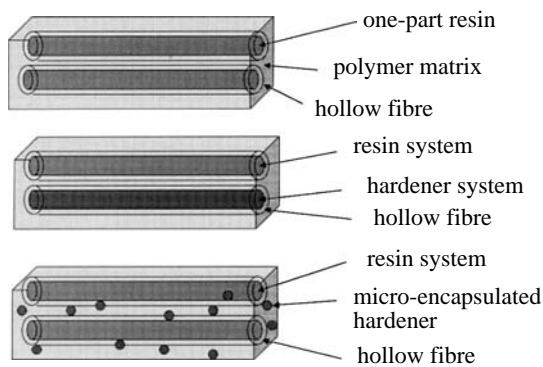
Figure 1. Schematic of different hollow fibre self-healing approaches (Bleay *et al.* 2001).

Hollow glass fibres (HGFs; Hucker *et al.* 1999, 2002) are used in preference to embedded microcapsules (Brown *et al.* 2003; Rule *et al.* 2005) because they offer the advantage of being able to store functional agents for self-repair as well as integrating easily with and acting as a reinforcement. A typical hollow fibre self-healing approach used within composite laminates could take the form of fibres containing a one-part resin system, a two-part resin and hardener system, or a resin system with a catalyst or hardener contained within the matrix material (Bleay *et al.* 2001). A schematic of these approaches is shown in figure 1.

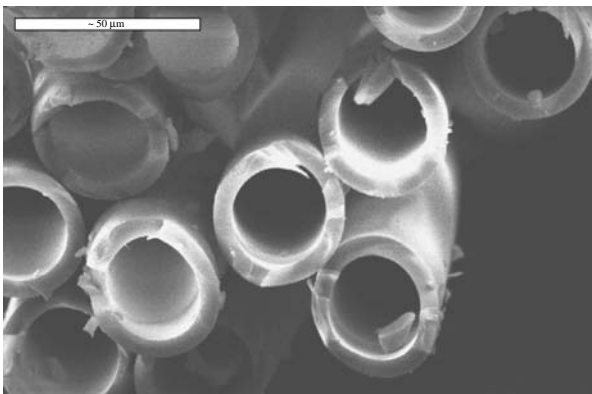
Figure 2. Typical hollow glass fibre (35  $\mu\text{m}$  external diameter with 55% hollowness fraction).

A bespoke HGF making facility (Hucker *et al.* 1999, 2002) has been used to produce HGF between 30 and 100  $\mu\text{m}$  diameter with a hollowness of approximately 50%, figure 2. These are then embedded within either glass fibre-reinforced plastic (GFRP) or CFRP and infused with uncured resin to impart a self-healing functionality to the laminate. During a damage event, some of these hollow fibres will fracture, thus initiating the recovery of properties by ‘healing’ whereby a repair agent passes from within any broken hollow fibres to infiltrate the damage zone, and acts to ameliorate the critical effects of matrix cracking and delamination between plies and, most importantly, prevent further damage propagation. This release of repair agent mimics the bleeding mechanism in biological organisms (e.g. human thrombosis).

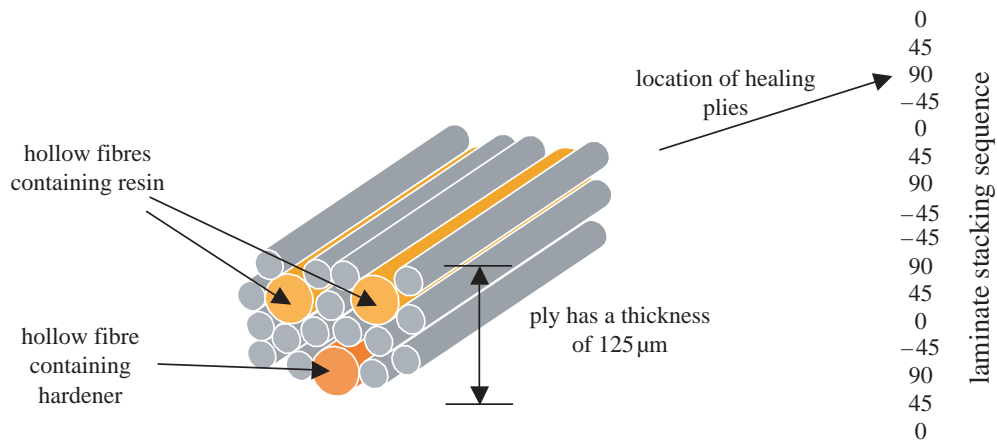
Figure 3. Location of resin and hardener self-healing filaments intermingled within an E-glass ply in the 16-ply stacking sequence of the composite laminate.

A 16-ply composite laminate with a  $[0^\circ/+45^\circ/90^\circ/-45^\circ]_{2s}$  stacking sequence manufactured from pre-impregnated E-glass/913 epoxy resin (Hexcel composites) was selected for the first evaluation of the HGF self-healing approach. The self-healing filaments were introduced at four  $0^\circ/45^\circ$  damage critical ply interfaces that were identified and reported previously (Trask & Bond 2006), as shown in figure 3. An epoxy resin system (CYTEC Cycom 823) was selected as the healing resin owing to the need to match the chemistry of the host laminate, its availability as a two-part system permitting inclusion in separate storage filaments, low-viscosity profile and time to gelation 30 min after mixing. Furthermore, it was observed experimentally that the individual components of the two-part Cycom 823 were sufficiently robust to survive the host laminate curing process (120°C for 1 h) after infiltration into the hollow filaments within the laminate stack.

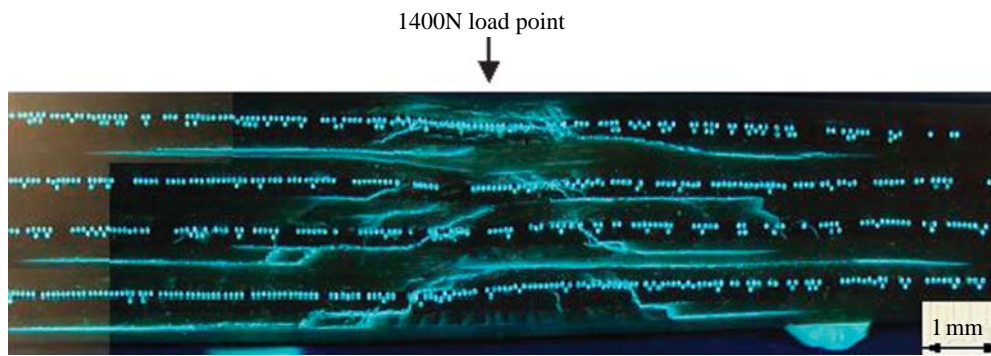
Figure 5. Impact damaged cross-section of  $[0^\circ/+45^\circ/90^\circ/-45^\circ]_{2s}$  GFRP laminate containing healing filaments at the  $+45^\circ/90^\circ$  and  $-45^\circ/90^\circ$  interfaces.

A damaged and healed GFRP specimen was examined to determine whether healing resin had infiltrated the damage zone. A cross-section of the healed damage illuminated under UV light is shown in figure 5, which clearly illustrates the extent of the infiltration by the healing resin into the damage zone when viewed along the  $0^\circ$  fibre direction. This result suggests that the four self-healing layer locations were ideally placed within the complex damage network to fully infuse the damage site. To understand the mechanism involved in the self-healing of the damage zone, further microscopic examinations were undertaken. This examination indicated the occurrence of crushed hollow fibres under the impact zone (figure 6*a,b*) and healing resin bridging fracture surfaces (figure 6*c,d*).

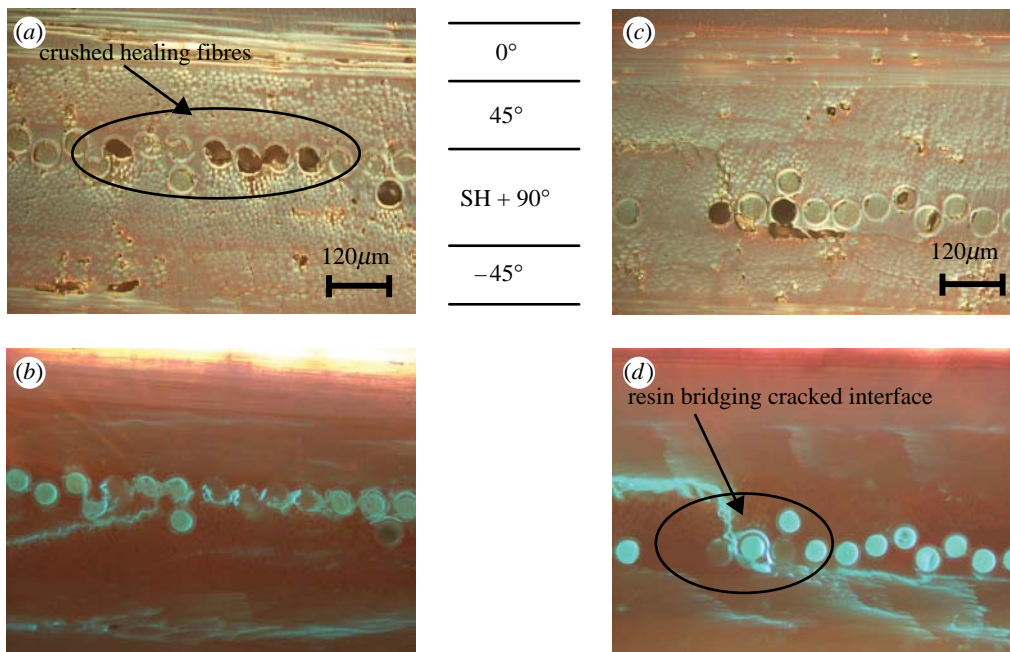
Figure 6. Crushed-healing fibres located under the impact site viewed under (a) normal and (b) UV illumination. Healing resin bridging cracked interface viewed under (c) normal and (d) UV illumination.

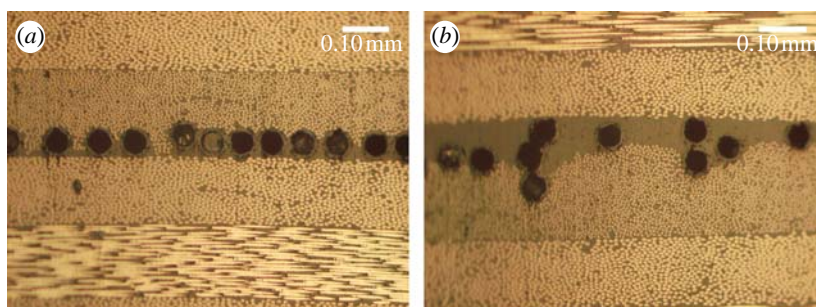
Figure 7. HGF spaced at 70  $\mu\text{m}$  showing (a) good embedment and (b) fibre clumping within host laminate.

Analysis of table 2 shows that the 70  $\mu\text{m}$  fibre spacing resulted in the largest reduction in undamaged strength (8%). This can be attributed to a significant disruption in fibre architecture (figure 7). However, after a quasi-static impact at 2000 N peak load, this configuration exhibited a significant amount of damage tolerance compared with the 200  $\mu\text{m}$  fibre spacing and control laminates. The large volume fraction of HGF also provides a considerable reservoir of healing agent as shown by a 97% recovery of undamaged strength (equivalent to 89% of the undamaged strength of the control laminate).

A fibre spacing of 70  $\mu\text{m}$  (figure 7) highlighted several issues about the resulting quality of embedding HGF within a laminate. This small pitch spacing was selected to ensure that the HGF were in close proximity and thereby facilitate a high degree of healing efficiency. However, during preparation, HGF could be mislocated resulting in disruption to the host ply (figure 7*b*). This was attributed to fluctuations in the fibre pitch control at low HGF spacing combined with poor tackiness of the 914 epoxy resin at ambient temperature. This was seen to result in lengths of HGF detaching from and reattaching to the surface producing fibre clumping and resin-rich regions post-cure.

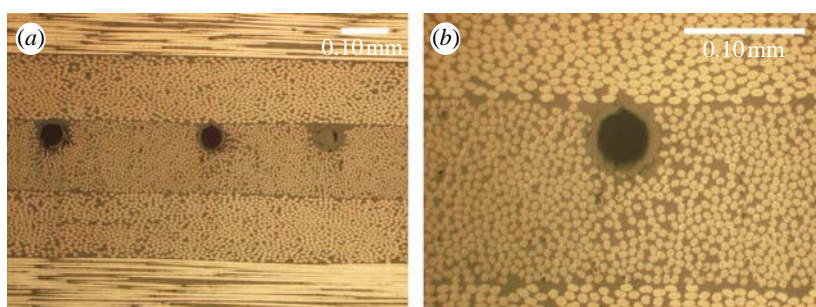
Figure 8. HGF spaced at 200  $\mu\text{m}$  showing (a) consistent spacing and (b) excellent embedment within host laminate.

The 200  $\mu\text{m}$  HGF spacing specimens exhibit little reduction in undamaged strength (2%) attributable to the reduced disruption to the host laminate (figure 8). These specimens behaved similarly to the control laminate when damaged, presumably due to the limited amount of HGF available for crushing. However, healed samples achieved 82% of their undamaged strength (equivalent to 80% of the undamaged strength of the control laminate), despite the significantly lower volume of available healing resin.

A fibre spacing of 200  $\mu\text{m}$  resulted in a much higher integrity laminate (figure 8). The resin-rich regions surrounding the HGF are minimized and there was no evidence of fibre clumping. The large spacing between fibres allowed the low tackiness of the 914 resin system to hold them in place, any that did detach were able to reattach without interfering with neighbouring fibres. The large spacing between the HGF permitted excellent consolidation during cure, further improving overall HGF embedment and reducing disruption to the laminate.

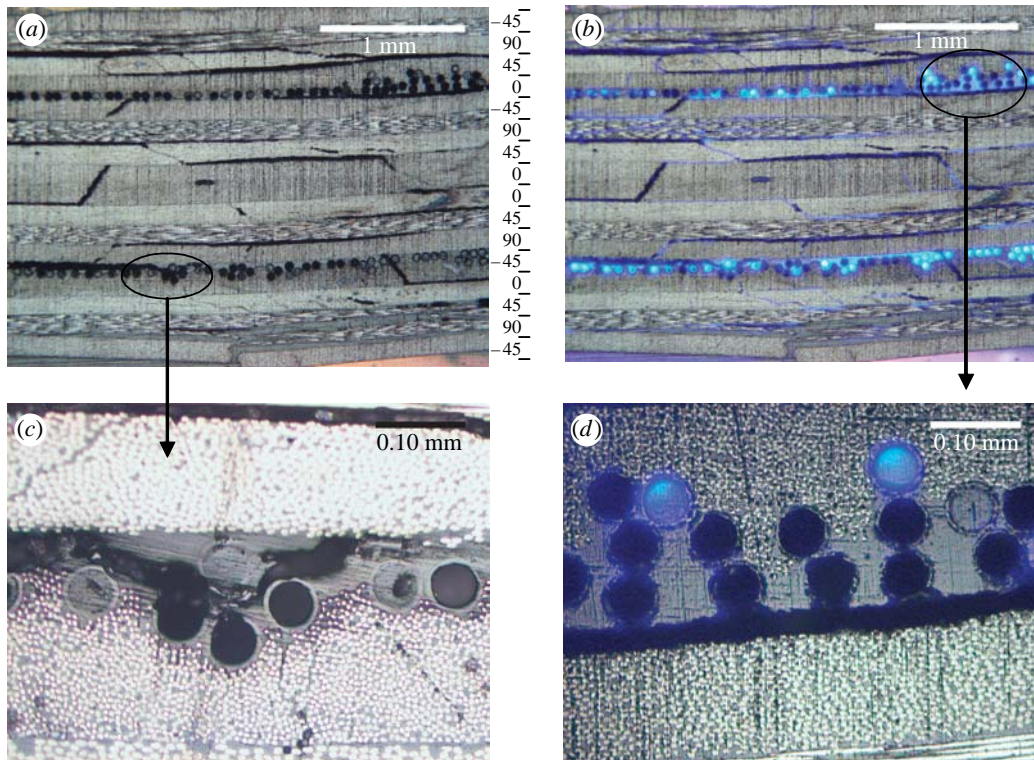
Figure 9. (a) Damage distribution within laminate, (b) damage infiltration with healing resin and fluorescent dye, (c) delaminations deviating from interface and (d) propagating along interface causing HGF fracture.

within the laminate is evident from figure 9a where shear cracks and delaminations are seen to intercept regions of HGF. Furthermore, figure 9b shows similar damage infiltrated with healing resin mixed with fluorescent dye. It can be seen from this image that the larger delaminations (greater than 30  $\mu\text{m}$ ) contain little or no healing resin. This could be due to the inability of capillary action alone to draw significant volumes of resin into the relatively wide cracks, combined with the limited lengths of HGF available for delivery of resin (test specimen width provided approx. 40 mm HGF length adjacent to damage site).

As expected, delaminations were observed to propagate along interfaces between plies of dissimilar fibre direction. It can be seen that this initiates HGF fracture via two mechanisms. In figure 9c, clusters of HGF cause deviation of a delamination, presumably due to a fibre cluster and the resulting resin-rich region causing a weakness in the laminate. However, the propagating crack passes directly through HGF causing fibre rupture and release of healing resin. In figure 9d, HGF are ruptured as the delamination propagates along a ply

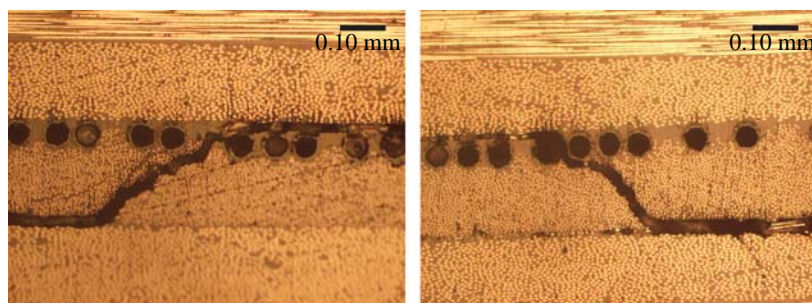
Figure 10. Intra-ply shear cracks intercepting HGF within a self-healing CFRP laminate.

The presence of intra-ply shear cracks linking delaminations provide connectivity between different damage sites in the laminate and facilitate healing at multiple interfaces. Shear cracks can be seen to initiate HGF fracture by similar mechanisms to delaminations (figure 10). However, the width of shear cracks is generally smaller than delaminations (approx. 10  $\mu\text{m}$  compared with approx. 30  $\mu\text{m}$ ) and so encourage a stronger capillary action to transport healing resin.
