Calcium silicate against clay brick masonry: an experimental comparison of the in-plane behaviour during light damage

Paul A. Korswagen¹ · Michele Longo¹ · Jan G. Rots¹

Keywords Calcium silicate · Clay masonry · Light damage · Cracks · DIC

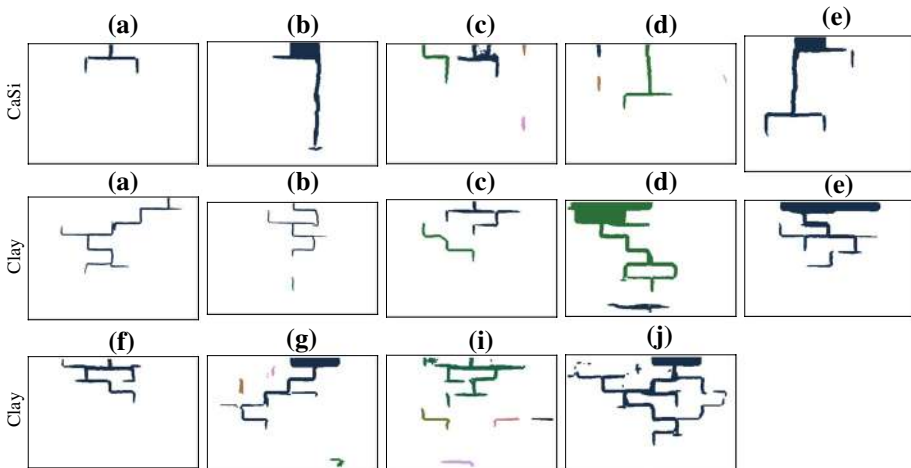
Fig. 13 Comparison of final crack patterns between calcium-silicate spandrels (top five) and clay specimens (bottom nine)

The increased damage of calcium-silicate walls is also observable in the crack patterns of these specimens when compared to the clay walls. Figure 12 shows five clay walls where cracks are spread into a larger number of individual cracks, and follow predominantly diagonal patterns of off the window corners. Figure 12 displays a cumulative summary of all cracks throughout the entire tests, hence, in contrast, the two calcium-silicate walls display only four cracks which propagate first horizontally from the window corners, then diagonally, and later run vertically through the bricks. The splitting of bricks was something only observed in the calcium-silicate specimens. In fact, spandrel tests, which were to mimic a vertical crack underneath the window bank of the walls, also displayed no brick-splitting in the clay material, but did allow for this brittle failure mechanism in the calcium-silicate specimens. Figure 13 shows that the vertical crack in CaSi spandrel

samples did cut straight down, while the vertical crack of identically-tested clay specimens, zigzagged down forming a toothed crack with complex patterns and bifurcations.

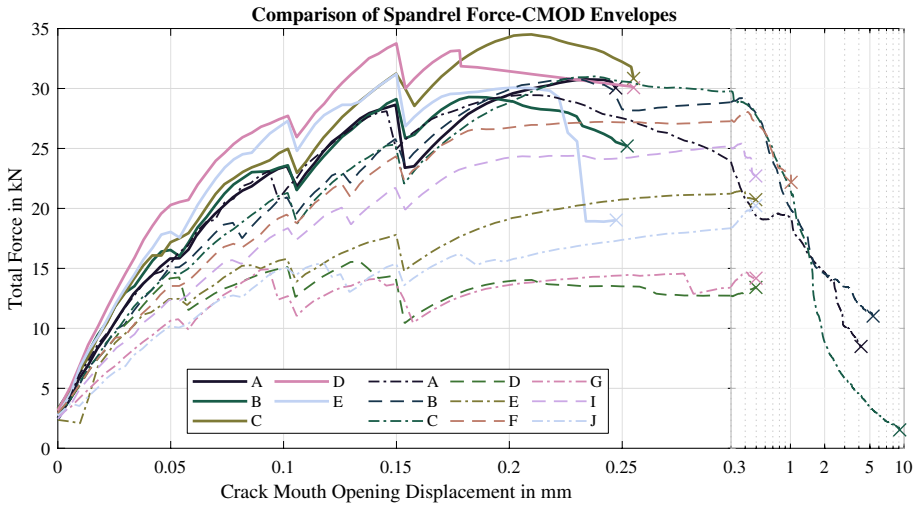
Fig. 15 Comparison of force–displacement (CMOD) envelopes between spandrel tests of calcium-silicate brick (solid lines) and clay brick (interrupted lines) masonry
