CHAPTER 92

CHANGES OF SEA BED DUE TO DETACHED BREAKWATERS

Osamu Toyoshima

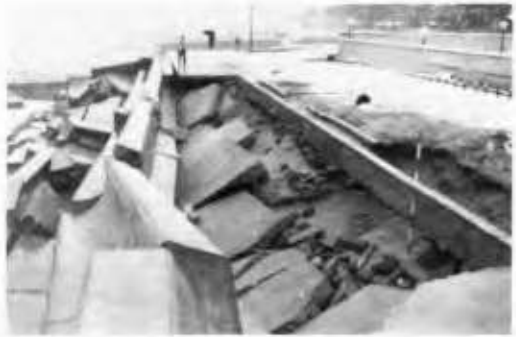
Fig.10 In January 1961, the stepped face seawall had been partly destroyed by the winter strong wave force. Waves had scoured beach at the foot of the seawall, and the body of the seawall had been scattered. The seawall had been reconstructed at once.

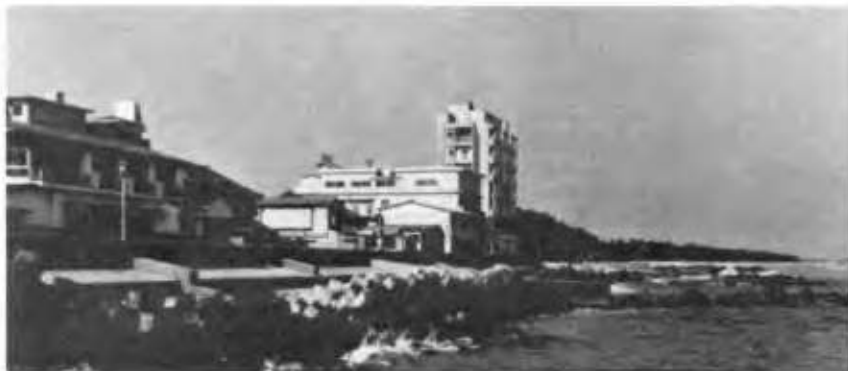
Fig.12 As the wave defence works, armour concrete blocks, named Hexa-leg block, were piled up in front of the seawall. But a number of these blocks have sank under the sea bed (photo in 1970).

After a lull in beach retrogression Kaike coast begun to retreat again in the early 1960's. Incident waves directly struck seawalls and overtopped. In order to reduce wave overtopping, wave defence works composed of artificial concrete blocks were constructed in front of the seawalls.

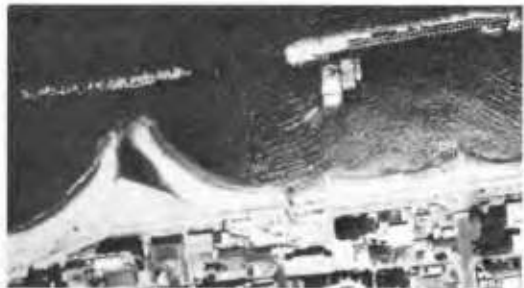
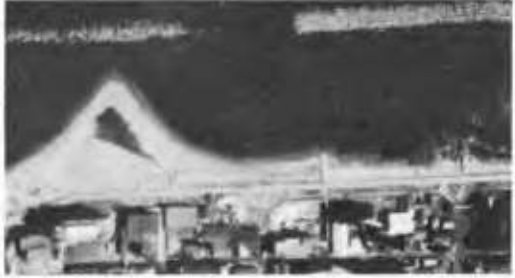
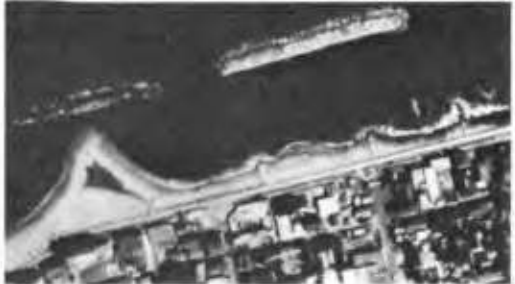
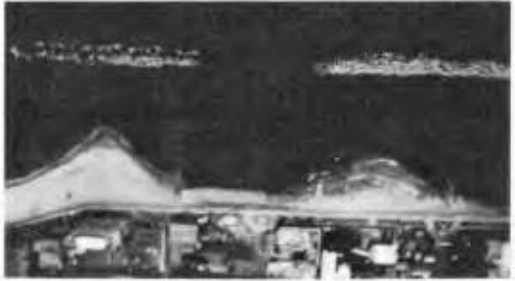
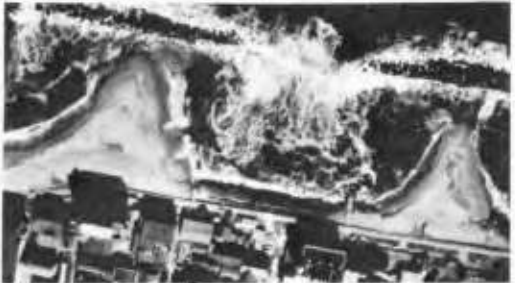
Fig.18 Aerial view of the Nos. 1 and 2 breakwater and tombolos by means of a radio controlled model plane.

1) July 27 '72
No.2 breakwater is under the construction.

- 2) Aug. 24 '72
Just after the construction.

- 3) Sept. 11 '72
Small tombolo appears.

- 4) Sept. 29 '72
The tombolo grows larger gradually.

- 5) March 9 '73
Strong waves attack the breakwaters and tombolos.

6) April 25 '73
The tombolos are stable.

At the Kaike coast, the progress of the construction of the breakwaters and changes in shoreline features have frequently been recorded by means of the radio controlled model plane. From the sequential aerial photographs, we can see the development of the tombolos and the refracting wave patterns due to the breakwaters.

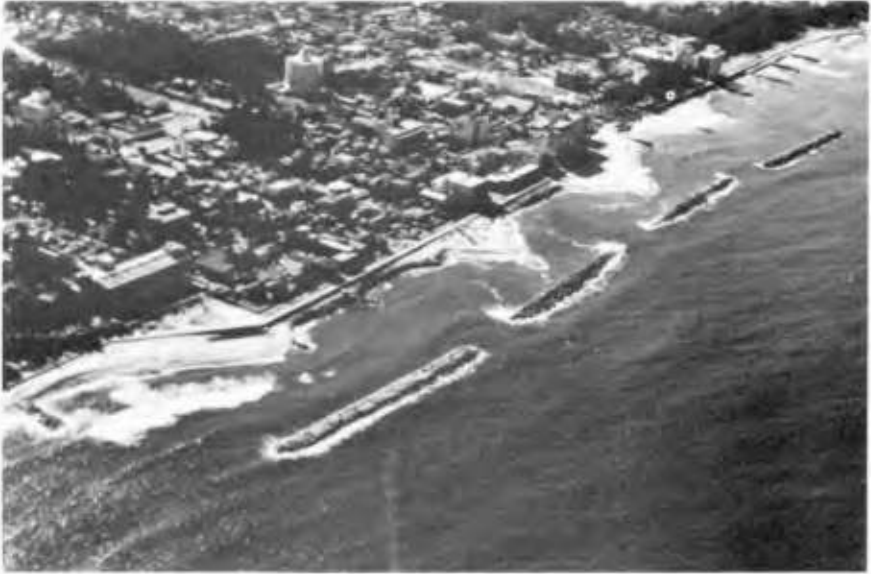
Fig.22 The latest aerial view of the Kaike coast (in 1975).
