Damage Detection in a Laboratory Wind Turbine Blade using Techniques of Ultrasonic NDT and SHM

K. Yang^a, J.A. Rongong^b and K. Worden^{b1}

This paper presents a case study in the use of ultrasonic NDE/SHM techniques for detecting and locating damage in a real (but small) wind turbine blade. Two techniques are considered: (i) nonlinear acoustics, and (ii) guided-wave ‘pitch-catch’ SHM. While the nonlinear acoustics approach proved disappointingly insensitive to damage induced experimentally in the blade, the guided-wave approach not only detected the damage, but proved capable of locating it, using a ‘network of novelty detectors’ methodology. A first, slightly ill-conceived, programme of guided-wave tests actually provided valuable insight into attenuation of waves in the structure of interest and supported the idea that actuator-sensor networks of a feasible density could be used for wind turbine blade SHM.

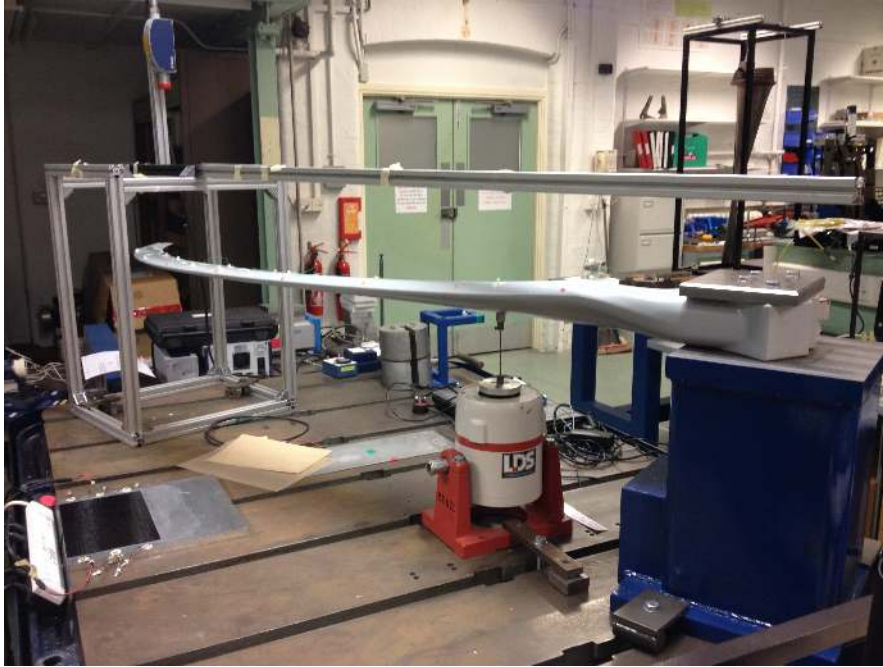
Figure 1: The experimental configuration of the WT blade, showing the geometric boundary conditions.

The structure was clamped at its base, to a substantial frame with four M10 bolts given a torque of 50Nm; this gave fixed-free (cantilever) boundary conditions (Figure 1). For the modal tests, the blade was excited using an LDS VS406 electromagnetic shaker attached to the lower part of the blade through a thin stinger, such that the force was applied perpendicular to the blade surface. The blade response was measured using unidirectional piezoelectric accelerometers, and a standard piezoelectric force transducer was used to record the excitation force. All data acquisition was accomplished using an LMS SCADAS III.

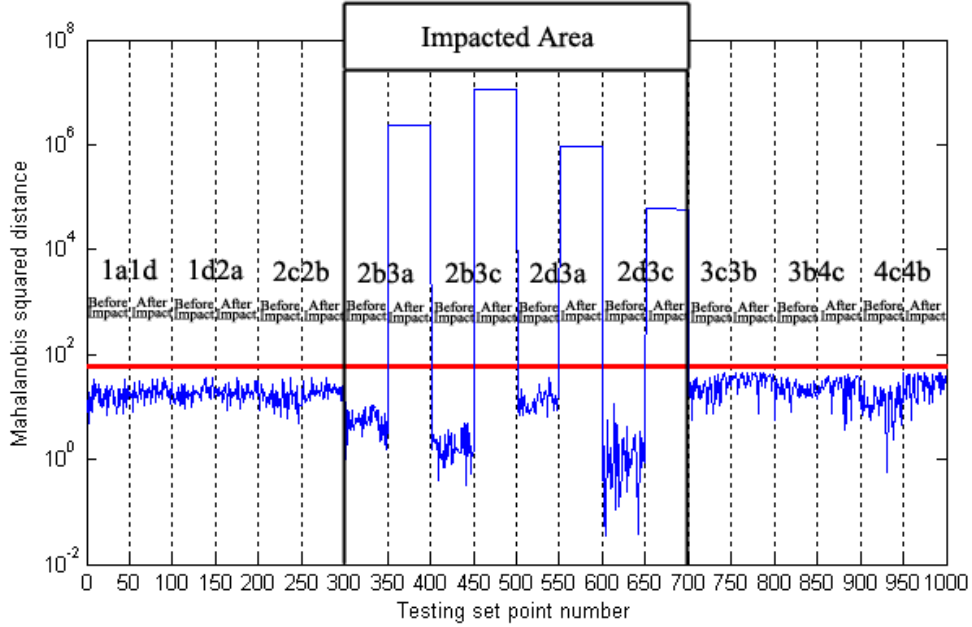
Figure 18: Outlier analysis classification results for the second impact test (‘1a1d’, ‘1d2a’, ‘2c2b’, ‘3c3b’, ‘3b4c’ and ‘4c4b’ indicate sensor groups with reference to Figure 17).

Data were acquired exactly as before with 50 averaged observations in the training, validation and test sets. The results of the outlier analysis are shown in Figure 18. This time, the procedure

shows complete success, both for detection and location. All the validation points are below threshold as required; furthermore, the MSD values for all actuator-sensor pairs which do not cover the damaged region are also below threshold. The MSD values for all actuator-sensor pairs that do cover the damage are all substantially above threshold (note the logarithmic vertical axis in Figure Figure 18). The methodology has thus detected and located the damage unambiguously. Finally, it is important to observe that the trends in the validation results, most visible in the ‘Before impact’ portions of Figure 16, are now absent. This is because the increased interval between actuation pulses is allowing the wavefield to decay between observations.
