Damage of Carbon/Epoxy Composite Plates Subjected to Mechanical Impact and Simulated Lightning

Paolo Feraboli* and Hirohide Kawakami†
University of Washington, Seattle, Washington 98195-2400

Damage is inflicted on carbon-fiber/epoxy composite plates using both simulated lightning strike and mechanical impact in the effort to understand the relative effect of the two damage mechanisms. A methodology is proposed to characterize the damage resistance and tolerance of unconfigured composite plates subjected to lightning strike in a fashion that is consistent with the extensive work previously done on low-velocity impact. Using current and voltage diagnostics, it is possible to extrapolate the amount of electromechanical energy absorbed by the plate during the strike and compare it to that absorbed during a mechanical impact. Damage resistance is characterized by means of ultrasonic C-scans and microscopy, whereas residual strength is measured by means of compression after impact testing. Results show that the energy dissipated in a specimen during the lightning strike is much greater than the strain energy introduced by mechanical impact, and hence a comparison based on energy is not

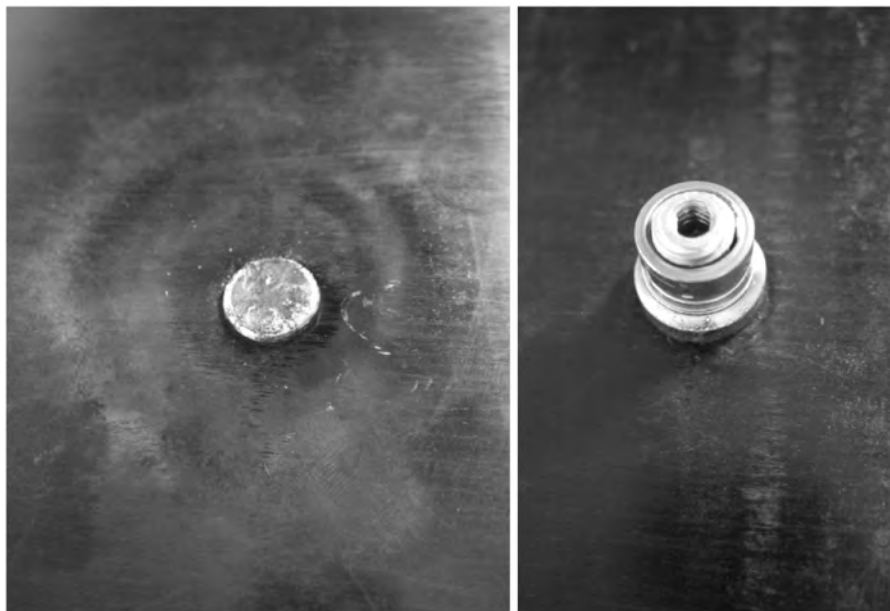
Fig. 6 Close-up of top and bottom surfaces of a filled-hole specimen subjected to a 50 kA strike.

strike takes place (see Figs. 5 and 6). For this material system and stacking sequence, even at 70 kA, only minor bulging of the plies toward the surface is visible in the proximity of the fastener, and modest fiber breakage is observable on both top and backfaces. For mechanical impact, all specimens show a small dent on the side of the impactor, but even at the highest energy values, the dent does not become particularly deep nor leads to visible surface breakage (see Fig. 7).

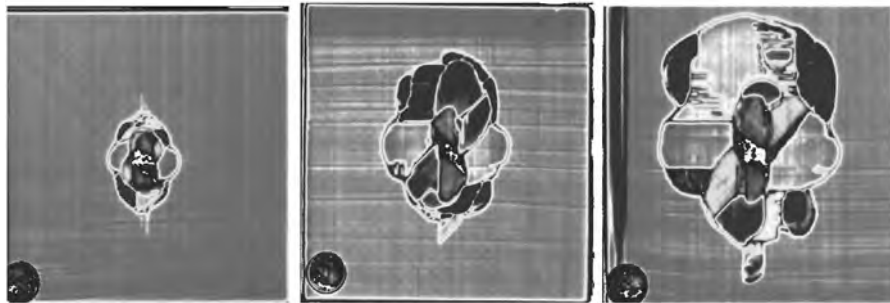
Fig. 9 Ultrasonic C-scan of the postimpact specimens at 5 ft · lb (6.78 J), 15 ft · lb (20.34 J), and 25 ft · lb (33.89 J).

For mechanical impact, ultrasonic images reveal that already at 5 ft · lb (6.8 J), the state of internal damage is quite large, and at 25 ft · lb (33.9 J), it has almost reached the boundaries of the test fixture (see Fig. 9). In general, the projected area of the impact damage is more circular compared to the highly elliptical one of the lightning strike.

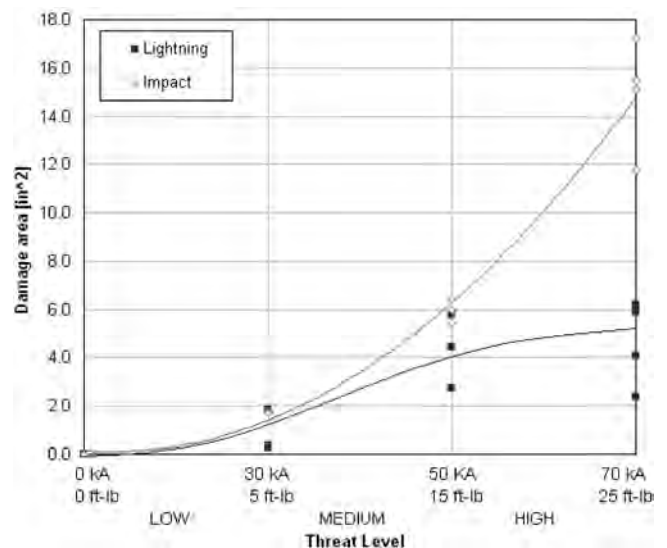
Fig. 10 Projected damage area for impact and lightning strike specimens.

Trends in projected damage area observed for filled-hole specimens subjected to lightning strike and for unnotched specimens subjected to impact damage are reported in Fig. 10. The plot shows projected damage area against severity of threat level, as described in Table 1. Results are summarized in Table 4. In general, the damage because of mechanical impact is much greater than the one caused by lightning strike, and the variation in measured data is much lower. The variability associated to lightning strike damage of filled-hole CFRP specimens is due to the relative fit of the fastener in the plate. Although not easily quantifiable, the degree of fit of the fastener in the hole has a great effect on the resulting damage. If the gap between the fastener and the laminate is sufficiently large, the electrical path is interrupted, and arcing between the fastener and the neighboring plies occurs. This results in a larger damage area. For the lightning strike, it should be noted that between the 50 and the 70 kA strikes, the damage area reaches an asymptotic value. This phenomenon is not easily explained because the variation in results is so high, as discussed just previously. However, a possible explanation is that once the current reaches all plies along the thickness by passing through the fastener, the incremental amount of damage area is so widely distributed that the projected damage area does not increase significantly. It should also be noted that a similar phenomenon is expected to occur, for different reasons, for mechanical impact specimens as well. For values of impact energy higher than tested in this study, a plateau would be reached as the damage area approaches the size of the circular aperture (i.e., the unsupported area).

In general, the residual strength following a mechanical impact is much lower than following a lightning strike of the same threat level. Mechanical impact appears to pose a more severe threat to this particular laminate material and layup, consistently with the greater area of damage reported in Fig. 10. The CAI strength following mechanical impact reaches a plateau between 40 and 50% of the pristine strength, and does not decrease further for increasing impact energy levels. For lightning strike damage, that is not the case, and the residual strength appears to continue to decrease for increasing threat levels and size of damage area.

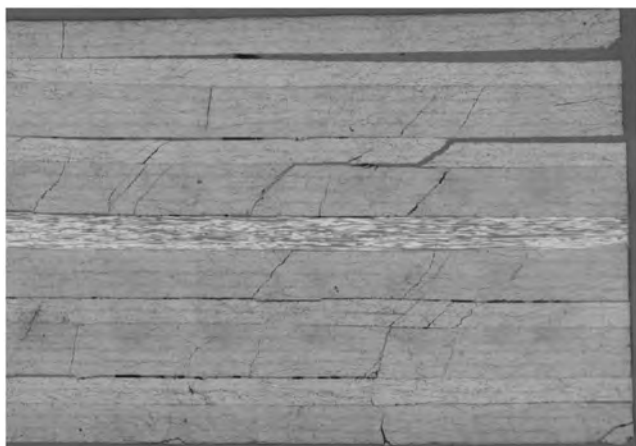
Fig. 15 Detail of the specimen impacted at 15 ft · lb (20.34 J) perpendicular to the 0 deg fibers and underneath the point of impact.

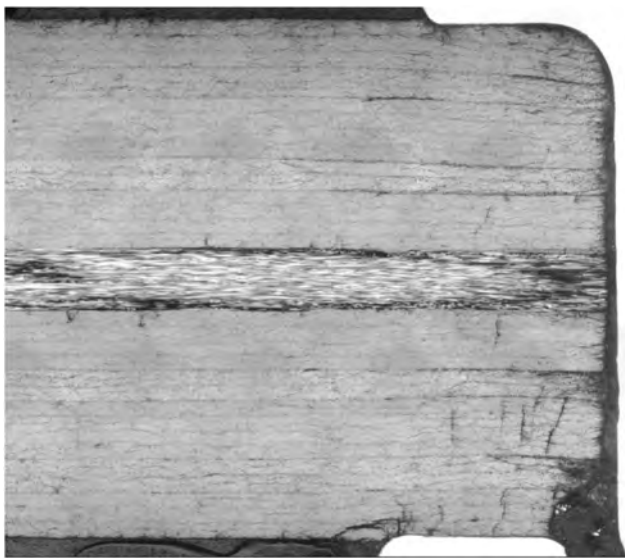
Fig. 23 Detail of the specimen struck with 70 kA, polished perpendicular to the 0 deg fibers in the proximity of the fastener head.

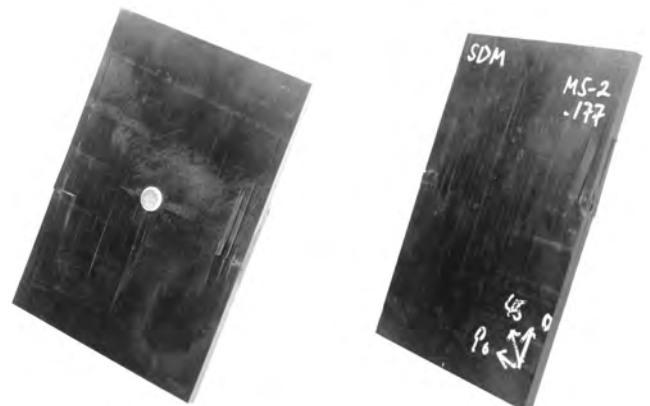
Fig. 25 70 kA lightning strike specimen (left) and 25 ft · lb (33.89 J) impact specimen (right) following residual strength CAI testing.

Fig. 24). For both pristine and filled-hole specimens, strength is calculated based on the gross section area, consistently with aerospace practice [12]. All specimens reported failed in the net section by an acceptable accepted compression failure mode as indicated by ASTM [17] (see Fig. 25).

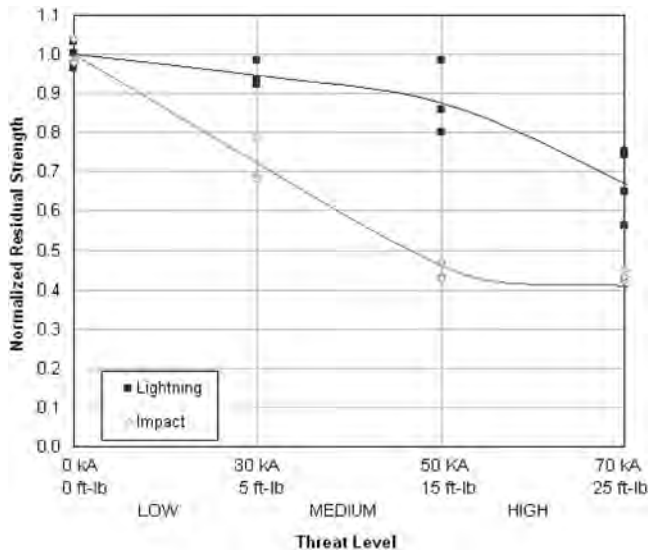
Fig. 26 Normalized CAI strength as a function of threat level for impact and lightning strike specimens.

Results for residual strength are reported in Table 5 and plotted in Fig. 26 against the severity of the threat and, in Fig. 27, against the projected damage area. This plot uses normalized strength values, which are obtained as the ratio of the damaged strength over the pristine or control strength. For impact damaged specimens, the normalized strength is calculated as

Considerations on the relative severity of impact damage and lightning strike damage are based on threat level rather than energy. The energy dissipated in a lightning strike event has been measured by means of current and voltage probes positioned strategically before and after the strike location. However, the amount of energy dissipated in the lightning strike event is an order of magnitude larger than the energy associated with an impact event of similar threat level. This makes the direct comparison of damage resistance and tolerance performance of the specimens subjected to impact and lightning strike threats difficult, as shown in Figs. 28 and 29. On the other hand, comparative evaluations can be performed successfully based on the relative severity of the threat level using impact energy and current intensity, respectively, as key threat metrics (see Figs. 10 and 26).

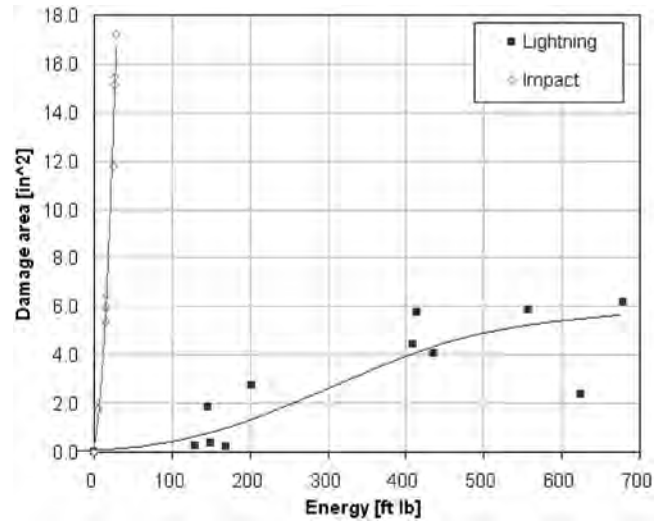
Fig. 28 Damage area for mechanical impact and lightning strike as a function of input energy.

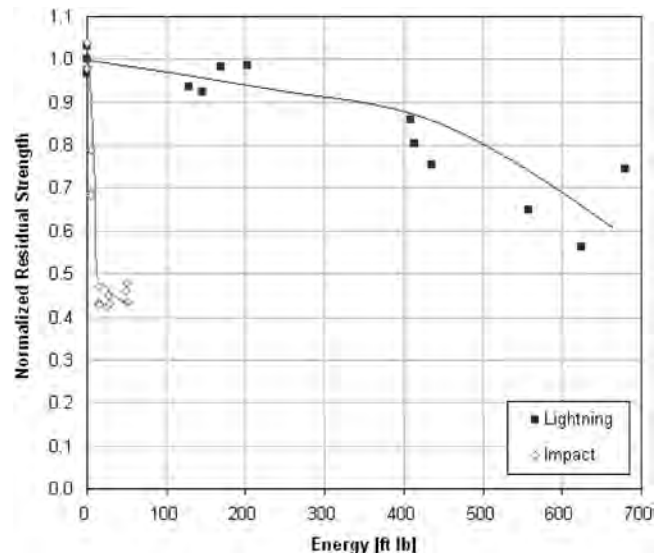
Fig. 29 Normalized CAI strength as a function of input energy for impact and lightning strike specimens.
