Equipment-related Electrocardiographic Artifacts

Causes, Characteristics, Consequences, and Correction

Santosh I. Patel, M.D., F.R.C.A.,* Michael J. Souter, M.B., Ch.B., F.R.C.A.†

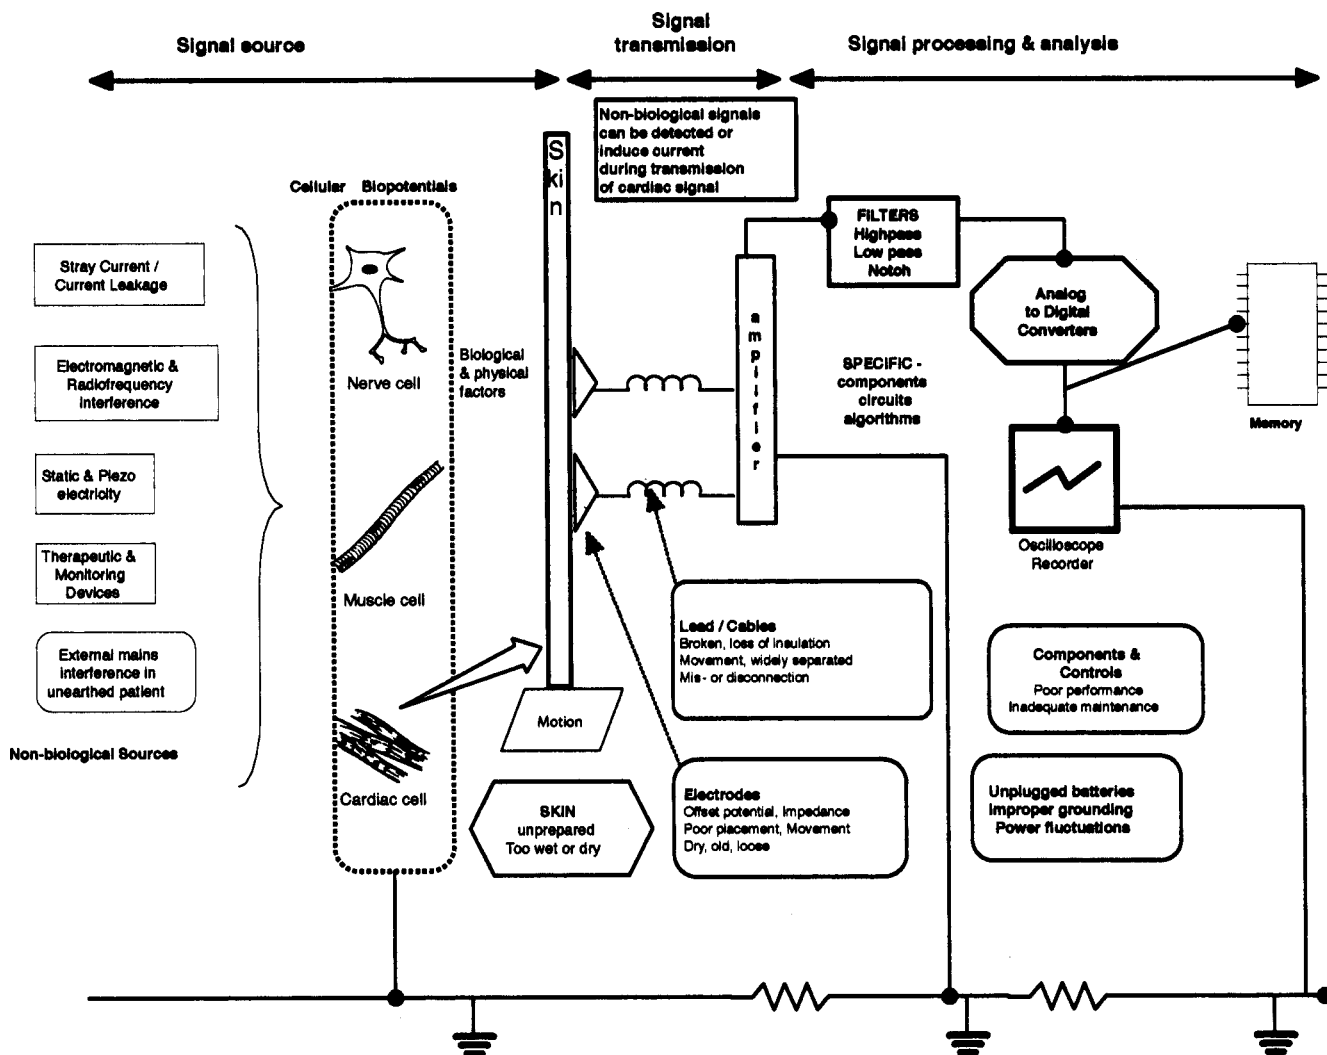
Fig. 1. Factors affecting the transmission of electrocardiographic signal and sources of artifacts.

The output of electrocardiographic electrodes and their leads are amplified, filtered, and displayed by a variety of electronic devices to construct an electrocardiographic display or recording (fig. 1).

[‡] See figure 1.
