Evaluation of Different Non-destructive Testing Methods to Detect Imperfections in Unidirectional Carbon Fiber Composite Ropes

Kim-Niklas Antin¹ · Miguel A. Machado² · Telmo G. Santos² · Pedro Vilaça¹

Abstract

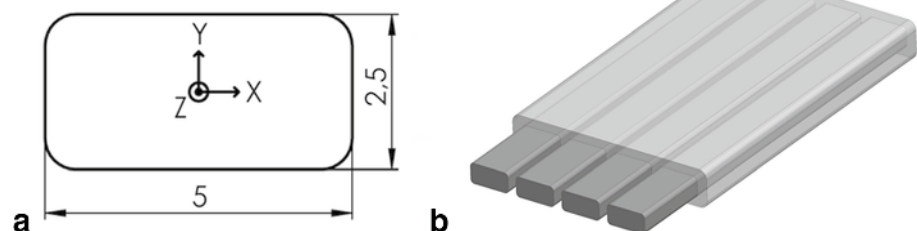
Fig. 1 Geometry of the carbon fiber rope system: **a** dimensions of the cross-section of the individual CFRP elements (in millimeters); **b** 3D perspective of the carbon fiber rope system with four parallel CFRP elements, protected by a polymer coating

The carbon fiber rope is a structural system consisting of four pultruded unidirectional (UD) CFRP elements protected by a polyurethane coating with a thickness of about 1 mm (Fig. 1). Each load carrying CFRP element has a

Electrical resistivity measurements were made on the CFRP elements using different methods. The CFRP bulk resistivity was measured in three directions (XYZ) represented in Fig. 1 using a four-point probe with four tungsten carbide needles, arranged along a straight line and spaced 0.635 mm, d [m], from each other. A current source forced a constant electrical current I [A] through the external needles. A 2182A nanovoltmeter simultaneously measured the voltage V [V] produced between the inner needles. Assuming equally spaced contact points, the resistivity of a bulk material (semi-infinite in lateral dimension and with $t \gg d$) is given by Eq. 1.

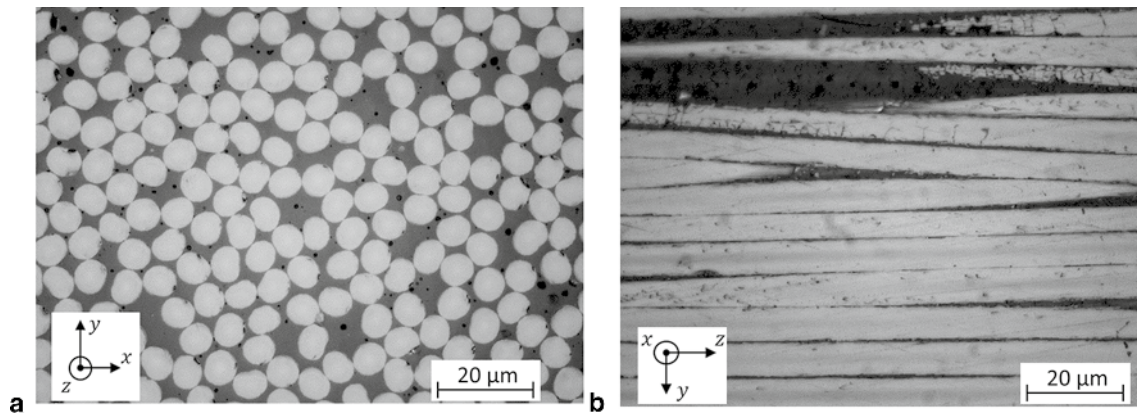
Fig. 2 Micrographs showing the contact between individual carbon fibers: **a** transversal view; **b** longitudinal view

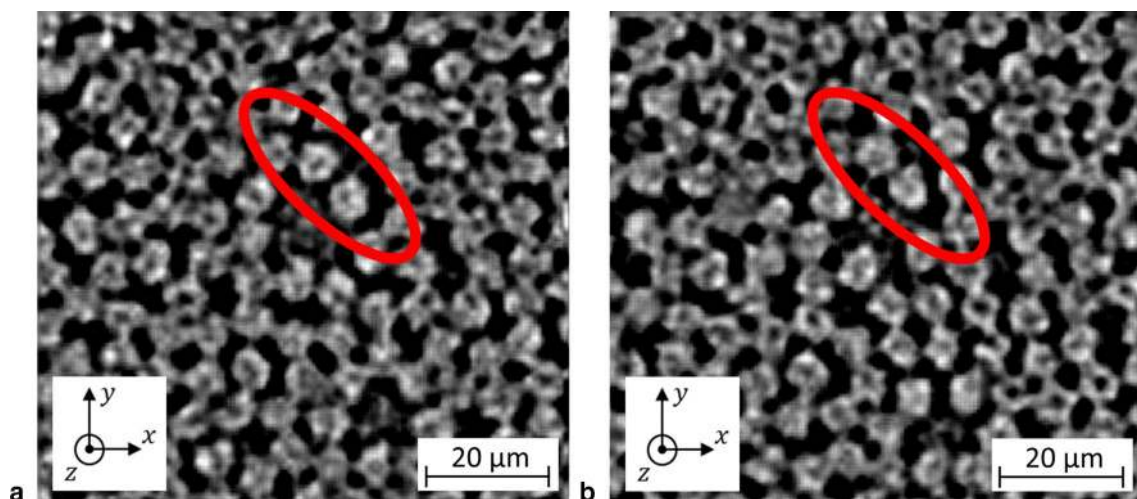
Fig. 3 X-ray microtomography 50 μm apart showing the fiber waviness and contact: **a** transversal section ($Z=0$); **b** transversal section ($Z=50 \mu\text{m}$)

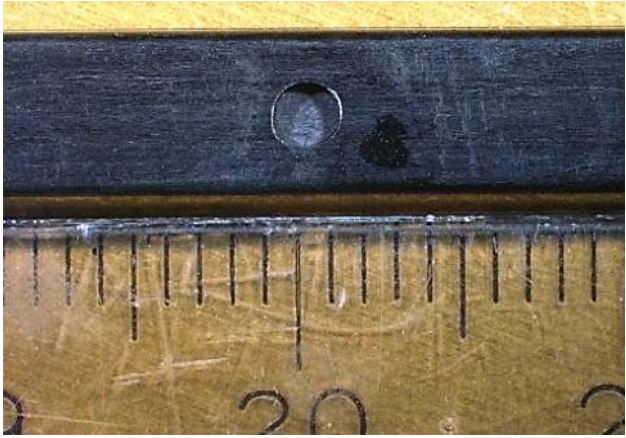
Defect	Type of defect	Picture
A	\varnothing 2 mm flat-bottomed hole defect produced via drilling

The flat-bottomed holes were drilled in the middle of the uncoated CFRP element with a depth of 1.0 mm using a high-speed steel end mill of 2.0 mm diameter. Rotation speed of the tool was set to 1600 rev/min and manual feed was applied in order to exert minimal force on the composite. Ethanol was periodically sprayed on the tool for lubrication and removal of carbon dust. The diameter and

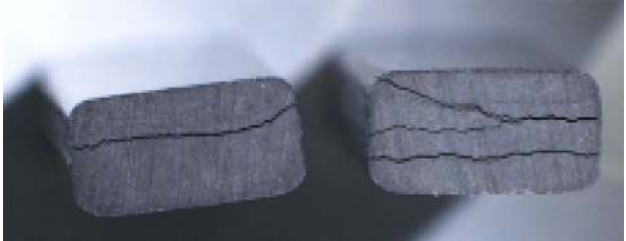
B	Delamination induced via three-point bending

depth of the hole was verified with optical microscopy. The size of machined defects was controllable, and the resulting defects were reproducible. However, they are not very realistic with respect to real-life applications. Therefore, three-point bending was used to induce delaminations. The loading conditions followed International Organization for Standardization (ISO) 14130 [22]. The support span was 12.8 mm and a roller diameter of 6.0 mm was used. The test speed was 1 mm/min and the bending was interrupted when a drop in force was observed, usually accompanied by an audible crack. The delaminations typically extend through the width (X-direction) and in the case of a relatively short sample, they also propagate all the way to one end (Z-direction) of the sample (Table 2). Using longer samples, such as 1000 mm, resulted in delaminations slightly longer than the support span.

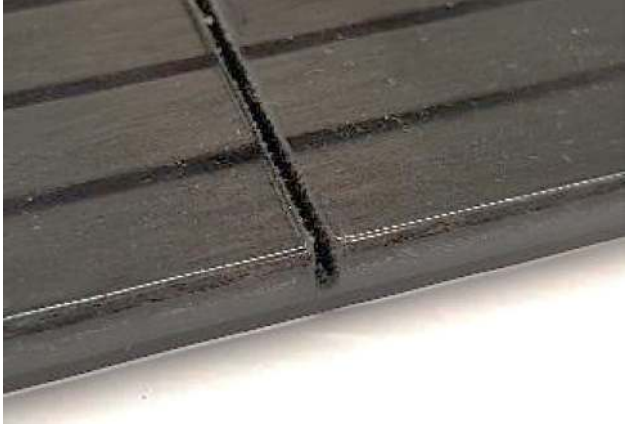
C	In-depth cut with penetration of 1/3 thickness produced via sawing

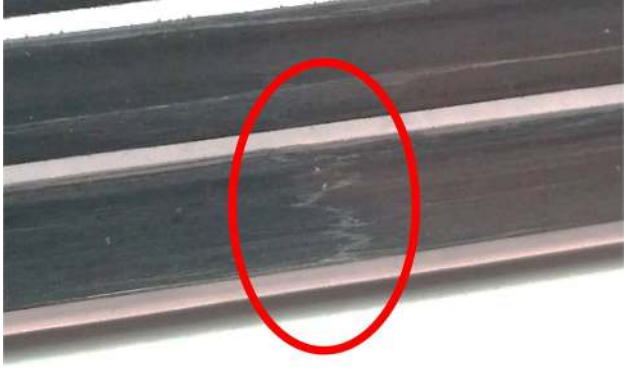
D	Multi-damage induced via low-velocity drop-weight loading (impact damage 15 J)

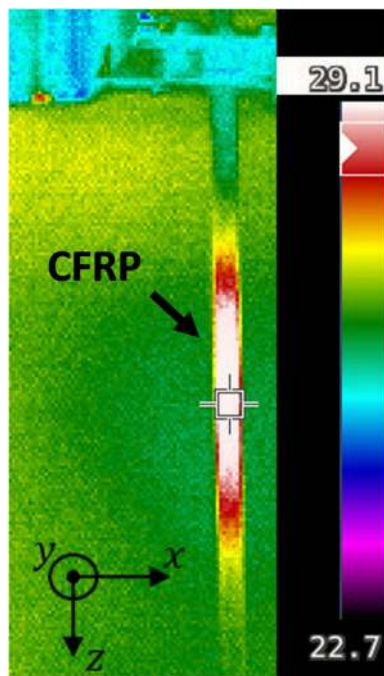
Fig. 6 Thermograph for flat-bottomed hole (defect A) on the backside, showing a local increase in average temperature (°C) during cyclic loading

to delaminations due to a local retardation of the heat flux, which leads to a phase lag of the thermal wave (Fig. 5). Lock-in condition is not necessarily needed if the local stresses are high enough and heat is generated irreversibly within the sample. Simply monitoring the average surface temperature with an inexpensive Fluke Ti32 infrared thermal imaging camera during cyclic loading ($\sigma_{max} = 300$ MPa, $f = 4$ Hz) can reveal large damage. A \varnothing 2 mm flat-bottomed hole with a depth of 1.25 mm causes an increase in temperature of 0.5 K (Fig. 6) whereas an undamaged reference sample showed no significant difference in surface temperature. Thermography did not work for specimens coated with a protective polymer coating (defects C and D in Table 2), because the coating was not transparent to the wavelengths detected by the camera. Thermography is therefore not a feasible online monitoring method for practical applications where a ductile and impact resistant coating is needed to protect the brittle CFRP material.

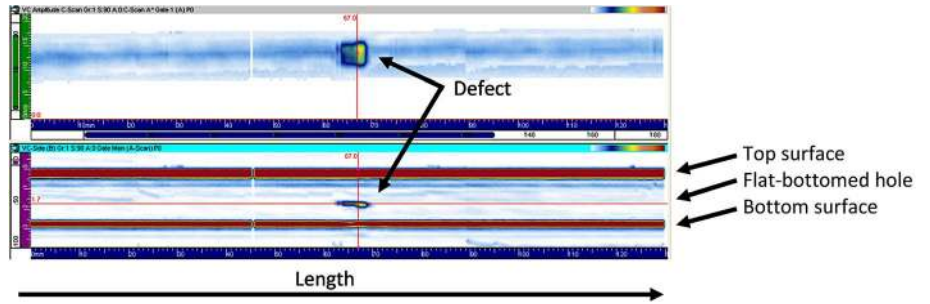
Fig. 7 Results from the ultrasonic testing of sample with hole (defect A): C-scan and B-scan

The damage morphologies and orientation of a flat-bottomed hole in sample with defect A (Fig. 7) and delaminations in sample with defect B (Fig. 8) are especially suitable for ultrasonic inspection, due to the large interface area and therefore clear images of the defects could be generated. The signal from the delamination was stronger than the one from the flat-bottomed hole. The impact damage and sawed cut are less optimal in terms of pulse-echo type inspection executed from the top, but the C-scans reveal damage locations and size accurately (Figs. 9, 10). The saw cut can be seen in all four parallel carbon fiber elements even when the coating causes attenuation of the signal. Although phased array ultrasonics was able to detect all damage types, inspection is relatively slow and requires contact, which makes it cumbersome for online monitoring of non-static ropes, and nearly impossible for high-speed inspection of long ropes.

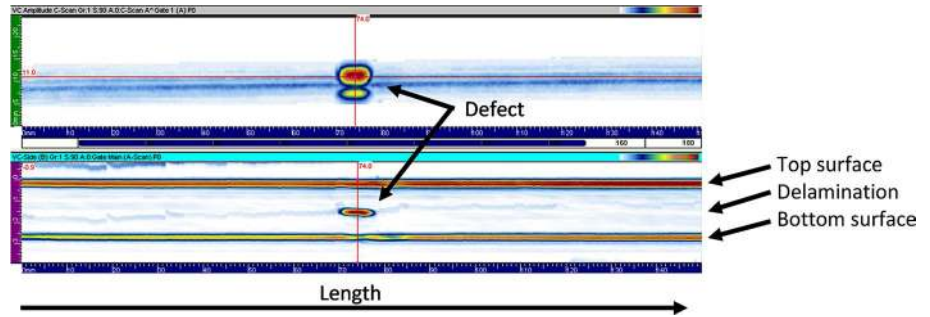
Fig. 8 Results from the ultrasonic testing of sample with defect B (delamination): C-scan and B-scan

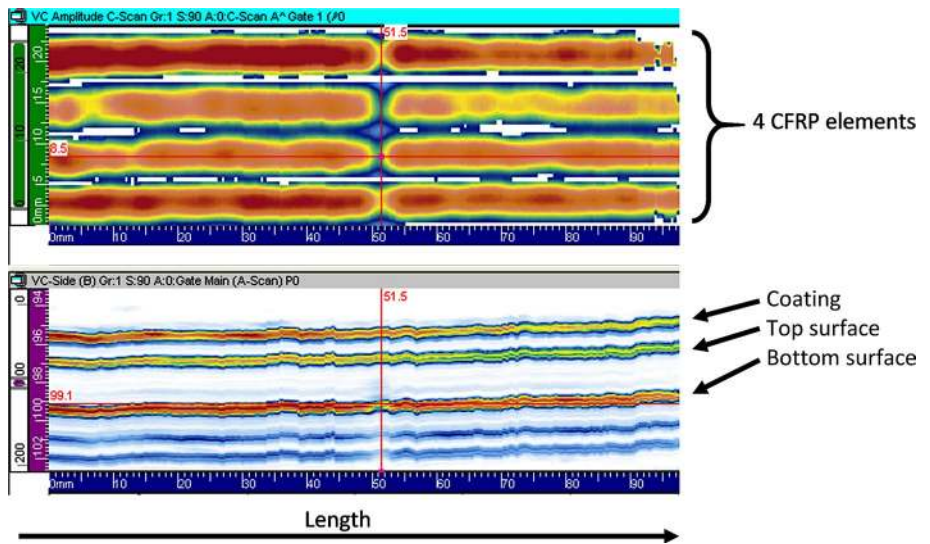
Fig. 9 Results from the ultrasonic testing of sample with defect C (coated rope system with sawed CFRP elements): C-scan and B-scan

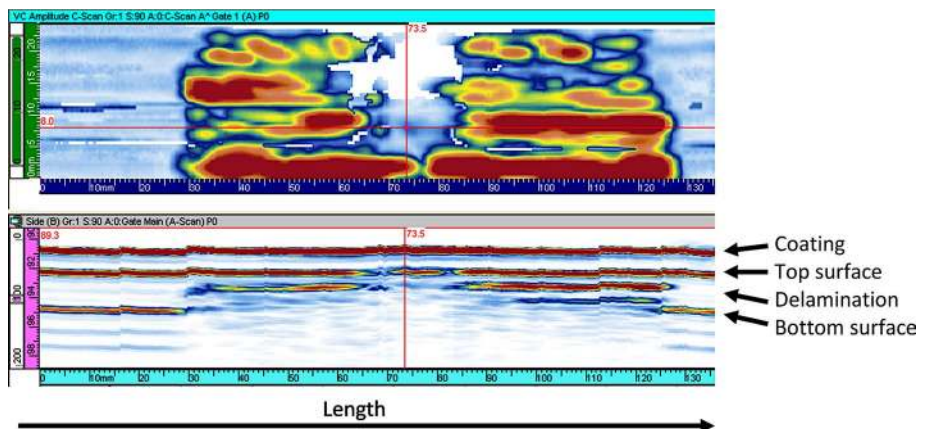
Fig. 10 Results from the ultrasonic testing of sample with defect D (coated rope with impact damage): C-scan and B-scan

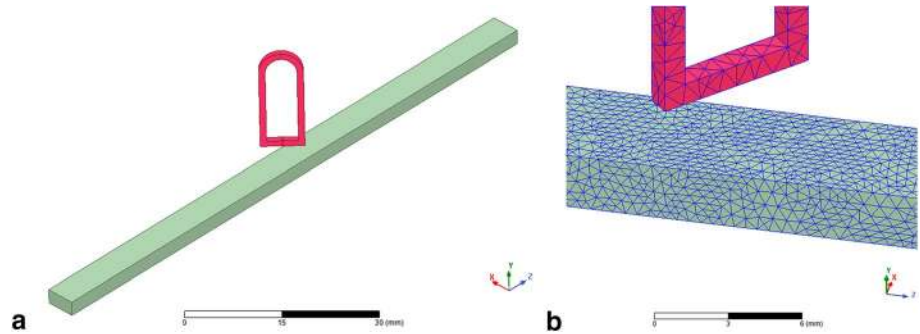
Fig. 11 Geometrical model used in the simulation of the eddy current induced by the excitation filament of the ECT probe: **a** geometric model; **b** mesh representation

Numerical simulation was performed in order to evaluate the behaviour of eddy current in the CFRP material. For this, a numerical simulation software (ANSYS Electronics) was used, and it calculates an approximate numerical solution of Maxwell's equations in their full formulation, Finite Integration Technique (FIT). The simulation comprises of one carbon fiber element and an excitation coil. The element has the same section as the individual CFRP elements, 5 × 2.5 mm, and 100 mm length. The excitation coil was placed 3 mm above the element to allow some clearance even in the presence of a protective coating and 1 A current was used with a frequency of 6 MHz. The excitation element section used was 1 × 1 mm where 10 parallel conductors pass. In Fig. 11 is depicted the model used and the tetrahedral mesh representation which contains 1.700.000 elements with a mesh refinement in the carbon fiber. An isotropic material (aluminium) was first considered in order to understand the different behaviour of eddy current in an isotropic and anisotropic material.

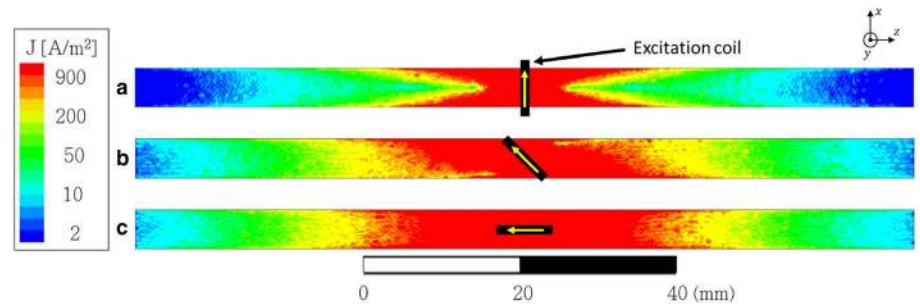
Fig. 12 Field of eddy current density on an isotropic material (Al) with different excitation orientations: **a** Excitation with 90° ; **b** excitation with 45° ; **c** excitation with 0°

Figure 12 shows the current density in one structural element when different excitation orientation are used and

isotropic conditions are assumed (aluminium). The current field is condensed near the excitation coil and is symmetric relative to it. There is a noticeable edge effect in the transversal excitation. Edge effect is a phenomenon that occurs when an inspection coil is at the end of the test piece. In these instances, eddy current flow is distorted, as currents cannot flow at the edge [24].

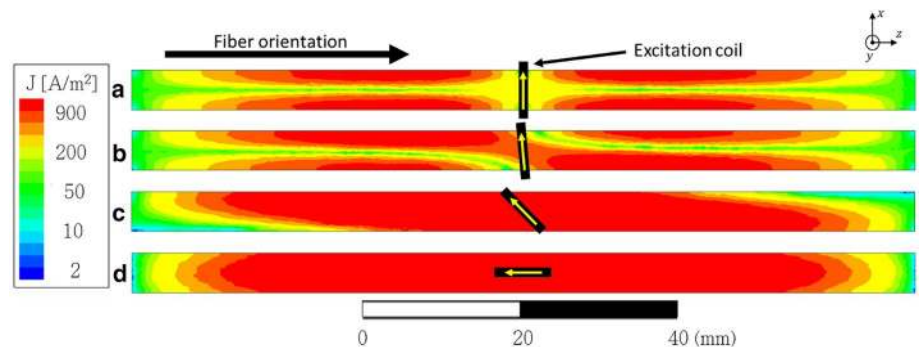
Fig. 13 Field of eddy current density in an anisotropic CFRP material with different excitation orientations: **a** excitation with 90° ; **b** excitation with 85° ; **c** Excitation with 45° ; **d** Excitation with 0°

Figure 13 shows the field of eddy current density in CFRP with different excitation orientations. Four loops are created in the edges of the element and away from the excitation when a transversal excitation is used (Fig. 13a). By applying a small angle (5°) to the excitation, it is possible to observe a preferred flow direction, which is the most conductive direction (Z direction) of the CFRP element. Increasing this angle will facilitate this current flow as depicted. With CFRP, the

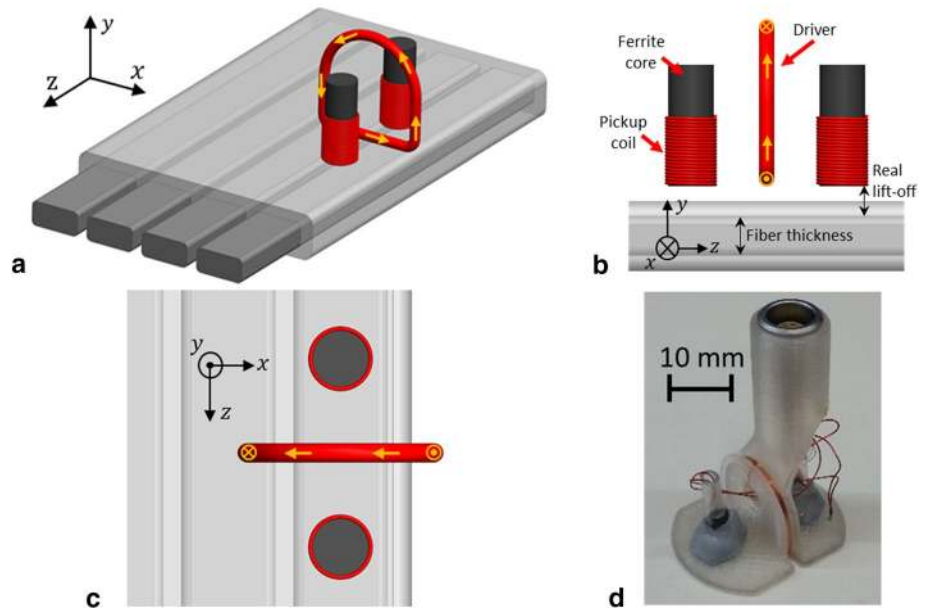
Fig. 14 Description of the ECT probe #1: **a** isometric view of the probe design positioned on the right-side carbon fiber element; **b** side view of the probe design; **c** top view of the probe design; **d** picture of the produced probe

Two probe configurations were designed, produced and validated experimentally for ECT. Probe #1 comprises of one excitation coil composed of 0.1 mm copper wire with 30 windings and two sensing helicoidal coils composed of 0.224 mm copper wire with 20 windings. The excitation windings are transversal to the CFRP elements with a length of twice the width of the element. On each side of the excitation winding there is one helicoidal coil which covers 90% of the element width as shown in Fig. 14. This probe will operate in reflection mode with a differential reading between the two sensing coils.

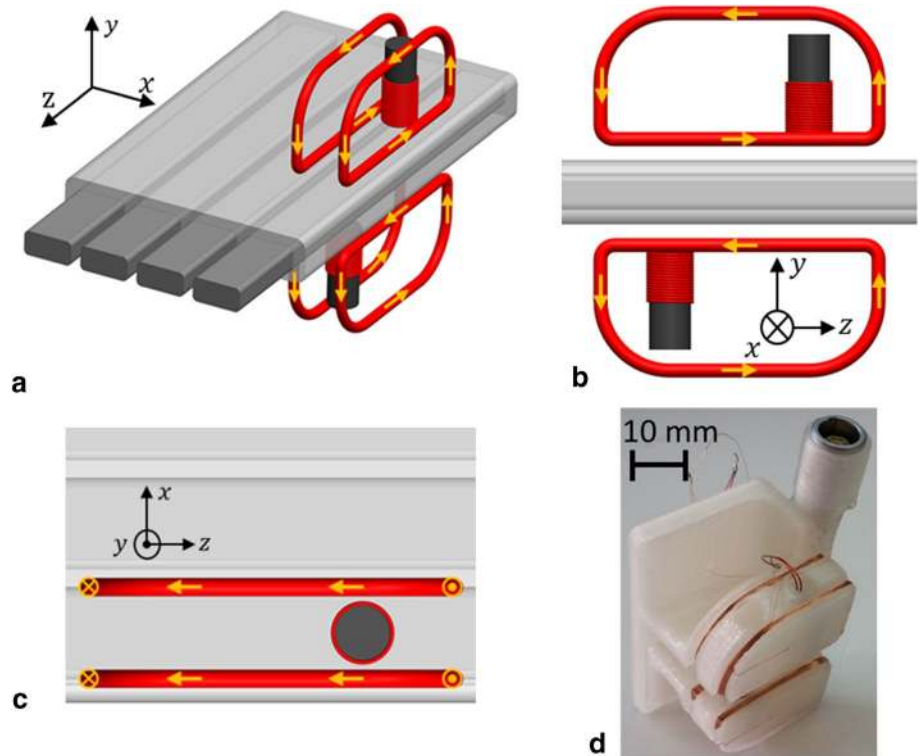
Fig. 15 Description of the ECT probe #2: **a** isometric view of the probe design positioned on the right-side carbon fiber element; **b** side view of the probe design; **c** top view of the probe design; **d** picture of the produced probe

helicoidal coils composed of 0.224 mm copper wire with 20 windings (Fig. 15). There are two excitation windings on the top of the element along each edge, and two on the bottom (one along each edge) and all four windings are parallel to the CFRP rods. All four windings have the same winding direction that will create eddy current in

the material in the same direction at the top and opposite direction at the bottom. This will force a closed eddy current loop inside the element. The probe also has two sensing coils but one at the top and one at the bottom, which will operate in a differential mode. This probe will operate in reflection mode with a differential reading between the two sensing coils.

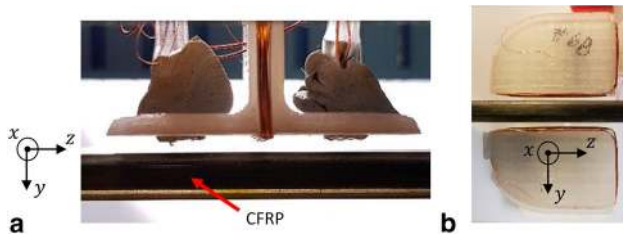
Fig. 16 ECT probes lift-off: a ECT probe #1; b ECT probe #2

Figure 16 shows the lift-off conditions for both probes, i.e. probe distance to the inspected component.

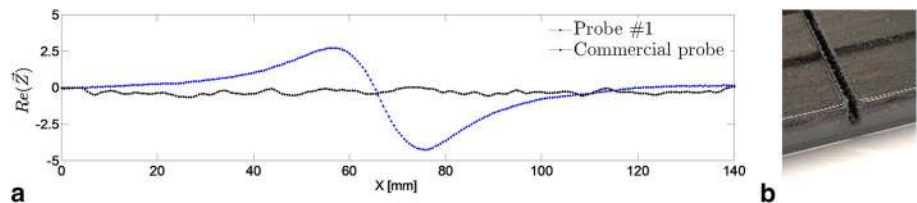
Fig. 17 Output signal of ECT probe #1 inspecting the saw cut sample (defect C) at 4 MHz, assessed from the defective side

Figure 17 depicts one scanned CFRP element with the sawed defect (Defect C) using EC probe #1 at 4 MHz in reflection mode and a commercial pencil probe at 6 MHz in absolute mode. The output signal of probe #1 follows the well-known shape due to the differential sensing arrangement. The sample with the 15 J impact damage was inspected with the same probes and operating parameters. This sample was longer, which allows identifying how high the signal-to-noise ratio is (Fig. 18).

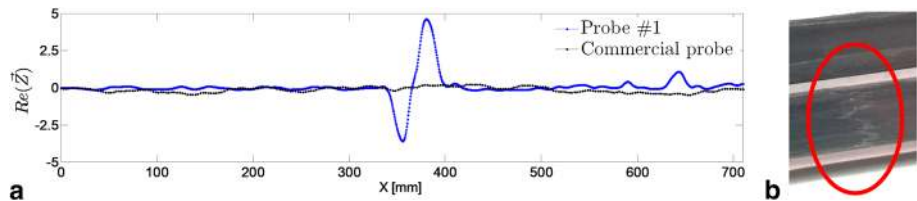
Fig. 18 Output signal of ECT probe #1 inspecting the impact damage sample (defect D) at 4 MHz, assessed from the defective side

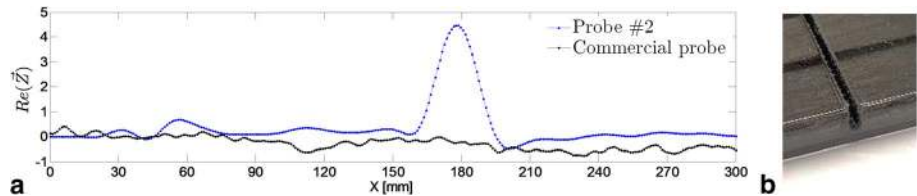
Fig. 19 Output signal of ECT probe #2 inspecting the saw cut sample (defect C) at 4 MHz

reflection mode and the test were done at 4 MHz. In Figs. 19 and 20 are presented the results for the sawed defect and impact defect respectively.

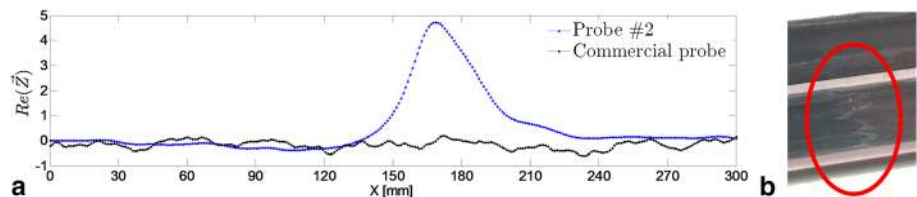
Fig. 20 Output signal of ECT probe #2 inspecting the impact damage sample (defect D) at 4 MHz
