EVALUATION OF LASER-GLAZED PLASMA-SPRAYED THERMAL BARRIER COATINGS UNDER HIGH TEMPERATURE EXPOSURE TO MOLTEN SALTS

Keywords: Hot corrosion; Laser glazing; Plasma spraying; Thermal barrier coatings; Zirconia; YSZ

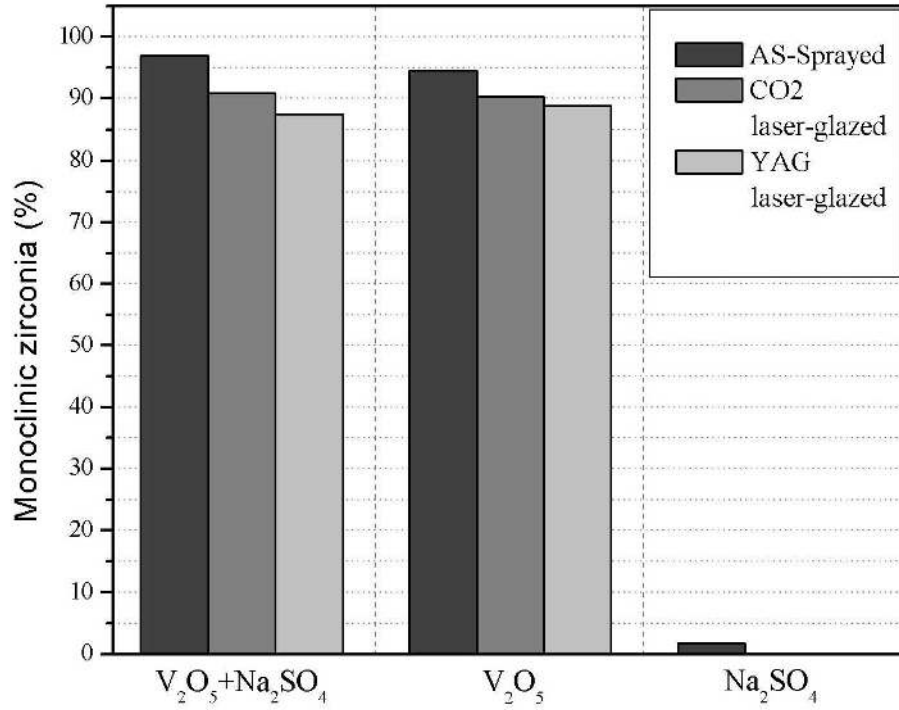
Fig. 5

Fig. 5. Destabilization of zirconia coatings after the corrosion testing at 1000°C during 100 hours. Evaluation of the three sets of specimens: glazed with CO₂ laser, glazed with Nd:YAG laser and as-sprayed condition; tested with Na₂SO₄, V₂O₅ and V₂O₅+Na₂SO₄.

It seems that the molten NaVO_3 has increased atom mobility enhancing the depletion of yttria and hence promoted the growth of YVO_4 crystals. In terms of destabilization and consequent phase transformation the results are quite similar (Fig. 5).
