**Examining the Effect of Cemented Natural Fractures on Hydraulic  
Fracture Propagation in Hydrostone Block Experiments**

**Thesis**

The University of Texas at Austin

**August 2012**

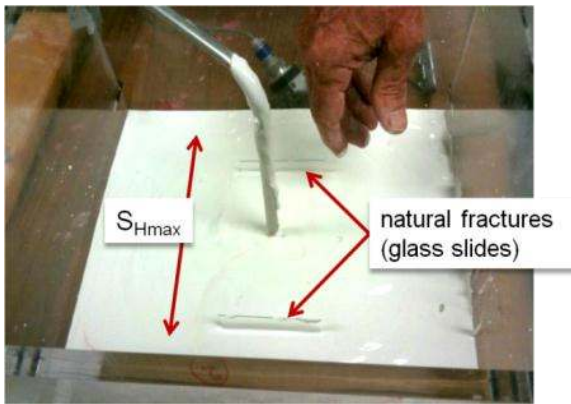
Figure 4. A test block in preparation with two glass slides set in the middle layer of plaster as it is being poured.

The wellbore was made from 3/8<sup>th</sup> inch (outer diameter) copper or aluminum tubing placed in the central area of the block prior to pouring (Figure 4 and Figure 5). To mimic an open hole completion, a nylon tube was inserted through the copper tubing to stick out the end of the wellbore by about 1 inch. To represent perforations, the embedded end of the wellbore was plugged, and nylon strings were threaded out holes drilled in the side of the wellbore. After the block hardened, the nylon strings or tubes were pulled out of the wellbore to leave space for the fluid to initiate a fracture. Natural

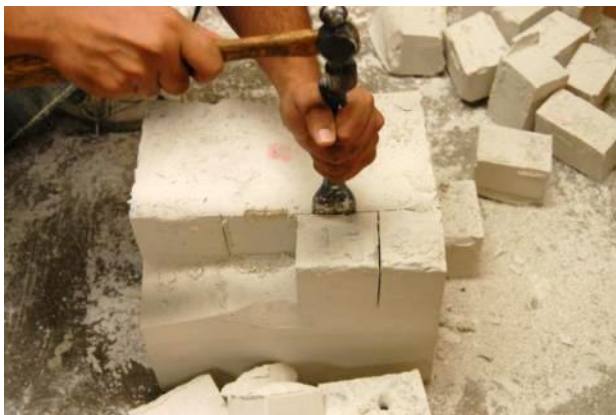
Figure 8. The dismantling of a specimen by chiseling after hydraulic fracturing.

After fracturing a sample, the block was broken open with a hammer and chisel (Figure 8). For more planar fractures, the block easily split open along the fracture with little effort by hammering along the plane of the fracture. However, in the case of more complex fractures, more detailed sculpting was required to uncover the fracture.

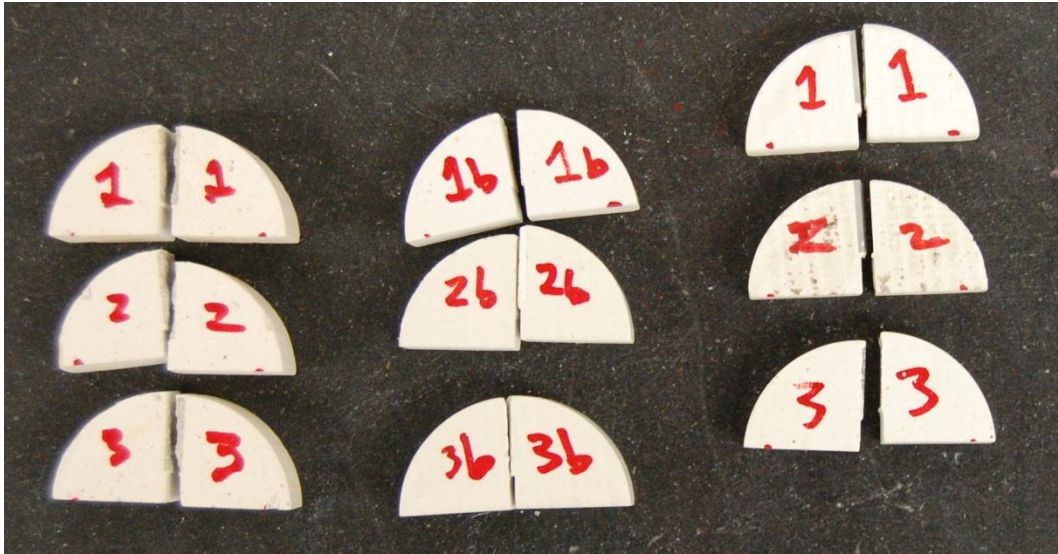
Figure 11. Gypsum plaster SCB specimens after testing. The samples on the left contain Berea sandstone discontinuities. The samples in the middle contain gypsum plaster discontinuities. And, the samples on the right contain glass discontinuities.

Figure 10 depicts a semicircular bending test sample with a sandstone discontinuity, but we also performed tests on samples with glass and plaster discontinuities as shown in Figure 11. We created the SCB samples by pouring gypsum plaster into 0.5 inch high semicircular molds. The bottom of the mold was sealed with tape so that the planar discontinuity would stay in place when we placed it before pouring the plaster. The different discontinuities were cut to the appropriate shape beforehand and the rough edges of the cured samples were ground down to ensure sample uniformity.

Considering that the SCB test equation (Eq. 5) assumes that the sample is homogeneous, we realize that these tests don't give us completely accurate results for the fracture toughness of the Berea-plaster bond and glass-plaster bond. However, in the case of the plaster-plaster samples (the middle column of specimens in Figure 11), the SCB test should give us an accurate result for the fracture toughness of the bond because the inclusion is the same material as the host rock.

As shown in Figure 11, the samples broke down the middle of the specimens. The samples with the plaster discontinuities and the samples with the glass discontinuities showed complete interfacial separation as the cracks propagated along the interface between the discontinuity (natural fracture) and the host rock. However, the samples with the Berea discontinuities cracked mostly through the middle of the Berea discontinuity (there also existed some visible interfacial separation on the face of these cracks). This result seems to indicate that the sandstone is not as tough as the bond between the Berea and the plaster host rock. However, since the fracture toughness of Berea is higher than the fracture toughness of plaster ( $0.28 \text{ MPa}\sqrt{m}$  vs.  $0.12 \text{ MPa}\sqrt{m}$ ), it is more likely that this splitting of the sandstone was due to the mechanical differences between plaster and

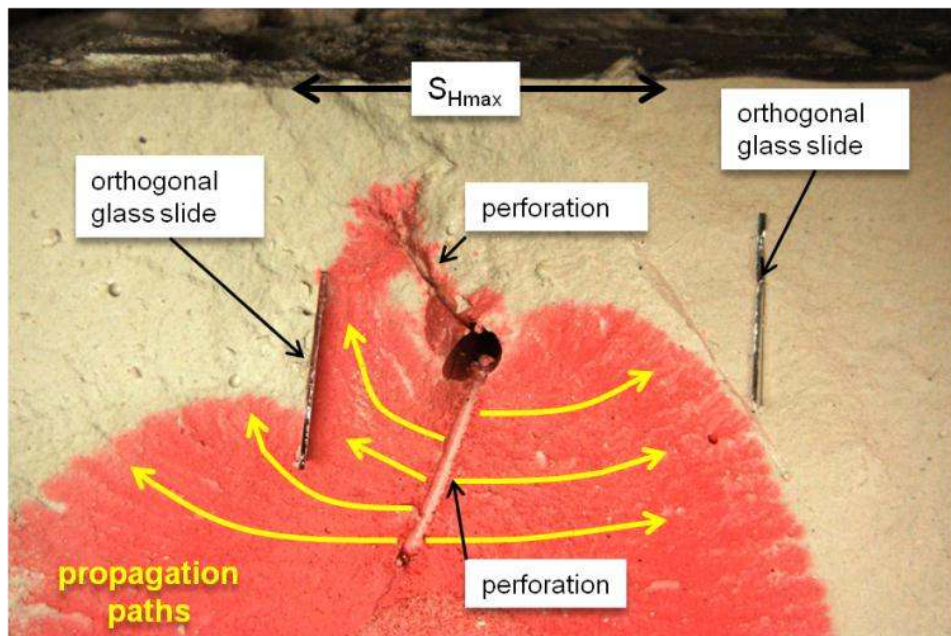
Figure 18. Test 1a exhibiting a hydraulic fracture in the plane of the photo (dyed red) propagating from perforations in that same plane. The wellbore is oriented perpendicular to the plane of the photo as are the glass slides (natural fractures). Yellow arrows represent interpretation of the propagation path of the fracture from the perforation.

Test 1a (Figure 18) is an example of propagation bypass with an orthogonal glass slide as the natural fracture. Since the hydraulic fracture was taller (or at least was free to grow taller), it propagated around the glass slide (a bypass) instead of being diverted down the glass slide (into the page). The photo is taken looking in the direction of the wellbore which was placed parallel to  $S_3$ . The yellow arrows represent the interpreted fracture propagation path based off of the small but noticeable plumose structure on the face of the fracture. The hydraulic fracture initiated from the two perforations in a plane orthogonal to  $S_3$  in a manner analogous to a transverse fracture from a horizontal well. In the process of bypassing the glass slide, the fluid-driven fracture propagates up the back side (away from the wellbore) of the glass slide, which could give the impression that the hydraulic fracture actually crossed the glass slide when it did not.

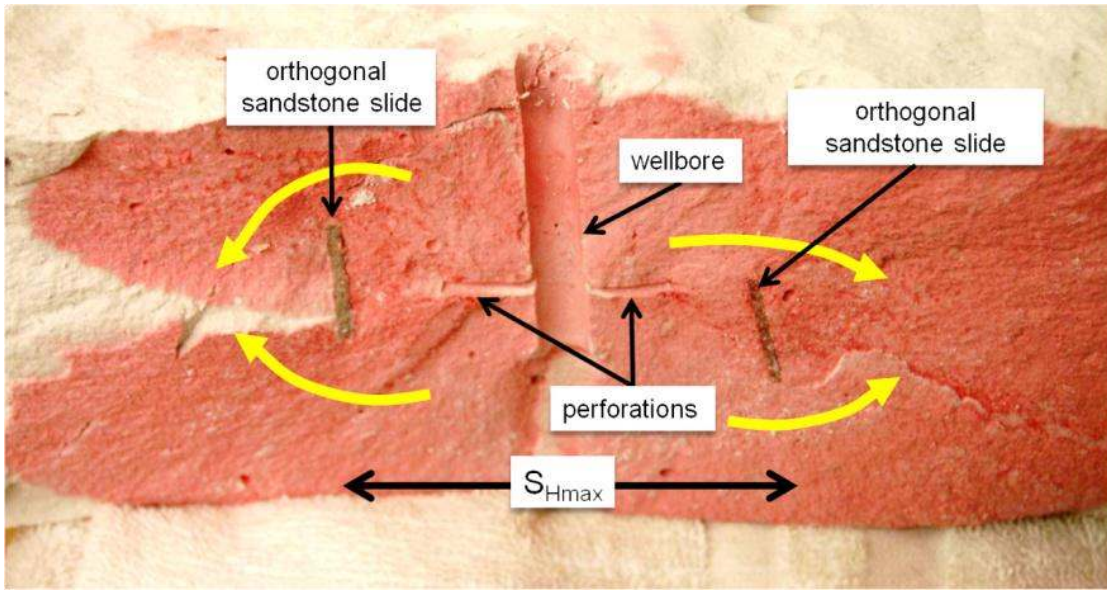
Figure 20. Test 2c exhibiting a hydraulic fracture bypassing two permeable natural fractures (Berea sandstone slides). Yellow arrows indicate interpreted propagation paths. The wellbore is vertical and the main hydraulic fracture propagates in the direction of  $S_{Hmax}$  as expected.

Another example of bypass is illustrated in Figure 20, where a planar fracture propagates around two permeable natural fractures (Berea sandstone slides). The yellow arrows indicate the interpreted direction of the propagation bypassing the natural fractures which are orthogonal to the hydraulic fracture propagation. We see evidence of bypass from the plumose structure seen on the face of the hydraulic fracture. The permeability of the Berea sandstone used was about 100mD whereas the permeability of the gypsum plaster (the host rock) was measured to be 57mD (Table 2). We performed 3 tests with Berea sandstone slides. We set each test up with a similar orientation of natural fractures, but we ran each test at a different horizontal differential stress. The test in Figure 20 was run at 15psi horizontal differential stress, and the other two tests were run at 30psi and 50psi respectively (see Table 3). Bypass in conjunction with separation of weakly bonded interfaces was observed in all three samples.

Figure 29. Part a) depicts a top view sketch of the hydraulic fracture shown in Figure 20. The red arrows show the shear on the natural fracture plane due to the opening of the perpendicular hydraulic fracture. The hydraulic fracture is shown in yellow and the hydraulic fracture crack width is greatly exaggerated for visual purposes. The zoomed portion of part a) shows how the shear is applied perpendicular to the crack front at the right edge of the glass slide. Part b) shows a top view of the fracture intersection in Figure 20 (Test 1c).

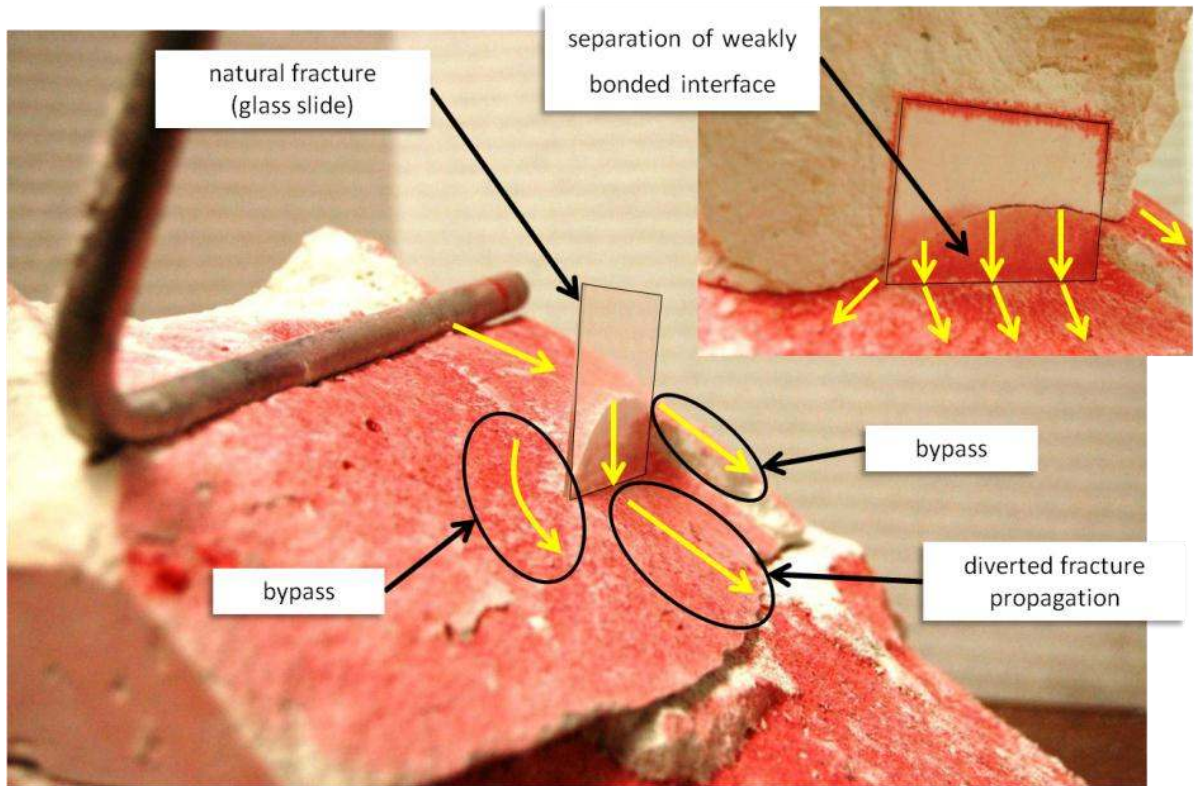
Figure 22. Test 1b exhibiting complex propagation paths with bypass around glass slide as well as diverted fracture propagation (inset shows that interfacial separation only happens in the direction away from the wellbore). The bypassed and diverted paths meet up on other side of glass slide away from wellbore. Wellbore placed parallel to the direction of  $S_3$  ( $S_{Hmin}$ ). The main hydraulic fracture propagated horizontally (perpendicular to  $S_1$ ) which was unexpected.

In the case of Figure 22 (test 1b – horizontal fracture), the hydraulic fracture propagates into the glass slide at an oblique angle, but the fracture is much wider (taller) than the glass slide, so the fluid-driven fracture can easily bypass around the slide. However, along the intersection line, the fluid keeps flowing between the glass slide and the gypsum plaster (see Figure 22 inset) only along the path leading further from the wellbore (the acute angle path where  $|\theta| < 90^\circ$ ). When the diverted portion of the fracture

following the glass slide reaches the edge of the slide, it kinks along a path that meets up with the bypassing fracture segment, coalescing back into one larger fracture. The inset of Figure 22 also shows that the fluid leaked completely around the perimeter of the glass slide (see the red outline along the top edge of the glass slide), but we don't consider that part of the fracture propagation process. The white portion of the rectangle in the inset indicates the fracture did not grow through that region.

pressures (see fracture pressure value compared to  $S_{hmin}$  in Figure 23). Most of our tests were conducted with a vertical wellbore (see Table 3). None of the tests with vertical wellbores produced a horizontal fracture whereas one of the two tests we conducted with horizontal wellbores produced a horizontal fracture.

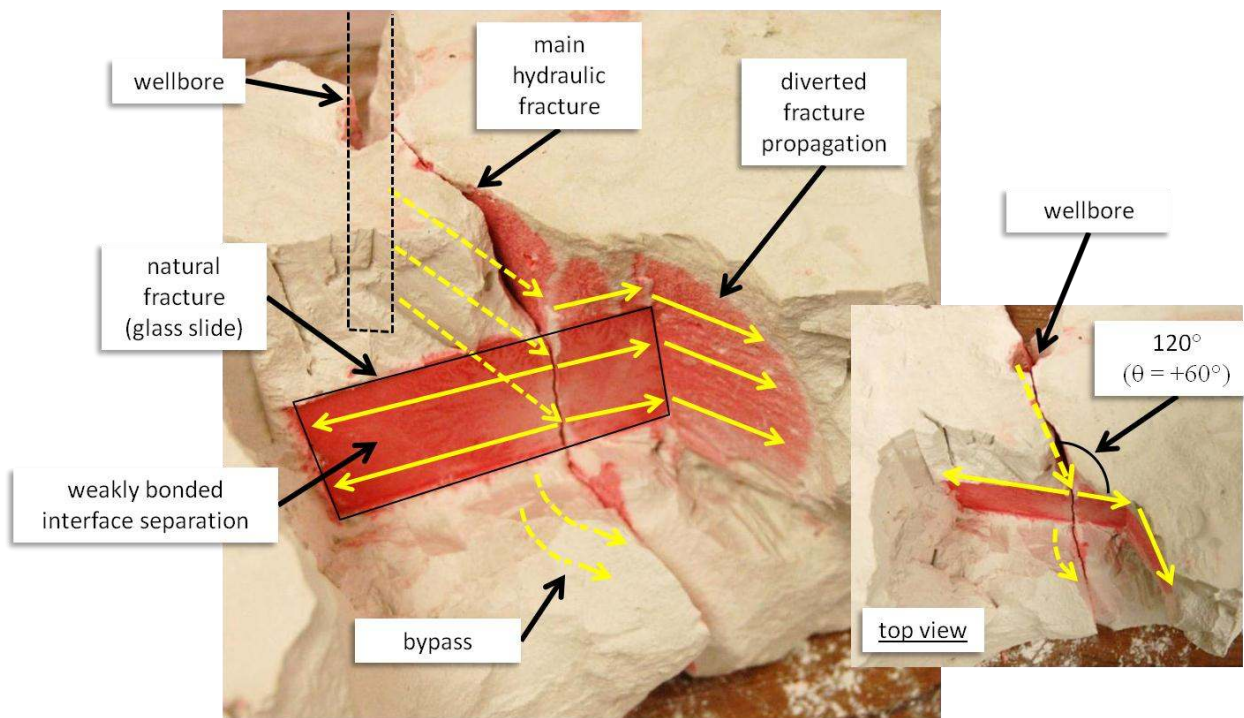
Figure 24. Test 1c exhibiting complex vertical propagation paths including bypass around glass slide as well as diverted fracture propagation. The inset shows a top view of the hydraulic fracture so the angle of intersection ( $\theta = 60^\circ$ ) can be easily seen. The wellbore is vertical and the main hydraulic fracture propagates in the direction of  $S_{Hmax}$  as expected.

In Test 1c, there was initial bi-wing propagation from the wellbore. In one direction was an obliquely oriented natural fracture and in the other was an orthogonally oriented one. In the oblique case (Figure 24), a complex intersection geometry developed involving bypass and diverted propagation kinking off of one end of the natural fracture (glass slide). The hydraulic fracture is taller than the natural fracture which allows for the bypass underneath (see Figure 25 for a closer view of the full hydraulic fracture face). The angle of intersection can be seen from the inset to be acute where  $\theta = 60^\circ$ . The inset shows the angle to be  $120^\circ$ , but that is not the angle of intersection ( $\theta$ ) as we defined it (see Figure 13). As seen, the hydraulic fluid separates the weakly bonded interface between the glass slide and the gypsum plaster in both directions after intersection. However, the propagation only continues from the end of the natural fracture that is located farthest away from the wellbore.

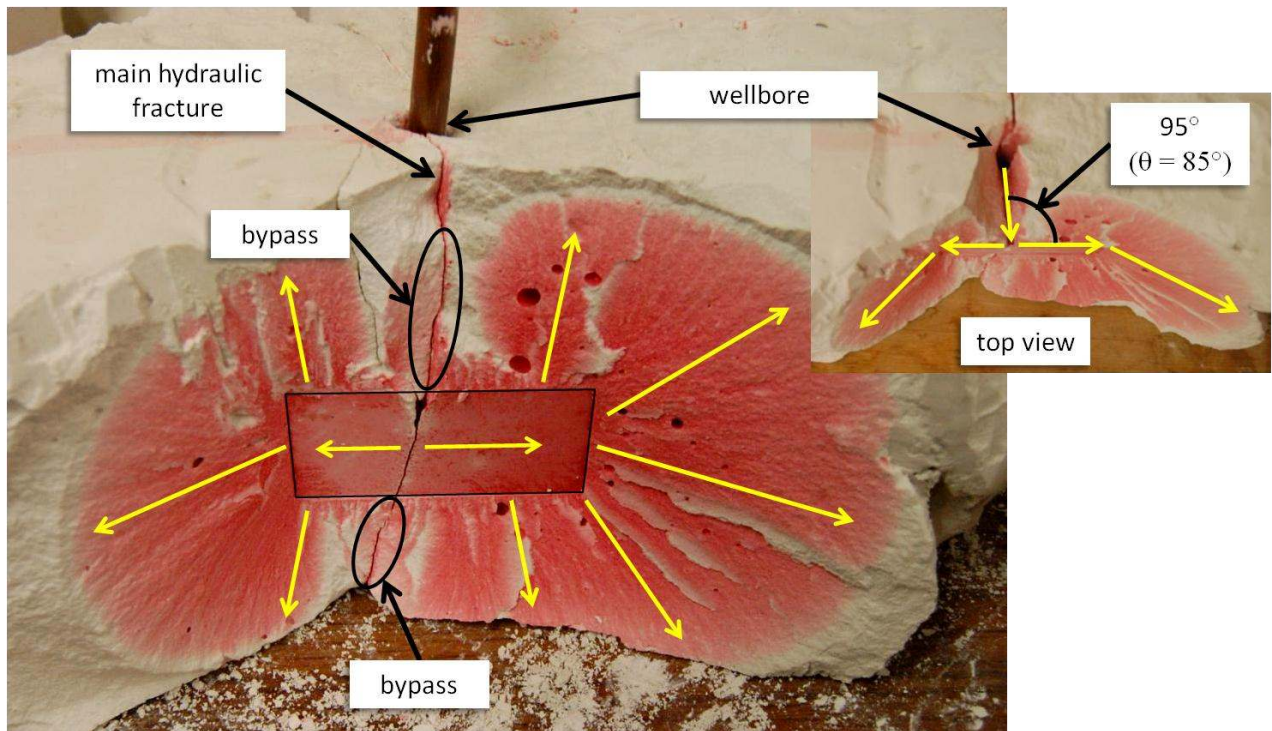
Figure 27. Test 1c exhibiting complex propagation paths including bypass above and below the glass slide as well as diverted fracture propagation off of all four edges of the glass slide which is roughly orthogonal to the direction of the main hydraulic fracture. The inset shows a top view of the hydraulic fracture so the angle of intersection ( $\theta = 95^\circ$ ) can be easily seen. The wellbore is vertical and the main hydraulic fracture propagates in the direction of  $S_{Hmax}$  as expected.

In the orthogonal case for Test 1c, the complex propagation involved bypass above and below the glass slide as well as diverted fracture propagation kinking off all four edges of the glass slide (Figure 27). The inset of the figure shows a top view of the hydraulic fracture indicating the angle of intersection ( $\theta = 95^\circ$ ). It is interesting to note that the fracture geometries for lateral propagation from the vertically oriented natural fracture tips and vertical propagation from the horizontally oriented natural fractures tips have very different geometric character, exemplifying mixed mode I-II and mixed mode I-III (Figure 28), respectively (Cooke and Pollard, 1996).

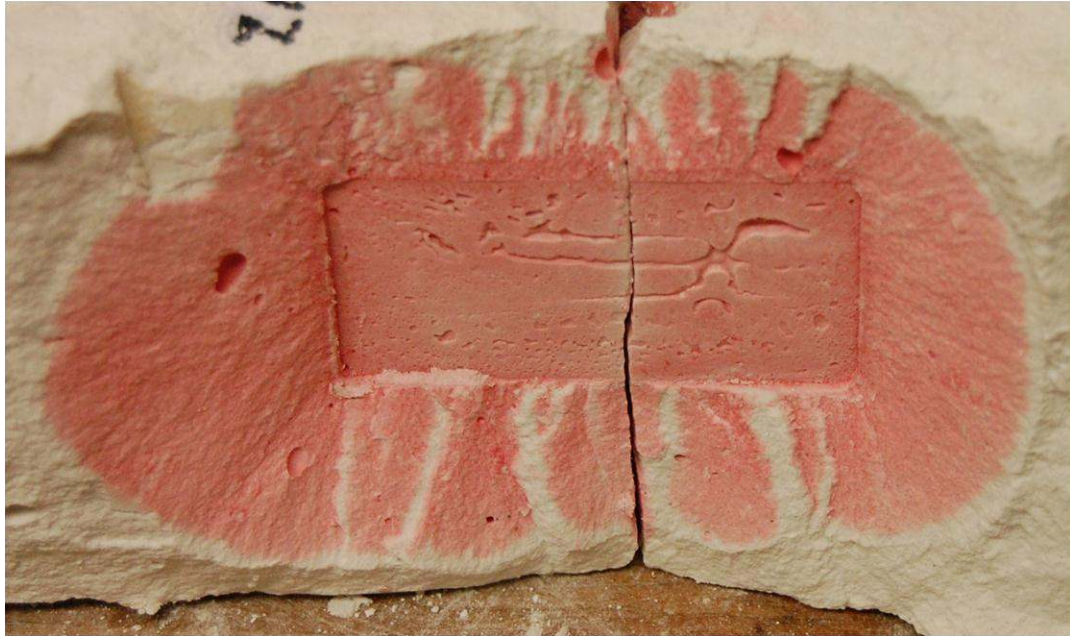
Figure 31. Test 3a exhibiting a roughly orthogonal intersection between a hydraulic fracture (propagating out of the page) and a plaster slide (seen by the rectangular outline). There is mode I-II propagation to the right and left of the natural fracture, and there is mode I-III propagation above and below the natural fracture. As seen, the mode I-III en echelon cracks propagate in directions that are mirror images of each other across the hydraulic fracture / natural fracture line of intersection.

The fracture intersection geometry in Test 3a (Figure 31) was very similar that in Test 1c (Figure 30) even though the natural fractures were completely different (Test 1c contained glass slides and Test 3a contained plaster slides). In general, the types of intersection geometries we observed did not seem to be functions of the natural fracture composition. Rather, the intersection geometries we observed were functions of angle of hydraulic fracture / natural fracture intersection,  $H_{HF}/H_{NF}$ , and the horizontal differential stress.

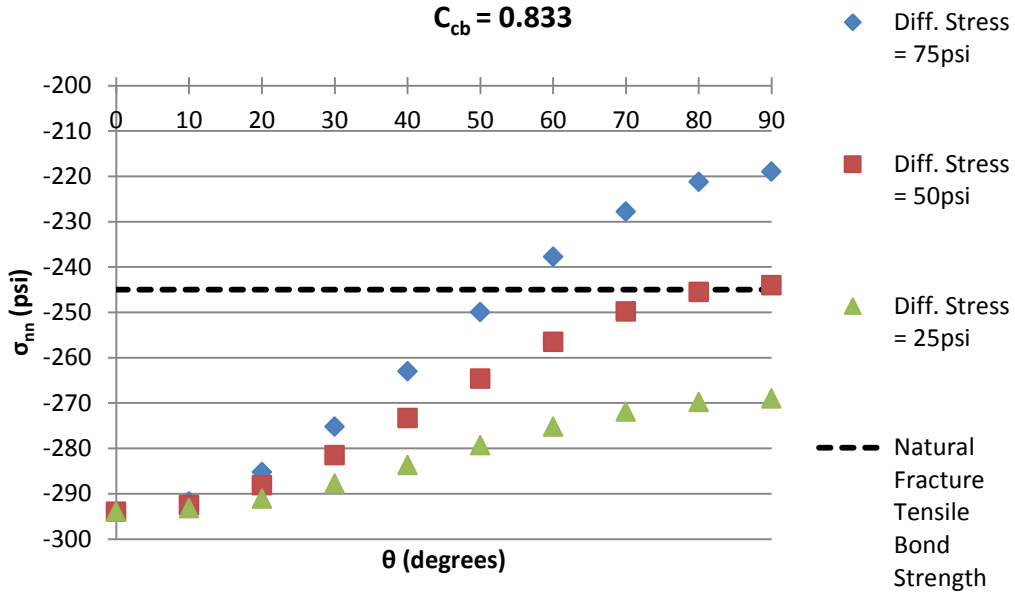
Figure 34. Normal stress on natural fractures is plotted vs. angle of intersection for a strong cement bond ( $C_{cb} = 0.833$ , compression is positive). The three different sets of points have different horizontal differential stress values as shown in the legend. The dashed line represents the estimated tensile strength of the plaster-plaster bond (245 psi).

Figure 34 was generated with appropriately scaled confining stress ( $S_{Hmin} = 125$  psi) and higher differential stress (25psi, 50psi, and 75psi). The dashed line represents the estimated tensile strength of the plaster-plaster bond (245 psi). If a point falls below the dashed line, then the tensile crossing criterion equation (Eq. 7) predicts that the natural fracture bond will fail in tension before the hydraulic fracture reaches a distance of  $r_p$  from the natural fracture which will prevent crossing. Assuming a cement bond factor ( $C_{cb}$ ) of 0.833, Figure 34 shows that crossing will not occur at all when the differential stress is 25 psi. However, Figure 34 also shows that crossing should occur when  $\theta > 85^\circ$  for a differential stress of 50 psi, and that crossing should occur when  $\theta > 55^\circ$  for a differential stress of 75 psi. If the cement bond factor ( $C_{cb}$ ) is smaller, the likelihood of crossing dramatically decreases.
