# Article Failure Prediction and Surface Characterization of GFRP Laminates: A Study of Stepwise Loading

Abstract: The present study explores the failure and surface characteristics of Glass Fiber-Reinforced Polymers (GFRP). Stepwise loading was applied in this study to understand the multi-static loading effect on the laminates before final failure. The loading was set three times to reach 10 kN with loading-unloading movement before final load until failure. The results showed that the angle of the GFRP UD laminates' position significantly impacts the system's failure. The results were analyzed using theoretical calculation experiment analysis, and then the failure sample was identified using ASTM D3039 standard failure. The laminates with  $0^{\circ}$  layer on edge ( $[0/90]_{S}$  laminates) underwent preliminary failure before final failure. The mechanism of stepwise loading can be used to detect the effect of preliminary failure on the laminates. The  $[0/90]_{\rm S}$  laminates are subjected to stress concentration on the edge due to fiber alignment and discontinued fibers in the 0-degree direction. This fiber then fails due to debonding between the fiber and the matrix. Th

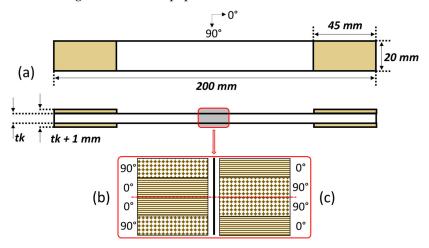
**Figure 1.** Specimen configuration. (**a**) ASTM D3039 dimension. (**b**) Layer configuration of [90/0]<sub>S</sub>. (**c**) Layer configuration of [0/90]<sub>S</sub>.

The specimen's geometry is based on the ASTM D3039 standard. Detailed dimensions of the specimen can be seen in Figure 1a, with the thickness of the sample being 3 mm. Two different stacking sequences of GFRP laminates were manufactured with the size  $200 \times 200 \text{ mm}$ —[90/0]<sub>S</sub> and [0/90]<sub>S</sub>—as shown in Figure 1b,c. Specimens were placed at room temperature for 24 h before being cut to ensure the laminates were fully cured. The specimens were tapped with 0.5 mm aluminum and glued with the epoxy to allow bonding between GFRP and aluminum after the surface of the aluminum and GFRP was sanded using P250 abrasive paper.

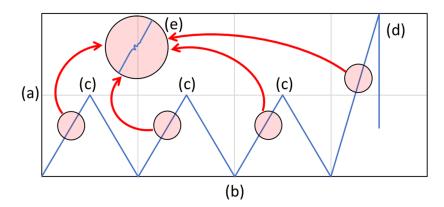
**Figure 2.** Stepwise loading applied in the present study. (a) Load (N). (b) Time (s). (c) Load limitation (10 kN). (d) Ultimate load (N). (e) Early failure during stepwise loading.

Stepwise loading in the present study was set with the designated load (10 kN) repetition 3 times before the final load until failure, as shown in Figure 2. The loading parameter of the current study used the ASTM D3039 standard, with the loading speed set at 2 mm/min. Using stepwise loading, pre-crack and early specimen failure can be detected. Small inconsistencies in the load–displacement graph can be easily detected, and based on the loading characteristic, stepwise loading can be used to determine the loading far below the final failure when the multi-static load was applied.

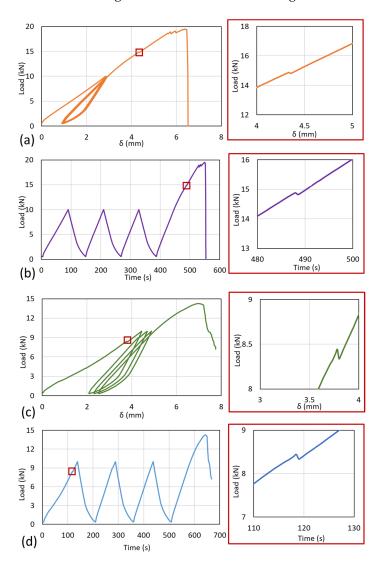
**Figure 4.** Stepwise loading from the different specimens. The  $[90/0]_S$  sample with (**a**) load vs. displacement and (**b**) load–time. The  $[0/90]_S$  sample with (**c**) load vs. displacement and (**d**) load–time.

The loading analysis from the stepwise loading of the representative samples can be seen in Figure 4. The results indicated that both different types of samples were subjected to pre-failure during the stepwise loading. In the  $[90/0]_{\rm S}$  samples, pre-failure occurred during the final loading after stepwise loading was applied, as shown in Figure 4a. The stress-strain curve showed that, during the stepwise loading, the elasticity of laminates stood still since the loading showed almost no gap from loadings 1 to 3. The load-time graph with detailed loading can be seen in Figure 4b. It also indicates that right before pre-failure occurred, the load slightly decreased, indicating that failure spots occurred inside the laminates. For the  $[0/90]_{\rm S}$  samples, Figure 4c shows that the pre-failure of the specimen occurred during the first stepwise loading. This failure affects the second, third, and final stepwise loadings of the specimen. Although the limit loading was the same as in the  $[90/0]_{\rm S}$  samples with 10 kN, as shown in Figure 4d, the stepwise loading process is different and creates hysteresis loading. The hysteresis effect is clearly visible in the  $[0/90]_{S}$ sample (Figure 4c,d) because, from the first loading cycle, preliminary failure occurred in the green line with the red circle (Figure 4c). Preliminary failure creates hysteresis that is indicated by the ultimate tensile stress decreasing. These different conditions between the two types of samples indicate that the pre-failure of laminates due to the loading can decrease the strength of the materials even though the laminates have the same sequences.

The crack propagation also occurred in the  $[90/0]_S$  samples before the final failure, but this phenomenon was not detected in the  $[0/90]_S$  samples. Crack propagation occurred after the culmination of the failure that occurred in the system laminates. When the pre-failure occurred during the stepwise loading, the system already underwent failure, and the final failure occurred without crack propagation.

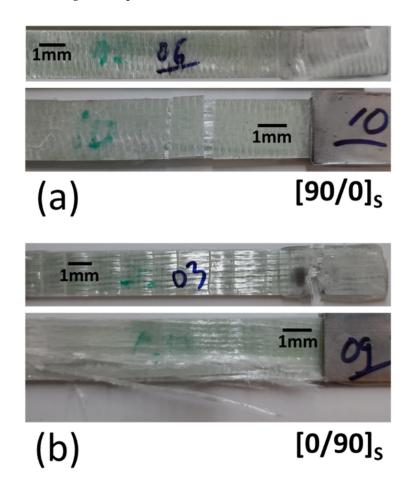
**Figure 5.** Specimen conditions where the failure was spotted after the test (macro images). (**a**) [90/0]<sub>S</sub>. (**b**) [0/90]<sub>S</sub>.

Macro images of the representative specimen after failure can be seen in Figure 5. The matrix crack clearly occurred on the surface, as seen in Figure 5a. Delamination also occurred in the area under the tab. Matrix cracking occurred after the tensile loading reached the maximum bonding strength of the matrix. The fiber breakages were clearly visible for the  $[0/90]_S$  sample, as illustrated in Figure 5b. The breakages occurred mainly on the edge of the plate and were distributed in almost all areas.

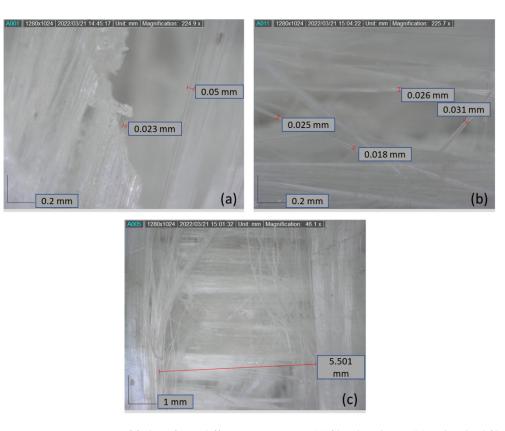
**Figure 6.** Micro images of failure from different specimens: (**a**) fiber breakage; (**b**) individual fibers' random angles after failure; (**c**)  $90^{\circ}-0^{\circ}$  layers gap after failures.

The specimen was then checked using a microscope to determine the detailed failure mechanism, as shown in Figure 6. Failures were spotted in different forms. Figure 6a showed that the fiber breakage clearly appeared. The fibers and matrix were also stuck together. In a different location, individual fibers were spotted after failure, as shown in Figure 6b. The fiber diameter ranged from 18  $\mu$ m to 31  $\mu$ m. These fibers were spotted due to matrix damage, and the fibers were spread at random angles. Another failure due to matrix damage is shown in Figure 6c. It is shown that the damage occurred in form of separated fiber at a 90° angle, making fibers at a 0° angle clearly visible. The gap after failure was around 5.5 mm.

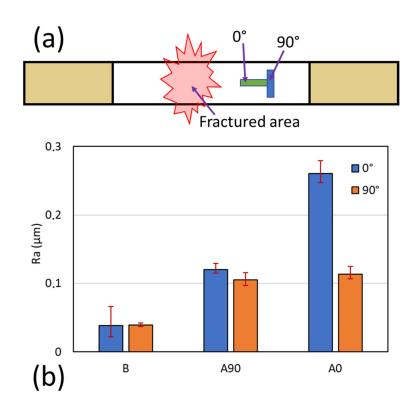
**Figure 7.** (a) The area's position for gathering surface roughness data. (b) Ra results of the specimen. B is the specimen before the test, A90 is the  $[90/0]_S$  specimen, and A0 is the  $[0/90]_S$  specimen.

The surface roughness of the specimen was assessed after failure. We checked the representative specimen and checked it three times in all combinations—specimens before and after the test. The summary of the results from the surface roughness assessment can be seen in Figure 7. For the surface roughness evaluation, we used ISO 1997 with the standard profile in  $\lambda$ s; the R was 2.5 µm and the length was 0.8 mm, determined using the Gauss model. In Figure 7, the average Ra is presented before the test; the Ra values were found to be 0.038 for the 0° direction and 0.039 for the 90° direction. These results showed that the surface conditions before the test were identical for the 0° direction and 90° direction. After stepwise loading, the roughness of the specimens changed drastically due to the failure that occurred on the surface and in the laminates. The Ra in the 0° direction jumped to 0.26 for the [0/90]<sub>S</sub> specimen and 0.12 for the [90/0]<sub>S</sub> specimen. Moreover, the Ra also increased by more than three times in the 90° direction to 0.11 for the [0/90]<sub>S</sub> specimen and 0.1 for the [90/0]<sub>S</sub> specimen.

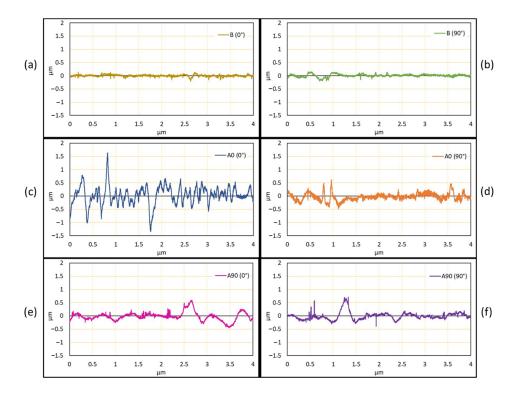
**Figure 8.** The surface profile of the specimen where the data were captured in the longitudinal directions (0°) and (90°). B is the baseline or sample before loading. A90 is the  $[90/0]_S$  specimen and A0 is the  $[0/90]_S$  specimen. (a) Surface roughness from 0° direction normal sample. (b) Surface roughness from 90° direction normal sample. (c) Surface roughness from 0° fiber angle of  $[0/90]_S$  specimen. (d) Surface roughness from 90° fiber angle of  $[0/90]_S$  specimen. (e) Surface roughness from 0° fiber angle of  $[90/0]_S$  specimen. (f) Surface roughness from 90° fiber angle of  $[90/0]_S$  specimen.

The results from the surface roughness test are shown in Figure 8a–f, which shows the different conditions before and after the final failure. Due to the laminate failure, the surface profile roughened for A0 (0°) and A0 (90°). This was also found for A90 (0°) and A90 (90°). The surface profile of the  $[0/90]_S$  specimen was more roughened than that of the  $[90/0]_S$  specimen. This occurred due to the fiber failure condition from the edge. The  $[0/90]_S$  specimen consists of a 0° layer on the edge. This fiber orientation causes explosive fiber failure (XGM) and, for the  $[90/0]_S$  specimens, the failure on the edge was Lateral failure (LGM) under the ASTM D3039 definition for fiber failure. The surface profiles also showed that laminate damage was higher for the  $[0/90]_S$  specimen than the  $[90/0]_S$  specimen. Moreover, the internal damage showed that the  $[90/0]_S$  specimen occurred in the middle of layers, where the  $(0^\circ)$  layers failed.

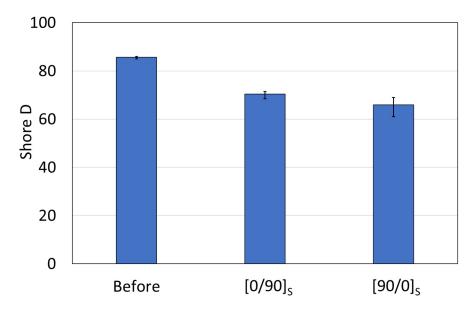
Figure 9. Shore D hardness of the specimen before and after the test.

The hardness test was conducted by using Shore D hardness. At least five points were used to evaluate hardness. The results showed that the hardness values before and after were changed, as shown in Figure 9. The hardness before was recorded with 85.6 SD and then decreased to 70.4 SD for  $[0/90]_S$  and 65.9 SD for  $[90/0]_S$ . The results indicated that, after failure, the matrix and the fiber were debonded, and the failure caused system rupture, with 0-degree fiber breakage and 90-degree fiber debonding. This result also indicated that the hardness of the specimen can be used to determine the condition of the laminate. If the hardness of the laminate decreases, the failure might occur in the laminates.

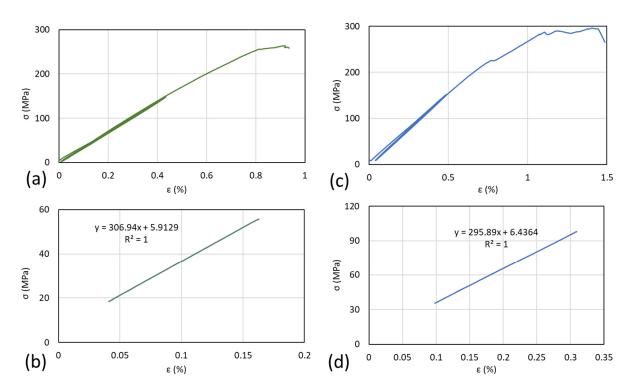
**Figure 10.** Stress–strain curves of the different samples. (a) and (b):  $[0/90]_S$  specimen. (c) and (d):  $[90/0]_S$ .

The stress analysis of the representative specimen is shown in Figure 10. The moduli of the first load from the  $[0/90]_S$  specimen and the  $[90/0]_S$  specimen were 30.7 GPa and 29.6 GPa, respectively. These results agree with previous works [22,29] that reported that the average modulus of the specimen is 30 GPa when using the properties mentioned in that paper. The stress–strain curve of the specimen shows that the  $[90/0]_S$  specimen has higher ultimate tensile stress and ultimate strain compared with the  $[0/90]_S$  specimen. It is also showed that both specimens showed pre-cracking that occurred at a different loading stage. For the  $[0/90]_S$  specimen, the preliminary crack occurred in the first load of stepwise loading, where, for the  $[90/0]_S$  specimen, the preliminary crack occurred in the last loading when the stress was observed at around 225 MPa. The preliminary crack recorded on the graph indicates that, for the specimen with 0° layers on the edge, the preliminary crack has a higher chance of failure due to the fiber being delaminated. Moreover, the comparison between the experiment and theoretical calculation in Figure 3 showed that the expected results were from the theoretical calculation were correct.

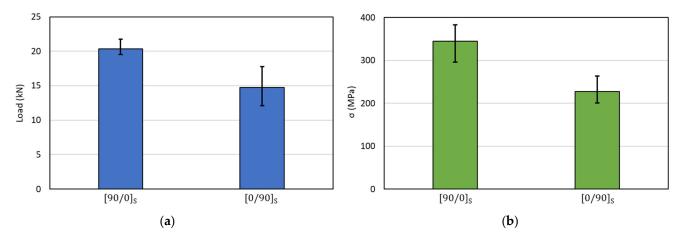
**Figure 11.** (**a**) The average of maximum load of the specimen and (**b**) strength (maximum stress) of the specimen.

A summary of the maximum loading and ultimate stress of the specimen can be seen in Figure 11. The average load for the  $[90/0]_S$  specimen was 20.3 kN and for the  $[0/90]_S$ specimen was 14.7 kN. Moreover, the strength values were 344.45 MPa and 227.8 MPa for the  $[90/0]_S$  specimen and  $[0/90]_S$  specimen, respectively. The results indicated that the preliminary failure that occurred during the first, second, or third load can reduce the strength of the specimen drastically. This is comparable to the  $[90/0]_S$  specimen, where preliminary failure occurred in the final loading.

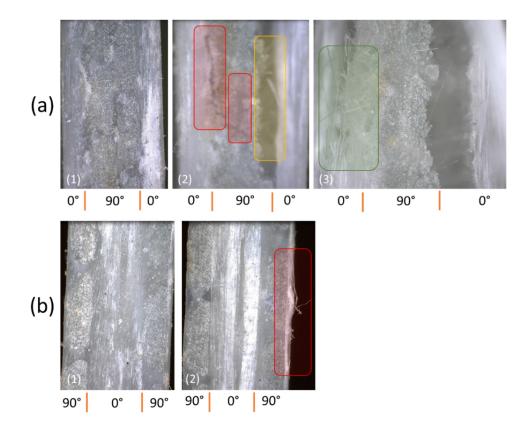
**Figure 12.** Specimen condition during stepwise loading (1) and after stepwise loading (2)–(3). (a)  $[0/90]_{S}$ . (b)  $[90/0]_{S}$ .

The results from further analysis during the tensile loading of the specimen can be seen in Figure 12. Data from before and after the test for the  $[0/90]_S$  specimen can be seen in Figure 12a. The specimen condition during loading (1) and after the test (2 and 3) are illustrated. Matrix debonding is clearly shown in the red rectangle, followed by layer delamination between the 90° layer and 0° layer, as shown in the yellow rectangle. As

shown in the green rectangle, the breaking of the fiber indicates the specimen's final failure. Furthermore, the conditions for the  $[90/0]_S$  specimen before and after the test are shown in Figure 12b. The fiber delamination from the 0° layers was revealed, where the condition of the specimen was not fully damaged like the  $[0/90]_S$  specimen. These findings showed that, for the specimen that needs to maintain the overall condition, the edge layers should be avoided using the 0° layer. This is because the preliminary crack and failure occurred.

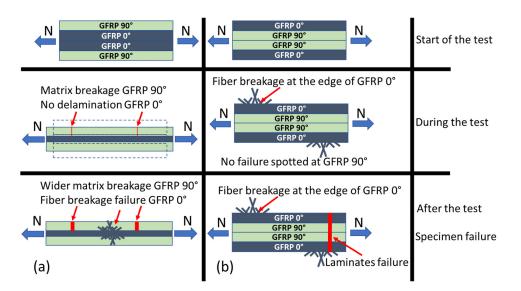
**Figure 13.** Failure mechanism of the specimen during and after the test was conducted. (**a**)  $[90/0]_S$  specimen. (**b**)  $[0/90]_S$  specimen.

This study was able to capture the failure mechanism of the laminates in two different models, as seen in Figure 13. The stepwise loading mechanism that causes the failure of the laminates has been described. For the  $[90/0]_S$  specimen, as shown in Figure 13a, the loading was mainly charged at the 0° layers due to its superior tensile strength compared to the 90° layers. The specimen also may have a pre-failure crack due to the matrix debonding. This small crack triggered the final failure and caused the gap in the 90° layers to be bigger. The failure mechanism for the  $[0/90]_S$  specimen is shown in Figure 13b. Since the outer layer was the 0° layer, and there was no matrix cracking after we observed it. Hence, the fiber debonding during stepwise loading occurred and final failure was clearly visible due to fiber breakage; this failure is the main cause of the system failure. Small fiber breakage was reported slightly before the final failure.
