FEMTOSECOND LASER MICROMACHINING OF SINGLE-CRYSTAL SUPERALLOYS

Q. Feng¹, Y. N. Picard¹, H. Liu², S. M. Yalisove¹, G. Mourou² and T. M. Pollock¹

Abstract

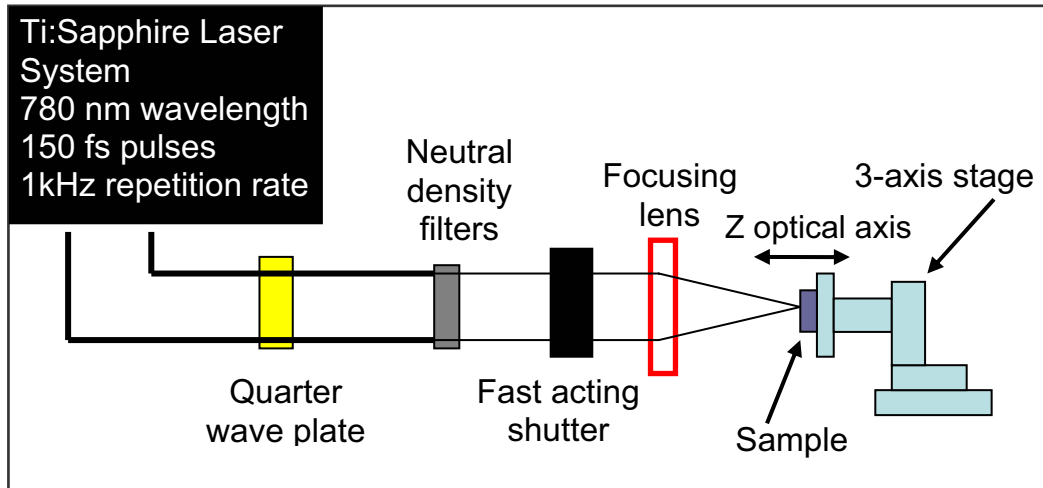
Figure 1. A sketch of the experimental setup for laser micromachining

Figure 1 illustrates the experimental setup for the laser micromachining. The micromachining experiments were carried out in air using a commercially available Ti:sapphire laser system, emitting a wavelength of 780 nm with a repetition rate of 1 kHz and a pulse duration of 150 fs. The specimens were mounted on a three-axis manual or computer-driven motorized stage. The output beam of the laser system was linearly polarized and further to be circularly polarized via means of a quarter wave plate. The laser beam was focused using a plano-convex or aspheric lens with a focal length of 350 mm or 18.4 mm (selected based on experimental objectives), and directed to a focal point on the specimen surface. The laser energy was varied in the range of 8 nJ to 775 μJ per pulse using neutral density filters, which were placed in the laser beam path prior to the focal lens. The number of laser pulse exposures was controlled using a fast acting shutter.

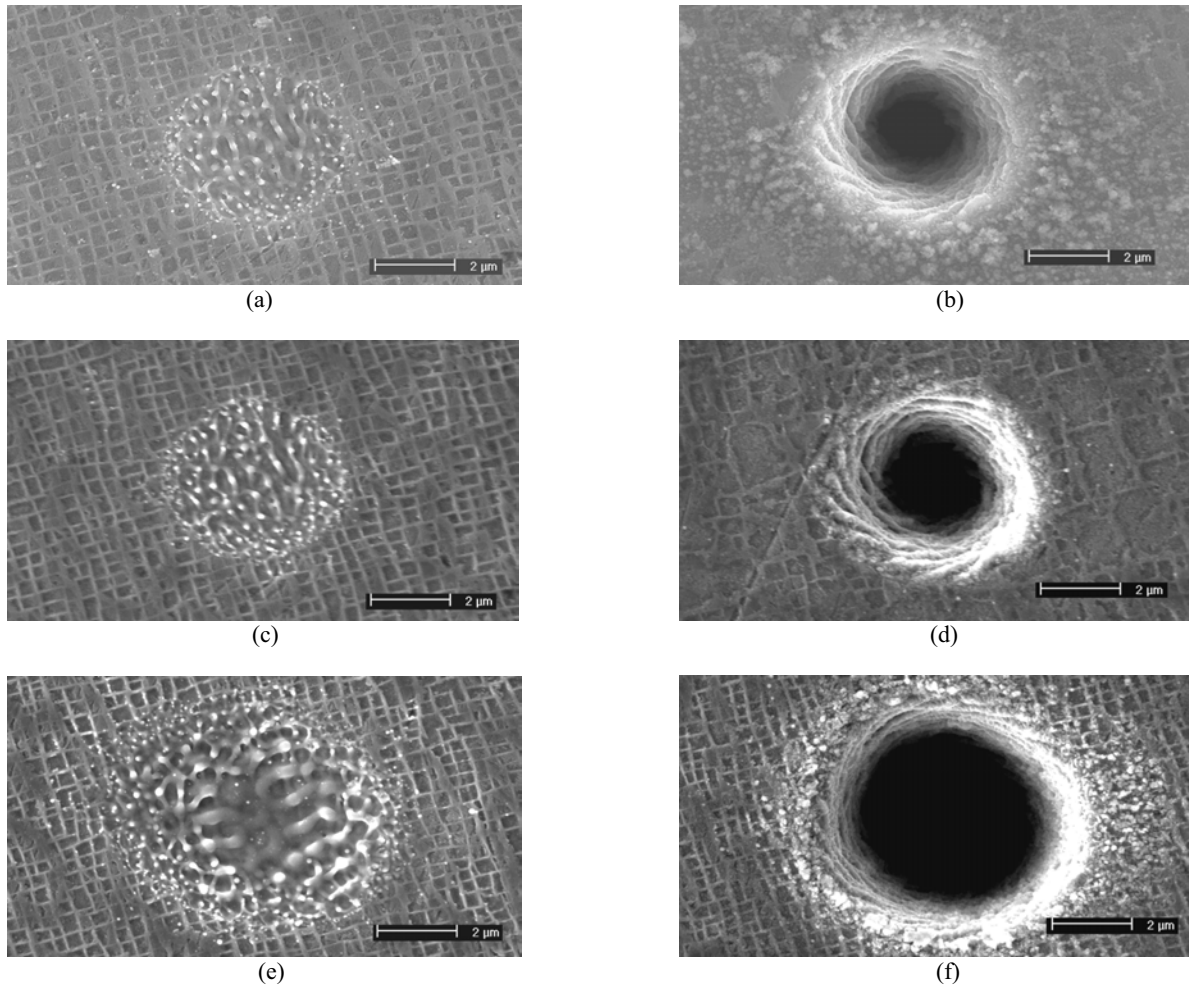
Figure 3. SEM images of the typical microstructures of laser-machined holes in single crystal alloy MK-4, (a) 2 shots, 785 mJ/cm², (b) 2000 shots, 785 mJ/cm², (c) 2 shots, 785 mJ/cm², (d) 2000 shots, 785 mJ/cm², (e) 2 shots, 3.13 J/cm², (f) 2000 shots, 3.13 J/cm²; (a) and (b) are microstructures before ultrasonic cleaning, (c)-(f) are microstructures after ultrasonic cleaning.

Figure 3(a) shows the typical $\gamma+\gamma'$ microstructure in the lightly-etched sample of alloy MK-4, where a spot of approximately $4 \mu\text{m}$ in diameter was generated by 2 laser pulses at a fluence of 785 mJ/cm^2 , close to 4 times the ablation threshold. No traces of melted material are apparent. However, nano-scale particles (bright contrast) re-deposited inside and around the spot from the plasma created by the laser radiation. Additionally, a fine scale ripple pattern can be observed at the surface of the spot. Figure 3(b) shows a machined region after 2000 laser pulse shots at the same fluence in the same sample. More plasma debris appears and partially shields the $\gamma+\gamma'$ microstructure. There are still no indications of damage in the form of a recast layer (re-solidified material accumulated on the side wall of the hole), microcracking or spatter (re-solidified material on the hole surface) in the vicinity of the hole. These features were confirmed by TEM investigations, described in the next section. After initial investigation, the same sample was subjected to ultrasonic cleaning in methanol for 5 minutes. Figures 3(c) and (d) show the same regions as Figures 3(a) and (b), respectively, after ultrasonic cleaning. The nano-scale particles were not strongly bonded to the substrate and were significantly reduced in density or were completely removed during ultrasonic cleaning. This suggests that

the particles are plasma debris and not melted particles impacting the sample surface. However, it was noted that the diameter of the hole at the top was larger than at the bottom, with a taper similar to that observed with conventional laser machining [5].

Figures 3(e) and (f) show a spot and a hole machined at 2 and 2000 laser shots, respectively, at a fluence of 3.13 J/cm^2 , which is about 16 times the ablation threshold. The general characteristics are similar to those generated at the low fluence shown in Figures 3(a)-(d), although more plasma debris appears around the holes. The size of the spot/hole caused by the high laser fluence is generally larger. The residual roughness of the hole surface on the laser-machined region is in the sub-micron range.

appears to have been on the verge of being vaporized during processing and remains with the same striated or rippled appearance. These TEM observations of the rippled structures in the single crystal alloy are consistent with SEM observations (Figure 3) and were also observed in the zirconia ceramic coating and a variety of other materials [8, 20, 21].

on the bulk single crystal superalloy in the current work indicate that there was no evidence of melting or microcracks after the femtosecond laser machining (Figure 3 and Figure 5). Although there was some nano-scale plasma debris around the hole and on the side wall, this was easily removed by the ultrasonic cleaning leaving a residual roughness of the laser-machined surface of less than 1 μm. The extent of microstructural degradation was also investigated by TEM on pre-jet-polished TEM foils micro-machined by the femtosecond laser for the first time (Figure 5). Electron diffraction analyses using TEM on the area at or close to the edge of the laser-machined hole indicated no loss of single crystal structure or any presence of an amorphous layer (Figure 6). This provides direct proof that no melting occurred and suggests that material removal was completely accomplished by a vaporization process. In the previous studies [12, 25], recast layers and heat-affected zones within at least 10 μm thickness were observed adjacent to the processed zones in copper, Ni-base superalloys and titanium alloys with nanosecond lasers. The direct ablation that occurs with the use of femtosecond lasers is clearly desirable from the point of view of minimizing damage. It should be noted that the holes exhibited some degree of the taper in the current study, but the optimization of laser processing parameters and more sophisticated machining stages could minimize this problem. Further research on this issue is under progress.

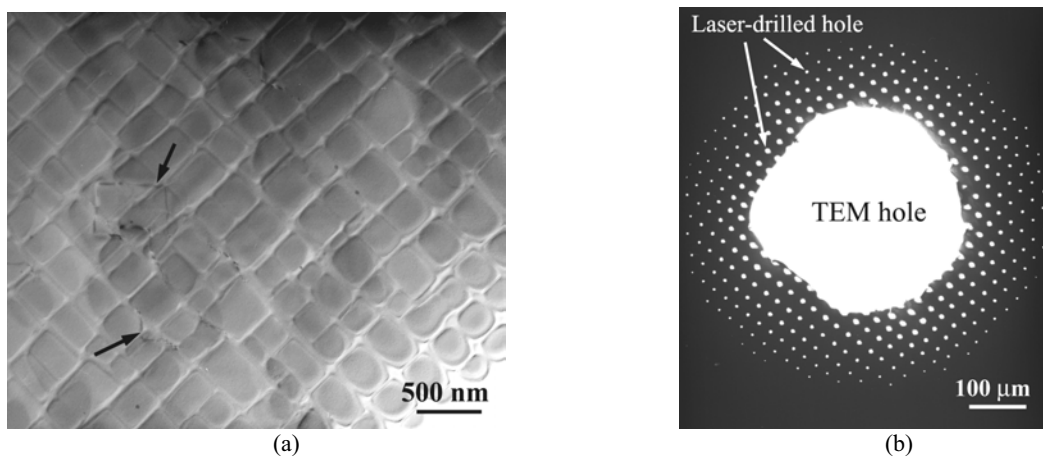
Figure 4. Bright-field TEM images of heat-treated single crystal alloy MK-4, (a) the typical microstructure before laser machining consists of γ and γ' phases as well as occasional dislocations marked by arrows; (b) a very low magnification image, showing a pre-jet-polished TEM foil was micro-machined by a femtosecond laser, leaving an array of multiple fine holes around the large TEM hole.

Figure 4(a) is a bright field TEM image close to the $\langle 001 \rangle$ zone axis, presenting the typical microstructure of the heat-treated single crystal alloy MK-4 prior to laser micromachining. It consists of cuboidal γ' precipitates and a γ matrix with occasional dislocations, marked by arrows. Such pre-jet-polished TEM foils were micro-machined with the femtosecond laser using a 150 fs pulse. One of machined foils is shown in Figure 4(b) as a TEM bright-field image taken at a very low magnification. The large hole at the center of the thin foil was a consequence of the standard jet-polishing foil preparation procedure performed before the machining. The jet-polished hole is surrounded by an array of multiple fine holes, which were each laser-machined with 200 pulses. The size of laser-machined holes generally decreased with the foil thickness with the maximum size being $\sim 5 \mu\text{m}$ in diameter.

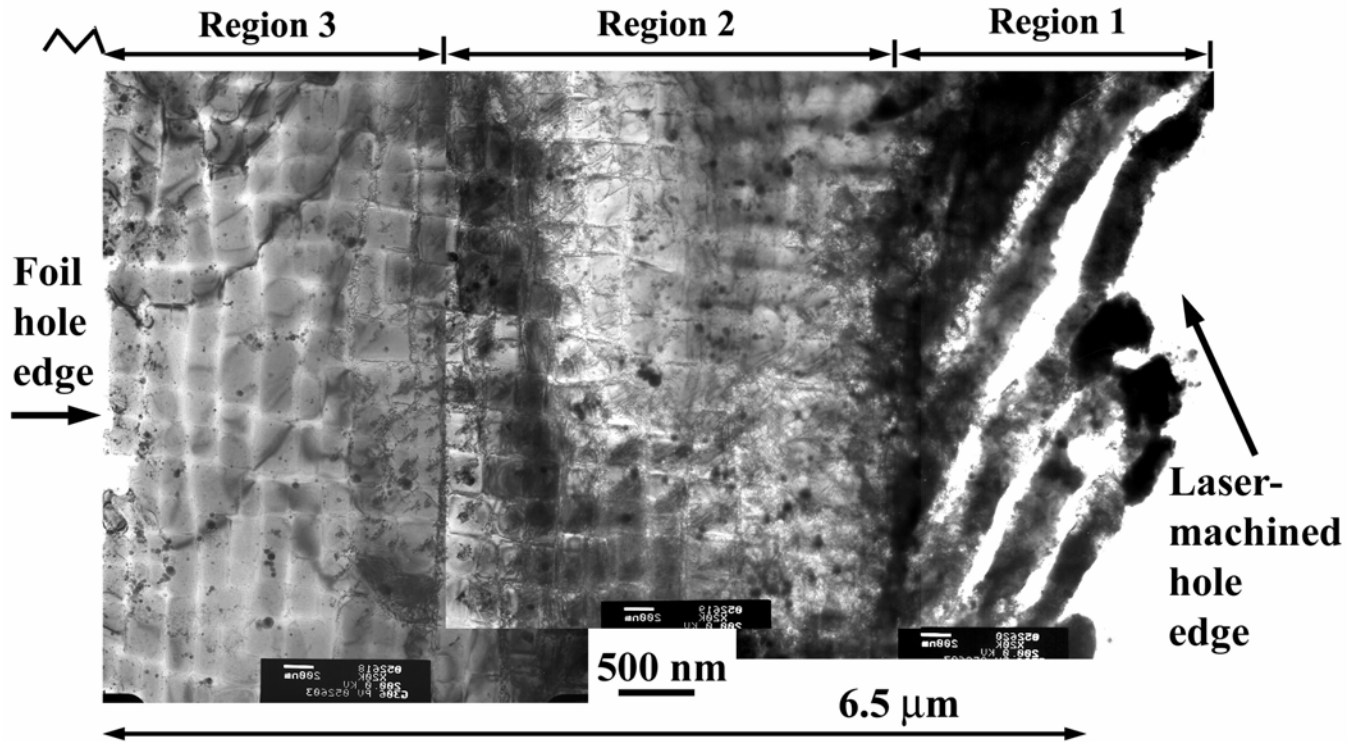
Figure 5. A bright-field TEM image, showing the typical laser-induced deformation microstructure around a laser-machined hole (right side) by a femtosecond laser operating at a fluence of 2.33 J/cm^2 in a pre-jet-polished TEM foil of single crystal alloy MK-4. The microstructure can be divided into three regions according to the deformation behavior. No conventional defects associated with laser machining including microcracks, spatter, heat-affected zone and the recast layer were observed.

Figure 5 is a bright-field TEM image showing the typical microstructure near the edge of one laser-machined hole at the right side, which is close to the edge of the TEM jet-polished hole to the left. The laser-machined hole was produced with the laser fluence of 2.33 J/cm^2 , over ten times higher than the ablation threshold of alloy MK-4. Laser-induced plastic deformation was clearly observed and the area adjacent to the edge of the laser-machined hole can be divided into three regions:

- 1) a $\sim 2 \mu\text{m}$ layer of intensely deformed material;
- 2) a $\sim 3 \mu\text{m}$ layer with moderate dislocation density;
- 3) a region where there is limited enhancement of dislocations and the structure is nearly dislocation-free.

The dark-contrast nano-scale particles are apparently plasma debris and were observed with decreasing frequency from region 1 to region 3. It should be noted that some material in region 1

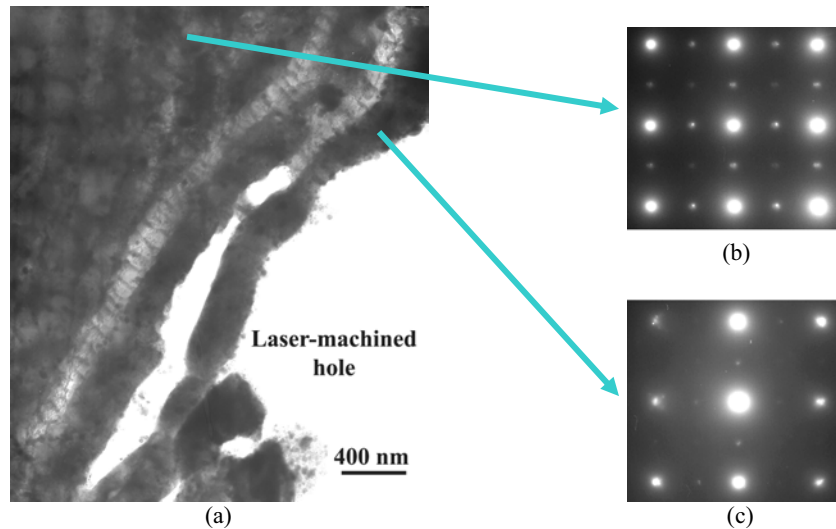
Figure 6. Single crystal alloy MK-4, (a) a bright-field TEM image of laser-induced deformation microstructure in region 1 of Figure 5, (b) and (c) are SAD patterns in the $\langle 001 \rangle$ zone-axis taken from the areas marked in (a), revealing the same crystal structure with the same orientation in both areas, indicating that no melting occurred during laser machining.

Selected area electron diffraction (SAD) analyses were conducted in the area adjacent to the laser-machined hole in order to assess the crystalline nature of the remaining material. Figure 6(a) is a bright-field TEM image of the microstructure in region 1 and the areas for SAD analyses are marked by arrows. Figure 6(b) shows the SAD pattern in the $\langle 001 \rangle$ zone axis of the $(\gamma + \gamma')$ matrix including superlattice diffraction spots of the γ' phase. It is important to note that it is the same diffraction pattern as observed in regions 2 and 3. There were, however, a few degrees of deviation due to the foil bending. The SAD pattern taken at the hole edge is shown in Figure 6(c) and again presents the $\langle 001 \rangle$ zone-axis diffraction pattern of the γ phase, which also contained the diffuse superlattice spots of the γ' phase. Electron diffraction analyses clearly indicate that the material remaining in region 1 maintained its monocrystalline character with the same crystal structure and orientation as observed in regions 2 and 3. This suggests that no material transformed from monocrystalline to polycrystalline or even became amorphous material during laser processing. These direct observations also clearly indicate that no melting occurred near the ablated region during femtosecond laser processing. The slightly more diffuse γ' superlattice diffraction

spots shown in Figure 6(c) may occur for several reasons: 1) the material, including the $(\gamma + \gamma')$ phases, was heavily deformed, 2) the material consisted of a higher volume fraction of the γ phase within the first 400 nm of the machined hole, relative to the base material or 3) some slight preferential vaporization of Al reduced the volume fraction of precipitates.

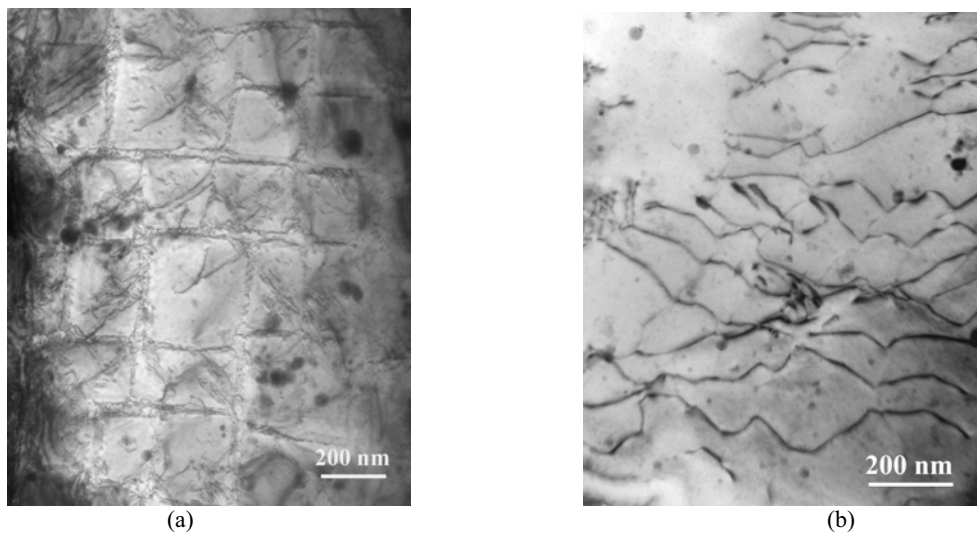
Figure 7. Bright-field TEM images of laser-induced deformation microstructure in region 2 of Figure 5, (a) showing multiple dislocation slip systems inside the channels of the γ matrix with relatively low dislocation density, (b) isolated dislocations demonstrating the distinct cusped morphology.

In region 2, the dislocation density was significantly less compared to region 1 and isolated dislocations along with dense dislocation networks were observed. This indicates that a strong gradient of plastic deformation was induced by laser machining within a region limited to a few microns around the hole. Figure 7(a) is a higher magnification image of region 2 in Figure 5, showing the individual dislocations, including segments inside the γ matrix channels in multiple-slip configurations and some isolated segments inside the γ' precipitates. Most dislocations were identified as $\frac{1}{2}\langle 011 \rangle$ type and they appeared to spread via glide within the γ matrix channels. No stacking faults created by shearing of the γ' precipitates were observed. Figure 7(b) is a bright field TEM image taken at the region 2 in another laser-machined hole from the same sample. It shows longer dislocation segments with distinct cusped morphologies and shorter bowed-out segments between the cusps. This suggests that these dislocations were pinned of the γ - γ' interfaces and underwent glide with the aid of cross-slip within the channels of the γ matrix [22]. Again, they were identified as $\frac{1}{2}\langle 011 \rangle$ type dislocations.

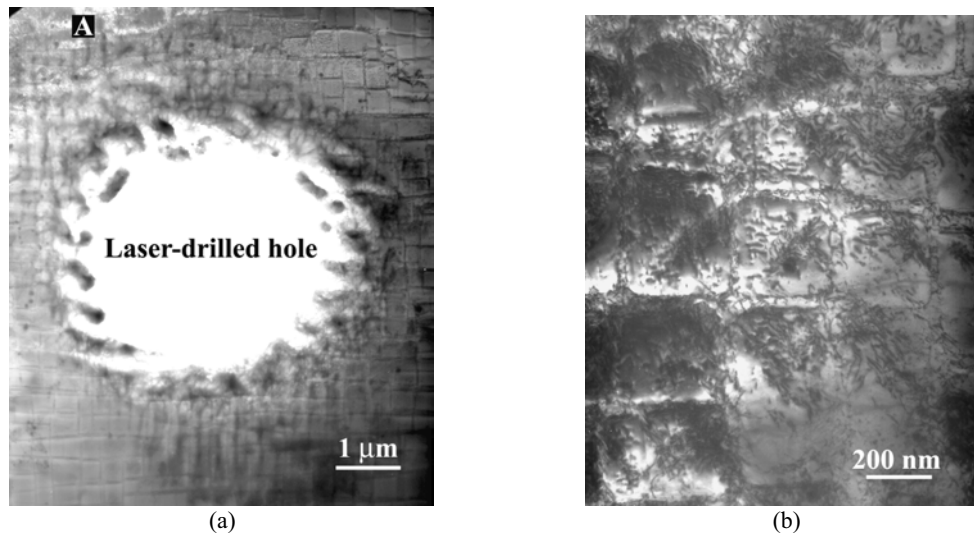
Figure 8. Bright-field TEM images of single crystal alloy MK-4, (a) a hole was drilled by a femtosecond laser operating at a fluence of 196 mJ/cm² in a pre-jet-polished TEM foil, the region adjacent to the hole showing a complete absence of melting, microcracking and a lower dislocation density, (b) a large magnification image of area A in (a), showing a significant dislocation density and multiple types of dislocations inside the channels of the γ matrix and at the γ - γ' interfaces.

Figure 8 (a) is a bright field TEM image of the heat-treated alloy MK-4, showing a hole drilled by a femtosecond laser operating at the fluence of 196 mJ/cm^2 , which is in the range of the ablation threshold of the material ($203 \pm 20 \text{ mJ/cm}^2$). It clearly demonstrates no melting, an absence of microcracking and no heat-affected zone or spatter around the hole. The size of the hole is about $4.3 \mu\text{m}$ in diameter, very close to the focused laser spot size. The general characteristics of the microstructure adjacent to the laser-machined hole are similar to the one drilled at a high fluence (Figure 5), except the deformation region and the dislocation density was significantly reduced, indicating very limited laser-induced deformation at the ablation threshold. Figure 8(b) is a high magnification image of area A in Figure 8(a) within

$2 \mu\text{m}$ of the edge of the laser-drilled hole. It shows a significant density of isolated dislocations and dislocation networks, again suggesting that the laser machining resulted in activation of multiple slip systems. Most of laser-induced dislocations in this sample were again characterized as $\frac{1}{2}\langle 011 \rangle$ type and appeared to glide inside through the γ matrix channels.

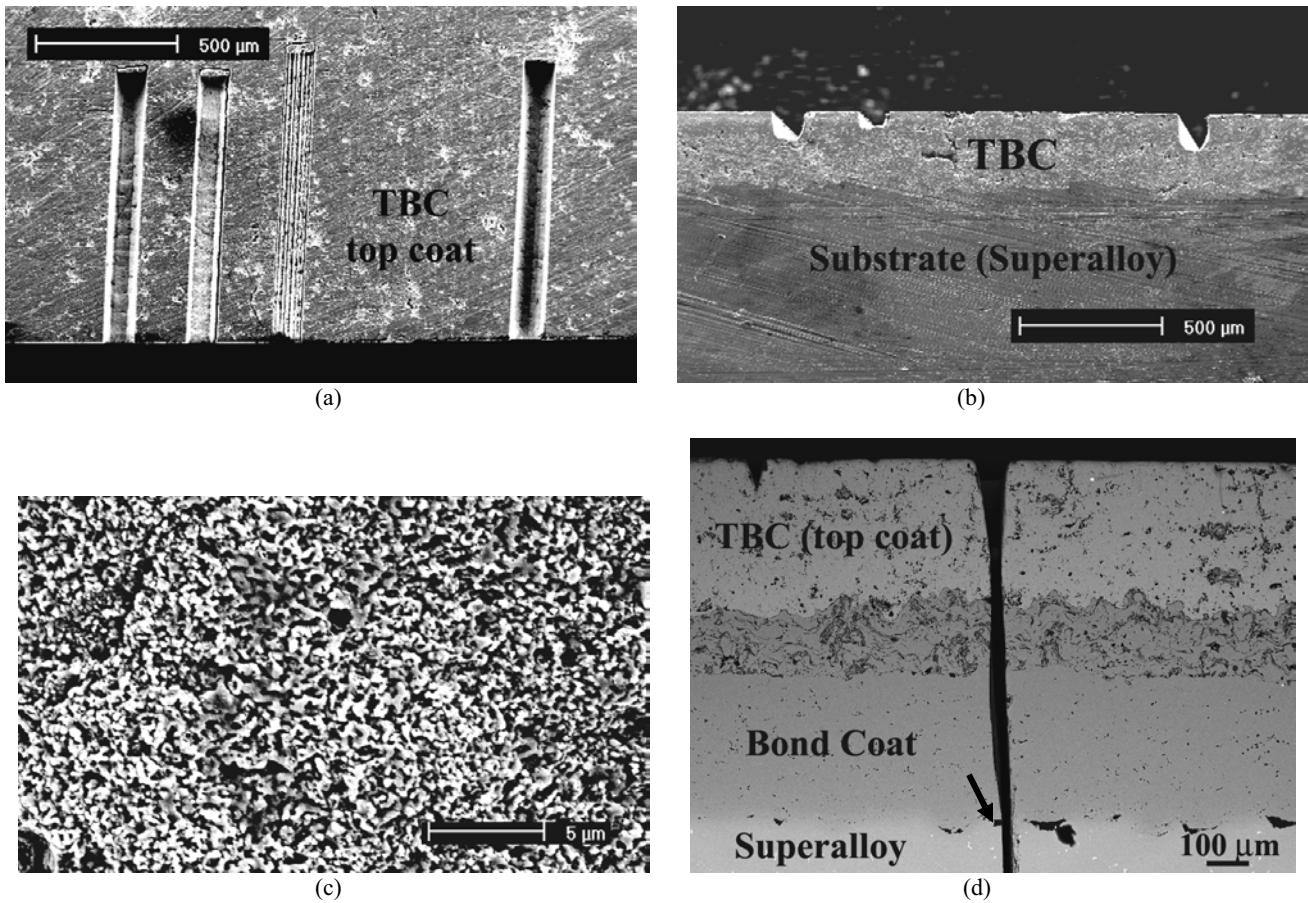
Figure 9. SEM images of the trenches machined by a femtosecond laser in the TBC-coated superalloy showing no laser-induced processing defects, such as microcracking and recast laser, etc., (a) and (b) are plan view and cross-section view of the trenches machined inside the top coat (ceramic layer), (c) typical microstructure of the trench surface, (d) BSE image, showing the trench machined through top coat/bond coat and bond coat/superalloy interfaces.

Figure 9(a) is a SEM image of the plan-view of a YSZ ceramic layer (top coat) in the TBC-coated superalloy, showing four trenches in the ceramic layer machined by a femtosecond laser operating at the fluence of 160 J/cm². From the top view, no cracks, spatter or plasma debris were observed around the trenches. The cross-sectional view of the same TBC-coated sample through the laser-machined trenches is shown in Figure 9(b). Again there was no obvious laser-induced microcracking or recast layers around these trenches in the ceramic layer. Figure 9(c) is a SEM image at a higher magnification, presenting the typical microstructure of the trench surface after the femtosecond laser micromachining. It shows the laser-induced sub-micron roughness that is typical of femtosecond machined surfaces in a wide range of materials including metals and glass [8, 21].

Figure 9(d) is a backscattered-electron (BSE) SEM image, showing the cross-sectional view of a trench, machined by a femtosecond laser operating at the fluence of 18 J/cm². The trench was drilled through the top coat/bond coat and bond coat/superalloy interfaces. It should be noted that the machining process did not produce any delamination of the top coat/bond coat or bond coat/superalloy interfaces, even the trench passed through a defect at the bond coat/superalloy interface (marked by

an arrow) during laser machining. These interfaces are well known as sites for laser-induced damage via conventional processes, due to high mismatch in thermal expansion coefficients of the different layers of materials in TBC-coated superalloys [23].
