FRP-TO-MASONRY BOND DURABILITY ASSESSMENT WITH INFRARED THERMOGRAPHY METHOD

Bahman Ghiassi¹, Sandra M. Silva², Daniel V. Oliveira³, Paulo B. Lourenço⁴, Luís Bragança⁵

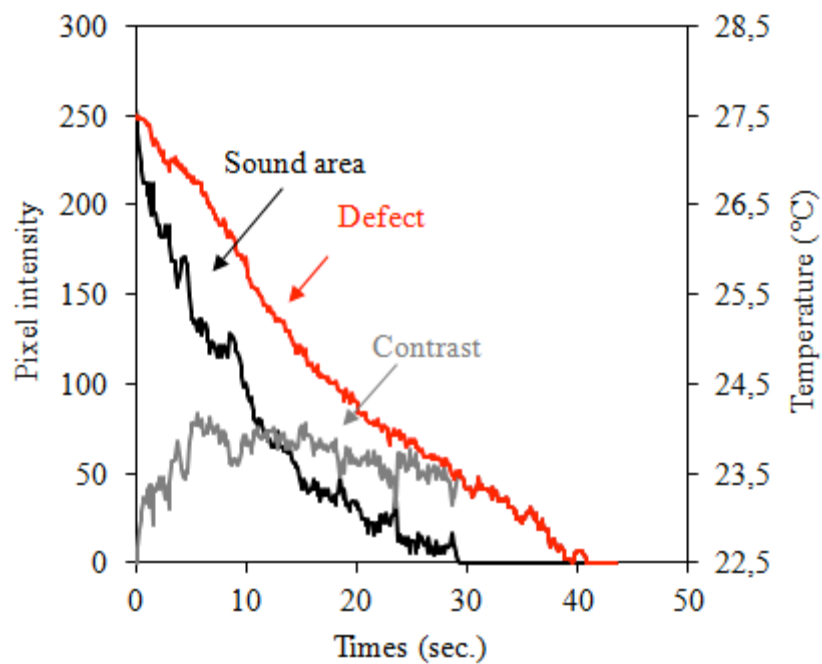
Fig. 2. Thermal history curves of sound and delaminated areas.

Fig. 2. Thermal history curves of sound and delaminated areas.

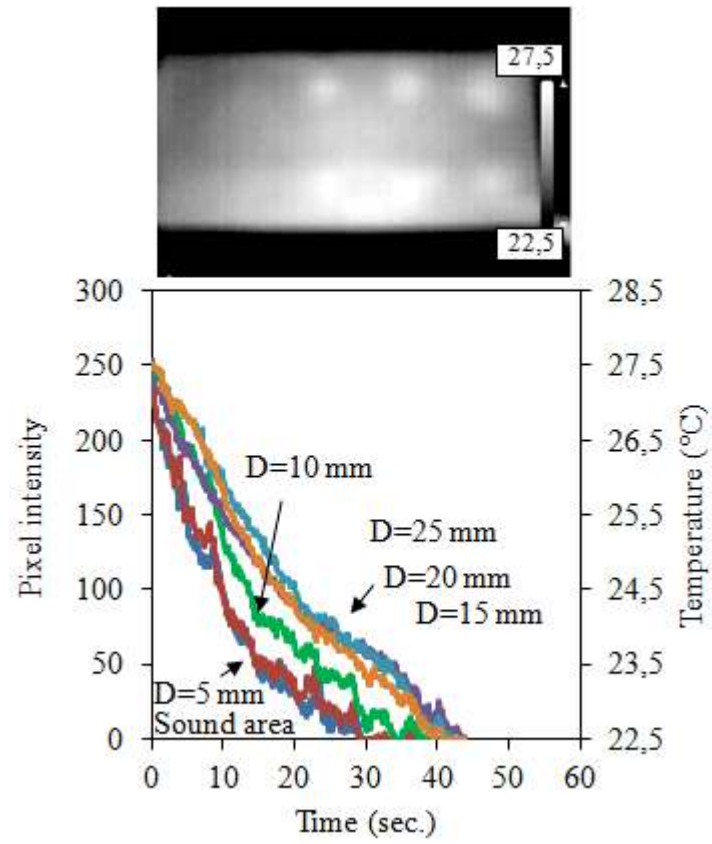
Fig. 6. Thermal history curves at defect locations and a typical thermogram.

The temperature history curves of defects with different sizes are shown in Fig. 6. These curves are obtained at the pixel corresponding to the centroid of each defect. It can be observed

Fig. 6. Thermal history curves at defect locations and a typical thermogram.

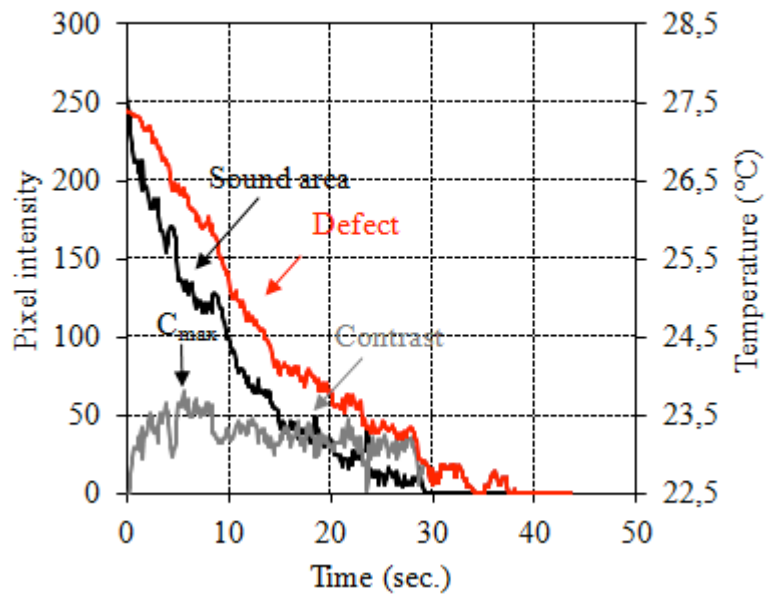
Fig. 7. Maximum thermal contrast evaluation for: (a) 10 mm defect; (b) 25 mm defect.

Fig. 7. Maximum thermal contrast evaluation for: (a) 10 mm defect; (b) 25 mm defect.

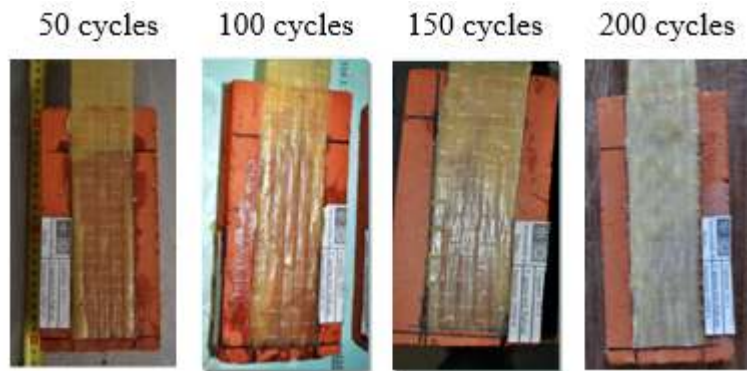
Fig. 11. Specimens exposed to different periods of: (a) HT exposure; (b) FT exposure.

Fig. 11 shows typical examples of specimens for each exposure period. Visual inspection and qualitative IR thermography were used for localization of FRP delaminations. Relatively large FRP delaminations were observed in the specimens exposed to HT conditions. On the contrary, the specimens exposed to FT conditions had very small delaminations. The thermal images and detected FRP delaminated areas, from IR thermography tests, for the specimens exposed to HT conditions are presented in Fig. 12. It can be observed that the FRP delaminations progressively increased with the exposure time. It should be noted that due to the physical properties of the materials used in this study, delaminations were also observable with visual assessment. This advantage could assist us in validating the IR technique in localization of interfacial delaminations. However, in case of strengthening with other composite materials and matrices or application of renderings over the strengthening visual observation is not applicable.

Fig. 11. Specimens exposed to different periods of: (a) HT exposure; (b) FT exposure.

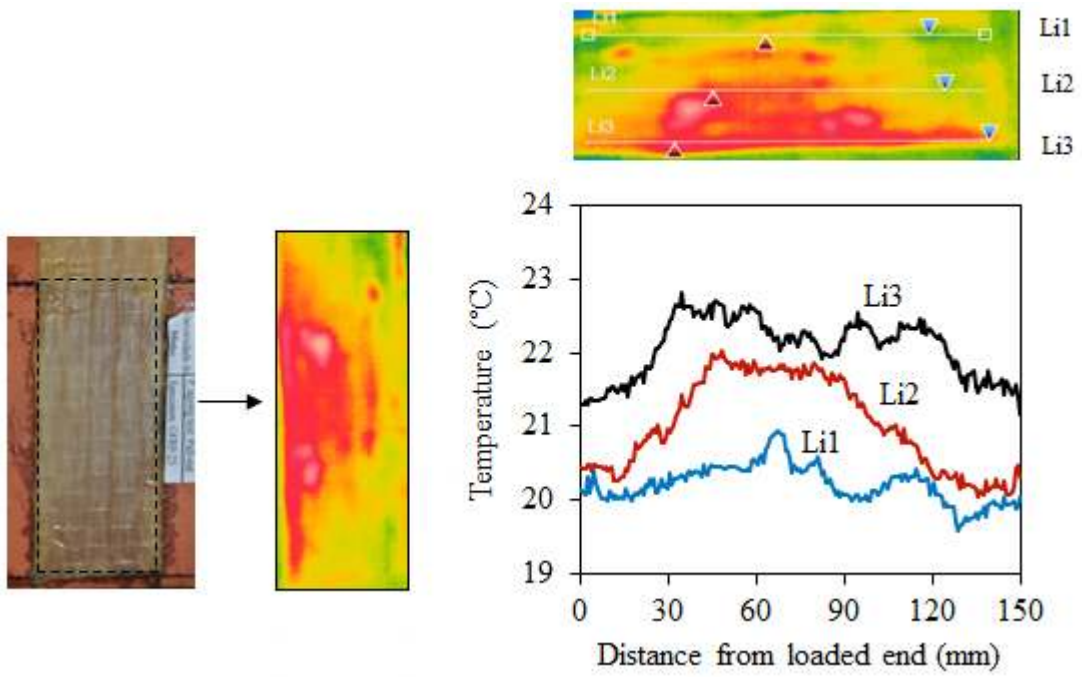
Fig. 13. Temperature profiles in a specimen exposed to 100 cycles of HT exposure.

In the specimen exposed to 100 cycles, delamination was observed in the center of the bonded length, shown as a hot spot in the thermogram presented in Fig. 13. Therefore, it was necessary to obtain the boundaries of the delaminated area on both sides of the defect in the longitudinal direction, as indicated in Fig. 14. However, the delamination in the specimen

Fig. 13. Temperature profiles in a specimen exposed to 100 cycles of HT exposure.

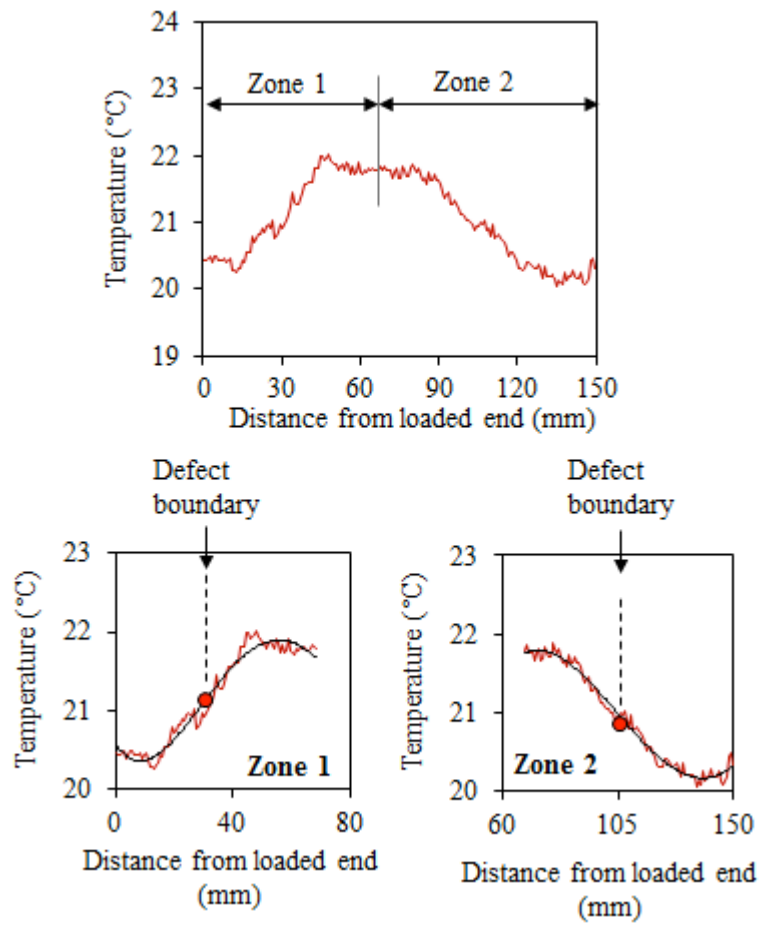
Fig. 14. Delamination boundaries evaluation in a specimen exposed to 100 cycles of HT exposure.

Fig. 14. Delamination boundaries evaluation in a specimen exposed to 100 cycles of HT exposure.

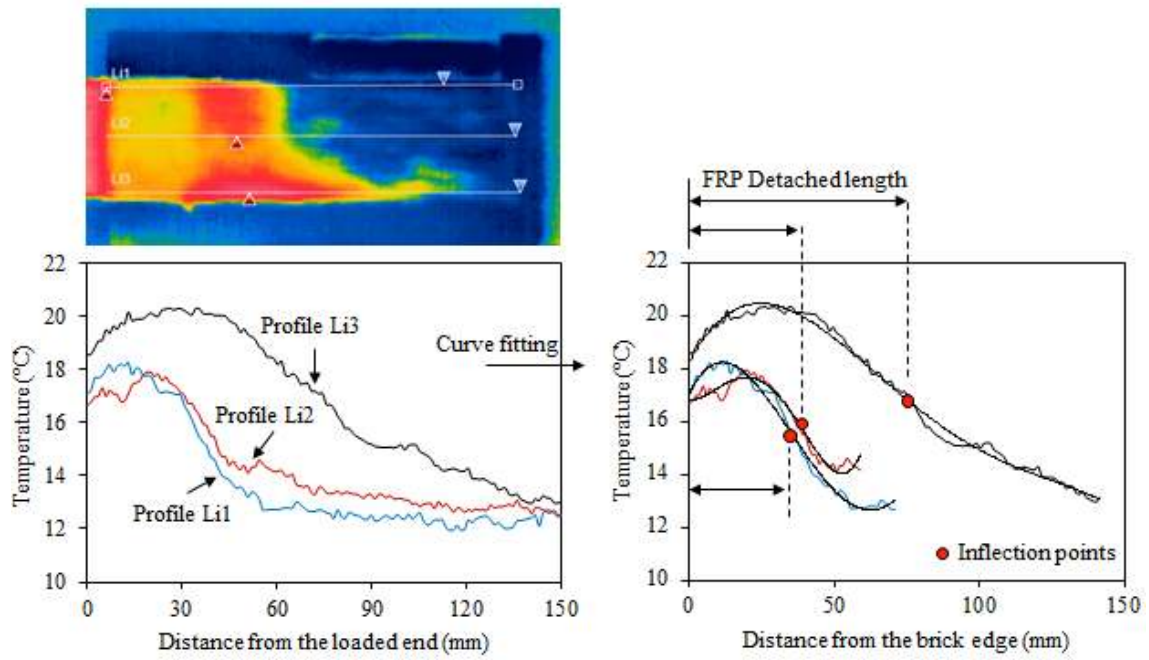
Fig. 15. Temperature profiles and quantitative assessment of delaminated areas in a specimen exposed to 200 cycles of HT exposure.

exposed to 200 cycles started from the loaded end of the specimen and progressed along the bonded length, see Fig. 15. Therefore, just one boundary in the longitudinal direction should be located for obtaining the delamination size. The large FRP delaminated area in the specimen exposed to 200 cycles of HT exposure shows the severity of the thermal incompatibility in the specimens used in this study.

Fig. 15. Temperature profiles and quantitative assessment of delaminated areas in a specimen exposed to 200 cycles of HT exposure.
