# Full Scale Accelerated Testing of Bituminous Road Pavement Mixtures

M.D. Gilchrist<sup>1</sup> A.M. Hartman<sup>1</sup> P.M.O. Owende<sup>2</sup> S.M. Ward<sup>2</sup>

**Keywords:** Damage Assessment, Accelerated Test, Fatigue, Asphalt, Bituminous Mixture

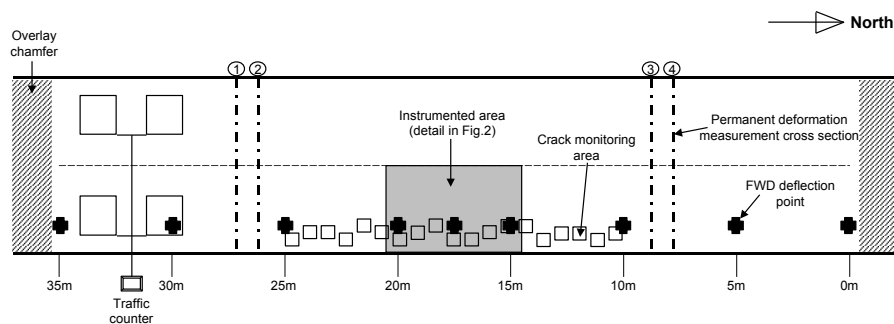
A suitable section of a forest access road was identified for the experiment. Figure 1 shows a schematic representation of the monitoring section, the dimensions of which are 3.3m (road width) by 35m (length of overlaid area). A central area in the outer wheel path was selected for instrumentation with pavement transducers, the detailed layout of which is shown in Figure 2. FWD points were marked over the test area to measure the global pavement response. Crack monitoring grids were randomly spaced in the outer wheel path over 15m along the section. A total of 19 grids were marked out to monitor cracking. Four permanent deformation cross section measurement positions were identified, two at both ends of the crack monitoring strip. The traffic counter was located at the end of the test section. The counter had to be placed as far away as possible from the crack monitoring and permanent deformation measurement positions since counter cables had to be machined into the overlay which could induce initial defects.

**Figure 1.** Layout of experimental road pavement section.

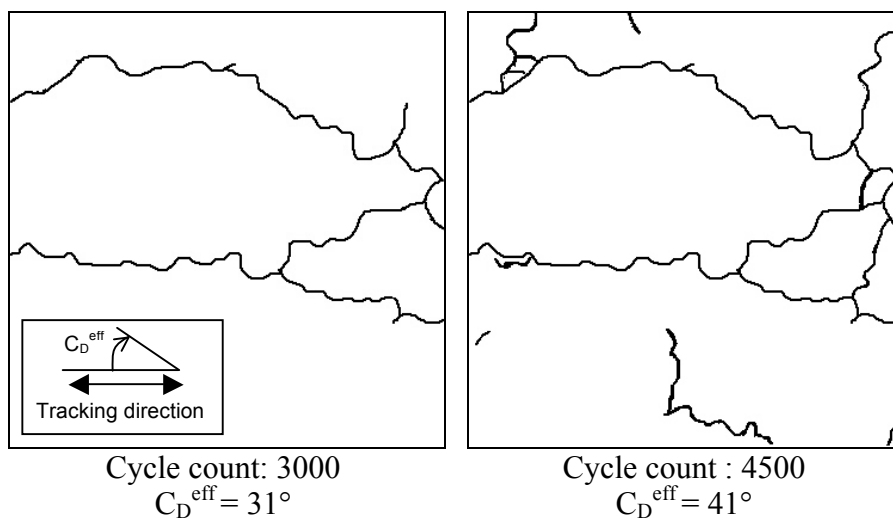
Figure 5 describes a typical example of traced cracks after the first and final tracings. On average, the crack angle changed from  $31^\circ$  to  $41^\circ$ , from the plane parallel to the direction of travel. Therefore, the majority of cracks formed in the longitudinal direction ( $C_D^{\text{eff}} < 45^\circ$ ). This observation suggests that cracks mainly initiate in the longitudinal direction with subsequent lateral networking. This implies that while the transverse strain governs the initiation of fatigue cracks, the subsequent networking of the cracks is influenced by longitudinal strains. The final crack pattern on the surface was typical of crocodile cracks as shown in Figure 6.

**Figure 5.** Change in crack direction over fatigue life.
