CHANSON, H., and WHITMORE, R.L. (1998). "Gold Creek Dam and its Unusual Waste Waterway (1890-1997) : Design, Operation, Maintenance." *Can. JI of Civil Eng.*, Vol. 25, No. 4, Aug., pp. 755-768 & Front Cover (ISSN 0315-1468).

Gold Creek Dam and its Unusual Waste Waterway (1890-1997) : Design, Operation, Maintenance

Keywords : spillway design, engineering heritage, concrete construction, stepped weir, spillway operation, spillway refurbishment, 19th century structure.

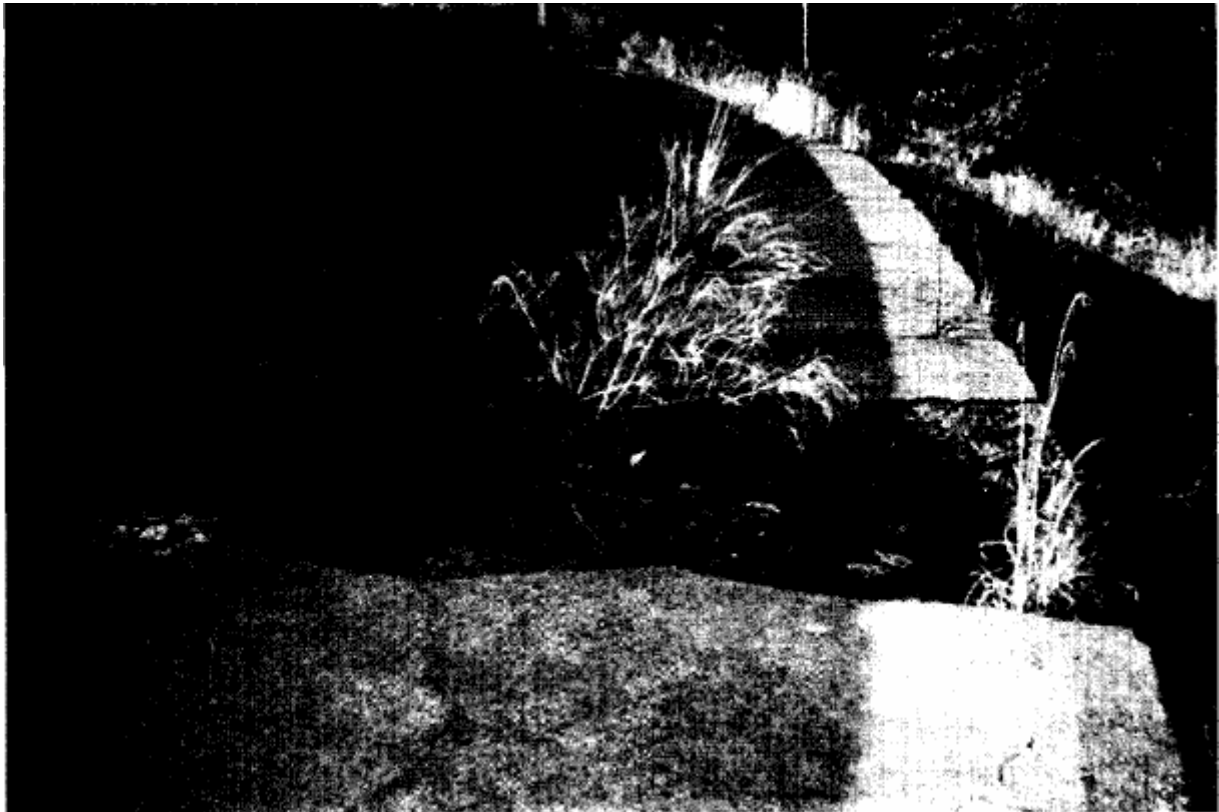
Fig. 5. Detail of the Gold Creek spillway (taken on 4 April 1996)

Damaged step (No. 6) showing the concrete construction

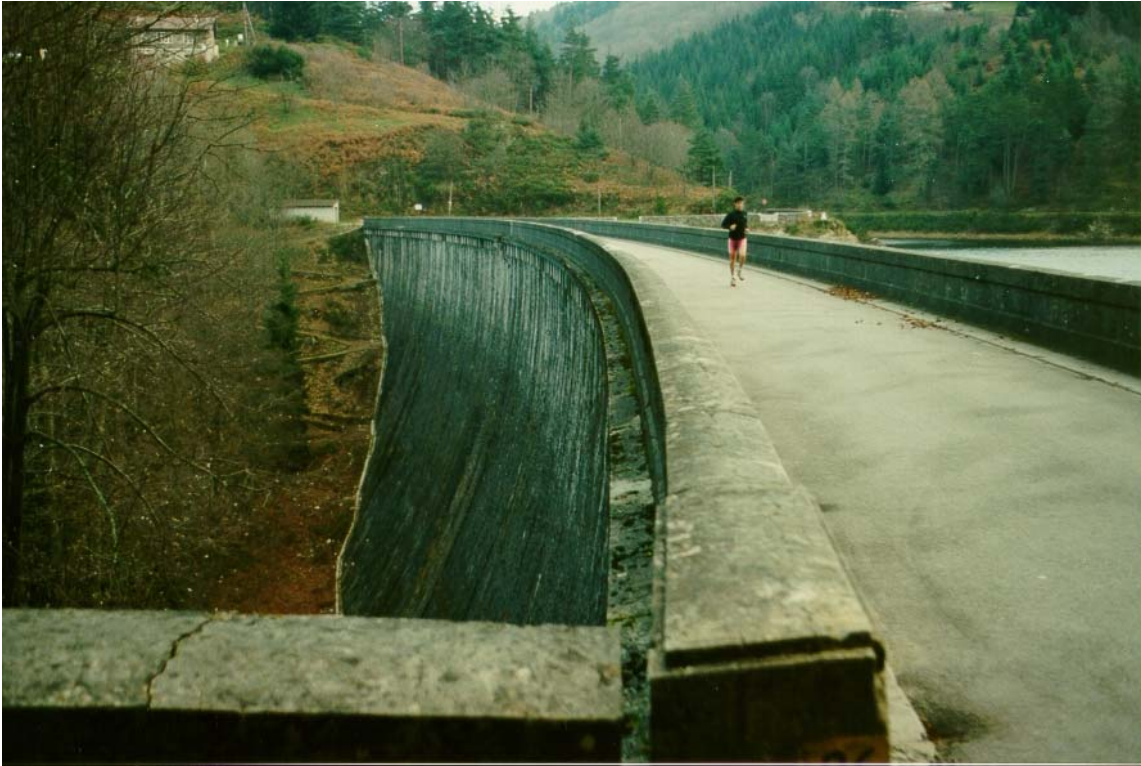
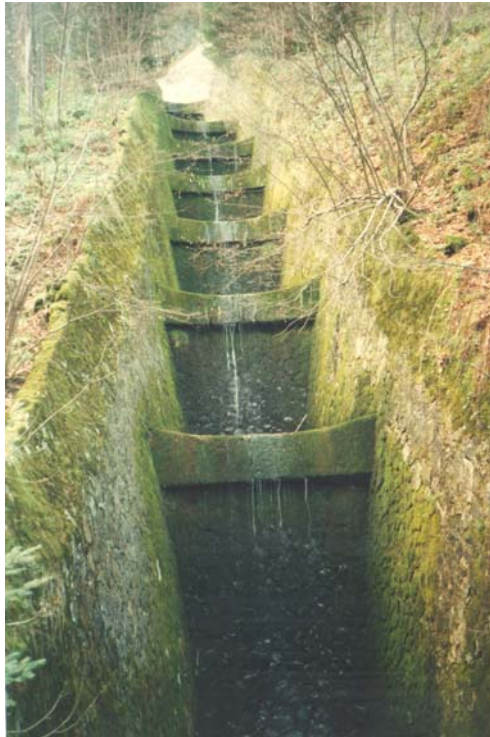
Fig. 7. Photograph of the Pas du Riot dam (taken on 3 December 1994)

Masonry dam completed in 1873 : H = 36 m, L = 154 m - Maximum discharge capacity : 65 m³/s

(a) View of the downstream dam face from the left bank.

(b) View from downstream of the masonry stepped spillway located on the left bank.

Another influence might have been the French experience in stepped spillway design. Between 1850 and 1900 several masonry dams were constructed with a lateral stepped spillway : e.g., the Gouffre d'Enfer dam (fig. 6), the Ternay dam, the Pas du Riot dam (fig. 7), the La Rive dam and the La Tâche dam¹⁴. The first of these structures was designed by the French engineer Delocre (1828-1908) while the next three structures were built as replicas of the Gouffre d'Enfer dam (Wegmann 1911, Smith 1971). In his book, Humber (1876) mentioned the work of Delocre and the construction of the Gouffre d'Enfer dam built in 1858 (Humber, p. 123) (see App. 1). It is likely that Australian engineers knew these references.

Three masonry dams were built subsequently as replicas of the Gouffre d'Enfer dam : the Ternay dam, completed in 1867, to supply water to the city of Annonay, France¹⁸; the La Rive dam (also called the Ban dam), completed in 1870, to supply water to the city of Saint-Chamond, France¹⁹; the Pas du Riot dam, completed in 1873, and located few kilometres upstream of the Gouffre d'Enfer dam, to supply water to the city of Saint-Etienne (fig. 7)²⁰.

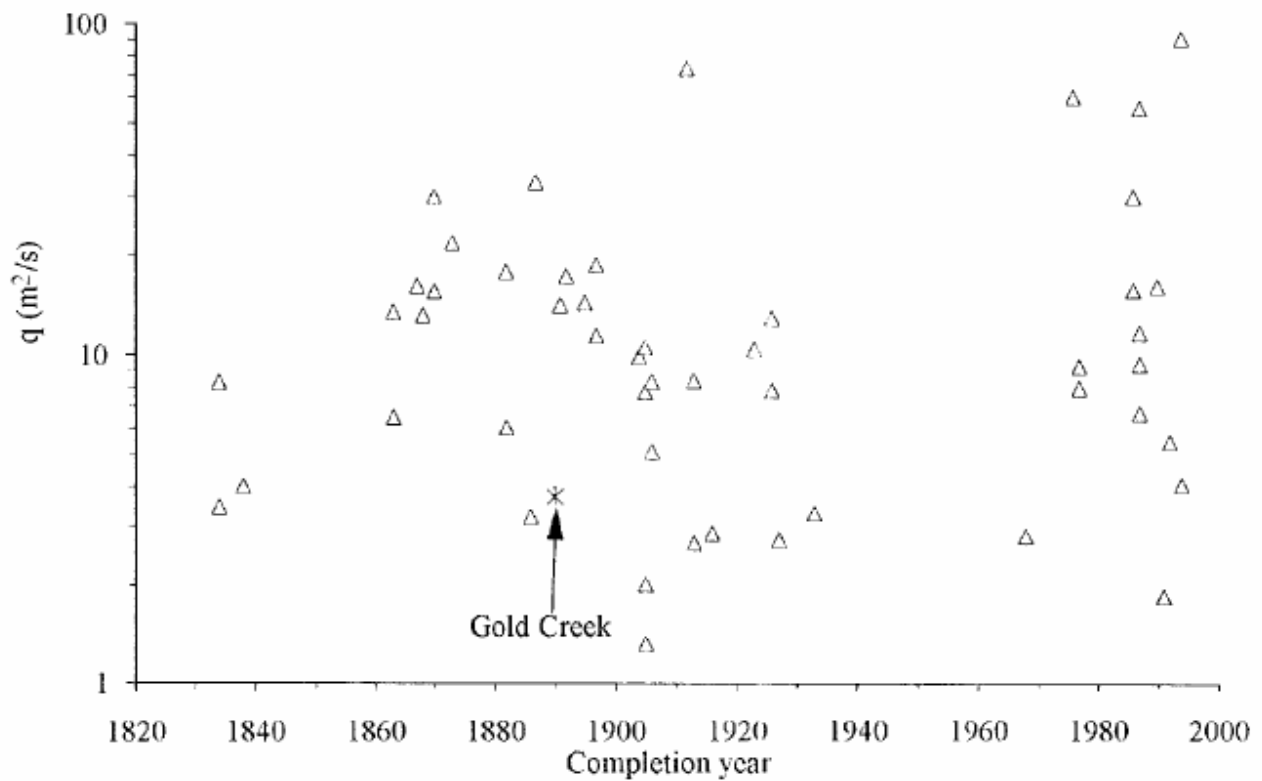
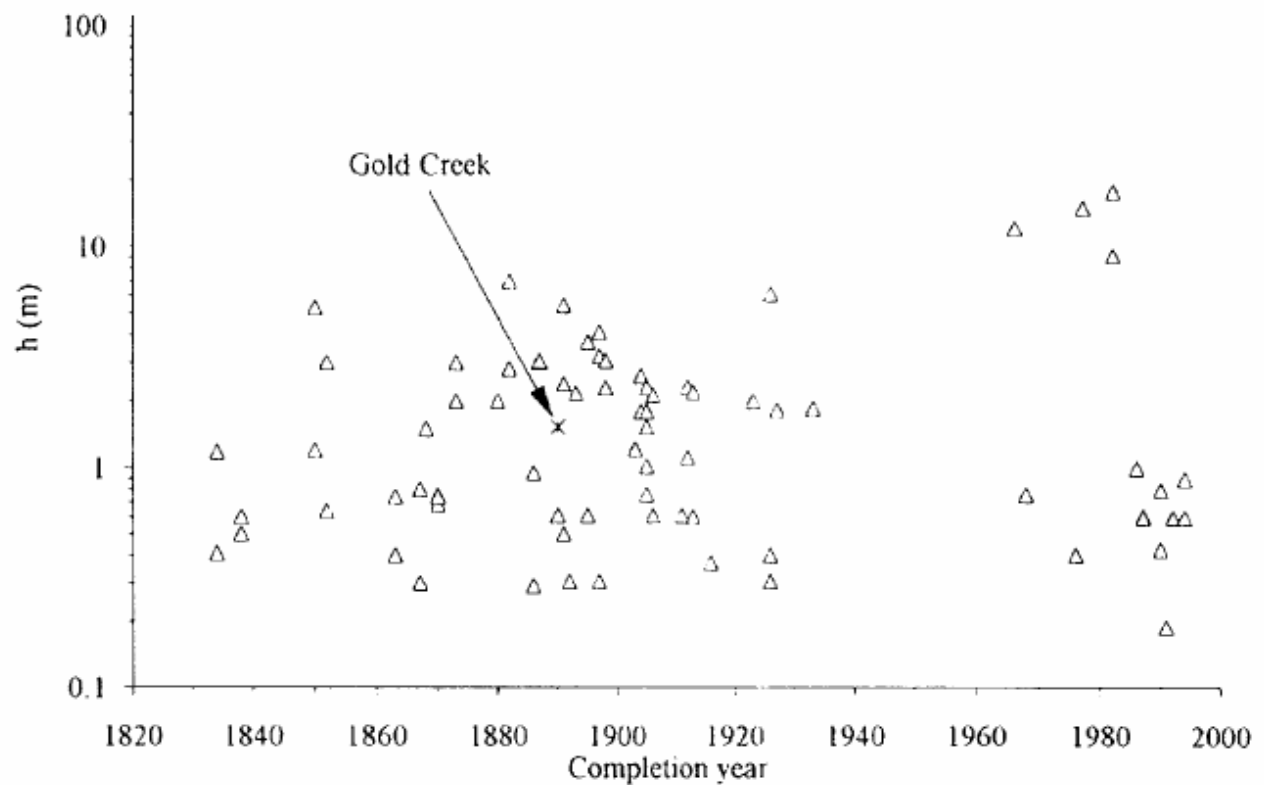
Fig. 8. Comparative performances of stepped spillways built since 1830

(a) Discharge per unit width q (m^2/s)

(b) Step height h (m)

It is worth comparing the Gold Creek spillway characteristics with contemporary and modern spillway standards with respect to discharge intensity and step dimension. Figure 8 presents discharges per unit width and step heights of stepped spillways as functions of the year of completion. Recent RCC stepped spillways and unlined rock cascades (e.g. La Grande 2, Canada, Dartmouth, Australia) are included. Overall figure 8 indicates that 19th century stepped spillways were designed with similar step heights as today (fig. 8b) but the maximum discharge capacity was somewhat smaller (fig. 8a).
