Guided wave scattering analysis around a circular delamination in a quasi-isotropic fiber-composite laminate

Event: SPIE Smart Structures + Nondestructive Evaluation, 2020, Online Only

L. Maio^a, F. Hervin^b and P. Fromme^b

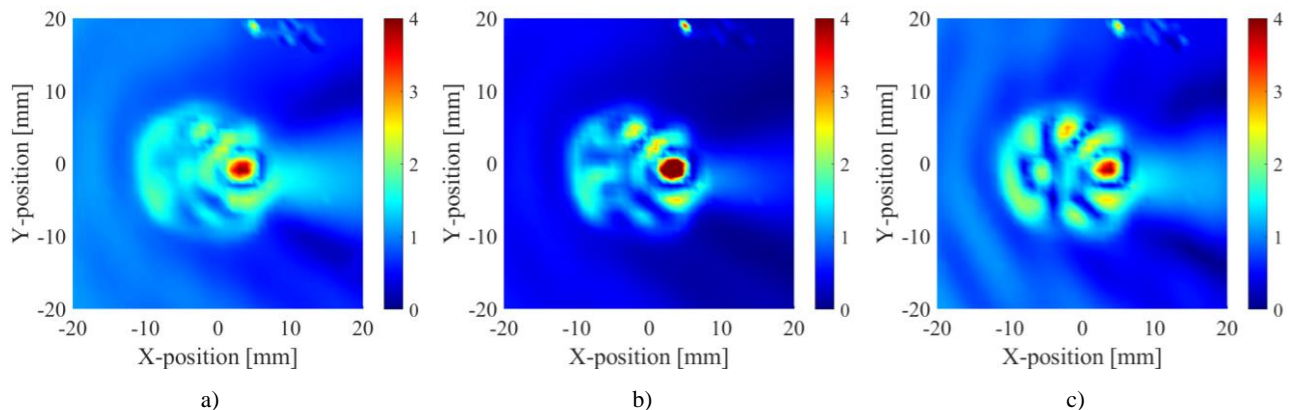
Figure 3. Measured scattered wavefield of A_0 mode at 50 kHz in 40 mm x 40 mm area centered on circular delamination (diameter: 20 mm); a) Normalized maximum amplitude of signal envelope; b) Normalized total energy of wave pulse. c) Normalized magnitude of FFT at 50 kHz. Position (0,0) approximately corresponds to center of delamination. Incident wave propagates from left to right.

Figure 3 shows the scattered wavefield of the 40 mm x 40 mm area surrounding the delamination. The incident wave propagates left to right (direction of x-axis). The maximum amplitude (Figure 3a) increases in a circular region that corresponds to approximately the size of the delamination (diameter: 20 mm). The points with high amplitude suggest that energy is trapped on top of the delamination, as reported in literature. The regions of high and low amplitude within the delamination area might indicate multiple reflections of the wave modes trapped within the delamination. A forward scattered wave with higher amplitude can be observed to the right of the circular region, behind the delamination. Two regions of low amplitude either side of the forward scattered wave can be seen. This suggests that destructive interference is occurring between the incident and forward scattered wave. The scattering pattern is reasonably symmetric, which is to be expected due to the symmetric shape of the artificial insert. A similar scattering pattern can be observed in the total energy of the wavefield (Figure 3b) and the magnitude of the FFT at 50kHz (Figure 3c). Therefore, only the maximum amplitude evaluation will be considered for the rest of this discussion.

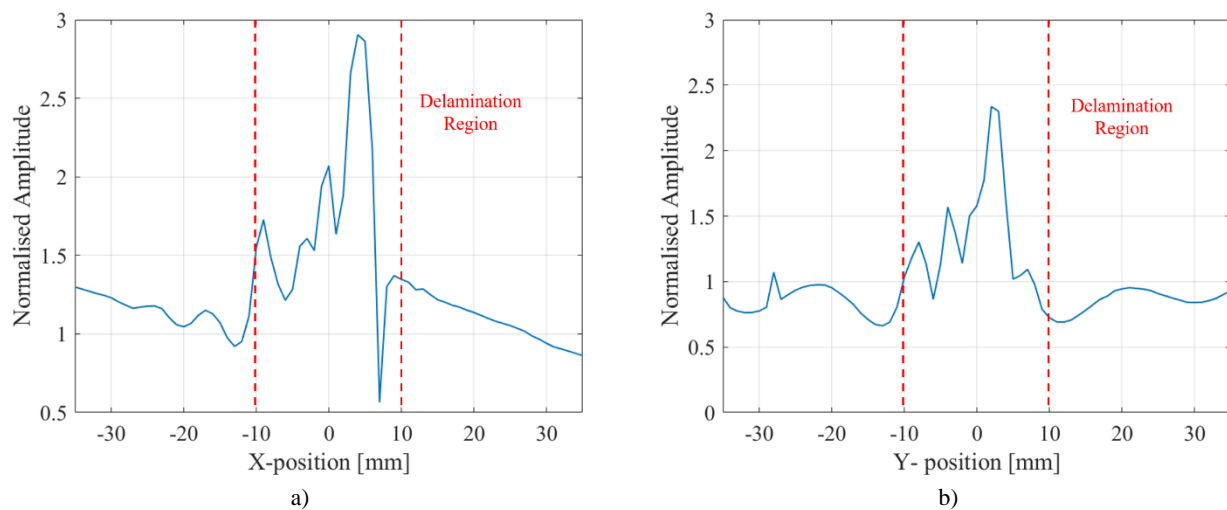
Figure 5. Normalized maximum scattered amplitude for a) 70 mm horizontal line scan b) 70 mm vertical line scan. Position at 0 mm corresponds approximately to center of delamination; delamination region indicated by red dotted lines.

Figure 5 shows the maximum scattered amplitude along 70 mm horizontal and vertical lines passing through the center of the delamination. The amplitude decreases along the horizontal line (Figure 5a) until the delamination region is reached, where a sharp increase in amplitude is observed. This is consistent with the scanning results shown in Figure 3. The decrease in amplitude with propagation distance outside of the delamination region is to be expected, as the distance from the transducer and thus wave attenuation is increasing. A significant decrease in amplitude can be observed at the edge of the delamination at +7 mm. After +10 mm the forward scattered amplitude is greater than that of the incident wave, consistent with the forward scattered lobe observed above. The amplitude of the vertical line scan in Figure 5b increases between -10 mm to +10 mm which corresponds to the delamination region. The amplitude of the scattered field is approximately symmetric on either side of the delamination region, showing some interference. The amplitude is not symmetric within the delamination for both the horizontal and vertical scans.
