Hydrogeological and hydrochemical features of an area polluted by heavy metals in central Nicaragua

Publisher's Note: Hydrogeology Journal (2006), pp 777–784 DOI 10.1007/s10040-005-0462-5

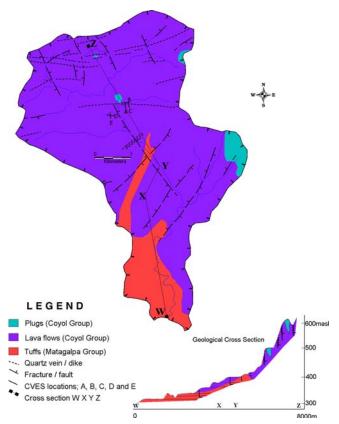
Fig. 2 The lithological and tectonic features of the area and location of CVES surveys (A-E)

Figure 2 shows the two main geological units present in the basin; the old pyroclastic rocks of the Matagalpa group in the south and the basalt to andesite lava flows of the Coyol group in the central and northern part. Several plugs of acid composition have intruded these units (Hodgson 1972; Ehrenborg 1996).

Continuous Vertical Electrical Sounding (CVES), which combines lateral with vertical data acquisition, was the applied resistivity imaging technique. The multi-electrode ABEM Lund Imaging System (Dahlin 1996) was used in varied layouts at diverse locations in the area to locate fractures, zones of quartz veins and to map weathered layers. Examples of five CVES, two using the Wenner array, one using Wenner-Schlumberger array and two using the dipole-dipole array are presented in this work. Documentation of the ground lithology and observations in available mine shafts was done along each line. Three of the CVES lines had a length of 160 m, with a 2-m electrode spacing, and two lines had a length of 200 m, with 2-m electrode spacing. The CVES were performed at several sites and results from two sites with geological setting representative of the area are presented here, crossing springs with weathered rock zones and a quartz vein area (Fig. 2).

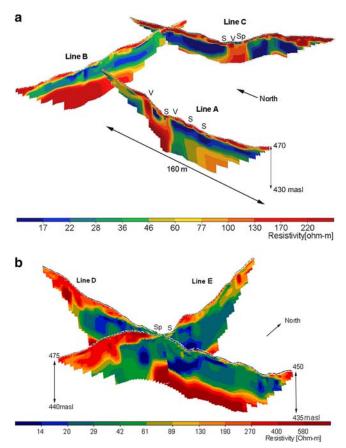
Fig. 3 CVES results. **a**), the resistivity inversion models for Line A, Line B and Line C, all 160 m long. Line A shows coarse-grain material on top of a low resistive layer with clay weathered material. Quartz veins (V) stand out as high resistive vertical zones. A spring (Sp) is found on top of a quartz vein (V) on Line C. **b**), Lines E and D show the low resistive clay weathered zones reaching the surface at spring 61 along a stream valley (each line is 200 m long). *Sp* Spring, *S* Stream, *V* Quartz vein

The results of the combined geophysical surveys and geological reconnaissance show that tectonics and weathering processes have dominant influence on the occurrence of groundwater flow systems. Figure 3 shows the 2D resistivity inversion results for five CVES lines performed in the upper part of the basin. Lines A and B were located at a site where the geology is characterized by a 5–10 m thick quartz vein intruding weathered andesite-basalt flows (see Fig. 2). Both resistivity lines meet at a spring location and the south-north line (Line A) crosses a stream three times. These two resistivity lines show three layers with different resistivity values. On the top, there is a 1-5 m thick layer with values of 60-220 ohm-m. Below this layer, the resistivity drops to 17-46 ohm-m, becoming at least 10 m thick. This area reaches the surface at the spring location at Line B (see Fig. 3). Two vertical patterns, corresponding to quartz vein areas are located at 95 and 120 m on Line A, giving very high resistivity values (>220 ohm-m). The strong correlation between tectonics and groundwater occurrence is confirmed on Line C, where a spring is found directly on top of a quartz vein. Lines E and

D were located so that they crossed one of the analysed springs (#61). Both lines show an upper layer with high resistivity values (>130 ohm-m) in the hilltops and hillsides, which get thinner towards the valley areas. Along Line D at the stream valley the resistivity values are lower (<42 ohm-m).

Using CVES, it was possible to clearly delineate three distinctly different resistivity layers at the investigated locations. For all lines, the results show relatively high resistivity values in the top layer, which is associated with hydraulically permeable coarse-grained material. This might be caused by material transported due to natural processes or leached weathered soil, but it might also originate from material removed from mining activities on the surface. The latter is the case for Lines A and B, where mining has been reported around the quartz vein. A second, underlying, layer is then found which appears to be clay weathered material. This clay layer may have low hydraulic conductivity, which explains the fact that a spring is formed where this layer meets the surface on Line E. The bottom resistivity layer is interpreted as less weathered or fresh rock, since very high values were obtained. An intrusive body was visible at the west extreme of Line B (see Fig. 3). As Line E reaches the hillsides and approaches spring 61 and the stream, the low resistive clay layer gets near the surface. This could have implications for discharge, since water infiltrating the uppermost coarse-grained layer can be discharged along the streams. This can also be appreciated on Line D, where the top layer is mostly the low resistive.

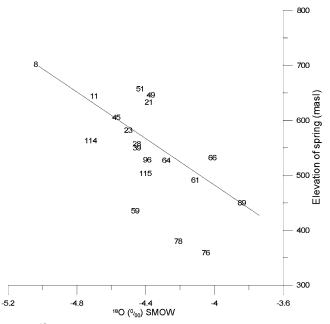
Fig. 7 ¹⁸O results plotted against the elevation of the springs. The trend line is adjusted to the elevations of spring 8 and 89, since those springs are judged to be located very close to their recharge area

The ¹⁸O analyses indicate that the springs occur at an altitude that ranges from 0 to 150 m from the average elevation of their recharge areas. The results of ¹⁸O are presented in Fig. 7 as function of the altitude of the springs together with an estimation of the average altitude of the recharge areas.
