# **Impact damage detection on composites using optical NDT techniques**

Jasson Gryzagoridis, Dirk Findeis  
Mechanical Engineering Department  
University of Cape Town, South Africa.  
Phone: +27 21 6503229  
Fax: +27 21 6503240  
E-mail: [jasson.gryzagoridis@uct.ac.za](mailto:jasson.gryzagoridis@uct.ac.za)

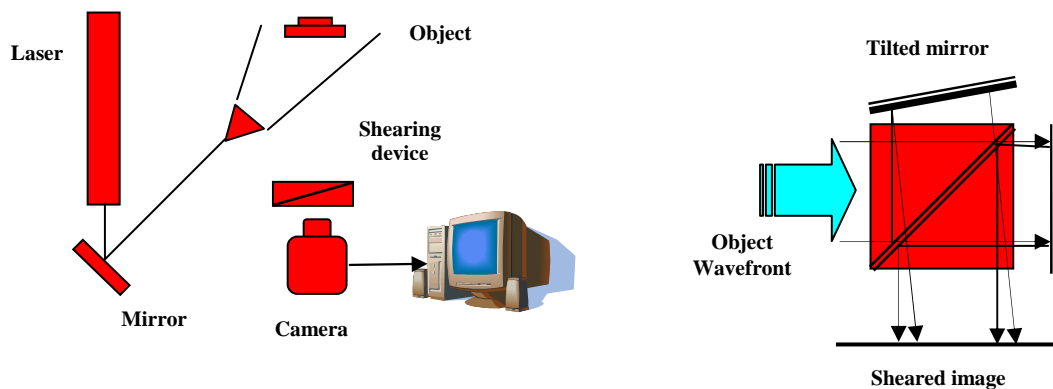
Figure 1. Typical Shearography set-up (left) and image shearing device (right)

Digital Shearography has its origins firstly as a strain measurement technique (1974) and later as a non-destructive testing tool (1982) as reported by Hung <sup>(3, 4)</sup>. Digital Shearography as a non-contacting, whole field view and practically real time technique, is capable of revealing sub surface defects as a localized disturbance in the fringe pattern depicting the gradient of out-of-plane surface displacements on the component under test. In response to a mild perturbation of the specimen under test by mechanical, thermal, pressure or vibratory means the surface of the test piece which is illuminated with a laser changes its speckled image. The subtraction of two speckled images of the object’s surface, obtained one before and the other after the perturbation, results in the fringe pattern which resembles zebra stripes superimposed on the object’s image. “The anomalies in the fringe pattern, basically display the position and approximate size of the defect, however not its depth relative to the surface”<sup>(5)</sup>. Typical Digital Shearographic NDT set-ups, similar to the one depicted in figure 1(left), include a personal computer equipped with software to process the images of the object under test. A single wavelength light source (a laser) is used to illuminate the object thus producing a unique speckled image. The images are obtained via a digital camera viewing the object through some shearing optics and are stored in the pc’s image digitizer. A typical shearing device (favoured by the authors as it is used in their portable shearography system<sup>(4)</sup>), is the modified Michelson interferometer as illustrated in figure 1(right).

When one compares the set-ups of Digital Shearography and ESPI (figures 1 and 2 respectively) the similarity is apparent, with the major difference being the reference beam. For example the reference beam in the Shearography set-up is generated by the actual surface of the test piece and therefore it carries the signals of the body motion. This of course is highly desirable in Shearography because it reduces the effect of environmental disturbances that de-correlate the speckle images. In the ESPI set-up the reference beam is produced from the original illumination beam and without being disturbed is combined with the beam reflected from the object by a beam splitter located after the camera’s lens. It appears therefore that if a reference beam can be introduced in the shearography set-up and combined with the image of the object under test we would obtain an ESPI result. This is relatively easily accomplished by introducing in say one third of the illumination field of the object an optically diffuse flat surface. The surface will reflect its image onto the beam splitter where it would combine with the reflected image of the surface under test and create the fringe pattern that exhibits displacements normal to the surface. What has been described above is depicted in figure 3 where we note that the shear distance is substantially increased (by the tilting of one of the mirrors) to and beyond the point that the two images share no common portion. Under these conditions with the reference beam generated by the neutral surface, one image (the lower one in fig. 3 or the one transmitted through the beam splitter) of the portion of the surface under test is combined with the reference beam creating ESPI conditions.

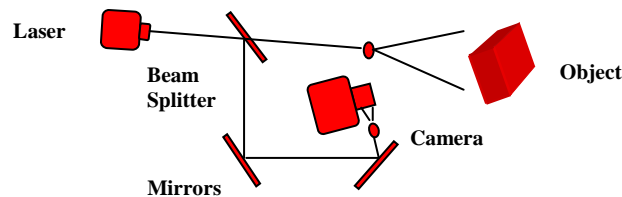
**Figure 2. Typical ESPI set-up for out-of-plane displacement measurement**

Electronic Speckle Pattern Interferometry (ESPI) was first announced or demonstrated by Butters & Leendertz <sup>(6)</sup> as a special version of holographic interferometry where the display of a fringe pattern is upon a pc's monitor, practically in real time. The fringe pattern is interpreted as a contour map of the surface displacement of an object when it is mildly stressed and compared to a reference state, identical to the process followed in the technique of Digital Shearography described above. The displacement can be measured either in the in-plane or out-of-plane direction depending on the arrangement of the optical components. The out-of-plane displacement sensitive arrangement, as shown in figure 2, is the more versatile of the two as it makes better usage of the light originating at the laser. The set-up is very similar to the Shearography one shown in figure 1 (left), with the exception of the reference beam created by the beam splitter and the two laser beam steering mirrors. The reference beam is combined with the object reflection beam behind the camera lens producing a unique speckled image. The process of obtaining a fringe pattern (as a contour of the normal surface displacements) superimposed on the image of the object's surface under test is identical to that detailed for the shearography technique. It can be shown that the out of plane displacement of any point on the object can be calculated using the following equation

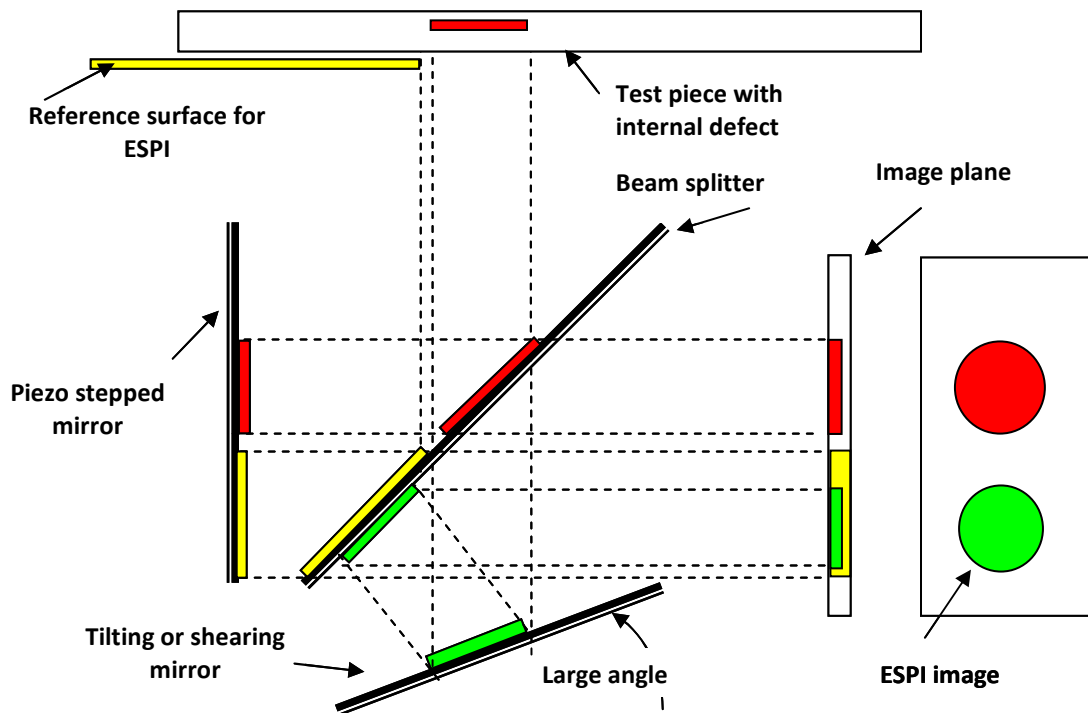
Figure 3. Transformation of Shearography to ESPI

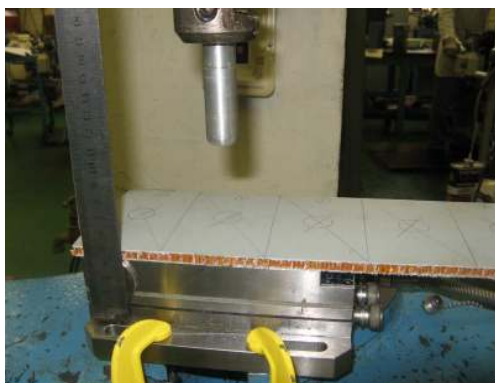
**Figure 4. Left, setup used to create the impact damage on the specimen with typical core damage obtained as depicted in the image to the right.**

Figure 4 shows a steel rule vertically positioned to measure the heights from which impact damage was to be initiated. The impactor head was hemispherical, made from an

aluminium bar 20 mm in diameter which was guided to fall on the specimen that rested on the tool dynamometer. The output (Newtons) of the tool dynamometer was read off an oscilloscope together with the impact time. Thus the experimental impulse could be found and compared to the theoretical impulse values however, for the purpose here being a comparative exercise, we will not require these calculations and results. The defects were created accordingly by releasing the impactor from different heights. Care was taken to ensure that the impactor was released from heights that did not result in creating visible damage to the surface of the specimen. (cracks, indentations, scratches etc.) Typical phased stepped shearographic results obtained by mildly heating the specimen are depicted in figure 5 below; impacts for this specimen were accomplished from heights of 200, 150 and 100 mm respectively starting from the left of the image.

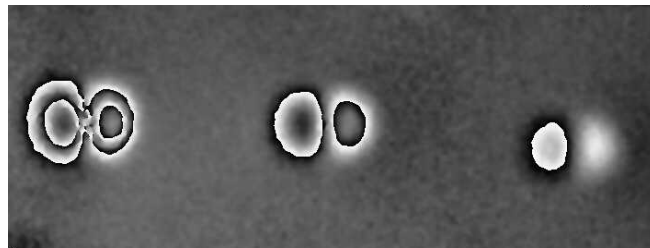
**Figure 5. Internal impact damage revealed with Shearography**

The same specimen as depicted in figure 5 was examined using the IRISYS-1011 Universal Thermal Imager after the specimen was heated mildly using a hair dryer for a few seconds. The results as depicted in figure 6, were obtained with a little effort by continuously manipulating the sensitivity of the infrared camera, are comparable to those obtained with the shearographic system.

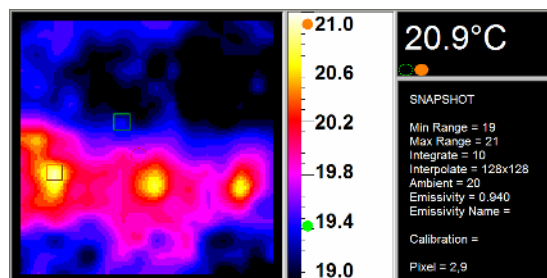
**Figure 6. Internal impact damage revealed with Thermography**

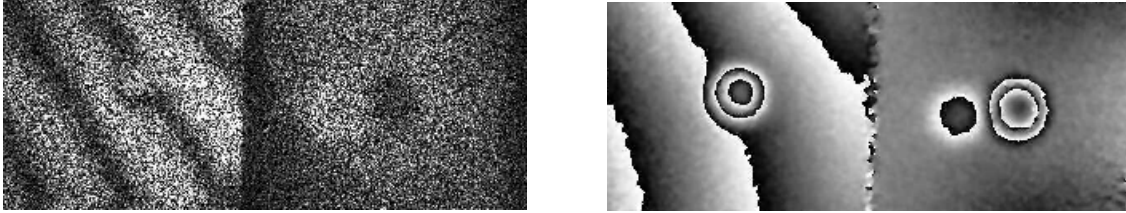
Continuing with the same specimen and concentrating on the middle of the three impacts that were simulated on the UAV's wing composite specimen, the position was examined for signs of internal damage by using UCT's Shearography system in the ESPI mode. The result which is shown in figure 7 below is as dramatic as those obtained in the Shearographic mode (see figure 5 above). The image on the left for both assemblies is in ESPI format, the first as an intensity image and the second as a filtered stepped phase interferogram and the ones on their right are their respective Shearography counterparts. The fringes that appear at an angle in the ESPI images are indication of body motion to which ESPI is very susceptible. They were probably

caused by the motion of the specimen itself, rather than motion of the reference surface that was placed quite securely and rigidly in front of the test piece.

**Figure 7. Internal impact damage (middle of the three) revealed with ESPI intensity image on the left and filtered stepped phase image on the right**

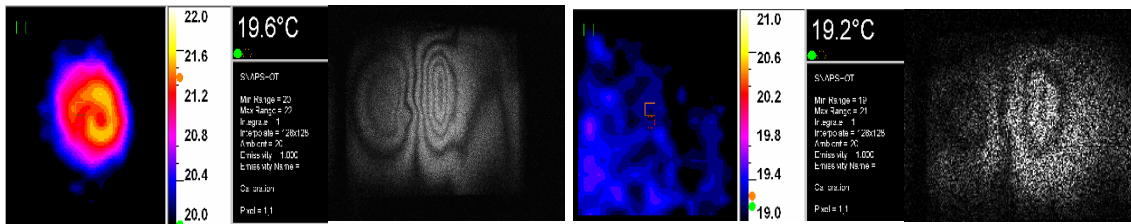
Finally the tests indicated that at all times Shearography continued to reveal the internal damage due to impact for a longer period compared to the Thermographic technique. This is demonstrated in the images depicted in figure 8 below.

**Figure 8. The Shearographic system continued to indicate the presence of a defect long after the Thermographic technique**

strength of the skin. However, when slightly loaded it was noticed that the core easily compressed and the specimen was a great deal weaker in the impact region. The lack of delamination at the skin-core interface does not agree with previous held conviction. What may in fact be happening is that an imperceptible dent has occurred and when the specimen is thermally loaded the skin flexes outwards against the weakened or crushed core much in the same way as if a delamination existed. The results presented in figures 5, 6, 7 and 8 clearly demonstrate that all three techniques, that is, IRT, Shearography and ESPI, detect and show readily the location of defects in the composite material tested. Moreover, the IRT images were not only indicating the position of the defect or flaw, but produced data concerning the temperature of the region of the defect in relation to the cooler surrounding material. The Shearographic system however, was exceptional in the display of the results. The system was not just more sensitive compared to IRT in responding to the heating stimulus on the specimens and readily displayed the image denoting the defect, but was also able to show the image for much longer period of time than the IRT system. In all the test results obtained, both the Shearographic and ESPI systems continued to show live fringes while the IRT system had lost the 'hot spot'. This effect can be explained quite simply; as the specimen's surface cools it is very probable that below the skin the temperature around the defect is still higher than equilibrium thus straining the body which obviously affects or strains the skin surface as well, hence the surface is still strained although its temperature has reached equilibrium with the environment.
