# Impact Fretting Wear Behavior of Alloy 690 Tubes in Dry and Deionized Water Conditions

**Keywords** Impact fretting wear · Alloy 690 · Oxidative wear · Crack · Fracture appearance

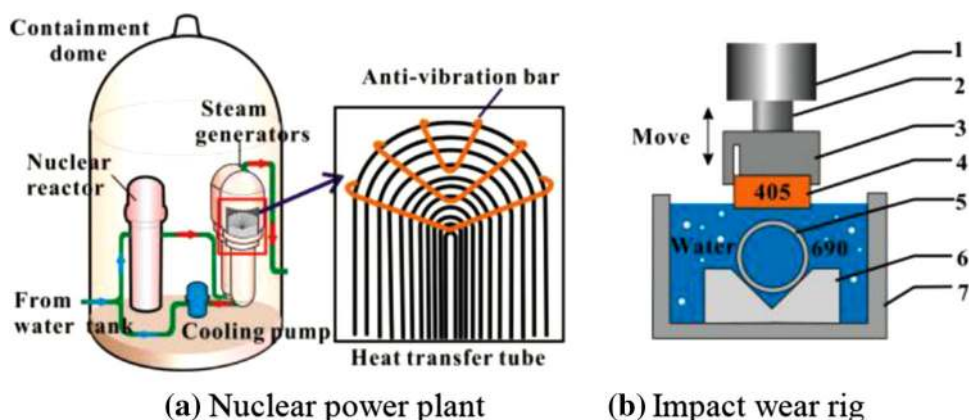
**Fig. 1** Schematic of the impact in the nuclear power device and its impact fretting wear tester. 1. Vibration exciter; 2. Force and acceleration transducer; 3. Upper clamp; 4. Plate specimen; 5. Tube specimen; 6. Lower fixer; 7. Container

A small displacement impact wear testing machine with tube-on-plate configuration had been developed to simulate the impact fretting wear phenomenon between the tube and the support material, as shown in Fig. 1.

As shown in Fig. 1, alloy 690 tube was fixed in a “V” groove fixture, the load sensor was connected to the vibrator, and the plate specimens were installed under the load sensor by the upper fixture. During the test, the impact wear test used a force control mode. The impact force could be changed by adjusting the magnitude of the

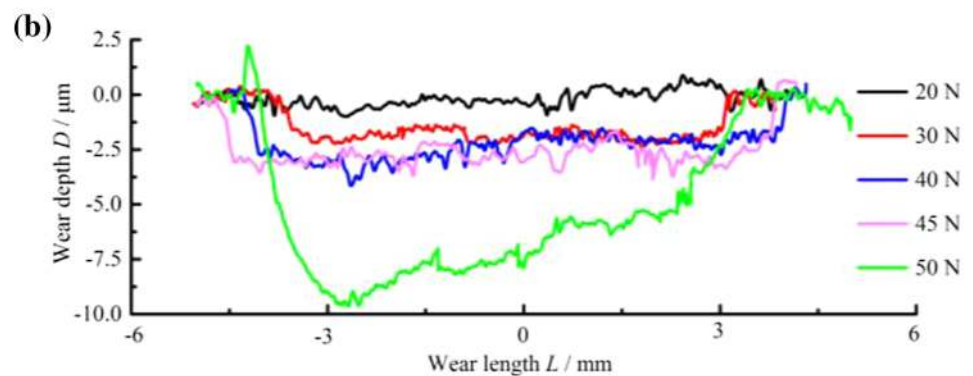
**Fig. 2** Morphologies and 2D profiles of the wear scars in the dry water condition,  $L = 15 \text{ mm}$

- (3) Compared with the impact of tube in dry and deionized water, when the tube cracks in dry water, the deionized water lubrication can significantly delay the cracking time. The cycle of crack appearance increases from  $1.3 \times 10^5$  to  $1.8 \times 10^5$  when the impact load set as 50 N. Figure 2 shows the OM and 2D profiles of the wear scar of the 15 mm long tube in dry water. Increasing the impact loads results in serious wear of the morphology of the tube. Particularly when the load increases to 45 N, the tube cracks until the end of the test. Wear depth increases from  $1 \mu\text{m}$  to  $10 \mu\text{m}$  when the impact load increase from 20 N to 50 N. The uplift phenomenon is observed at the edge of the wear surface. This phenomenon indicates that the extrusion deformation of material occurs during impact fretting wear and remains negligible in smaller load.

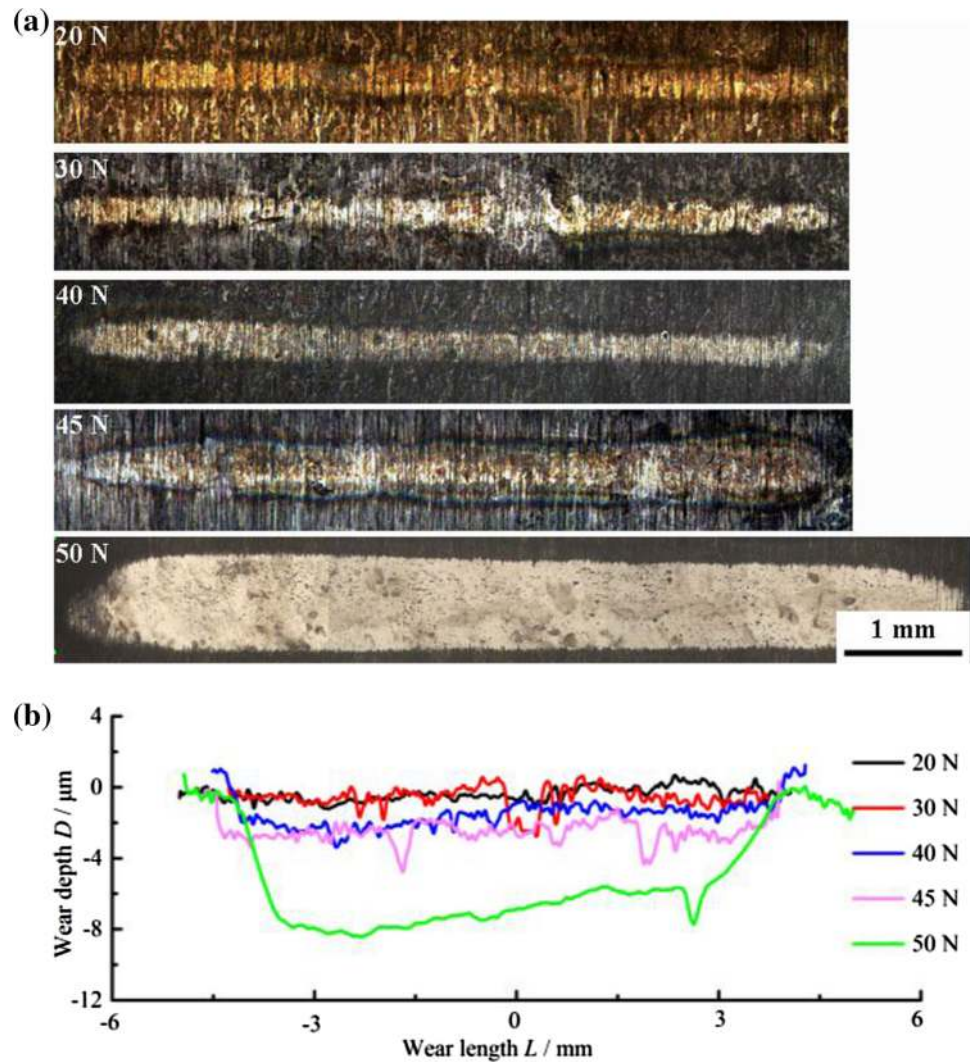
**Fig. 3** Morphologies and 2D profiles of the wear scars in the deionized water condition,  $L = 15$  mm

The OM and 2D profiles of the wear scar of the 15 mm long tube in deionized water are shown in Fig. 3. Between the OM and 2D profiles of the impact wear scar in the dry and deionized water conditions, the impact wear depth is smaller in the deionized water condition than that in the dry

water condition. The maximum wear depth was approximately 8  $\mu\text{m}$  in water.

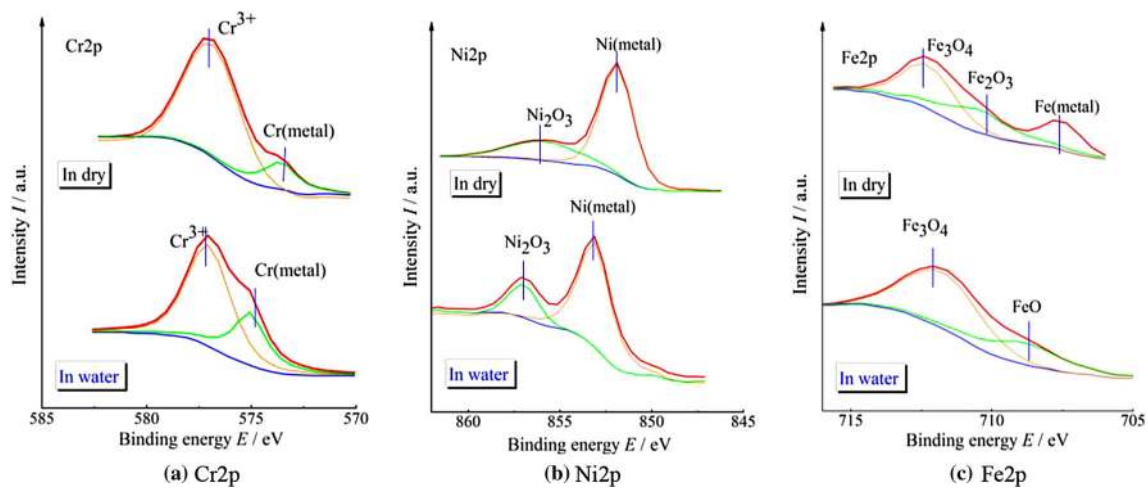
**Fig. 8** XPS spectra of the wear scars in the dry and deionized water conditions:  $F_n = 40$  N,  $L = 15$  mm

Figure 8 shows the XPS spectra of  $Cr2p$ ,  $Ni2p$ , and  $Fe2p$  from the scar surfaces in the dry and deionized water conditions. As shown in Fig. 8a, two typical peaks in the spectrum of  $Cr2p_{3/2}$  are observed. The peak observed at 577.3 eV is ascribed to  $Cr_2O_3$ , and the other peak is ascribed to Cr (its binding energy is 574.3 eV), Cr(III) oxide fit with multiplet as shown above and fit Cr metal with asymmetric peak, Native oxide on Cr metal may be a mix of Cr(III) oxide and Cr(III) hydroxide [21]. From

$Ni2p_{3/2}$  of the spectrum shown in Fig. 8b, two peaks are observed: one peak is  $Ni_2O_3$  (its binding energy was 856.3 eV) and the other peak is Ni (its binding energy is 852.5 eV) [22]. Three peaks are observed in the XPS spectra of  $Fe2p$  in the dry water condition (Fig. 8c). The binding energy of  $Fe_3O_4$  is 712.4 eV, the binding energy of  $Fe_2O_3$  is 710.6 eV, and the binding energy of Fe is 706.8 eV. Two peaks are observed in the XPS spectra of  $Fe2p$  from the scar surface in the deionized water

condition: one peak is  $\text{Fe}_3\text{O}_4$  (its binding energy is 712.4 eV) and the other peak is FeO (its binding energy is 709.5 eV) [23]. The XPS results of the elements Cr and Ni show that the chemical compositions of the worn surfaces of the dry and deionized water conditions are similar. The  $\text{Cr}_2\text{O}_3$  and  $\text{Ni}_2\text{O}_3$  peaks are observed in the two types of lubrication conditions. The results of the element Fe show that the chemical compositions of the scar surfaces of the dry and deionized water had several differences. The  $\text{Fe}_2\text{O}_3$  and  $\text{Fe}_3\text{O}_4$  peaks are observed in the scar surface of the dry water condition. The FeO and  $\text{Fe}_3\text{O}_4$  peaks appears in the scar surface of the deionized water condition.

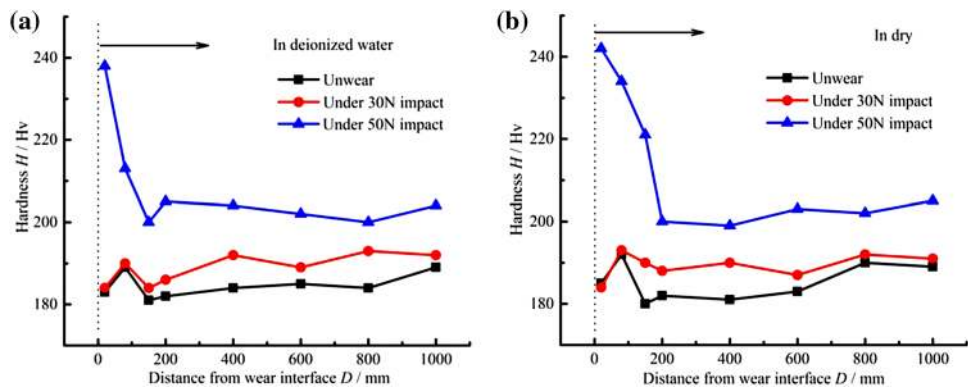
**Fig. 10** Hardness of the cross-section from worn surface to inner layer,  $L = 15$  mm

specimen, the hardness tests are conducted at different locations and the average values are plotted in Fig. 10. Prior to the impact wear test, the hardness value of the tube is 190 HV. However, the hardness near the worn surface rapidly increases with the increase in the impact load regardless of the water or dry state. Within 1 mm of the subsurface, the impact load has a remarkable effect on hardness and a high load lead to higher secondary surface hardness.

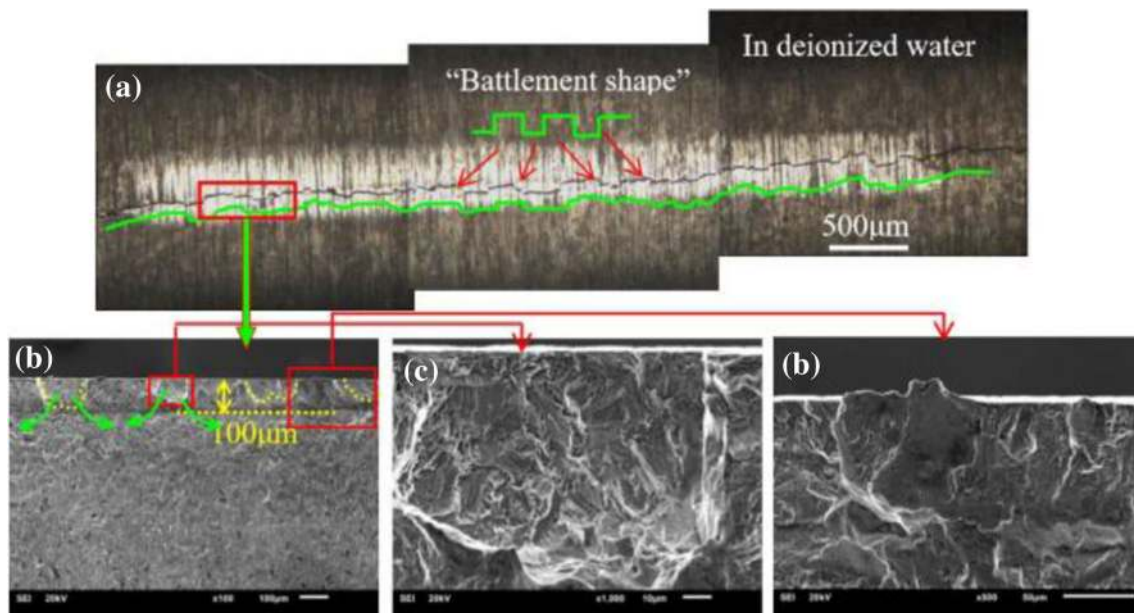
**Fig. 12** Morphology of crack and fracture appearance in the deionized water condition,  $F_n = 50$  N,  $L = 10$  mm

the deionized water condition. The quasi-cleavage characteristics are observed, and the contact stress is small because of the presence of the deionized water film. The material shows a formation of a deformation layer, and the impact wear is small under the impact test. The material is separated along a certain crystallographic plane. In the deionized water condition, the wear scar was slight. The traces of the original processing can also be observed. The crack propagation morphology shows a jagged shape (similar to the battlement shape) in the water, but extends disorderly in the dry condition. The results of Meng's study [26] shows that stress corrosion cause the tube to crack in the fluid condition, and the cracks extend along the grain boundaries. Thus, the crack of the wear surface exhibits a "wave shape" in the deionized water condition. This phenomenon does not occur in the dry water condition. In the analysis of crack fractures in tubes, a quasi-cleavage fracture characterized by river pattern and cleavage terrace is observed and confirmed.
