Muhamad Fatikul ARIF, Fodil MERAGHNI, Yves CHEMISKY, Nicolas DESPRINGRE, Gilles ROBERT - In situ damage mechanisms investigation of PA66/GF30 composite: Effect of relative humidity - Composites Part B: Engineering - Vol. 58, p.487-495 - 2014

In situ damage mechanisms investigation of PA66/GF30 composite: Effect of relative humidity

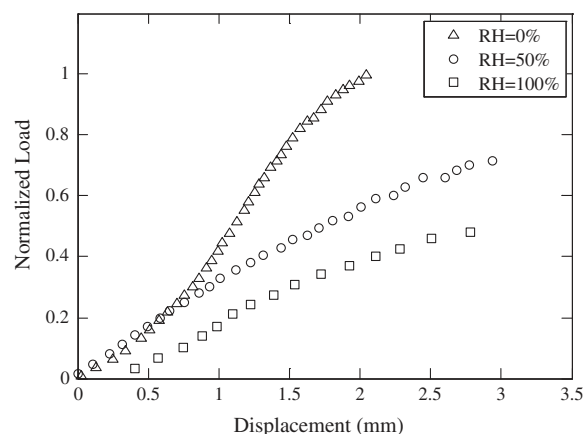
Fig. 2. Normalized load vs. displacement curve of PA66/GF30 specimens with variation of relative humidity.

Fig. 2 shows the normalized load – displacement responses of the in situ SEM three-point bending tests of PA66/GF30 specimens conditioned at various RH conditions. For each specimen, the relative ultimate loads before failure were recorded. Flexural strength (σ_f) was defined, for each RH content, as the maximum flexural stress in the specimen at the ultimate load according to ISO 178 standard. Relative flexural stress was defined to be the ratio of flexural stress in the area of observation with respect to the flexural strength. As described in Fig. 2, the RH content highly influences the mechanical properties of PA66/GF30. Flexural strength and stiffness of PA66/GF30 decreases with the increase of RH. The noticeable differences on the strength and modulus of PA66/GF30 by variation of RH are assumed to be due to damage and plasticization effect. Indeed, the RH = 0%, 50% and 100% specimens represent the conditions where the composites are respectively in glassy ($T_g > T_{\text{room}}$), glass transition ($T_g \approx T_{\text{room}}$) and rubbery states ($T_g < T_{\text{room}}$) [26,27]. Strain to failure in RH = 50% and 100% specimens are higher than that in RH = 0% specimen, whereas no significant difference is observed between the strain to failure at RH = 50% and 100% specimens. While the increase of strain to failure due to higher RH is noticeable for pure polyamide 66, this phenomenon is not strongly marked for fiber reinforced composite material [32].

The damage mechanisms observed in PA66/GF30 are strongly affected by the moisture content variation. The flexural strength is reduced with increasing moisture content, which is assumed to be due to the combination of damage and polyamide plasticization effects (Fig. 2). Consistent results are also observed regarding to the qualitative observation of the number of damaged zone on the composites surface which shows that the higher RH results in higher damage level, at every stage of the loading. Moreover, Fig. 14 shows a comparison of damaged area for the three specimens with different moisture content at high relative flexural stress near to the failure. It is obvious that the number of damaged area increases while increasing the moisture content. The presence of water molecules inside the composite can reduce the mechanical performances of the polyamide as well as the fiber-matrix interfacial properties due to the plasticization effect and the mismatched fiber-matrix expansion during the ageing period. This might bring about a change in the overall mechanical and damage properties of PA66/GF30.
