**Published on:** 01 May 2020 - Journal of Composite Materials (SAGE PublicationsSage UK: London, England)

# Influence of machining damage generated during trimming of CFRP composite on the compressive strength

N Nguyen-Dinh, Christophe Bouvet, Redouane Zitoune

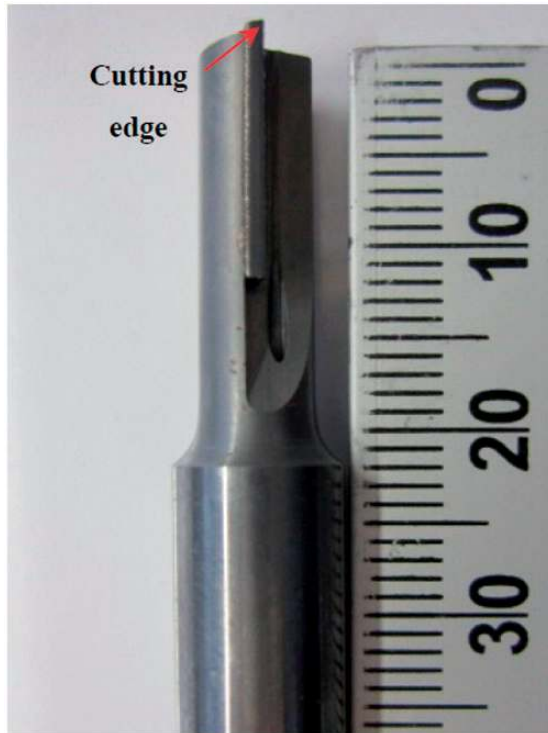
**Figure 3.** PCD tool used with two straight flutes.

Cutting tools	PCD tool: helix angle = $0^\circ$ , rake angle = $5^\circ$ , clearance angle = $7^\circ$ Diameter = 6 mm Number of cutting edge = 2
Cutting conditions	Radial depth of cut ( $a_e$ ) = 2 mm Full factorial design Feed rate (mm/min): $V_f = 500, 1000,$ and 1500 Cutting speed (m/min): $V_c = 150$ and 250 Extreme condition Feed rate (mm/min): $V_f = 29$ Cutting speed (m/min): $V_c = 339$

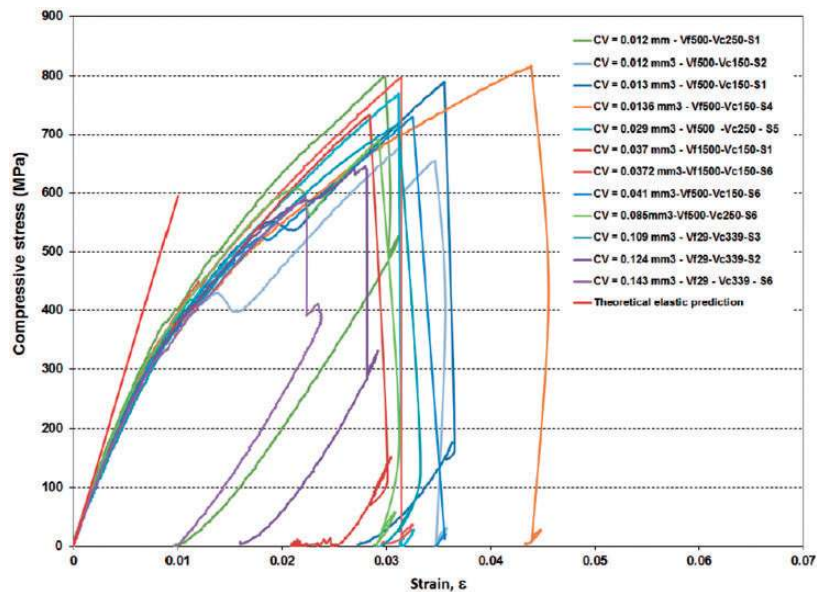
**Figure 19.** Evolution of compressive stress versus strain for specimens in group B.

Regarding the evolution of compressive strength versus strain resulting from the tests of specimens of group B, it is noticed that almost all specimens in group B have similar fracture mechanism as that present in Figure 19. Moreover, it is realized that the failure scenario in this group is different from that in group A when only two steps are observed during compressive loading, i.e. appearance of first crack and final failure of specimens. For the first step, based on the films obtained by infrared camera we realize that the first crack/delamination occurs randomly. It is not always in the same location in the stacking sequence for all tested specimens, and varying between layers upward two  $0^\circ$  layers; it can be located in the  $0^\circ/45^\circ$  interface (the second and third layer),  $45^\circ/90^\circ$  interface (the third and fourth layer),  $90^\circ/-45^\circ$  interface (the fourth and fifth layer), or  $0^\circ/45^\circ$  interface (the fifth and sixth layer). This is schematically described in Figure 20. For the final break, it occurs at the end zone of the tightening of the grips which is also a zone of important shear stress.

One more time it can be noticed a difference between the linear parts of the stress–strain curve obtained by experiment and by a theoretical elastic prediction (Figure 19). As previously mentioned this difference should be partially due to the strain evaluation using a linear extrapolation of the displacement measured by the machine and by the extensometer data; then the strain measurement should be once again taken with caution.

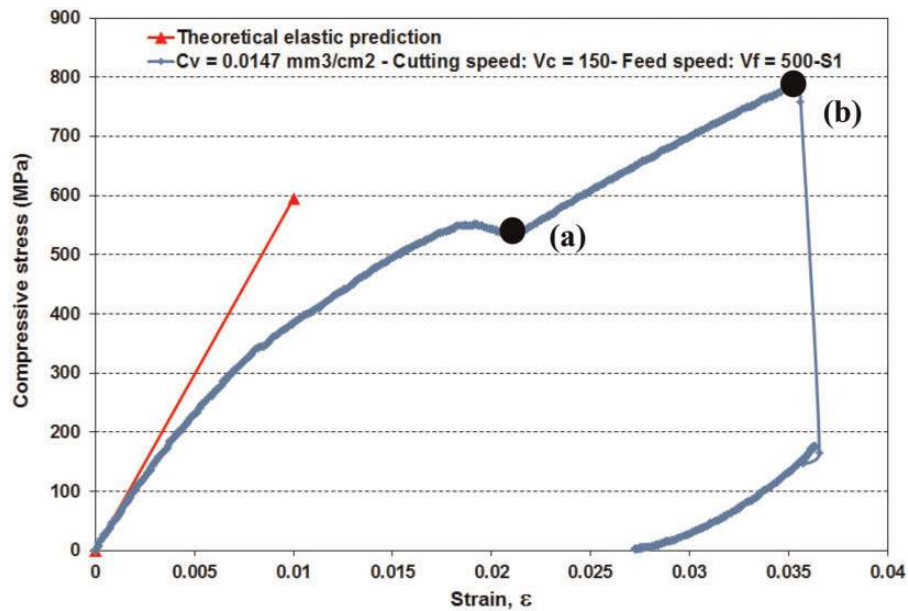
**Figure 21.** Evolution of the load vs displacement obtained for a representative specimen in group B.

To better understand the failure scenario of this group, a stress–strain curve of a specimen, which is considered as good surface quality with crater volume of  $0.0147 \text{ mm}^3/\text{cm}^2$ , is chosen to be the representative of all specimens in group B (Figure 21).

samples were put on the grips ends. Moreover, the non-linearity is more or less pronounced depending on the tests (Figure 19). Then first crack/break (point a of the Figure 21), which is schematically presented in Figure 20, occurs in the  $90^\circ/45^\circ$  interface of the two layers corresponding to fourth and fifth layers in stacking sequence, when stress reaches value of 540 MPa (Figure 22(a)).
