Influence of sub-surface deformation induced by machining on stress corrosion cracking in lead-free brass

Abstract

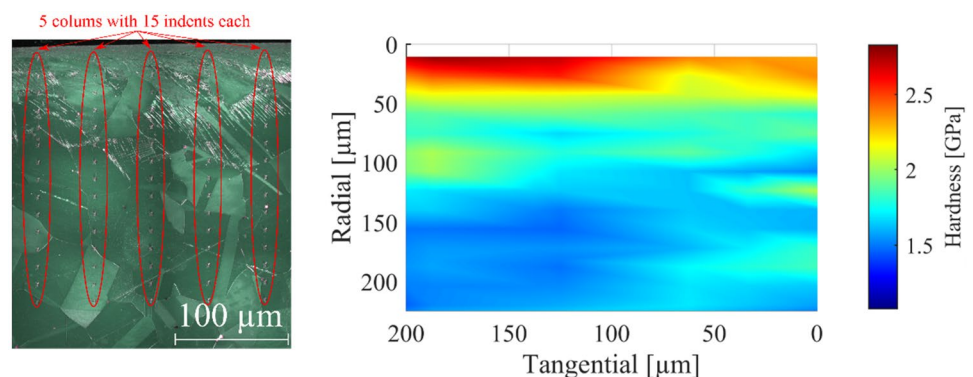
Fig. 4 Example of hardness measurement imprints captured using a light optical microscopy in polarized light and mapping of measured hardness for a sample machined using a worn insert at $f=0.4$ mm/rev in alloy CuZn38As

To characterize the sub-surface deformation using nano-indentation, 15 indentations were made in depth below the surface, all spaced 15 μm apart. Five indentations were

performed for each depth level, spaced 50 μm apart. Thus, a matrix of 5 by 15 indentations was done for each sample as seen in Fig. 4.

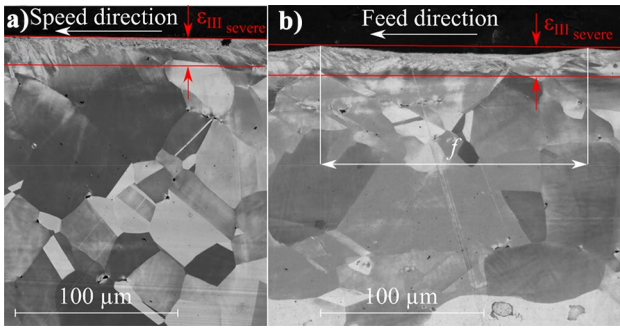
Fig. 5 Ion Channeling Contrast Images (ICCI) after FIB polishing of the deformation zone with the severely deformed part marked by red arrows, for a sample cut in the tangential direction, (a), and a sample cut in the axial direction, (b). The samples of CuZn38As alloy were machined using a sharp insert with $f=0.15$ mm/rev

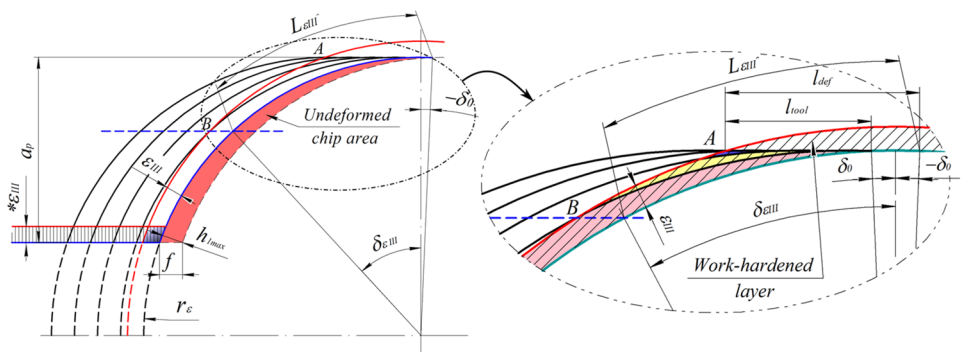
Fig. 6 Schematic of the interaction between sub-surface deformation from single and sequential cuts in longitudinal turning with tools having a nose radius. Adopted from Bushlya et al. [33]

Still, tool wear is among the most defining factors influencing sub-surface deformation and sub-surface damage [32]. This rather predicable and linear behavior becomes much more complicated when machining with cutting tools having a nose radius, $r_ε$ [33]. Sub-surface deformation that is generated during the current cut affects not only machined surface but also the temporary surface, Fig. 6. During the sequential cut, when the tool has moved one feed forward and the workpiece makes one revolution, the cutting tool might cut through already work-hardened layer; thus, multiple deformation might take place. The magnitude of such multiple deformations is controlled by three parameters: tool nose radius— $r_ε$, feed— f and depth of sub-surface deformation from a single cut— ϵ_{III} .

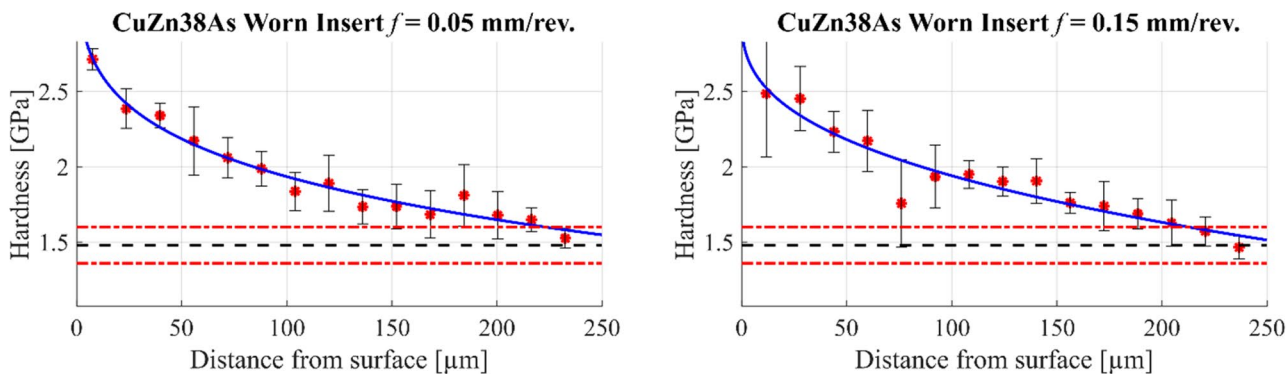
Fig. 7 Hardness distribution for two samples machined with a worn insert and different feed. The red lines show max and min hardness, and the black line shows the average hardness for the unaffected bulk material

Involvement of so many parameters makes the surface integrity response to the machining operation rather difficult to predict analytically. While it is expected that machining with low feed should generate lower plastic deformation, in the case of a worn tool a rather comparable sub-surface deformation ϵ_{III} is found for $f=0.05$ mm/rev and $f=0.15$ mm/rev, see Fig. 7. For both machining conditions, the depth of work-hardening is approximately 220 μ m. Still, for low feed of $f=0.05$ mm/rev the surface hardness is higher because the cutting tool passed over the surface several times. When the feed is very large and is bigger than the original ϵ_{III} , the tool will not re-engage with previously deformed layer and will generate lesser overall deformation, as seen in Fig. 8 for $f=0.4$ mm/rev.

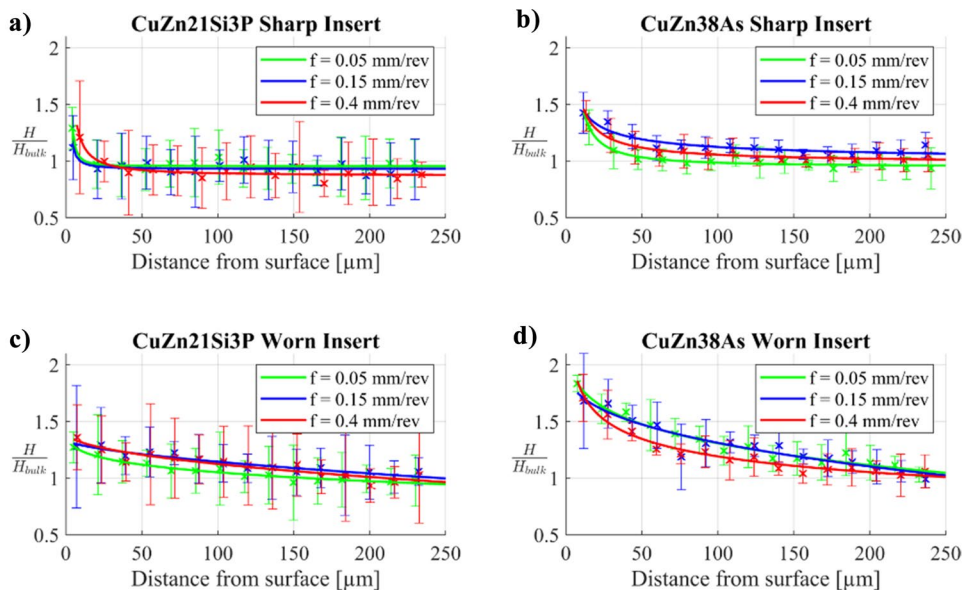
Fig. 8 The quotient between measured sub-surface hardness and the average hardness of unaffected bulk material for all used machining conditions

The influence of feed rate was not significant in this study; however, the wear condition of the tools was important. An increase of both depth of ϵ_{III} and the severity of work-hardening were seen for the worn tool. The two alloys showed different response to the tool conditions. In Fig. 8, a quotient between the local sub-surface hardness, H , to the unaffected bulk hardness, H_{bulk} , is presented for all cases. For unworn tools, machining of alloy CuZn38As generated

nearly twice as deep plastic deformation zone and approx. 20% higher degree of work-hardening compared to the silicon brass CuZn21Si3P. It is worth noting that the depth of work-hardened layer is, as expected, small for low feed condition ($f=0.05$ mm/rev), yet the degree of work-hardening (H/H_{bulk}) is nearly equivalent to the high feed ($f=0.4$ mm/rev) case. As demonstrated in Fig. 6, the case of low feed is accompanied by multiple consecutive cuts over the same sub-surface region, and such multiple deformation then results in a severely deformed but shallow ϵ_{III} layer. Machining with a worn tool gave larger differences between the two alloys. The depth was somewhat comparable for the alloys, yet the work-hardening for CuZn38As was more than 40% higher. The severity of deformation, H/H_{bulk} , for CuZn38As was close to 2, as compared to CuZn21Si3P, where H/H_{bulk} was well below 1.5. In this case, the worn tools induce comparable depth of ϵ_{III} irrespective of feed, since deformation caused by tool geometry dominates over the deformation

caused by feed. However, due to multiple deformations in the cases of low feed a slightly more severe work-hardened layer for $f=0.05$ mm/rev and $f=0.15$ mm/rev is seen in Fig. 8d.

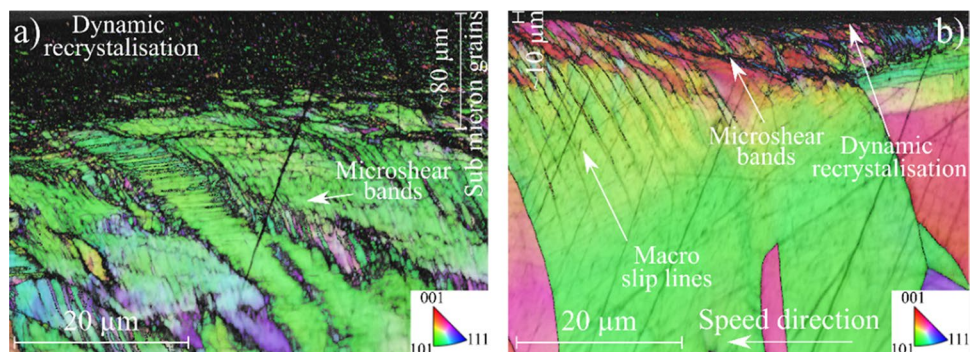
Fig. 10 EBSD at higher magnification of the severely deformed layer $\epsilon_{III\text{severe}}$ for CuZn38As machined with **a** worn tool and $f=0.4$ mm/rev and **b** sharp tool and $f=0.05$ mm/rev

submicron and nano-sized grains, Fig. 10. Formation of such microstructural features in the near-surface region is typically attributed to either severe plastic deformation (SPD) under conditions of high strain and low homologous temperature, T_{hom} , or dynamic recrystallization (DRX) under high strain and high homologous temperature. Dynamic recrystallization typically requires $T/T_{hom} \geq 0.5$ [34], which for brass alloys is equivalent to $T \geq 320$ °C. The temperature when machining these two brass alloys was measured with Infra Red thermal imaging in orthogonal turning following the methodology described elsewhere [35]. Figure 11 shows that the cutting tool temperature is slightly higher than this threshold for sharp tools, and likely even higher for worn tools. Therefore, the submicron grains are likely the result of DRX, while presence of microshear bands is the result of SPD [34], which is related to a gradient temperature reduction deeper into the sub-surface layer, Fig. 10. These

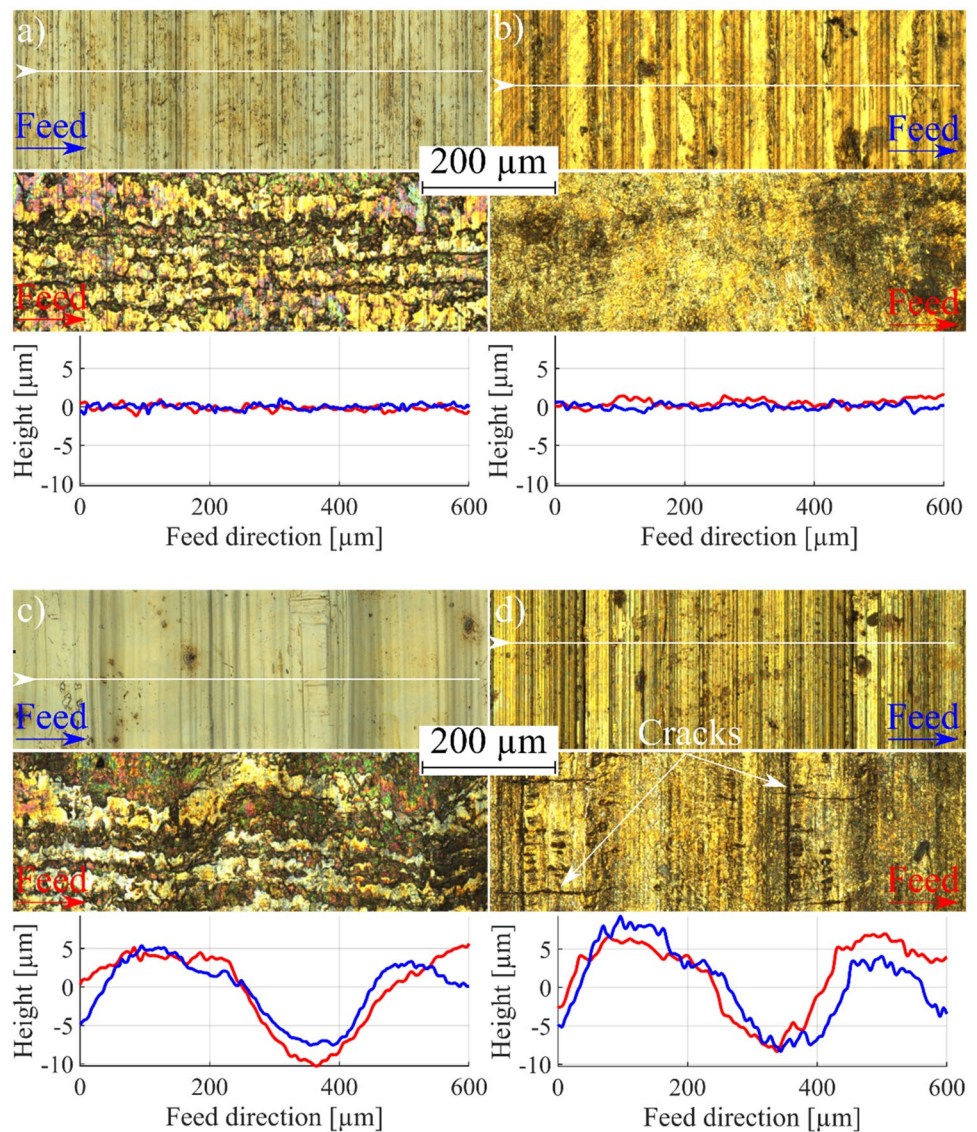
Fig. 12 Optical images of test specimens before (blue) and after 30-min exposure (red) with respective surface profile, measured as indicated by the white arrow. **a** CuZn21Si3P machined with a sharp insert and $f=0.05\text{ mm/rev}$, **b** CuZn38As machined with a sharp insert and $f=0.05\text{ mm/rev}$, **c** CuZn21Si3P machined with a worn insert and $f=0.4\text{ mm/rev}$, **d** CuZn38As machined with a worn insert and $f=0.4\text{ mm/rev}$

Figure 12 shows optical images of test specimens after corrosion experiments. Compared to the as-machined samples both brass alloys had a more dull appearance after testing. Spots and areas with darker coloration were visible. This appearance was expected since the exposure time was relatively short compared to the maximum exposure time, 48 h, referred to in guidelines to standard SIS 117102 [29]. For alloy CuZn21Si3P, a fraction of the surface had the appearance of corroded striations perpendicular to the cutting speed direction, see Fig. 12. The fraction of corroded surface was higher for a sample machined with a worn tool. For

alloy CuZn38As, the corrosion striations were not observed, and the surface was affected uniformly. However, the cracks propagating from the surface into the bulk material were present on the CuZn38As sample machined with a worn insert, and also in this case the cracks propagate perpendicularly to the cutting speed direction. The cracks were spaced rather uniformly, approximately 30–50 μm apart, see Fig. 12. The difference in cracking behavior of the alloys cannot be attributed to a difference in the surface topography. Surface roughness before and after exposure was comparable for equivalent feeds and tool wear conditions, as shown by the surface profiles extracted from 3D images in Fig. 12.

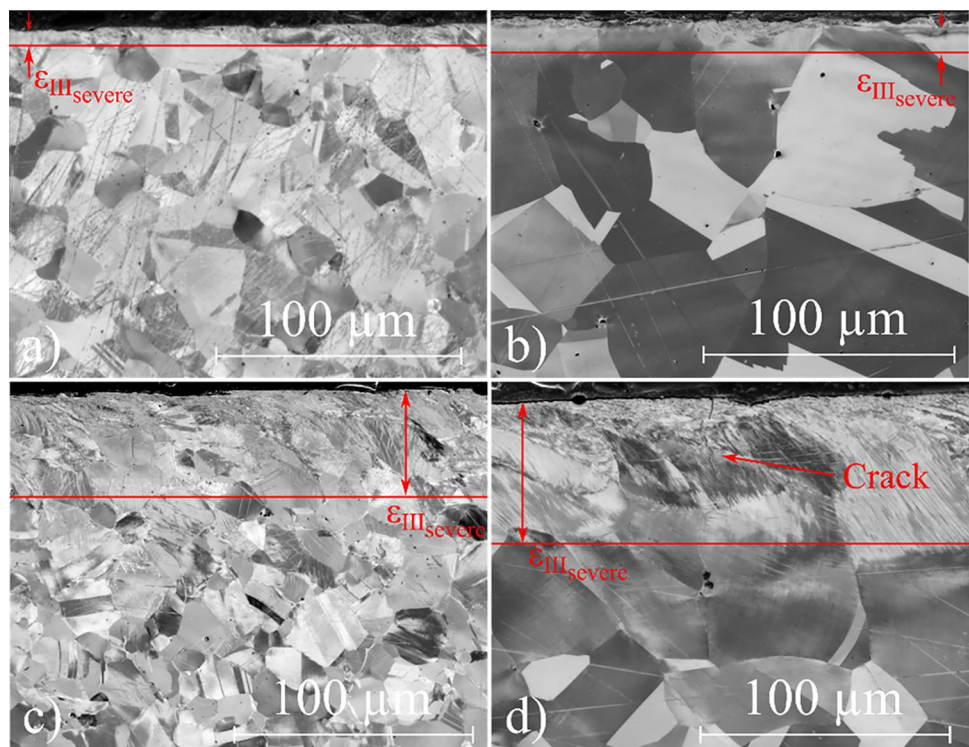
Fig. 13 **a** CuZn21Si3P machined with a sharp insert and $f=0.05$ mm/rev, **b** CuZn38As machined with a sharp insert and $f=0.05$ mm/rev, **c** CuZn21Si3P machined with a worn insert and $f=0.05$ mm/rev, **d** CuZn38As machined with a worn insert and $f=0.05$ mm/rev showing a crack from the corrosion test

Cross-sectioning of the corroded samples was performed in the cutting speed direction, which was followed by mechanical grinding, polishing and ion beam polishing. ICCI was used to analyze the effect of sub-surface deformation on the stress cracking corrosion, because EBSD was not able to resolve the severely deformed near-surface region (see Fig. 10) where crack initiation and propagation are expected. Despite the very different degree of work-hardening (see Fig. 8) for CuZn21Si3P samples machined with a sharp and worn tools, neither of the samples had cracks, see Fig. 13. The cross section of corroded CuZn38As machined with a sharp tool revealed plastic deformation identical to as-machined samples, but without distinct localized corrosion defects and cracks. On the contrary, CuZn38As sample machined with a worn tool had a series of cracks perpendicular to the surface. Figure 14 shows a detailed view of a crack, which was approximately

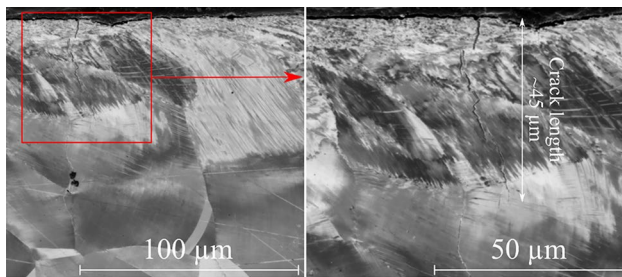
Fig. 14 Detailed view of the crack formation in CuZn38As with a high degree of deformation after machining. The crack is approximately 45 μm deep, and several similar cracks were found in the sample

45 μm long. The crack originated on the surface and propagated until it met the grain boundary where it was deflected.
