Lifetime Prediction of PVC Push-fit Joints

Proefschrift

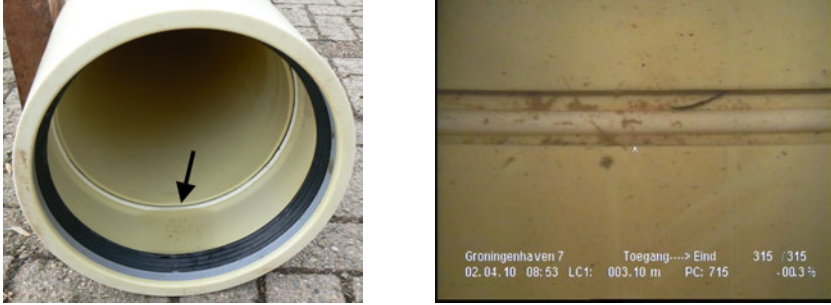
Figure 3.1: Left: image of the interior of a 315 mm PVC joint. The gap is signaled with an arrow. Right: underwater image of the interior of the same PVC joint obtained with CCTV. Please note the difference between this joint and the one presented in Figure 2.2: in this situation the ring separating both joints (white) was molded with the joint and is not a stand-alone piece.

Most of the failure modes presented in Chapter 2 can be detected by analyzing the alignment of the pipes inside of a joint. Other failure mechanisms (e.g. slow crack growth) cannot be detected when employing this approach. Inside of a joint, there is a gap (Figure 3.1). For double-socket PVC joints, the gap is the separation between the two pipes connected inside a joint. Different alignments of the pipes will correspond to different shapes of the gap.

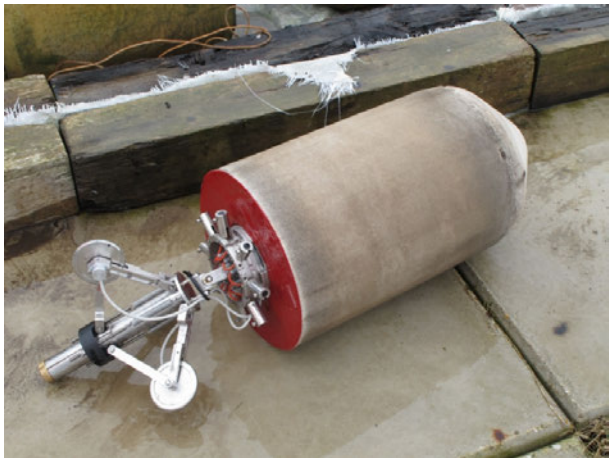
Figure 3.8: Photograph of the ultrasound tool used in the tests attached to a foam pig. Courtesy of Applus RTD.

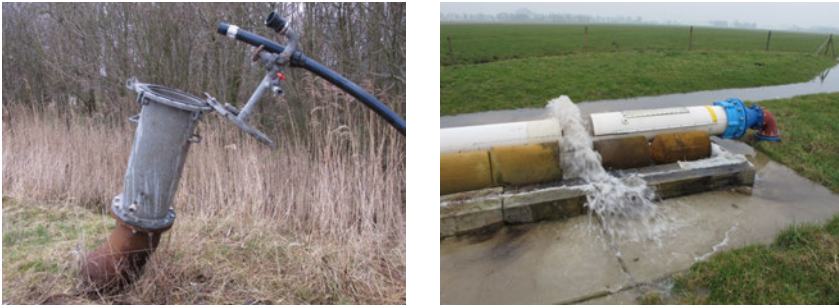
Figure 3.11: Entry point with flange and hose (left). Exit point with sliding door above ground level (right).

A DN300 620 m long AC pipe was used. The first 20 m of pipe were PVC. This pipe was selected for the following reasons. First, it possessed all of the adaptations necessary to perform an ultrasound inspection using a foam pig - an entry and an exit point. The entry point was a flange connected to the network through a hose (Figure 3.11, left). The exit was a sliding door above ground level (Figure 3.11, right). Second, the barrels of this AC pipe were also connected with push-fit double-socket joints. Finally, an inspection of another pipe material proves that this assessment procedure can be applied to any pipe material connected with push-fit joints.

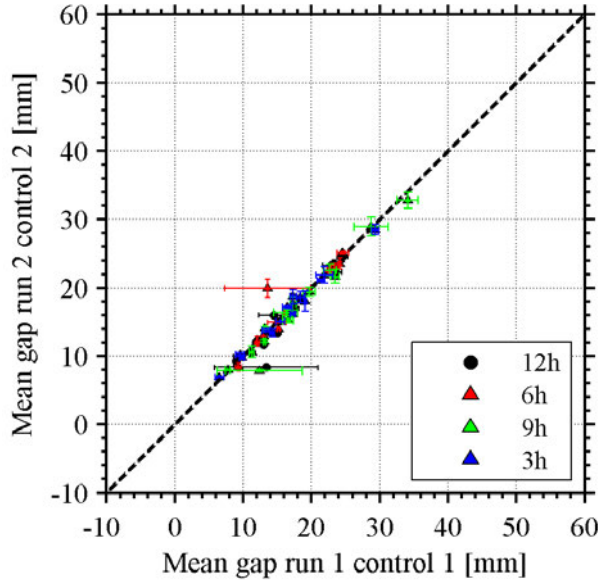
Figure 3.18: CCTV results of inspection three. The mean gap calculated for run 2 and control 2 is plotted against the mean gap calculated for run 1 and control 1. The line $x=y$ is also presented.

The results of inspections one, two, and three are illustrated in Figure 3.16, Figure 3.17, and Figure 3.18, respectively. In these figures, the error bars represent the standard deviation of the measurements. The results of the Wilcoxon Rank Sum Tests are provided in Table 3.7.

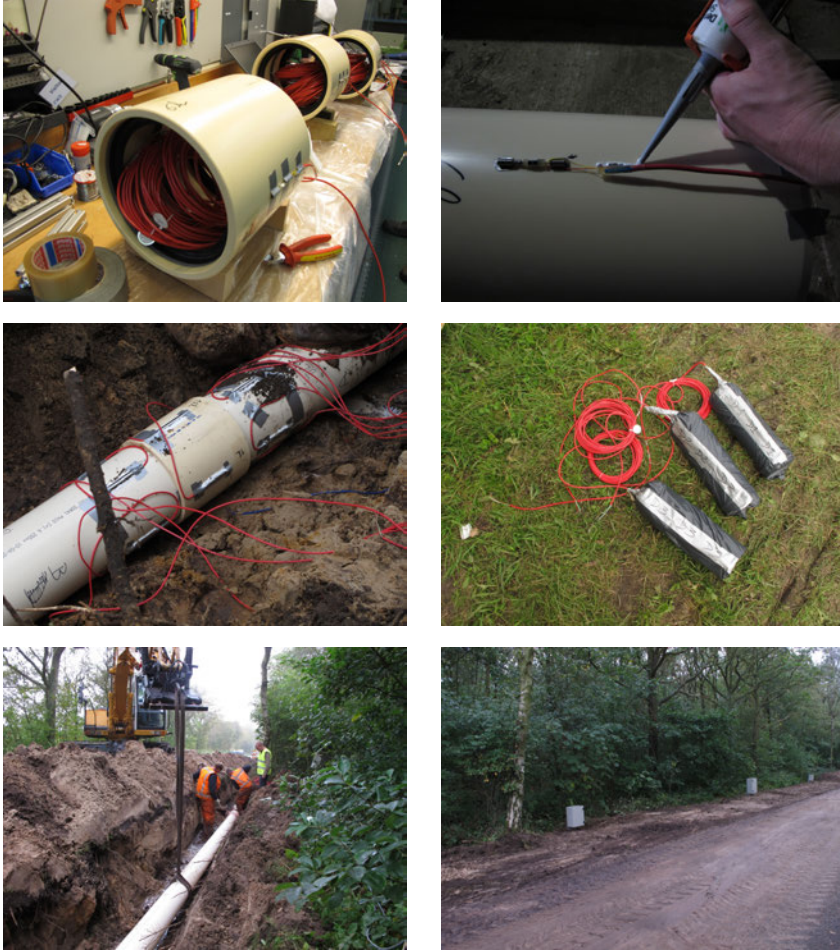
Figure 4.2: Photos taken during the installation of the sensors. Top left: the strain gauges fixed on the joints. Top right: a strain gauge being fixed on a pipe. Middle left: the dummy strain gauges inside sealed PVC canisters. Middle right: the installation of the pipe. Bottom left: the strain gauges fixed to a joint and two pipes. Bottom right: following the installation, the three cabinets are visible above ground.

To monitor strain on pipes and joints, strain gauges were used (Figure 4.2, top and middle-left). Three monitoring locations were created:

strain dummy strain gauges were also used. To prepare the dummies, strain gauges were glued to small rectangular coupons (10 cm×4 cm) made of PVC similar to the installed pipe. These coupons were then sealed in water proof-canisters to isolate them from the surrounding soil and water (Figure 4.2, middle-right). The PVC canisters were 50 cm sections of 110 mm PVC pipes. These dimensions minimized the friction between the PVC coupons and the inside of the PVC canisters. Therefore, the dummy strain gauges, while being responsive to temperature changes comparable to those experienced by the gauges installed on the pipe and joints, are isolated from all other factors (e.g. traffic).

For this work, a newly installed 250 mm PVC pipe that serves approximately 1,250 customers in the region of North Holland, in the Netherlands, was selected. The installation of the sensors was performed on the 27th of September 2011 (Figure 4.2,

Pipes and joints are monitored with strain gauges and, adjacent to each joint, a thermistor and a dummy were installed. Three cabinets were placed above ground 1 m away from the pipe (Figure 4.2, bottom right). A complete list of the installed sensors (per monitoring location) is provided in Table 4.1. All sensors were first checked in the laboratory.
