# Morphodynamic effects of stone and wooden groynes in a restored river reach

**Abstract.** Restoration works on an 11 km long reach of the Spree River near Cottbus in Germany were accomplished in 2014. The overall objective was to improve the biodiversity, changing the morphological structure from a straight single-thread river to a braiding one with reshaped thalweg, and creating zones with varying flow velocities required for fish spawning. Several interventions were made, among which also two types of groynes were constructed along the reach: impermeable stone groynes, with an inclined crest so that only the tip is typically submerged during normal flow conditions, and wooden groynes made of several large trunks, which are mainly submerged at normal flow conditions. To compare local morphodynamic effects caused by the different types, flow velocities and bed topography were measured at distances of 12 m upstream and 16 m downstream of two selected groynes. The vertical profile was captured by measuring at five levels above the bed. Bed material was sampled at several locations around the groynes. The analysis of the measurements showed the effect of each groyne type on the flo

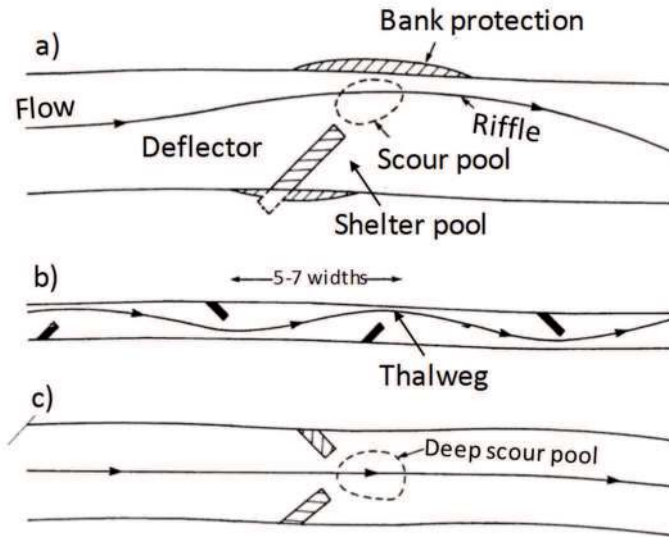
**Fig. 1.** Use of groynes to re-creation of (a) pool and riffle, (b) meander pattern, and (c) scour ([2]).

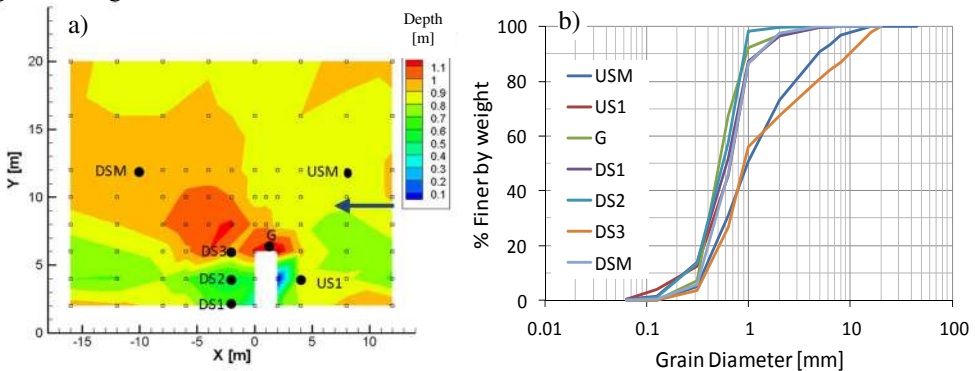
**Fig. 5.** (a) Bed topography with black filled circles for bed material sample locations, (b) bed material grain size distribution.

The effect of the stone groyne on the bed topography is presented in Fig. 5a. The maximum scour on the river bed was found at the groyne tip, which is typical for emerged structures (e.g. [9, 10]) whereas the scour develops at a distinct distance downstream of the tip for fully submerged structures, e.g. shallow groynes ([11]). The scour extended in the downstream direction for about 8 m. In addition to the scour, deposition areas were determined locally at the upstream side of the groyne, and in the lee side extending 5 m downstream of the groyne.

Fig. 5b presents the grain size distributions of the bed material sampled at the locations given in Fig. 5a.

The bed material mainly consisted of medium and coarse sand with a mean grain size of  $d_{50} = 0.6$  mm. Only at two locations coarser sediment was sampled. One location was in the middle of the river (USM), the other one in the scour downstream of the groyne tip (DS3).

These inconsistencies can be explained by the fact, that small dunes consisting of medium to coarse sand were travelling over the surface made of the coarser sediment shown in Fig. 5b.

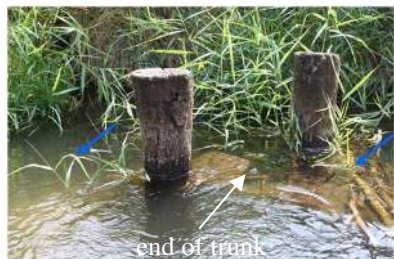
**Fig. 6.** Scour and flow at the wooden groyne toe.

The wooden groyne consisted of several trunks arranged vertically allowing the flow to pass between the trunks. The trunks were fixed to wooden piles up- and downstream of the tip. The trunks were not attached to the bank (Fig. 6) and local bank erosion was observed between the bank and the trunk, allowing water to flow between the bank and the groyne toe. The structure was slightly submerged during the measurements (less than 10 cm under water in the middle of the groyne).

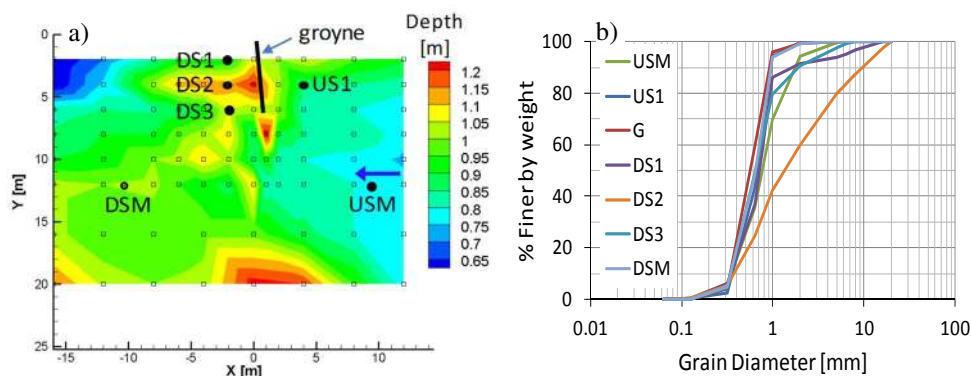
**Fig. 8.** (a) Bed topography with black filled circles for bed material sample location and (b) bed material grain size distribution.

Fig. 8 shows the bed topography. The presence of the wooden groyne resulted in two scour areas around the groyne (Fig. 8a). One scour area was found at the groyne tip and a second larger scour zone was noted around the mid section of the groyne. The second scour started around 1 m upstream of the groyne and extended for about 6 m downstream of it. The depth of the scour at the middle of the groyne was almost the same of the one at the groyne tip. A deposition area was found 12 m downstream of the groyne. The large scour area at the right bank was caused by the aforementioned branches of the large tree.

The analysis of the bed material showed that upstream of the groyne at US1, and at the groyne tip, the bed consists of fine sand (Fig. 8b). The coarsest bed material was found at DS2 in the middle of the scour downstream of the groyne. The composition of the fine
