Andreades, C, Malfense Fierro, GP, Meo, M & Ciampa, F 2019, 'Nonlinear ultrasonic inspection of smart carbon fibre reinforced plastic composites with embedded piezoelectric lead zirconate titanate transducers for space applications', *Journal of Intelligent Material Systems and Structures*, vol. 30, no. 20, pp. 2995-3007.
<https://doi.org/10.1177/1045389X19873419>

Nonlinear Ultrasonic Inspection of Smart CFRP Composites with Embedded PZT Transducers for Space Applications

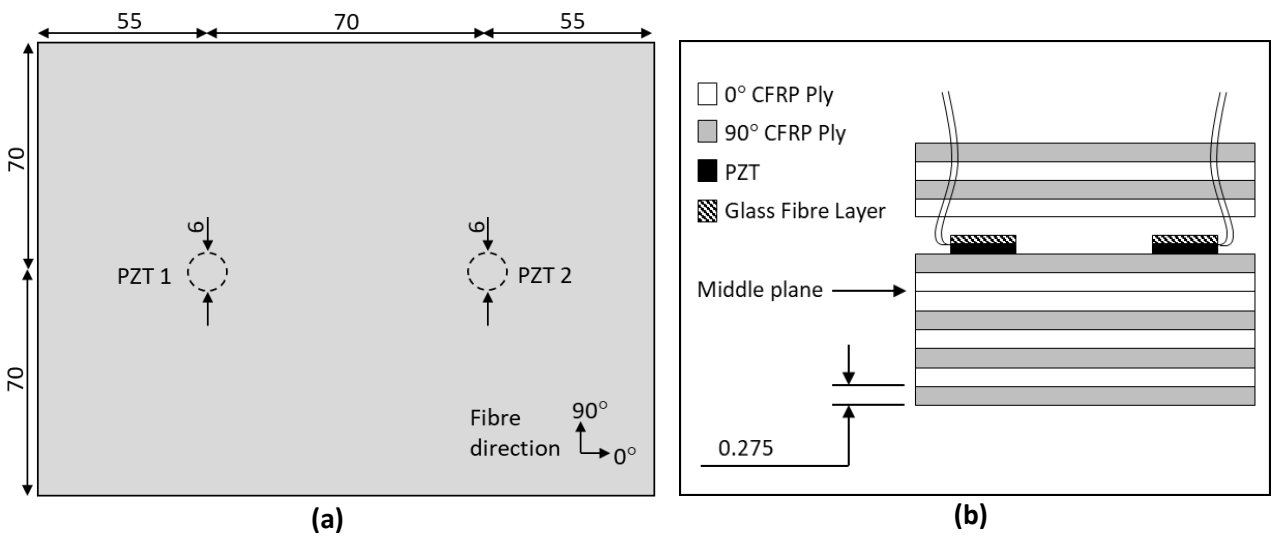
Figure 1: Design of undamaged CFRP plate - top view (a) and stacking sequence (b). Dimensions in mm. Not to scale.

A total of three carbon/epoxy (T800/M21) laminates with dimensions of 180 x 140 x 3.5 mm were used in the experiments of this study. The laminates were made from unidirectional prepreg layers with a $[90^\circ/0^\circ/90^\circ/0^\circ/90^\circ/0^\circ]$ s lay-up, and they were cured in an autoclave for 180 minutes at a pressure of 0.7 MPa and a temperature of 150°C with a ramp rate of 3°C/min. As illustrated in Figure 1, all three plates included two embedded PZTs (ferroelectric soft piezo material PIC 255) of 6 mm diameter and 0.3mm thickness, for the propagation of ultrasonic elastic waves. A 10 x 10 mm layer of woven E-glass fibre fabric was also interlaced between the top surface of the PZTs and the CFRP plies, for electrical insulation. The PZTs were directly placed between the 8th and the 9th layers from the bottom. The thin wires from to the positive and negative electrodes of the PZTs were connected to 50 Ω straight Bayonet Neill-Concelman (BNC) plugs through low noise cables (RG174/U). The wires were directed outside the top surface of the plate through small slits in the fibre direction of every CFRP ply (i.e. without cutting any fibres).

The first laminate (Figure 1) was kept intact and used as the reference plate. The second laminate (Figure 2a) included two double-layered patches of different size to cause controlled artificial in-plane delamination. Each patch consisted of two square layers of 12 μm thick Fluorinated Ethylene Propylene (FEP) film stacked one on top of the other. The FEP patches were inserted at the same plane of the PZTs (between layers 8 and 9 from the bottom). The third plate (Figure 2b) was impacted at its centre with a hemispherical indenter of 20 mm diameter. The damage was initially created with

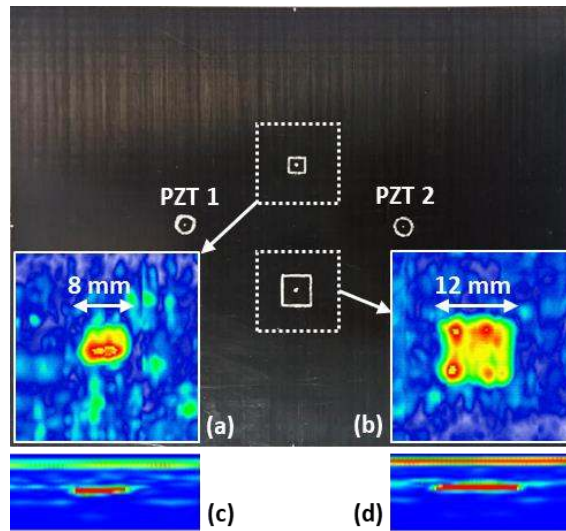
Figure 3: Ultrasonic C-scan of the small (a) and the big (b) artificial damage in AD-laminate and the associated B-scans (c), (d) - Images not to scale.

Prior to performing any experiment, the size of the damage in AD- and ID- plates was evaluated by conducting stepped linear C-scans using a phased array system (Diagnostic Sonar Ltd) equipped with a 5 MHz probe containing 128 elements. More specifically, the C-scans were carried out in steps of 12 elements (single cycle pulse, element pitch of 0.52 mm) and the damage was assessed based on the signal amplitude. The front face of the probe included a 30 mm acrylic (Perspex) delay line and coupling was achieved using ultrasonic gel. As shown in Figure 3 and Figure 4, the areas at which delamination was detected matched the positions of the double FEP patches and the impact damage. In the AD-plate, the two defects had a similar size to that of the double FEP patches. In the ID-plate, the initial damage diameter (10 J impact) was approximately 18 mm, and the final diameter (15 J impact) was around 32 mm.

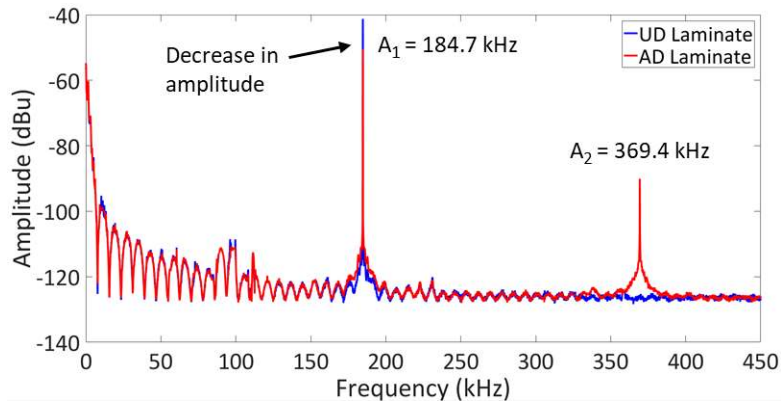
Figure 7: Frequency spectrum of the received signal in the UD-laminate and in the AD-laminate - Input signal of 60 V at 184.7 kHz.

As explained in Section 3.3.1, by sweeping the frequency of PZT1 in the AD-plate from 20 to 500 kHz, the two highest A_2 amplitudes were observed at 104.5 kHz and 184.7 kHz frequencies. Hence, these two were considered as the frequencies causing the strongest excitation of the two FEP patches. Similarly, in the ID-plate, the two input signal frequencies related to the excitation of the 10 J and the 15 J impact damage were chosen at 310 kHz and 128 kHz, respectively, based on the A_2 amplitude. After exciting the UD-laminate at these four frequencies, A_2 harmonics were not found in the frequency spectrum, thus verifying that the plate was intact. An example is presented in Figure 7. Additionally, the A_1 amplitude in the case of the UD-plate was always greater than in the damaged laminates. That was expected as in the damaged laminates part of the transmitted wave energy was transferred from the fundamental input wave to the nonlinear harmonic one. Moreover, as can be seen in Figure 8 and Figure 9, the results obtained from the AD- and ID-plates indicated that by increasing the input voltage to PZT1 from 60 to 100 V, the received signal amplitude at A_1 and A_2 frequencies was also rising. The A_2 amplitude was around two orders of magnitude smaller than the A_1 amplitude, in both plates.

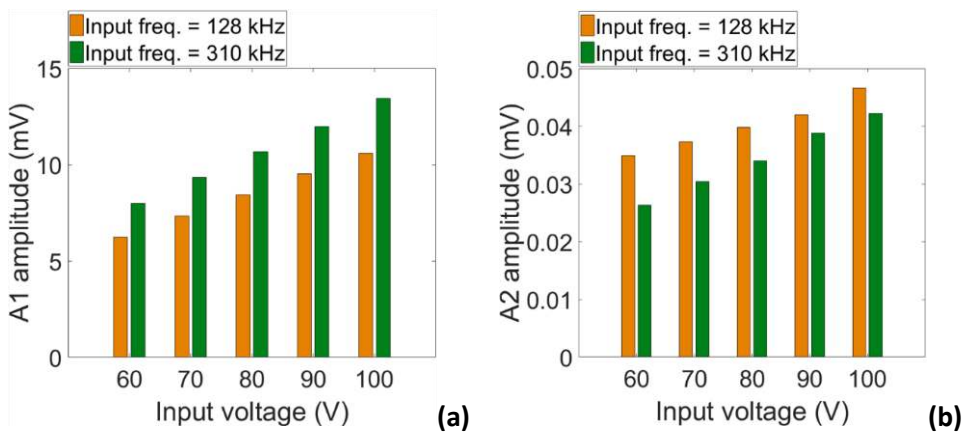
Figure 9: Amplitude of the received signal in ID-laminate at the fundamental (a) and second (b) harmonic frequencies - Input signals of 60, 70, 80, 90, and 100 V at 128 and 310 kHz.

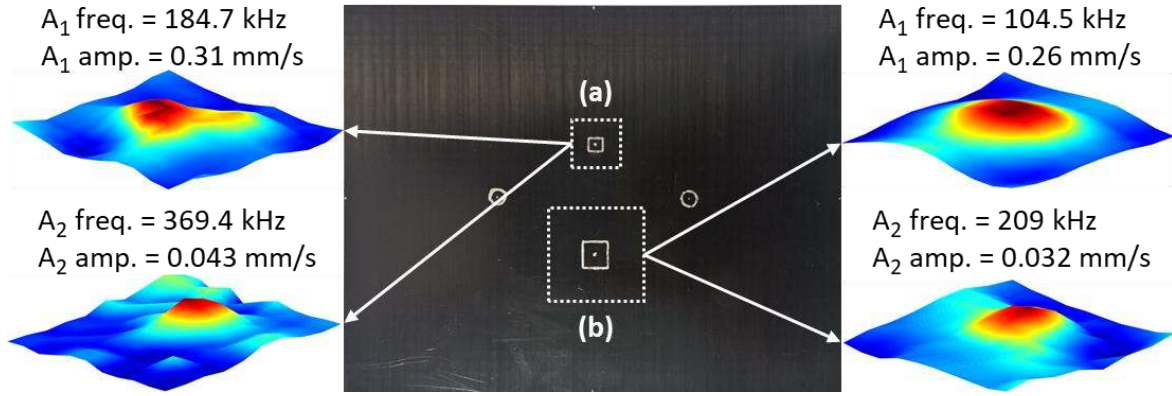
Figure 10: 3D representation of the out-of-plane vibrational velocity around the location of the small (a) and the big (b) artificial damage at the fundamental and second harmonic frequencies.

Furthermore, three-dimensional plots of the results obtained from the LV experiments on AD- and ID-laminates (Figure 10 and Figure 11) confirmed that the out-of-plane vibrational velocity was always higher at the location of the impact. The A_2 amplitude was about an order of magnitude smaller than the A_1 amplitude. The LV experiments on the AD-laminate showed that the input signal at 104.5 kHz caused excitation only to the big FEP patch and, at 184.7 kHz, only to the small FEP patch. Similarly, the 10 J impact damage in the ID-laminate was only excited at 310 kHz, and after

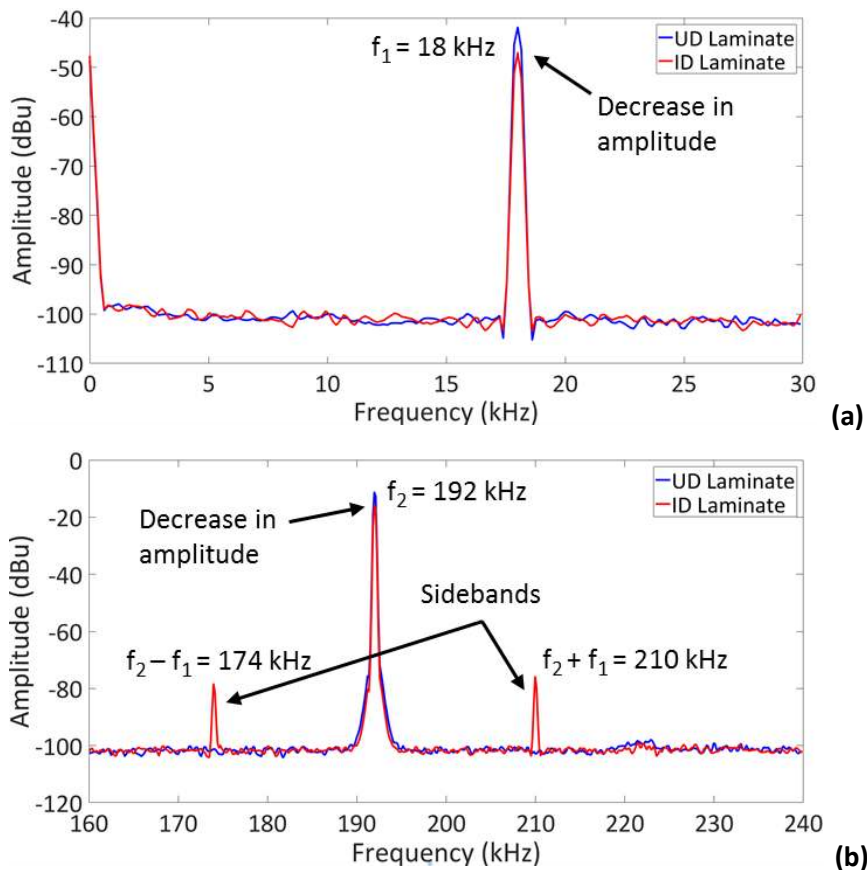
Figure 12: Amplitude of the received signal in the UD-laminate and the ID-laminate at f_1 (a) and at f_2 and $f_2 \pm f_1$ (b) - Input signal voltage to PZT2 = 50 V and to PZT1 = 60 V.

According to the process described in Section 3.3.1 and based on the amplitude of the sidebands in the ultrasonic response of the ID-plate, the effect of nonlinear wave modulation was evaluated by transmitting periodic waves from PZT1 at $f_1=18$ kHz and from PZT2 at $f_2=192$ kHz. The UD-laminate was also subject to multiple-frequency using the same f_1 and f_2 frequencies. For an input voltage of 60 V applied to PZT1 and 50 V applied to PZT2, the received signal amplitude at 18 kHz and 192 kHz was lower in the case of the ID-plate (Figure 12). As previously explained, that was reasonable because an amount of the input wave energy was transferred from the f_1 and f_2 signals to the sidebands. In addition, first-order sidebands were only presented in the spectrum of the ID-laminate at 174 kHz ($f_- = f_2 - f_1$) and 210 kHz ($f_+ = f_2 + f_1$), and this confirm its nonlinear response under wave modulation. Also, in the ID-plate, by increasing the input voltage to PZT1 from 60 to 100 V and keeping the input voltage to PZT2 constant at 50 V, the amplitude of the f_1 harmonic and the two sidebands increased proportionally by around 70%, whereas the amplitude of f_2 harmonic

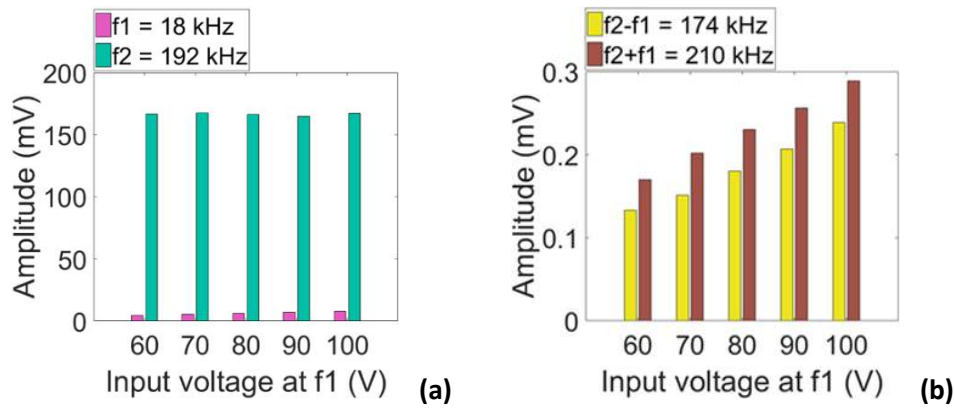
Figure 13: Amplitude of the received signal in the ID-laminate at f_1 & f_2 (a) and at $f_2 \pm f_1$ (b) - Input signal voltage to PZT2 = 50 V and to PZT1 = 60, 70, 80, 90 and 100 V.

remained almost constant (Figure 13). This verified that the existence of sidebands was attributed to the wave modulation by the f_1 signal. For all five values of the input voltage, the amplitude of sidebands was three orders of magnitude smaller than the amplitude of f_2 harmonic and one order of magnitude smaller than the amplitude of f_1 harmonic. The amplitude of the right sideband f_+ was on average 27% greater than the left one f_- .

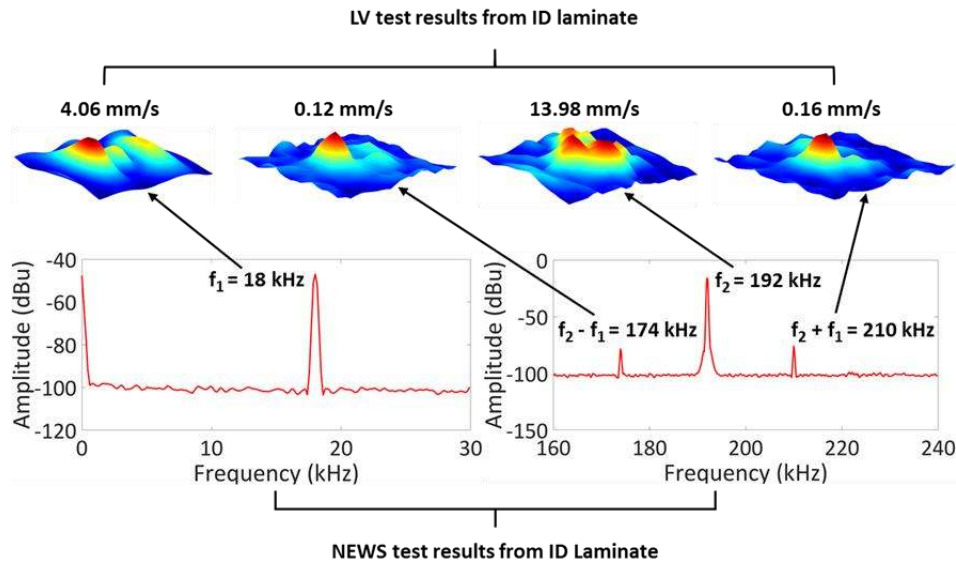
Figure 14: 3D representation of the out-of-plane vibrational velocity at the location of the impact damage at f_1 , f_2 and $f_2 \pm f_1$.

Regarding to the LV experiments, the three-dimensional plots of the results illustrated in Figure 14 proved that the out-of-plane vibrational velocity at f_1 , f_2 , f_+ and f_- was always higher at the impact location. These results were in agreement with the results from the NEWS experiments with respect to the amplitude difference between the sidebands and the f_1 , f_2 harmonics. Particularly, the amplitude of the right sideband, f_+ , was around 30% greater than the amplitude of the left one, f_- . Moreover, the amplitude of both sidebands was two orders of magnitude smaller than the amplitude of the f_2 harmonic and one order of magnitude smaller than the amplitude of the f_1 harmonic. Hence, the LV experiments confirmed that the detection of intermodulation products was associated with the nonlinear elastic behaviour of the damaged plate.
