## On the embrittlement of zircaloy-4 under RIA-relevant conditions — Source link

TITLE OF SYMPOSIUM, JOURNAL, OR MANUAL: Zirconium in the Nuclear Industry: Thirteenth International Symposium, Annecy, France, June 10-14, 2001, ASTM Special Technical Publication 1423.

On the Embrittlement of Zircaloy-4 Under RIA-Relevant Conditions\*

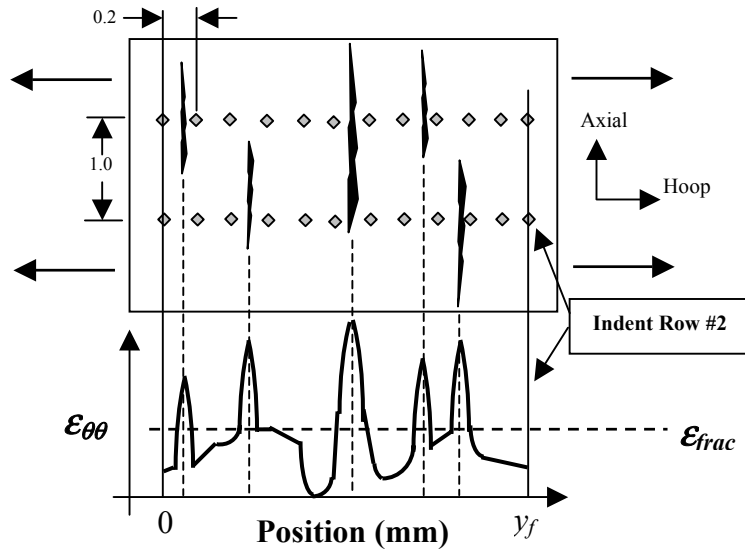
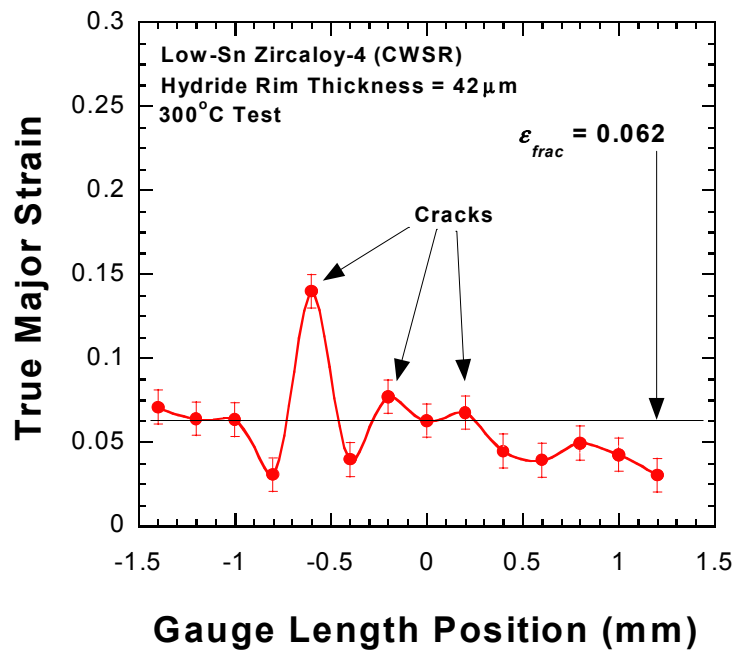
FIG. 4 – (a) Schematic of Mode I cracks with respect to microhardness indentation array and corresponding schematic of strain distribution of Indent Row #2 (dimensions in millimeters and not-to-scale) and (b) actual strain distribution of plane-strain ring-stretch specimen (N7R#1) with hydride layer thickness of 42  $\mu\text{m}$  tested at 300°C.

FIG. 4 – (a) Schematic of Mode I cracks with respect to microhardness indentation array and corresponding schematic of strain distribution of Indent Row #2 (dimensions in millimeters and not-to-scale) and (b) actual strain distribution of plane-strain ring-stretch specimen (N7R#1) with hydride layer thickness of  $42 \mu\text{m}$  tested at  $300^\circ\text{C}$ .

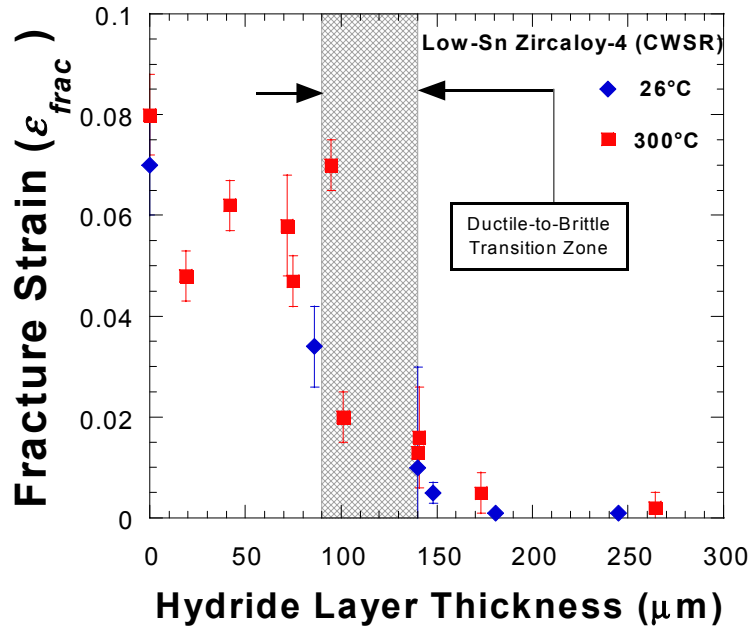
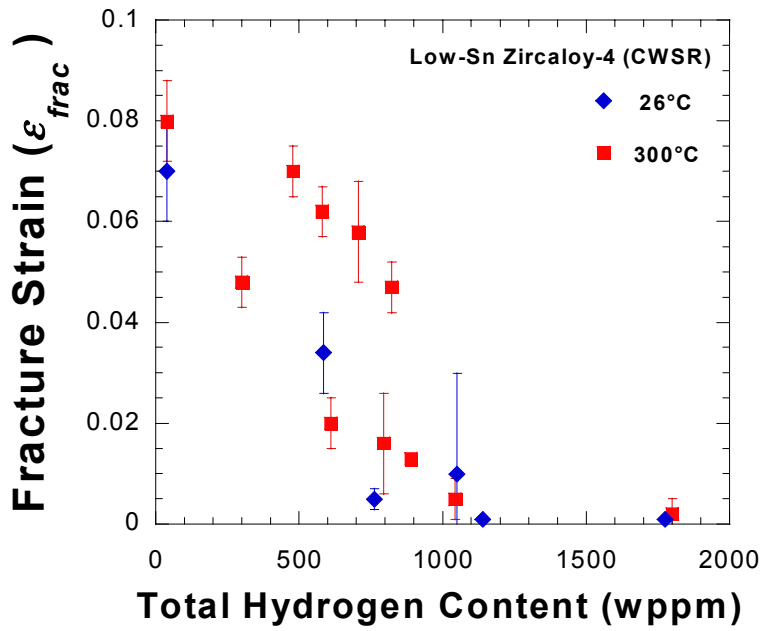
FIG. 7 –Fracture strain ( $\epsilon_{frac}$ ) at room temperature and 300°C as a function of (a) hydride layer thickness and (b) total hydrogen content.

Figure 7 shows the dependence of the fracture strains on thickness of the hydride rims and total hydrogen content in Zircaloy cladding tubes deformed to failure at near plane-strain tension at room temperature and 300°C (these results are also shown in numerical form in the Appendix). It is important to recognize that these ring-stretch tests impose a biaxial stress state that results in near plane-strain deformation path with the major principal strain component being the hoop strain. The most important trend in Fig. 7 is the obvious dependence of cladding ductility on hydride-rim thickness (see Fig. 7a). At both room temperature and 300°C, there appears to be a gradual ductile-to-brittle transition with increasing hydride layer thickness. Specifically, cladding with hydride rims of thicknesses  $\geq 140 \mu\text{m}$  show little or no plastic deformation to failure. In view of the fact that the experimental accuracy of our measurements of local strain is  $\pm 0.01$ , we concluded that these cladding tubes are essentially brittle. At the 100- $\mu\text{m}$  hydride thickness level, there may be a small level of plastic deformation to the cladding prior to failure. However, cladding samples with hydride-rim thicknesses  $< 90 \mu\text{m}$  are distinctly ductile with hoop failure strains of roughly 0.04 or greater. We have not collected sufficient data to detect the expected influence of temperature on the ductile-to-brittle transition.

As an alternative approach to examining the influence of hydrogen on failure of the Zircaloy, Figure 7b presents the dependence of fracture on total hydrogen content. The brittle

cladding with a thick hydride rim had total hydrogen contents  $\geq 700$  wppm. Although most of the ductile specimens had hydrogen contents in the 300-600 wppm range, ductility was also observed in specimens with thin hydride layers in excess of 700 wppm hydrogen. Therefore, comparing Figures 7a and 7b, it is clear that the ductile-to-brittle transition as a function of hydride rim thickness is *sharper* or more definable than the similar transition as a function of total hydrogen content. For example, in Fig. 7b, several results are in the 500-1000 wppm range with similar hydrogen concentrations but widely varying values of ductility. This is because these samples have different hydride layer thicknesses, and thus, thickness is the predominant factor in causing failure.

FIG. 7 – Fracture strain ( $\epsilon_{frac}$ ) at room temperature and 300°C as a function of (a) hydride layer thickness and (b) total hydrogen content.

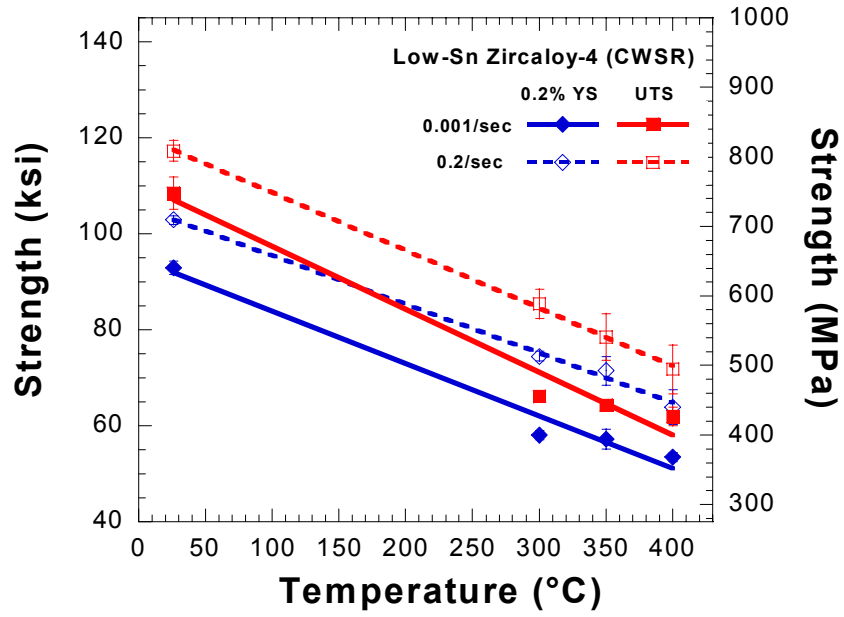
FIG. 8 – (a) Yield and ultimate tensile strengths and (b) uniform elongation for non-irradiated cladding as a function of temperature and strain rate.

Uniaxial ring-stretch specimens were machined from as-fabricated cladding (no hydrogen) and tested under thermal and mechanical loadings relevant to the RIA transient in order to obtain baseline stress-strain data for comparison to irradiated cladding. Figure 8 shows results of yield strength (YS) and ultimate tensile strength (UTS) and uniform elongation as a function of temperature and strain rate for the Zircaloy deformed in the *hoop* direction of the cladding tube.

As shown in Fig. 8a, the Zircaloy exhibits strain-rate hardening and strain-rate sensitivity ( $m$ ), such that  $m = d(\ln\sigma)/d(\ln\dot{\epsilon})$  and is found to depend on temperature, where  $\sigma$  is the true stress, and  $\dot{\epsilon}$  is the strain rate. This study and previous studies have reported a strain-hardening exponent ( $n$ ) value of 0.06 from compression and tensile tests of specimens oriented for hoop

Figure 8b shows uniform elongation to be relatively insensitive to temperature and to have a nominal value of 0.06 at low strain rates, which is consistent with the measured  $n$ -values. There appears to be a small decrease in uniform elongation at the higher strain rate for all testing temperatures.

FIG. 8 – (a) Yield and ultimate tensile strengths and (b) uniform elongation for non-irradiated cladding as a function of temperature and strain rate.
