On understanding the microstructure of SiC/SiC Ceramic Matrix Composites (CMCs) after a material removal process

O. Gavalda Diaz^a, D.A. Axinte^{a,*}, P. Butler-Smith^a, D. Novovic^b

^a*Rolls-Royce University Technology Centre in Manufacturing and On-Wing Technology, Faculty of Engineering, University of Nottingham, NG8 1BB, UK*

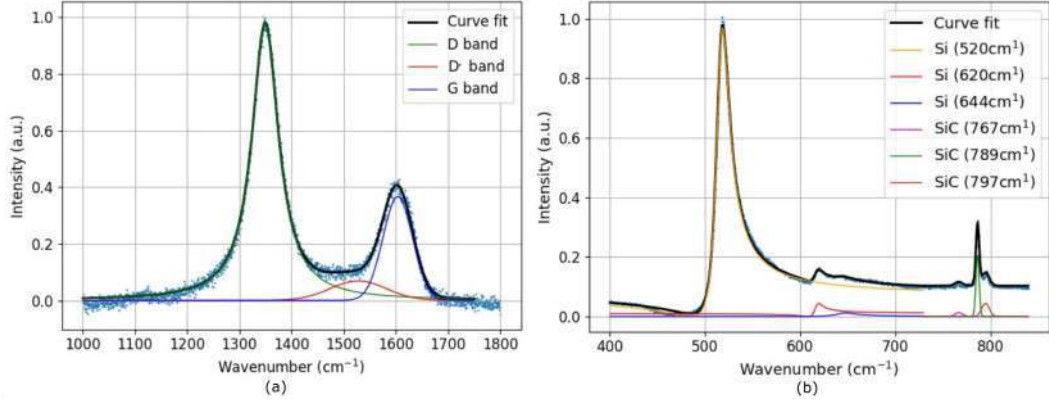
Figure 3: Raman spectra of (a) Hi-Nicalon SiC fibres with a Lorentzian fitting of the D peak (green) and Gaussian fitting of the G peak (blue) and D' peak (red) with the resultant fitting plotted in orange; (b) SiC-Si matrix with three fano-line fitting peaks (Si) and the three Gaussian peaks (SiC).

As reported in the literature for Hi-Nicalon fibres [18, 30], when analysing the Raman spectra, a Lorentzian fitting for the carbon D peak (green) and Gaussian fittings for the carbon G (blue) and the D' (red) peaks have been employed, as shown in Fig.3a. To characterise the fibre-rich regions, repeated (> 10) measurements (scanning an area of $50 \times 50 \mu\text{m}^2$) have been carried out on three different conditions:

In the case of the SiC-Si matrix, the B-doped Si and the 6H-SiC peaks are found, producing the spectrum shown in Fig.3b. The B-doping changes the electronic structure of the Si producing non-symmetric peaks [31, 32] which are commonly fitted with a Fano line shape (Eq.1) [33]:

where: I_0 - arbitrary intensity factor, q - the symmetry parameter, τ - width parameter and ω_0 - phonon wavenumber. As shown in Fig.3b, three fano-type peaks are found in the B-doped Si at 520 cm^{-1} (optical phonon), 620 cm^{-1} (B^{11}) and 644 cm^{-1} (B^{10}). On the other hand, the SiC particles showed the Raman spectrum typical from a 6H polytype with free-stress peaks at 767 cm^{-1} , 789 cm^{-1} and 797 cm^{-1} [34].

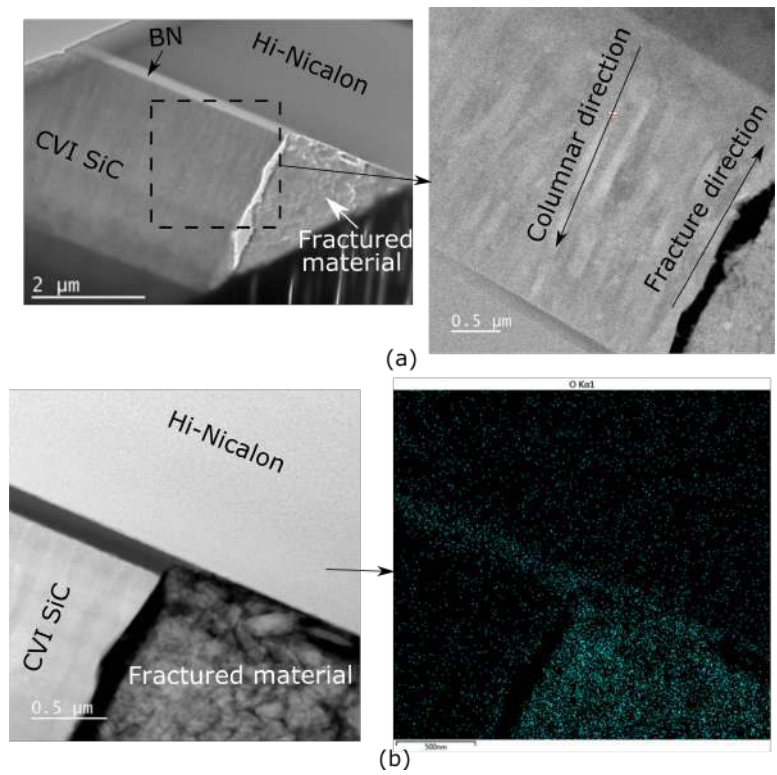
Figure 8: TEM analysis of a region including a Hi-Nicalon fibre, a CVI BN and CVI SiC coating (a) BF TEM image of the fracture mechanism suffered by the SiC columnar structure; (b) STEM analysis and EDS signal showing a greater concentration of oxygen in the fractured material.

To further validate the chemical analysis concluded with Raman spectroscopy and in order to better understand how the material fractures by interpreting the microstructure and morphology of the CVI SiC coating, a TEM study of a region including a Hi-Nicalon fibre, a CVI BN and a CVI SiC coating is presented in Fig.8. It can be observed that, while the Hi-Nicalon fibres show a nanocrystalline structure, the CVI SiC coating has columnar preferential grain growth (which expands radially from the fibre surface) and

that the radial fracture follows this intercolumnar direction, which is the weakest fracture plane. Hence, the specific fracture mode appearing in cutting is affected by the CVI growing structure leading to a unique signature on the machined surface.

Electron energy loss spectroscopy (EELS) was performed in a Hi-Nicalon fibre from the machined surface to the subsurface. The graphitic and amorphous Carbon signature did not show any considerable change, confirming the conclusions drawn from Raman spectroscopy using the bandwidth of the D peak and the D-G peak ratio analysis. Moreover, the EDS spectra showed that no significant increase in oxygen content is found at the surface but only on the material that has filled the fractured area (called fractured material in Fig.8b), concluding that in the machined surface of the fibre-rich region, no C or SiC oxidation occurs.

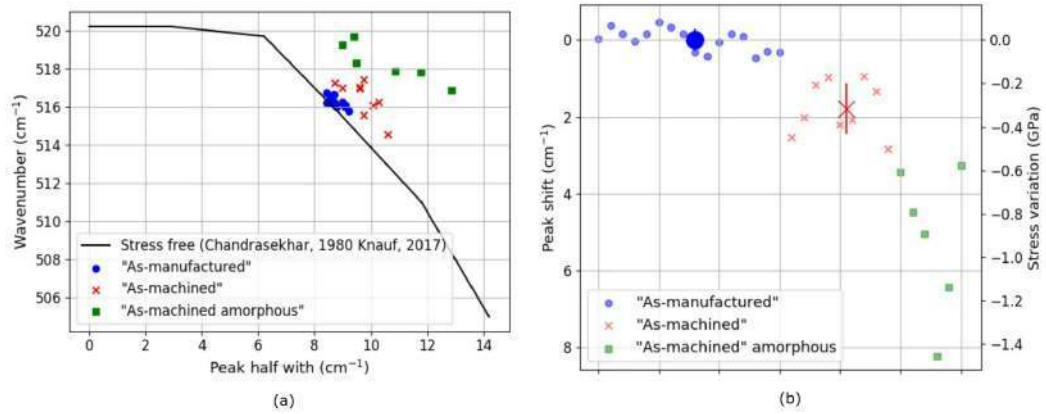
Figure 10: Raman spectroscopy results from the B-doped Si using (a) a stress free line in a wavenumber vs peak half width plot and (b) peak shift (left scale) and stress variation (right scale) using Eq.2 and normalising for the 'as-manufacturing' average.

Following the strategy defined by Knauf [20] to calculate the residual stresses in a B-doped Si with a non-constant concentration, a stress free line which considers the peak half width (as an indicator of the B concentration) and the wavenumber of the 520 cm^{-1} peak has been plotted with a black line in Fig.10a. It can be observed that initially (“as-manufactured”) the Si appears slightly under compression which shows a comparable tendency with the results from the literature [19]. However, back to back values should not be compared because in the current work a different laser wavelength is used (532 nm in the current work instead of 515 nm [31, 19]) and this can slightly influence the results. Nevertheless, as the main objective of this work is to enable deeper understanding of the effect of machining on CMC structures, the values of peak shift have been normalised by the “as-manufactured” average. It can be observed from Fig.10b that between the “as-manufactured” and the “as-machined” samples there is a variation in peak shift corresponding to $316 \pm 117\text{ MPa}$ of residual stresses in compression. However, in specific regions of the CMCs, the Raman peak shift seems to suffer a greater drop (green squares) which is directly related to a variation in the Raman spectrum.

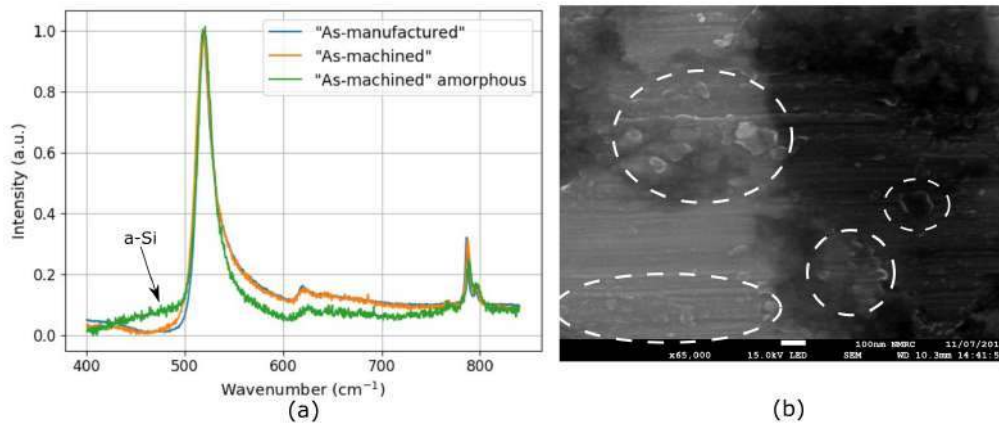
Figure 11: (a) Raman spectra of three different measurements of the B-doped Si: “as-manufactured”, “as-machined” and “as-machined” amorphous; (b) SEM image of the matrix region showing some evidence of redeposited material on the machined surface (scale 100 nm).

Analysing these zones in further detail, it is observed that only specific regions of the Si matrix tend to suffer a transformation in the Raman spectra where a peak starts to appear below 500 cm^{-1} (as shown in Fig.11a). This alteration in the Raman spectra can be related to an amorphisation of the Si [37] that due to the high strain and temperature applied during the machining process leads to a redeposition of melted Si on the machined surface (see Fig.11b).

Hence, it can be concluded that compressive residual stresses are induced to the Si regions and specific areas might experience an amorphisation which has been associated with a redeposition of melted Si (Fig.11) during machining. Moreover, the SiC particles also tend to suffer an increase in peak shift which translates in compressive or release of tensile residual stresses. Nevertheless, because of the higher laser penetration depth in the SiC, Raman spectroscopy should not be used to quantify the results but just to present the tendency behind the material removal process. An in-depth understanding of the material removal mechanism and surface damage is presented in the next section.

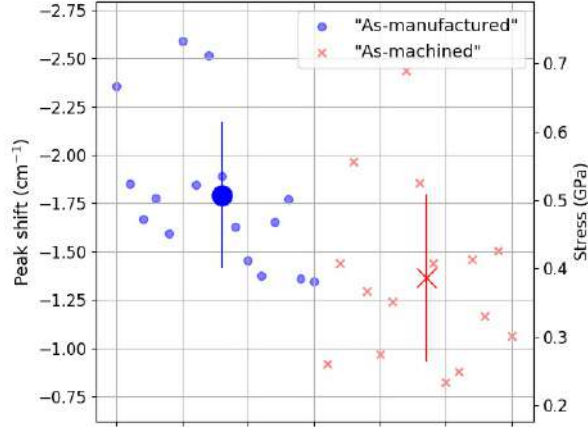
Figure 12: Peak shift and residual stress conversion (calculated with Eq.2) obtained for the 789 cm^{-1} stress-free peak appearing in the 6H-SiC Raman spectra.

The Raman peak shift and the stress conversion of the 789 cm^{-1} peak found in the 6H-SiC particles is shown in Fig.12. It can be seen that initially (“as-manufactured”) the SiC particles are under tensile residual stresses, as presented in the literature [19]. However, after machining a reduction in the peak shift is observed, resulting in a decrease of tensile stresses (either inducing compressive or releasing tensile stresses). Nevertheless, the

variation in peak shift is small and with large values of standard deviations, questioning the statistical significance of the determined results.
