IEEE Transactions on Dielectrics and Electrical Insulation, Vol. 17, Issue 2, pp.
521-532, April 2010

Performance of Silicone Rubber in DC Inclined Plane Tracking Tests

The inclined plane tracking and erosion test IEC-60587 is not specified for DC testing. A dc test has been developed from the current ac standard and three formulations of silicone rubber tested. These materials were tested under three voltage levels (2.3, 2.7 and 3.2 kV) for both polarities. Positive dc tests have the highest average and peak leakage current and exhibit a higher degree of surface damage. The observed surface degradation pattern is heavily dependant on polarity. Consistently higher levels of erosion have been observed in the higher voltage positive cases. Erosion of the surface always starts at the bottom electrode, and spreads toward the top electrode. Puncturing of the 6 mm thick samples or deep erosion over more than half the distance between electrodes has only been observed under 2.7 and 3.2 kV positive polarity tests. Results have been analysed using a variety of leakage current analysis techniques going beyond the criteria specified in the original ac standard. The low-frequency behaviour o

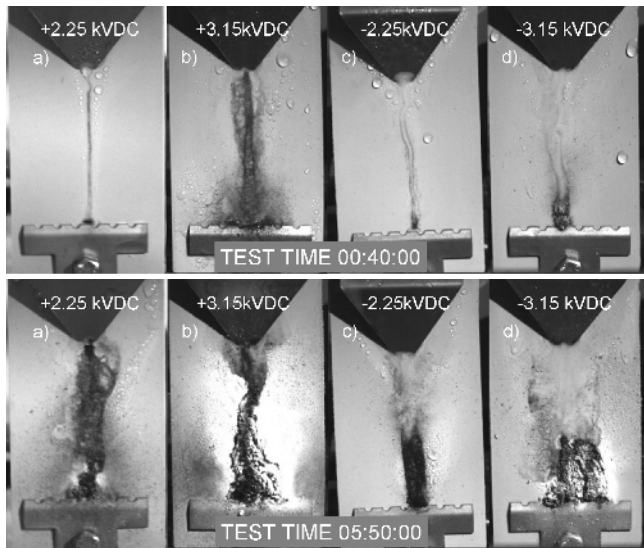
Figure 2 shows the pattern of degradation on typical samples after testing for 40 minutes and almost 6 hours. After 40 minutes all samples show damage due to surface discharges. The damage at 3.15 kV dc is more widespread than the thin line which is developed under 2.25 kV dc. Even at this early stage in a test the patterns of damage under each polarity are different. In positive tests a) and b), a continuous, flat and solid hydrophilic line has formed between the electrodes, whereas in the negative cases c) and d), the track is more predominant in the bottom half of the sample. In -2.25 kV dc tests, a foam forms around the negative electrode tip, which maybe the result of contaminant boiling under Joule heating, but is more likely to be the formation of hydrogen gas as a by-product of electrolysis.

At the end of the test under positive conditions, the solid hydrophilic layer formed between the electrodes is considerably wider than at 40 minutes. However, under negative conditions, this solid layer still only reaches approximately half way up the sample. The charred region which can be seen in both the 3.15 kV dc tests formed from the grounded, bottom electrode and grew upwards and outwards, however, the result is a very different shaped charred region in each case. The principle difference being the extension up to the top electrode in the positive case.

Figure 2. Condition of material A after: top picture 40 minutes and bottom picture 5 hours 50 minutes, where a) +2.25 b) +3.15 c) -2.25 d) -3.15 kVDC tests

take place, for example, decomposition of the ATH or decomposition of the base polymer at higher temperatures. The associated changes in the properties of the material surface may facilitate higher surface currents and so a cycle of increasing degradation evolves. It can be seen from Figure 2b that the maximum current observed throughout the test is considerably higher under positive conditions than it is for negative. This suggests that the potential arc temperature is higher, and we could expect higher levels of damage based on the principle that higher temperatures are being experienced on the sample surface.

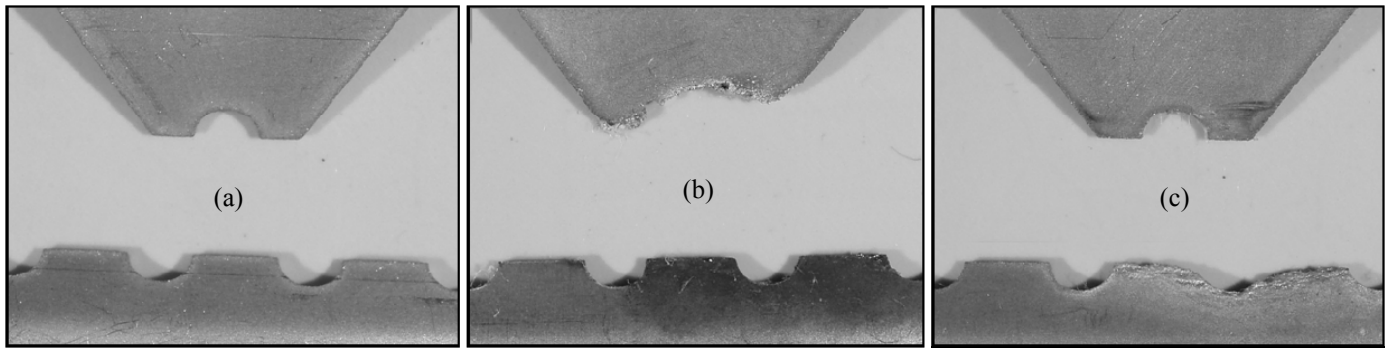
During both ac and dc tracking tests, electrodes can become significantly eroded such that they are unsuitable for use in further tests [10]. For this reason they are only used once. In the dc tests, one electrode erodes significantly more than the other, and the polarity of the dc voltage dictates whether this is the top or bottom electrode. In positive tests, the top positive electrode is more eroded, whereas in negative tests the bottom grounded electrode is more eroded. Figure 4 shows pictures of such electrode erosion after 6 h of testing at 2.7 kV dc. In Figure 4b, there is also a solid dark layer which has built up on the bottom electrode.

Figure 4. Pictures of quill hole of top electrodes (energised) and the middle-section of bottom (grounded) electrodes a) before testing b) after a 6 hour +2.7 kV dc test and c) after a 6 hour -2.7 kV dc test; picture widths are 18 mm

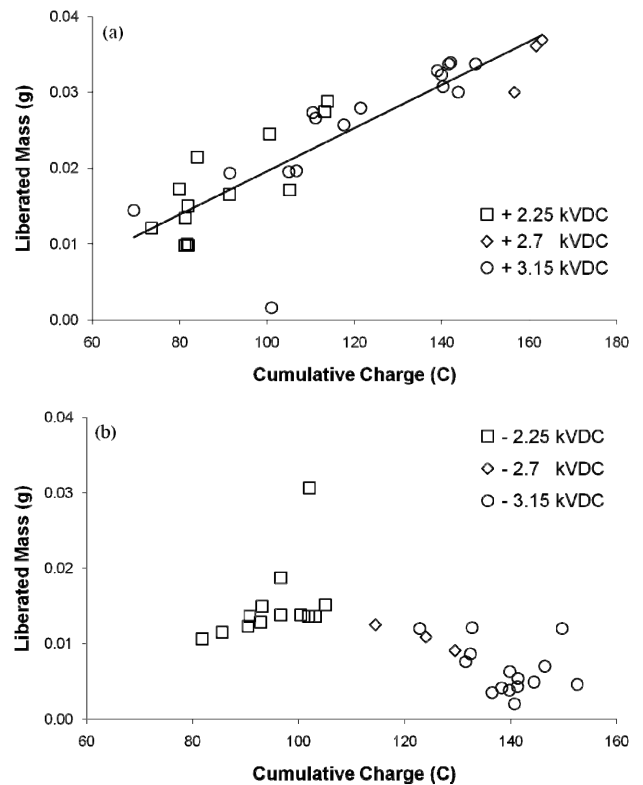
Given that the electrodes used are allowing a current to pass through an ionic solution, it is reasonable to assume the erosion process is due to electrolysis. If electrolysis is taking place, the mass of electrode liberated should be proportional to the total charge passed. In Figure 6a, the trend line shows, this is clearly the case on the top electrode under positive dc.

Figure 6. Cumulative charge versus liberated HV electrode mass for a) top electrode in positive tests and b) bottom electrode in negative tests with all materials shown

locations where deep erosion of the SIR has taken place; this is not seen under -2.25 kV dc. As a result, the trend in Figure 6b does not follow for electrode mass loss under negative conditions on the bottom electrode.

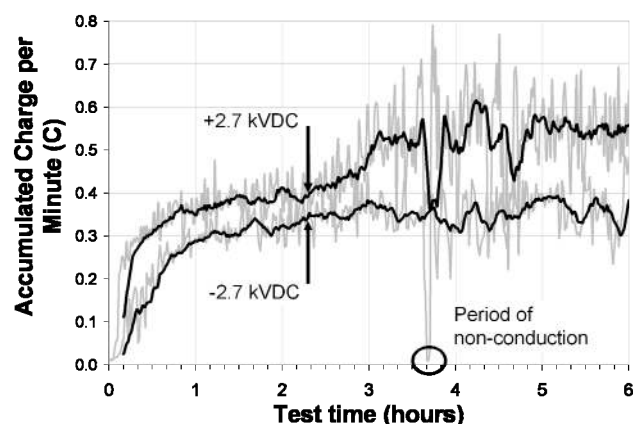
Figure 8 shows that the magnitude of the accumulated charge per minute is higher in the positive case over the duration of the test, despite intermittency being 10% greater than the negative case. This is because positive average current is 2 times greater, and from equation 3 this would be the expected overall effect. In the first hour of the test, accumulated charge per minute increases rapidly, as this is the period when the sample surface is being conditioned by the discharges. By 1 h, the pattern of surface damage looks quite different for each polarity. This raises the question of whether it is the surface degradation which dictates the leakage current, or the leakage current which controls the surface degradation pattern. This is investigated further in section 8.2 where polarity is changed three hours into a test.

Between 1 to 3 h, the accumulated charge per minute increases steadily as the surface becomes more degraded. From 3-6 h under negative conditions there is no significant change in the rate of accumulated charge, however, in the positive case, there is a transition at the three hour point where the rate increases by 0.1 C/minute. This occurs at the onset of deep erosion in the test, where the formation of char on the surface allows a larger volume of contaminant to be retained at any one time. The result is often higher peak currents and more damaging discharges. The char on

the surface can also change the path in which the contaminant flows, which may cause periods of non-conduction as happens at 3 hour 40 minutes in the positive test shown.

Figure 8. Moving average of 10 of accumulated charge per minute for material C in a positive and negative polarity 2.7 kV dc test

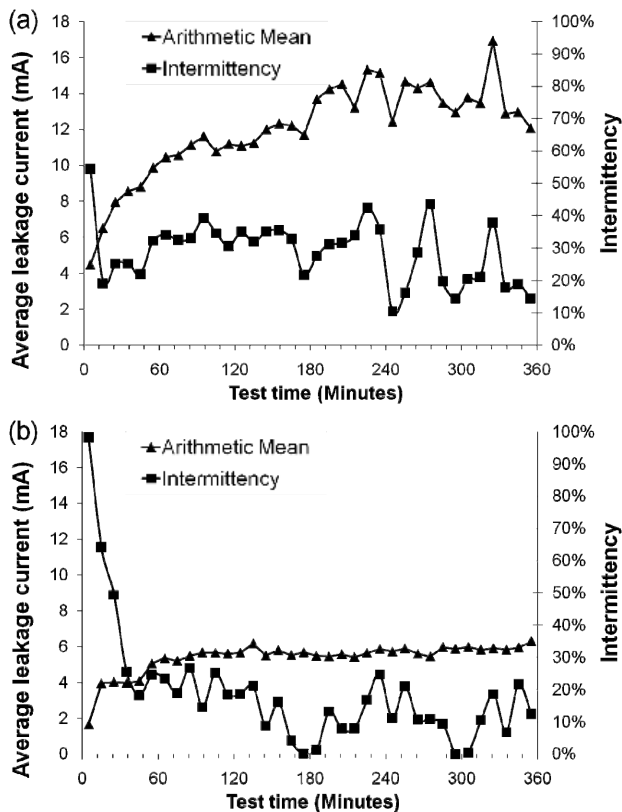
As in the accumulated charge plot, Figure 9a shows a rise in average leakage current at 3 h (180 minutes) in the +2.7 kV test. After the onset of deep erosion, the intermittency begins to vary as the sample alternates between non conductive and highly conductive states. After 5 hours 20 minutes (320 minutes) there is a 2 milliamp rise in average current and a 20% increase in intermittency. Observed video images at this time, does not show if this particular condition gave any increased rate of damage. Because the increase in current was met by an increase in intermittency, the accumulated charge for this period remains fairly constant. In the -2.7 kV dc test, the average current is smaller in magnitude, but is also remarkably stable over the course of the test. The intermittency is also lower than the positive case, and there are a number of

Figure 9. Intermittency (%) and average current (mA) in 10 minute intervals for (a) +2.7kVDC (b) -2.7kV dc on material C.

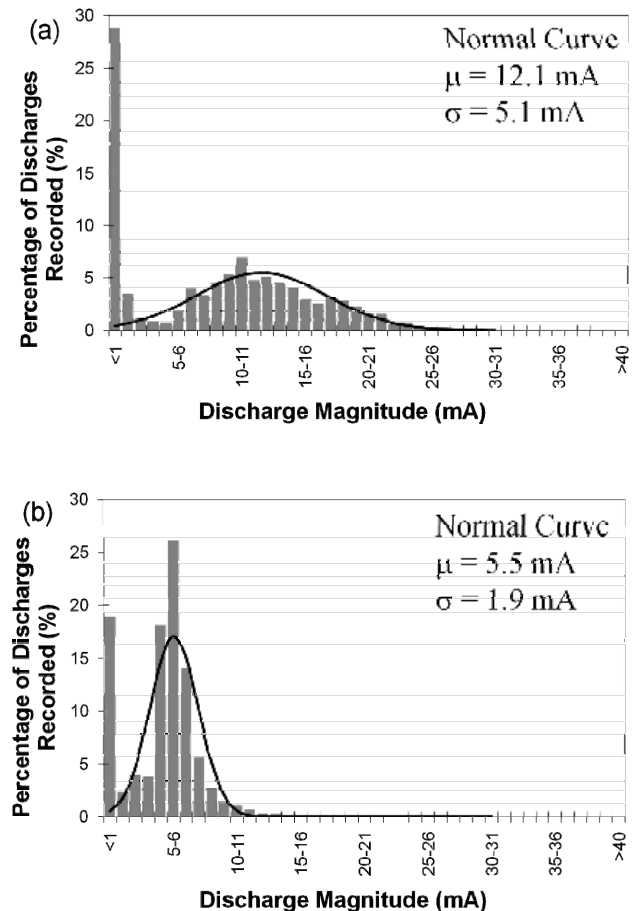
Figure 10, the first column (<1mA) shows the percentage of recorded discharges where the sample surface was non-conducting; this is the measure of intermittency. When the sample is conducting, the distribution of leakage current magnitude follows a normal distribution. It is envisaged that the current follows a normal distribution because there are a large number of factors which contribute to its overall nature.

Figure 10. Histogram of leakage current magnitude for (a) +2.7 kV, and (b) -2.7 kV on material C. Best fit normal distributions are shown and mean (μ) and standard deviation given (σ)

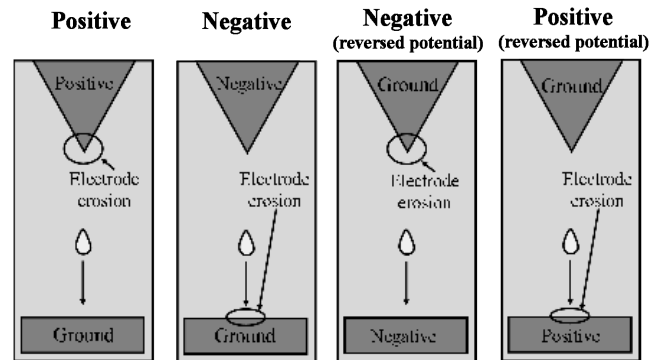
In the following 'reversed potential' tests, the bottom electrode is energised and the top electrode is grounded as depicted in Figure 12. The effect of this is that the potential across the sample is opposite polarity and equivalent to the standard opposite polarity test, however, the potential with respect to external objects is changed. Results are presented from single 2.7 kV dc tests on material A.

Figure 12. Electrode reversal configurations. The two cases on the left are traditional with grounded bottom electrodes, in the reversed cases on the right the upper electrodes are grounded.

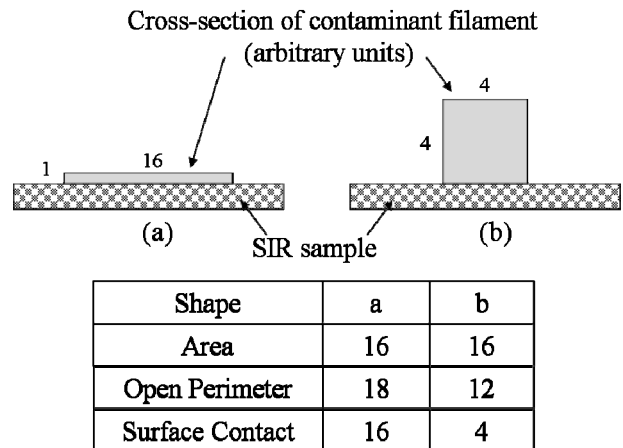
The shape which the contaminant takes on the surface of the SIR will change the evaporation rate. This means that the surface condition of the material is very important. The difference in the shape and extent of the aged surface is very different in the positive and negative cases, and may be the fundamental difference controlling the disparity of results in the two situations. Consider two different shapes of contaminant cross-section on the dielectric surface, which are of the same cross-sectional area: In case A, the perimeter which is open to the air and that can be evaporated is greater than case B. The situations could be compared to a hydrophobic and hydrophilic surface in the case of SIR, where case A is hydrophilic. This could potentially increase the evaporation rate, if there is sufficient heat being generated to maintain the contaminant temperature. Similarly case A has greater contact area with the solid surface and may be cooled by the thermal mass of the solid. Conversely, the bulky filament will be cooled less per unit volume by the air and the solid surface, and so may reach higher temperatures, and hence evaporate quicker. Each cross-sectional area may also influence arc longevity, and arc-root localisation. Further analysis is required to understand the thermodynamics of the two cases.

Figure 16. Contaminant cross-sectional area.
