Position-dependent mechanical characterization of the PBF-EB-manufactured Ti6Al4V alloy

Abstract

Keywords Additive manufacturing · Electron beam powder bed fusion (PBF-EB) · Ti6Al4V · Fatigue properties

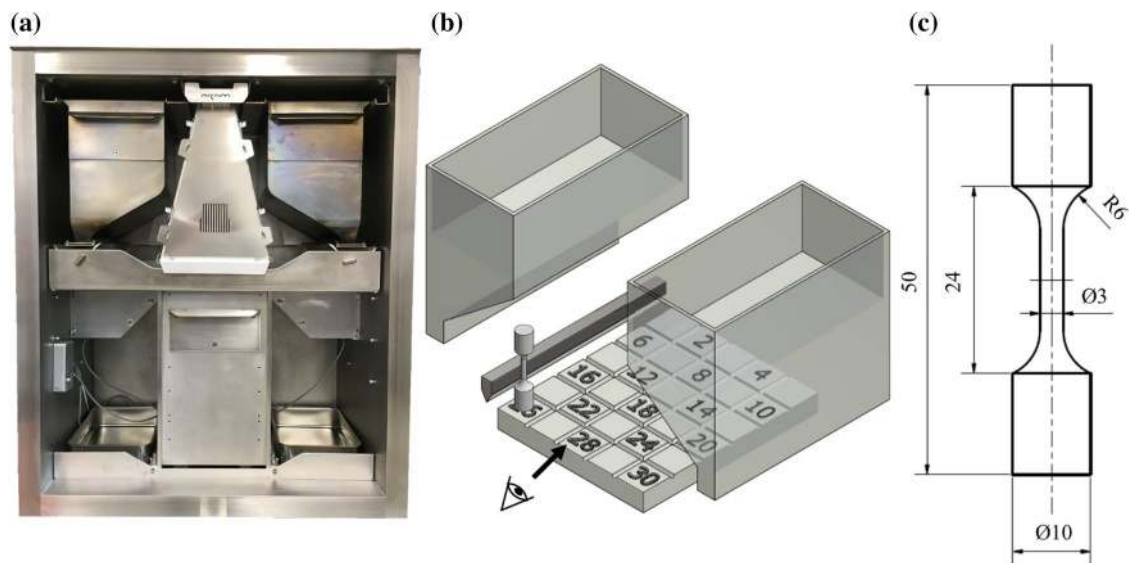
Fig. 1 a Arcam EBM A2X, b schematic illustration of segmentation of build platform and c the specimen geometry used for fatigue testing (dimensions in mm)

3 mm (Fig. 1c). A detailed figure regarding the segregation of the BP can be seen in Fig. 1a, b.

The results from surface roughness measurements are shown in Fig. 2a, b. Specimen 1 is located in the upper left corner and specimen 30 is located in the bottom right corner, respectively (cf. Fig. 1b). As already mentioned in Sect. 2, two different measuring techniques, i.e., tactile surface roughness tester and μ -CT were used. The average surface roughness value for all investigated specimens which were tested with tactile surface roughness tester was found to be $Ra = 20.9 \pm 1.3 \mu\text{m}$ whereby Fig. 2a shows the arrangement of all specimens on the BP with their associated Ra value. All values range between the least surface roughness of specimen 24 amounting $Ra = 18.4 \mu\text{m}$ and specimen 18 having a value of $Ra = 23.3 \mu\text{m}$. Regular trends of occurring roughness values on the BP were not observed. Taking into account the Ra values from μ -CT, it can be seen, that the results differ significantly with respect to the measurement technique. In general, calculated Ra values from μ -CT are nearly twice as high as Ra values which were measured by tactile surface roughness tester and average surface roughness was found to be $Ra = 40.7 \pm 2.3 \mu\text{m}$. Furthermore, it can be mentioned that specimens in the front of the BP show

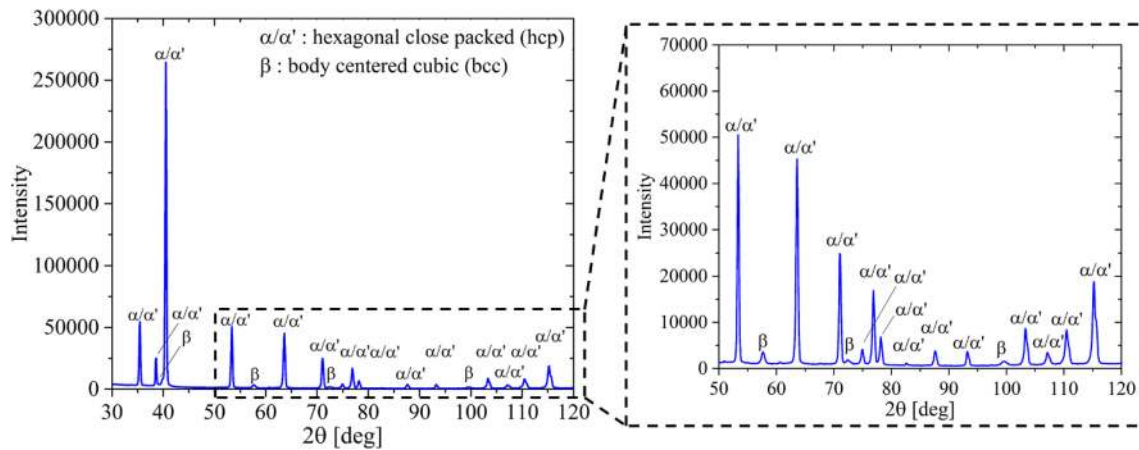
XRD pattern for the PBF-EB-manufactured Ti6Al4V alloy whereby the majority of the peaks can be attributed to the α/α' phase. Since α and α' have the same hexagonal close-packed (hcp) structure, a clear differentiation between both phases is challenging [10]. However, it was already reported in [1, 11] that the α' phase can be completely eliminated during the PBF-EB process. Next to the α/α' phase, even the body centered cubic (bcc) β phase is present (cf. Fig. 5), which was earlier reported by different researchers [13, 22].

Fig. 4 XRD patterns of PBF-EB-manufactured Ti6Al4V alloy

Hardness measurements for all specimens were found to be $331 \pm 10 \text{ HV}$ on average. As displayed in Fig. 3, hardness values over the entire BP does not show significant differences and regular deviations were not observed. Within investigations done by Masuo et al. [6] an average hardness of 369 HV for PBF-EB-manufactured specimens was determined, which is slightly higher than the results presented in this study. The absence of harder martensitic structures is characteristic for the PBF-EB-manufactured Ti6Al4V alloy and results in lower hardness values compared to other AM techniques such as PBF-LB/M. According to Dallago et al. [30], average hardness for PBF-LB/M manufactured specimens was found to be 380 HV resulting from several martensitic areas. Hardness values in this study are accordingly lower due to the process- and geometric-related lower cooling rates and the predominant α -phase morphology (cf. Fig. 4).

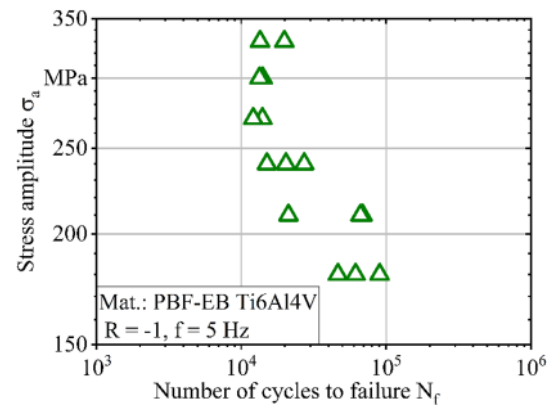
Fig. 7 Results from CAT plotted in form of S–N curves

As can be seen, fatigue life values of as-built specimens are ranging between 10^4 and 10^5 cycles. For a stress amplitude $\sigma_a = 180$ MPa, a maximum number of cycles to failure $N_f = 90,200$ cycles was detected. However, for stress amplitudes ranging between 240 and 330 MPa, comparable number of cycles to failure were determined.

The basis for the following fatigue tests are the calculated values for the average equivalent diameter which were introduced above. The fatigue tests were performed at different stress amplitudes to investigate the material's cyclic properties. The results are given in Fig. 7.

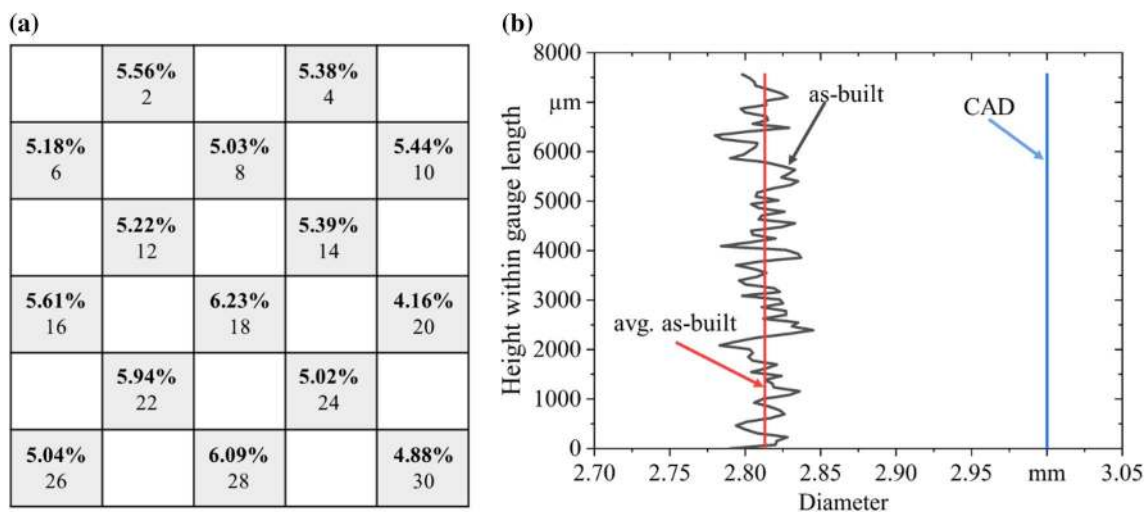
PBF-EB-manufactured specimens can suffer from geometrical deviations when compared to the initial CAD data [19, 23]. Furthermore, these deviations can locally change with regard to the position on the BP. Therefore, average equivalent diameter was calculated for all specimens based on the μ-CT scans. The local differences between CAD and average equivalent diameter are plotted in Fig. 6a. In general, it can be stated that all sample cross sections are smaller than the prescribed CAD cross section and average deviation was found to be $-5.34 \pm 0.50\%$. In detail, specimen 20 showed the lowest deviation of -4.16% corresponding to the largest equivalent diameter which was found to be 2.88 mm. Highest deviation, in total -6.23% , was found for specimen 18 resulting in the smallest average cross section. The actual diameter for specimen 18 within the investigated gauge length is presented in Fig. 6b and is colored in black. The average equivalent diameter of 2.81 mm is marked in

red color and the CAD diameter of 3 mm is presented in blue, respectively. As can be seen, actual specimen diameter changes between single material layers which might lead to the formation of notch-like defects. Notch-like defects are typically described by their geometrical parameters such as depth and thickness of the notch as well as the radius at the lowest point [24]. The total amplitude of local diameter deviations ranges between 2.78 and 2.85 mm.

Fig. 6 a Local differences on building platform between CAD- and average equivalent diameter in percent in accordance with platform number. b Graphic depiction of cross section variations, average diameter and CAD diameter along building direction for specimen 18

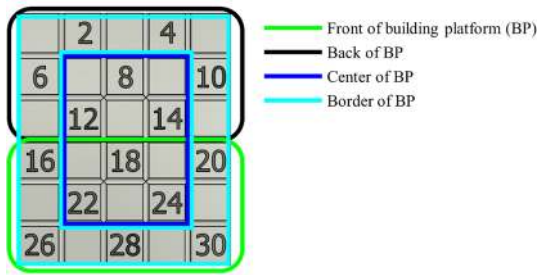
Fig. 8 Segmentation of the building platform

stress amplitude $\sigma_a = 210$ MPa. To further investigate the influence of the position of the BP on the fatigue life, the BP was divided into either front and back or center and border areas, as can be seen in Fig. 8.

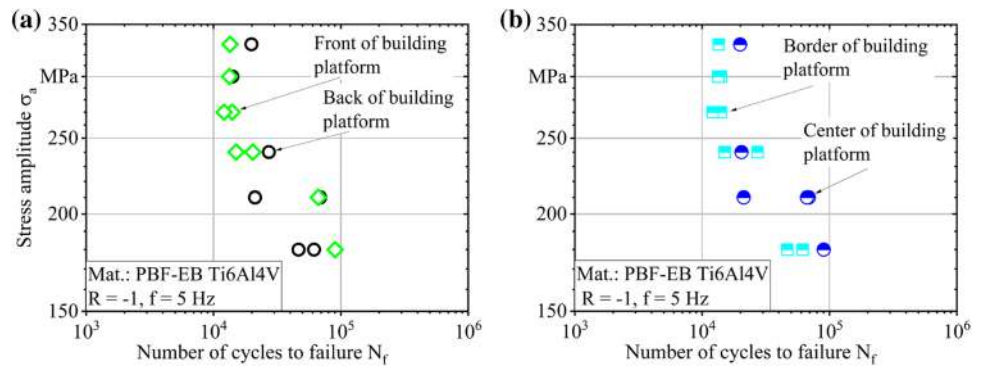
Based on this segmentation, specimens of each area were separately colored and results are plotted in Fig. 9a, b. In detail, specimens in the front of the BP are colored in light green, in the back of the BP in black, in the center of the BP in blue and in the border of the BP in light blue. Taking into account the results plotted, no clear influence of the position on the BP is visible. However, it has to be mentioned that specimens in the front of the BP show slightly weaker fatigue performance at higher stress amplitudes (cf. Fig. 9a). With decreasing stress amplitude, differences are reduced. Even specimens positioned at the border of the BP show lower fatigue life compared to specimens located in the center of BP (cf. Fig. 9b). This phenomenon can be detected at higher as well as at lower stress amplitudes. Solely specimen 14 ($\sigma_a = 210$ MPa, $N_f = 21,188$ cycles) shows a contrary tendency implicating that an individual irregularity led to

Fig. 9 Results from CAT plotted in form of S–N curves: differentiation between **a** front and back and **b** center and border of the BP

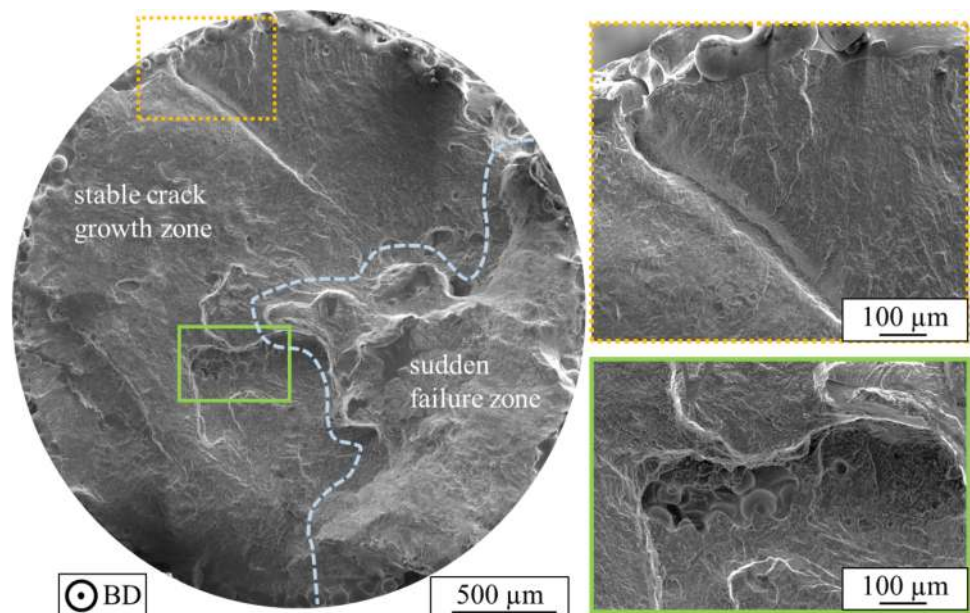
Fig. 10 Fracture surface of specimen 10 tested at a stress amplitude of $\sigma_a = 240$ MPa ($N_f = 27,210$ cycles)

The fractured surface of specimen 10 ($\sigma_a = 240$ MPa, $N_f = 27,210$ cycles), representing a specimen from the front of BP, was subsequently analyzed to localize the initiation of the fracture and to retrace crack growth mechanisms. The fractographic image as well as two magnifications are plotted in Fig. 10. As can be seen, the fatigue crack originated at the specimen surface which can mainly be attributed to the increased as-built surface roughness and near-surface defects leading to an irregular surface topography. However, based on the interaction of multiple factors, the fracture initiation cannot be attributed to a single origin. Furthermore, the fractured surface can be subdivided into two areas which are separated by a dashed line colored in light gray.

On the left side, the stable crack growth zone is clearly visible which is typically relatively flat and even. Within the stable crack growth zone, small spherical pores and certain LoF can be observed which are shown in higher magnification. Next to the stable crack growth zone, the second area shows a sharp and uneven surface which is characteristic for the sudden failure zone. In this zone, the specimen failure is caused by an overload fracture.

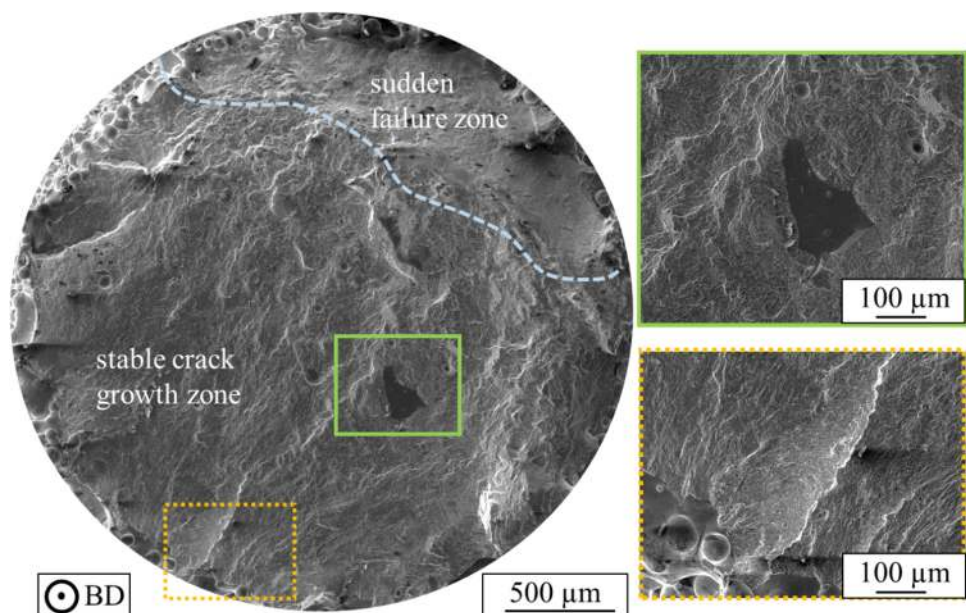
For comparison, the fractured surface of specimen 14 ($\sigma_a = 210$ MPa, $N_f = 21,188$ cycles) is shown in Fig. 11. This specimen is located in the back of BP and showed relatively low fatigue life during CAT. As can be seen, even here, multiple crack initiation sites are present and fatigue crack initiated at the surface.

Fig. 11 Fracture surface of specimen 14 tested at a stress amplitude of $\sigma_a = 210$ MPa ($N_f = 21,188$ cycles)
