Potentially active faults in dam foundations

J. L. SHERARD,* L. S. CLUFF† and C. R. ALLEN‡

The Paper contains information on existing dams founded on active faults, a summary of pertinent lessons learned from study of historic fault breaks and fault mechanisms, recommended practice for evaluation of active faults, and opinions concerning design of dams on active faults. While a dam site with an active fault should be avoided if possible, if a reservoir is vitally needed and a better site is not available, it is reasonable practice to construct a conservatively designed embankment dam. Concrete dams on active faults, or near some major active faults, are not advisable. For evaluation of fault activity, geological studies usually must be carried a considerable distance from the dam site, a departure from recent past practice. Experience of the last few years with many fault studies indicates that thorough geological investigations with modern techniques will usually provide sufficient evidence to allow a judgement on the activity or inactivity of a fault.

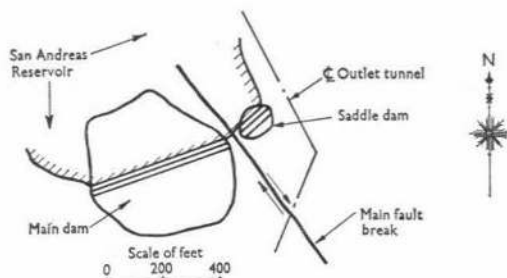
Fig. 1. San Andreas Dam—location of main fault break (after Lawson, 1908)

The San Andreas Dam is a 27 m high earth dam, built more than 100 years ago a few miles south of San Francisco, California. It comprises a main embankment and a smaller saddle dam on the east abutment separated by a narrow ridge. During the 1906 San Francisco earthquake ($M=8.3$), the main break on the San Andreas Fault passed through the small ridge forming the common abutment between the two embankments (Fig. 1). The main embankment dam was moved bodily, approximately 2.5 m north relative to its east abutment and the saddle dam. A tunnel in the east abutment was twisted about 3 m out of line, but there was no damage to the dam. The 20 million m^3 reservoir was full and no leakage or other alarming symptoms developed (Lawson, 1908).

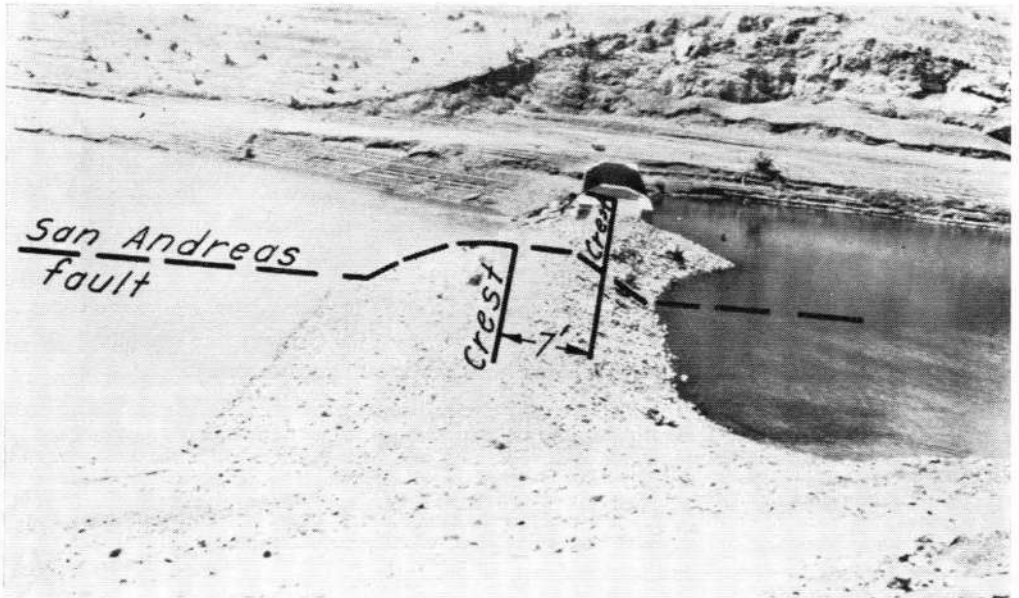
Fig. 4. Old San Andreas Dam showing offset of embankment caused by 1906 break on the San Andreas Fault. At the time of the earthquake the dam was abandoned and submerged in the north arm of the Crystal Springs Reservoir. The photograph was taken in 1931 at a time of low reservoir level (after Louderback, 1937)

Figure 4 shows an offset (about 2 m) of yet another small dam (Old San Andreas Dam). This abandoned dam was submerged under the north arm of the Crystal Springs Reservoir at the time of the 1906 earthquake and was only exposed in 1931 when the reservoir was lowered (Louderback, 1937).

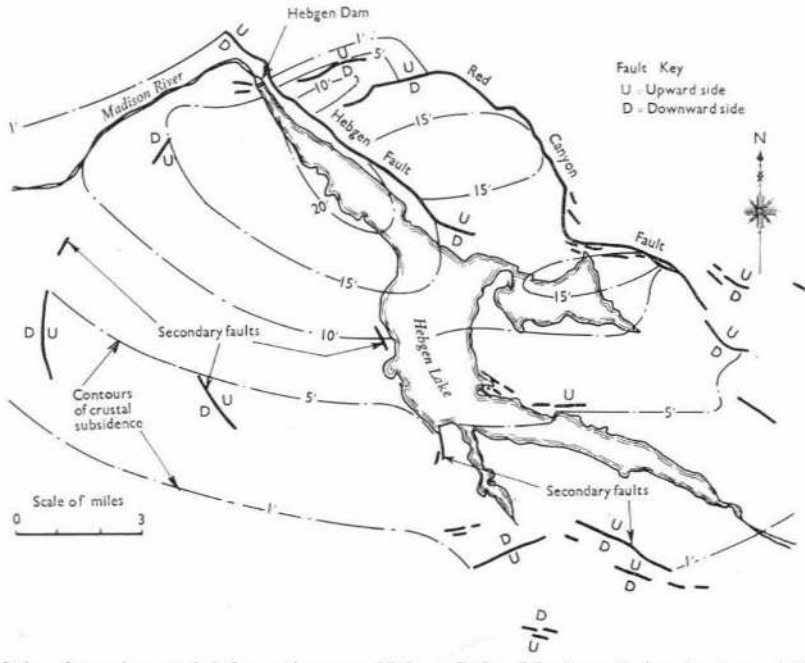
Fig. 5. Fault breaks and crustal deformation near Hebgen Lake, Montana during the August 18, 1959 earthquake (after Witkind *et al.*, 1962)

Associated with the faulting there was a general subsidence of the bedrock underlying the reservoir, with maximum of about 22 ft (6.7 m), (Fig. 5). The bedrock under the dam (and the whole dam, spillway and outlet conduit) went down approximately 3.0 m in a remarkably uniform fashion. The 'average' subsidence of the large reservoir was about 3.2 m, so that the dam and water surface remained at the same relative elevation.

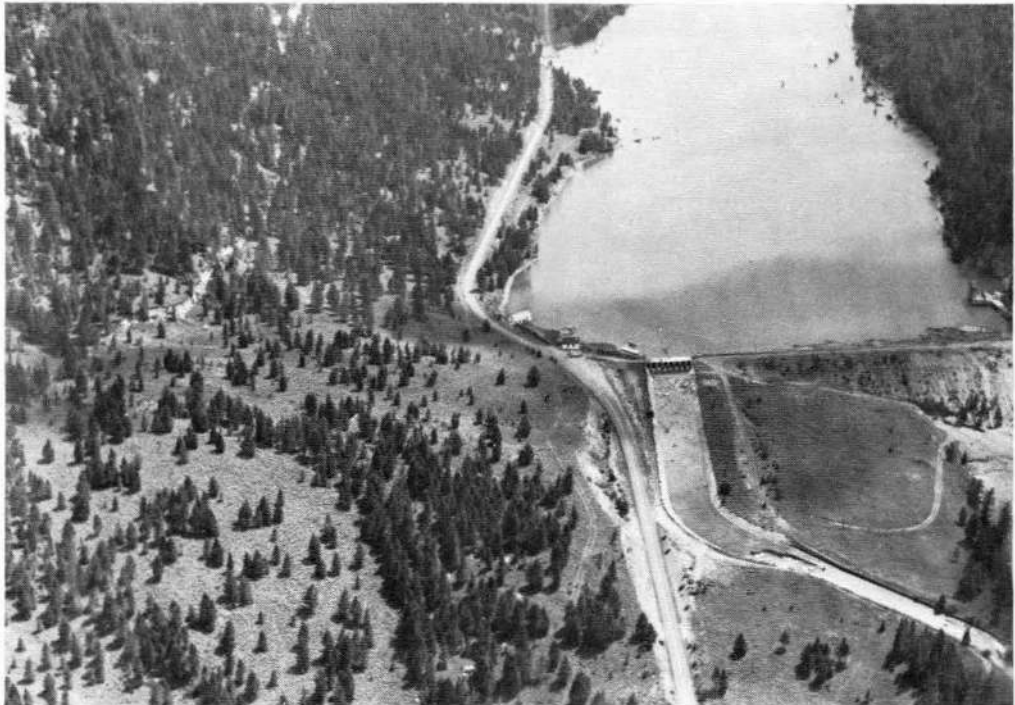
Fig. 6. Looking upstream with Hebgen Dam in foreground, three days after the earthquake. The main Hebgen Fault break is clearly visible in the trees running along the valley wall parallel to the lakeshore on the left side of the photograph

The second example of a 'near miss' was at the Hebgen Dam, Montana, during the West Yellowstone earthquake of 17 August 1959 ($M=7.1$). The 27 m high, 210 m long earth dam, constructed in 1914, retained a 370 million m^3 reservoir with a length of about 25 km. The reservoir was full at the time of the earthquake. Movements occurred on a number of major faults with primarily vertical displacement (Fig. 5). The aggregate length of all the main fault breaks was more than 75 km. The main Hebgen Fault break traversing the north wall of the reservoir, about 200 m from the right end of the dam had a vertical displacement of about 5 m at this point, with the north side of the fault going up relative to the south side (Figs 6-8).

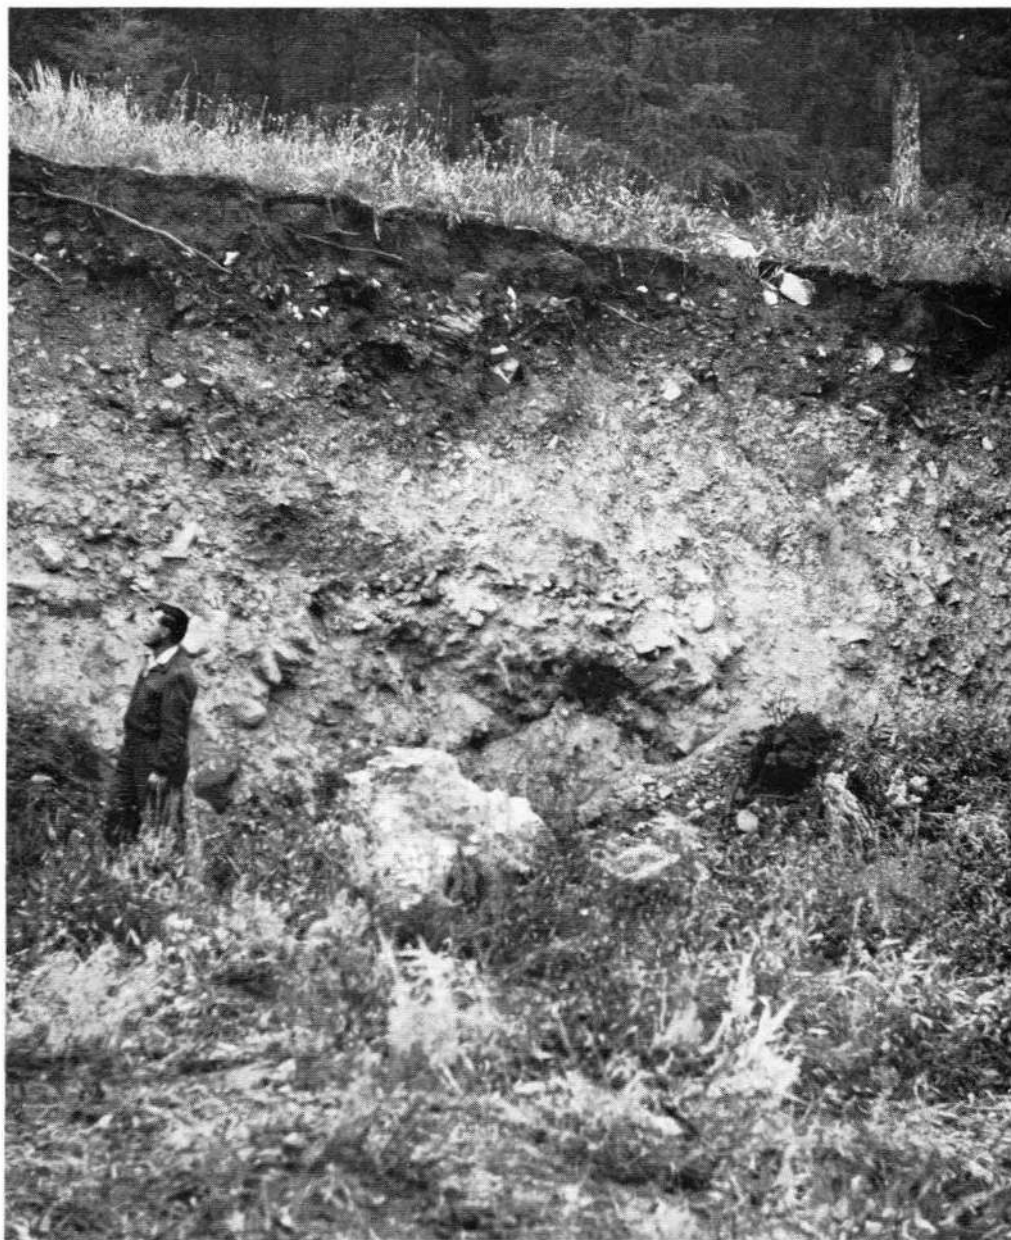
Fig. 7. Break on Hebgen Fault directly opposite dam; approximately 5 m vertical displacement

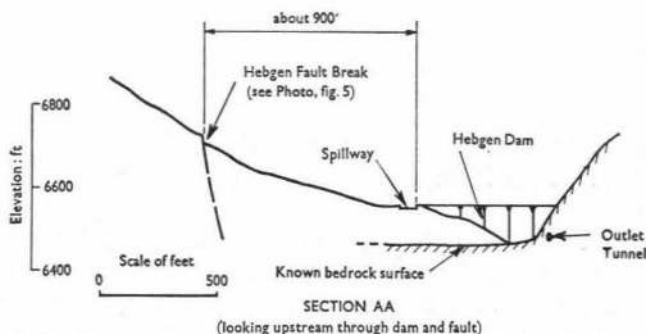
Fig. 8. Hebden Dam—longitudinal section through dam and fault looking upstream

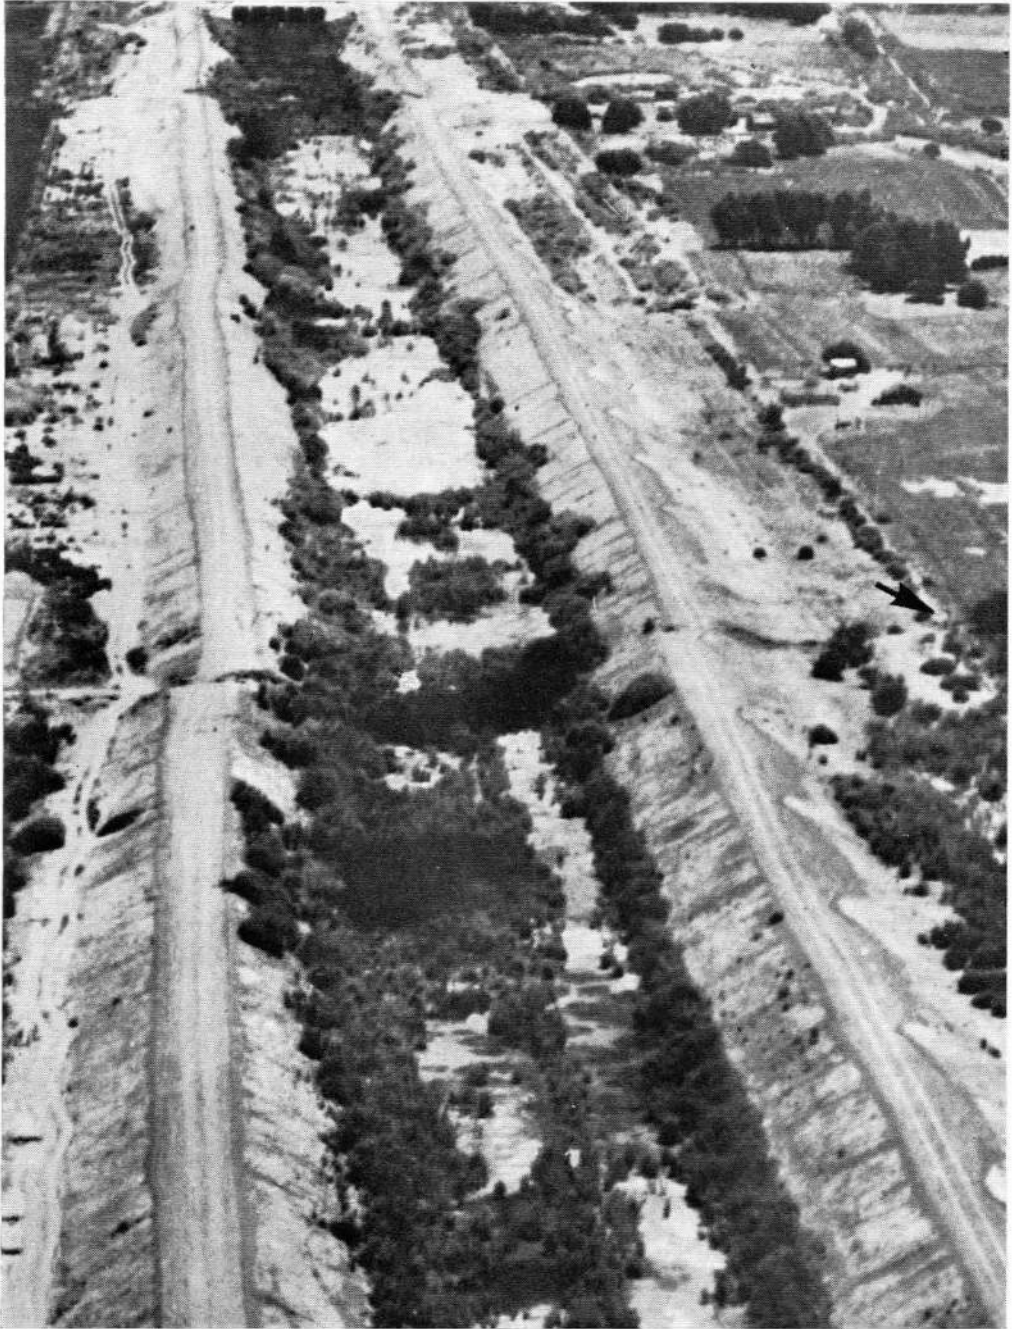
Fig. 9. Break on the Imperial Fault displaced the All-American Canal during the 1940 El Centro earthquake ($M=6.7$). The fault offset was nearly completely horizontal (strike-slip), approximately 4.3 m. The canal was nearing completion of construction but not carrying water at the time of the earthquake. Note that the fractured zone between offset canal embankments is relatively narrow

Figure 9 shows the resulting fault breaks through a large canal in 1940, illustrating particularly that for breaks on strike-slip faults (with primarily horizontal movement) the zone of fracturing is limited to a relatively narrow zone.

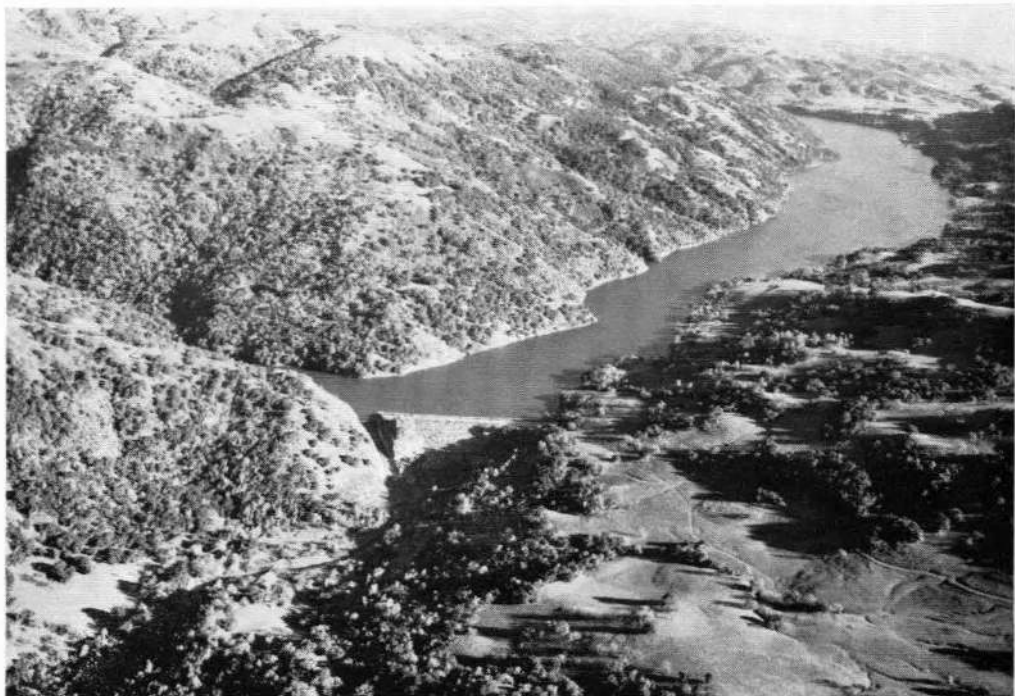
Fig. 10. 38 m high Coyote Dam built across the rift valley of the Calaveras Fault, California. Note typical narrow valley of strike-slip fault

The 38 m high Coyote Dam, retaining a 30 million m³ reservoir, was constructed in 1936 near San Jose, California, at a site where the foundation is underlain by the main branch of

the Calaveras Fault (Fig. 10). The nearby Hayward Fault broke last in 1868 causing an earthquake with a probable magnitude of 6.5 to 7.0.

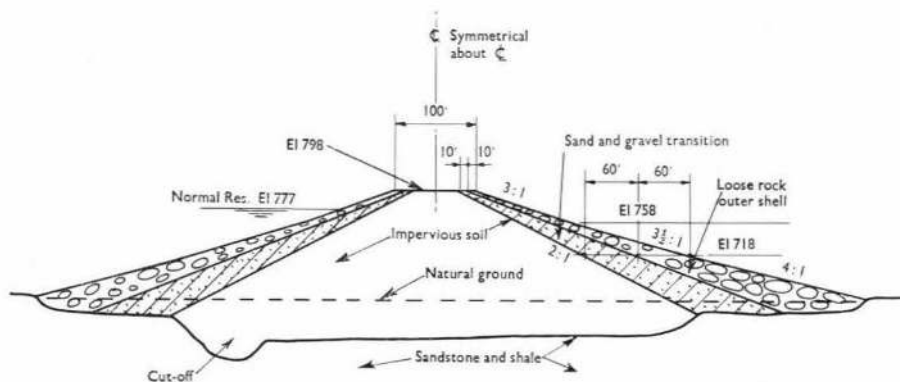
Fig. 11. Coyote Dam (after Tibbetts, 1936)

The dam was constructed according to these recommendations. As shown in Fig. 11, it has a crest width of 100 ft (30.5 m), freeboard of 22 ft (6.7 m) above normal water level and zones of sand-gravel and rockfill both upstream and downstream.

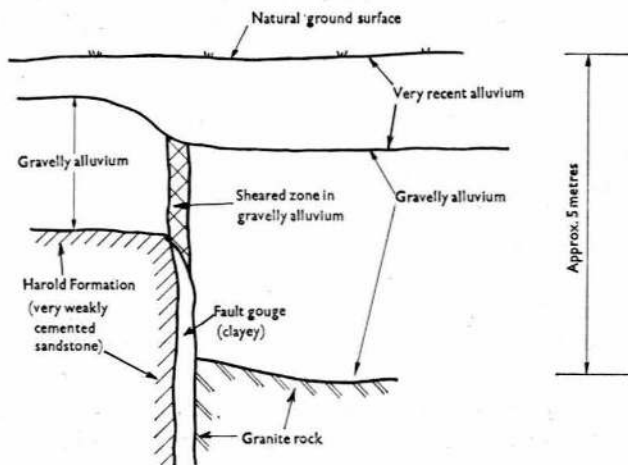
Fig. 13. Cedar Springs Dam; appearance of small active fault exposed in exploratory test trench

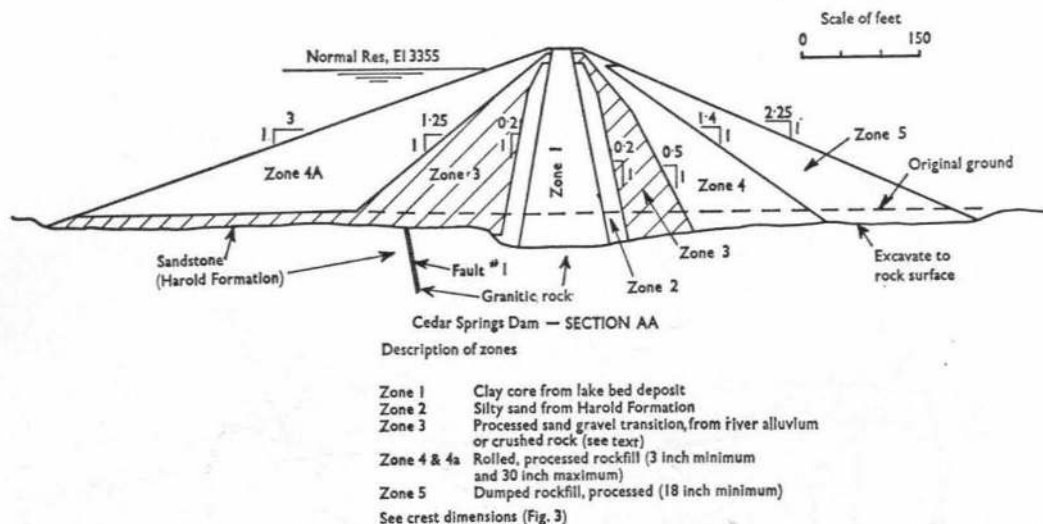
Fig. 14. Cedar Springs Dam—typical cross-section A-A (after California Department of Water Resources, 1968)

coarse, sand-gravel mixture (Fig. 14). Instead of using locally available silty sand for the core, a lake-bed clay, of especially tough and apparently erosion-resistant nature, was hauled from a distance of about 50 km. A wide crest was used for the main dam with generous widths of clay core and transition zones at the top of the dam. In the portion of the dam (west end) where the fault crosses the dam from upstream to downstream, the crest width was increased to 62 ft (19 m), or probably twice the width that might otherwise have been employed (Fig. 12).

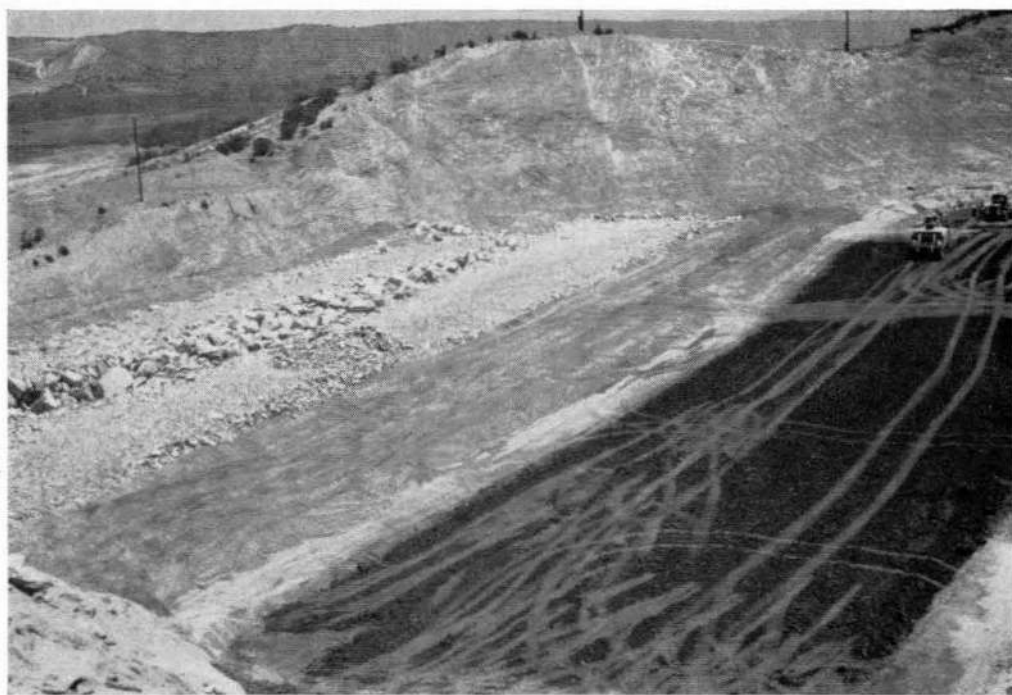
Fig. 15. Cedar Springs Dam during construction, looking downstream showing core at right and zones 2, 3, 4 and 5 progressively downstream

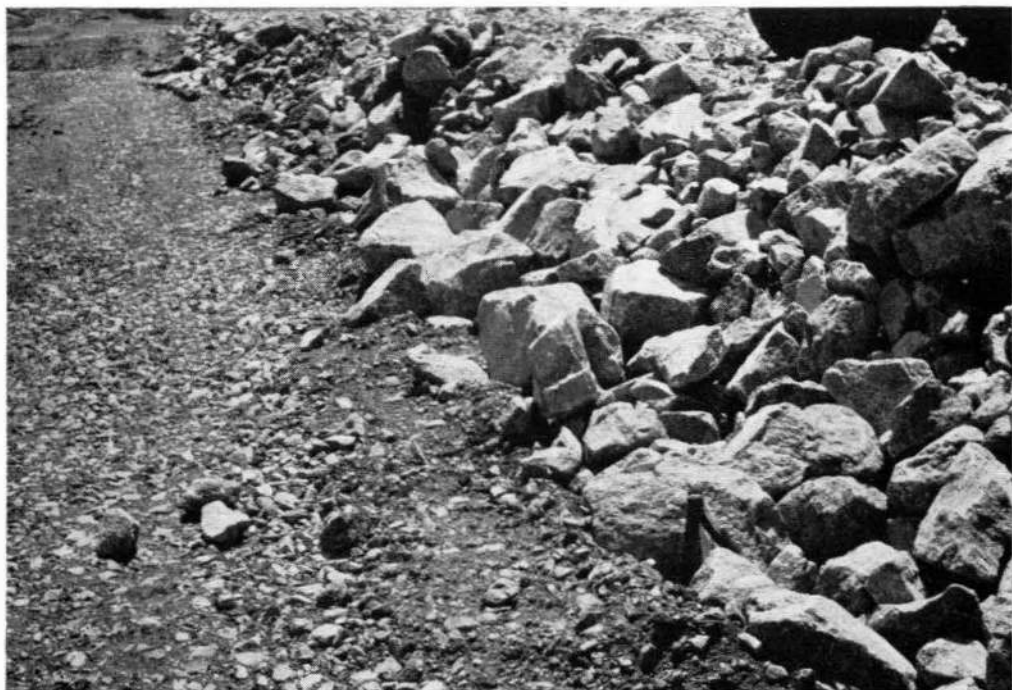
Fig. 16. Cedar Springs Dam during construction, looking at the boundary between transition zone 3 and downstream rockfill zone 4. It is apparent that the permeability of rockfill zone 4 is several orders greater than that of zone 3

typical view during construction of the juncture between zones 3 and 4 of the downstream shell, which gives confidence that any amount of water that could get through the zone 3 material would percolate away into the downstream rockfill safely.

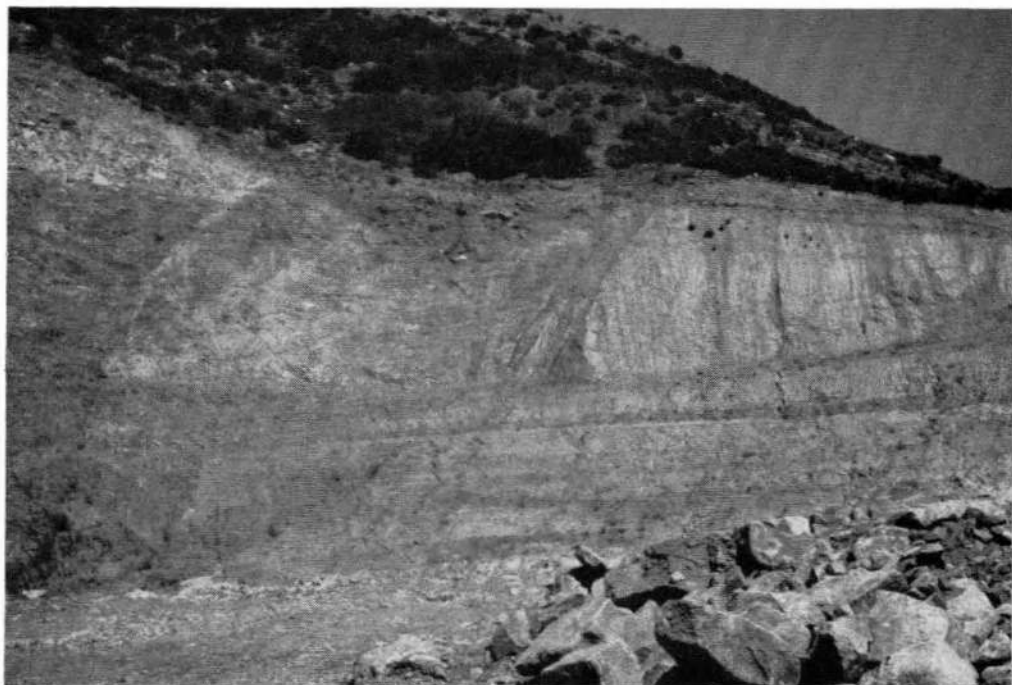
Fig. 17. Cedar Springs Dam during construction showing fault No. 1 exposed in excavation in east abutment at location shown in Fig. 12

The examples of Coyote, Cedar Springs (Fig. 17), Palmdale and Morris are believed to comprise practically all the experience in the profession in which dams were constructed on demonstrably active faults and where the designer, owner and official agencies were all consciously aware of the situation. In addition, however, it can be confidently assumed that there have been many other unpublicized cases where dams have been built at sites crossed by faults for which the designing engineer suspected possible activity and where he quietly assumed the fault might move several feet and proceeded with the construction of a conservatively designed embankment dam.

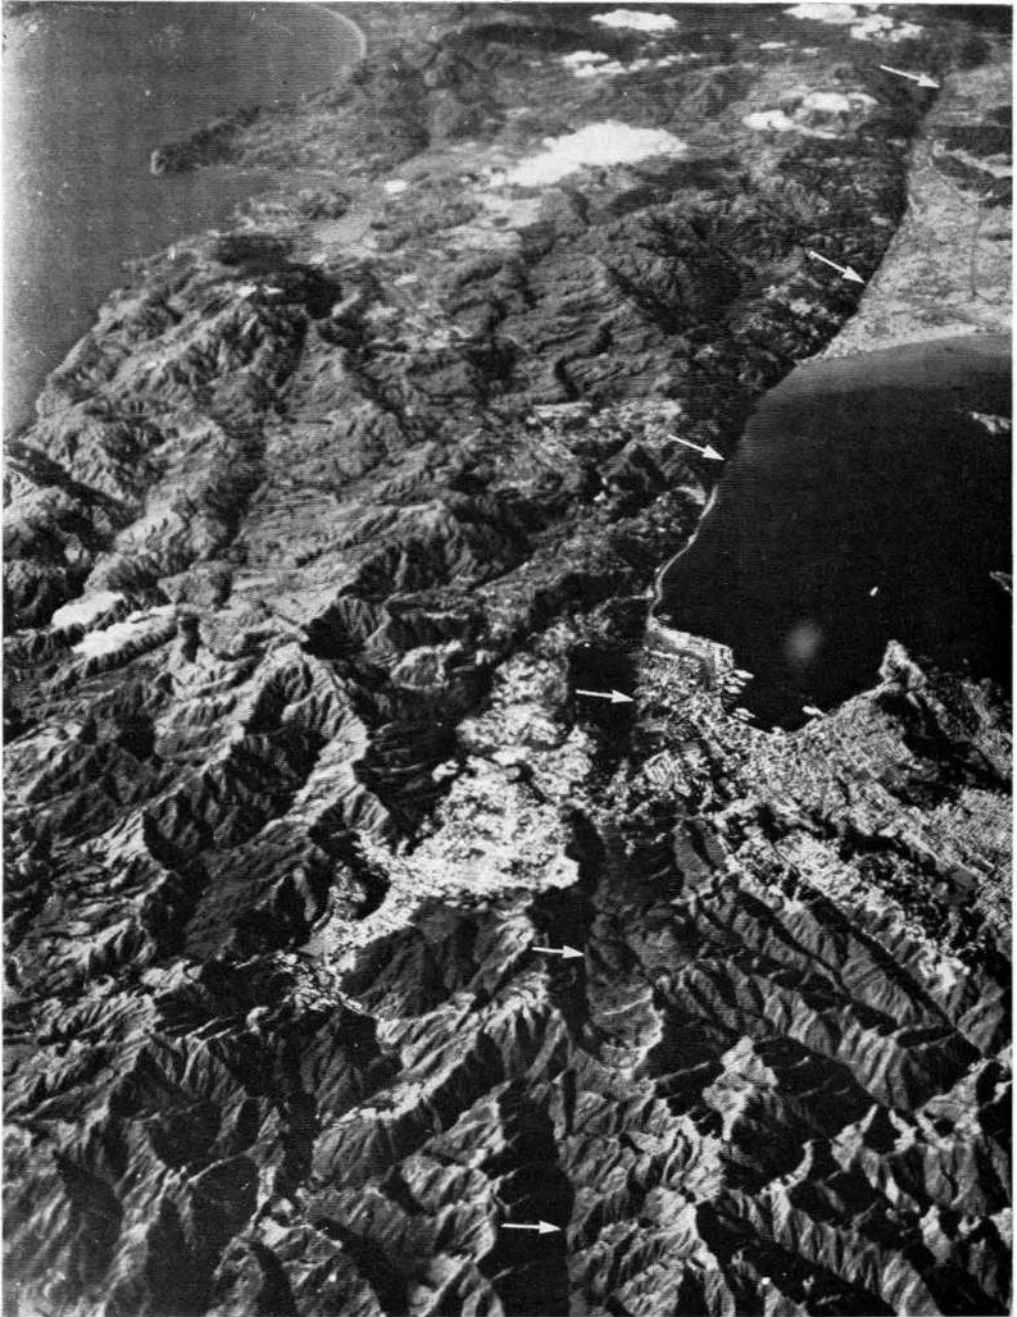
Fig. 18. Wellington Fault (arrows), New Zealand: one of the several parallel major active faults traversing the north island. City of Wellington in centre of photograph

Undoubtedly there are many dams in various parts of the world with foundation faults which would be shown to be active by adequate geologic study, and some cases have been discovered after many years of reservoir operation. One example is the Wellington Fault in New Zealand (Fig. 18). Two dams were built in the fault valley for water supply reservoirs about 1 km apart. The Upper Karori Dam is a concrete dam built in 1908 and the Lower Karori Dam is an earth dam built in 1872 (Fig. 19). Both dams are about 25 m high and both retain very small reservoirs (about 250 000 m³). It is now recognized that both these old dams straddle the active fault. They are kept in service nevertheless because it was concluded that the flood from release of the small reservoirs by dam failures would be impeded by a culverted road embankment and reach Wellington harbour without hazard of loss of life or property damage.

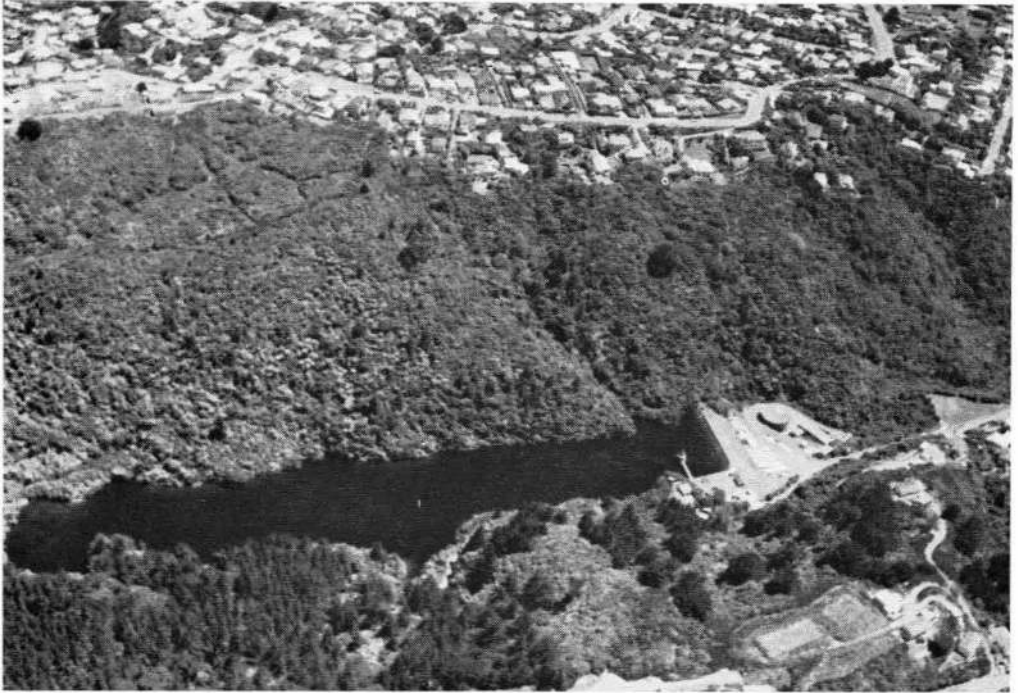
Fig. 19. Lower Karori Dam: 25 m high earth dam across the active Wellington Fault near Wellington, New Zealand. The reservoir is in the photograph of Fig. 18 but too small to be seen. Note the typical narrow reservoir in valley of strike-slip fault

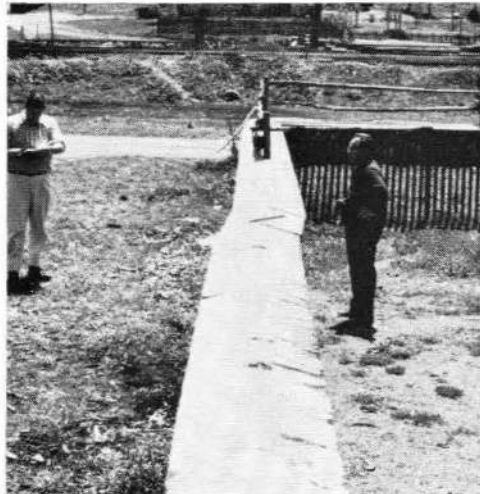
Fig. 20. Horizontal offset of wall by creep along North Anatolian Fault, Ismetpasa, Turkey. It is reported that creep is progressing at 1–2 cm/year since the photographs were taken in 1969 (Nason, 1972). During the 1944 Bolu earthquake ($M=7.6$) 1.5 m of horizontal displacement took place at this same location

fault creep—has recently been recognized in several parts of the world (Fig. 20). Furthermore, it is now known that earthquakes resulting from displacement and energy release on one fault can sometimes trigger small displacements on other unrelated faults many kilometres distant.

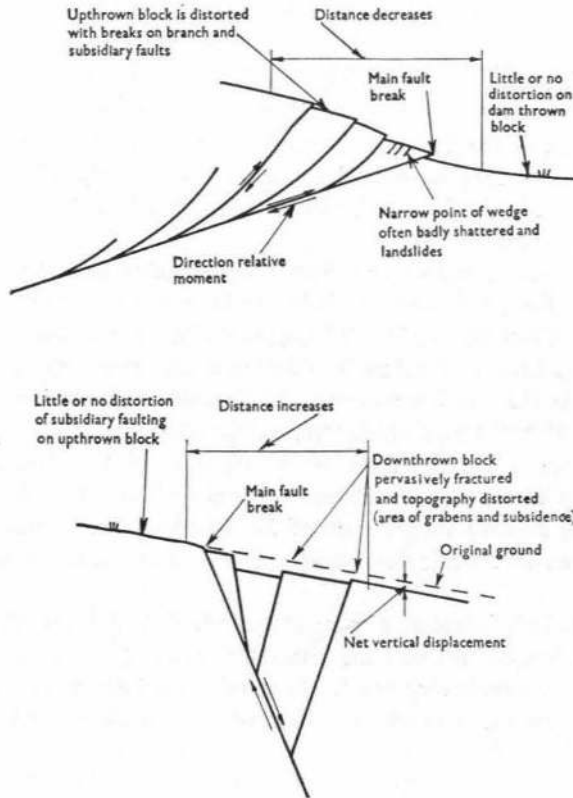
Fig. 21. Characteristics of thrust and normal faults

Normal faults. These involve vertical displacements caused by horizontal extension (Fig. 21). The distance between points on opposite sides of the fault is increased by the fault displacement. Normal faults tend to dip steeply (typically about 60° from the horizontal) and their traces are moderately complex in plan view. They are less frequently found on the land masses than the other fault types; most of the areas of crustal extension in the world are along the mid-ocean ridges. Three areas of pervasive normal faulting in continental areas are the so-called basin ranges of the western United States (Nevada, Utah and adjacent regions), the great rift valleys of East Africa, and the Shansi Graben area of China.

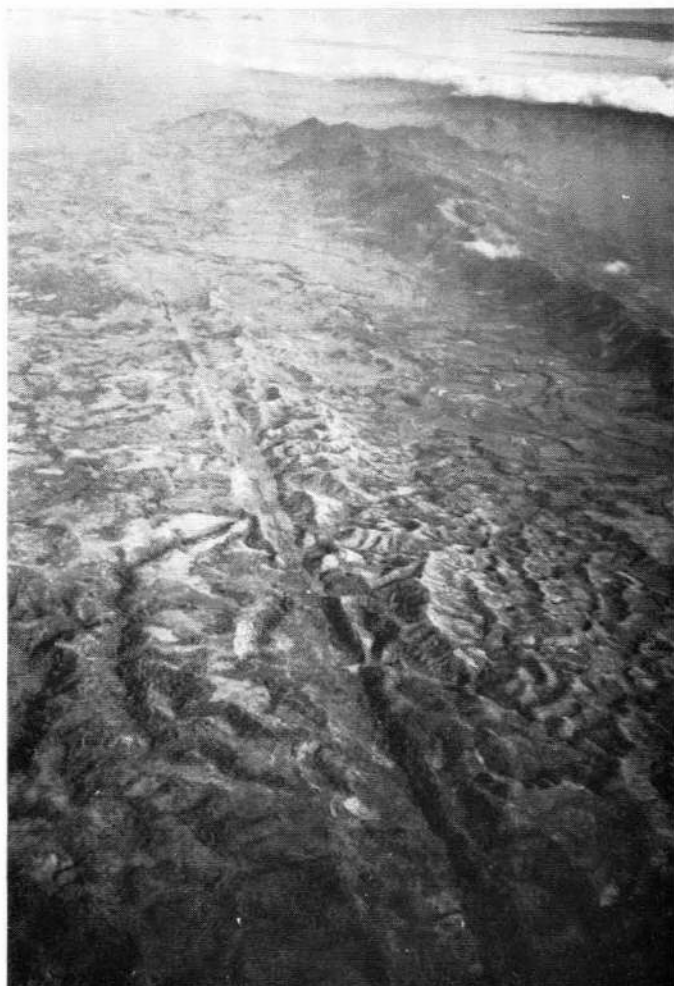
Fig. 22. Philippine Fault in northern Leyte: master strike-slip fault of more than 1000 km length. Note tendency of streams to erode along the fault valley. No historic displacements are known along this segment of the fault, but a 3.2 m displacement occurred on the fault 400 km further north, during the 1973 Ragay Gulf earthquake (Morante and Allen, 1973)

Strike-slip faults. These involve primarily horizontal displacements. The fault planes are typically near vertical and are markedly linear in plan view, master faults of this type often appearing as linear 'scars' on aerial photographs (Figs 22 and 23).

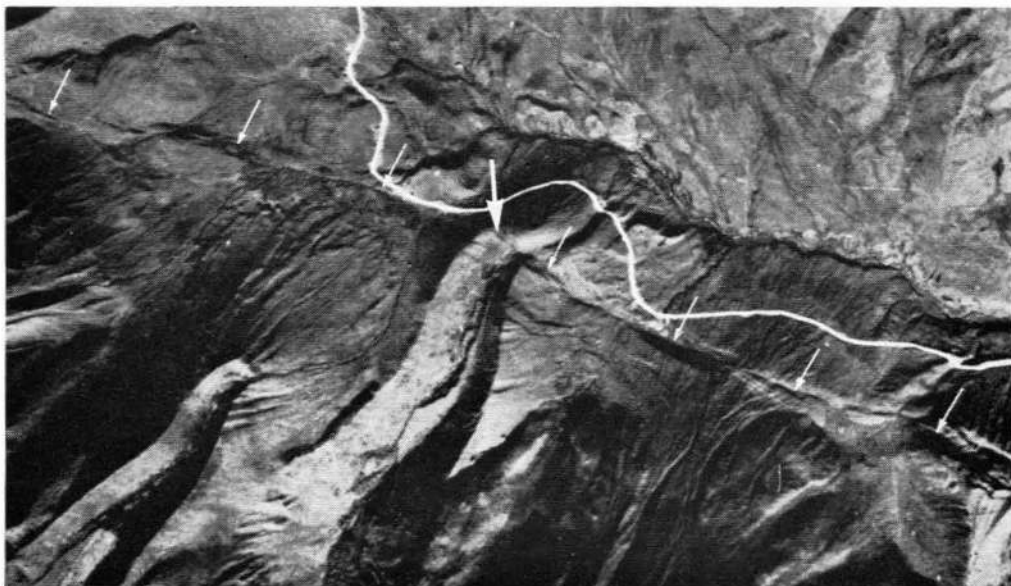
Fig. 23. Scarps (arrows) showing recent displacements on the Boconó Fault (strike-slip) in Merida Andes, Venezuela, a master fault of more than 500 km length which probably broke during the $M=8$ earthquake in 1812. Amounts of offset of 10 000-year-old glacial moraines (large arrow) suggest $M=8$ earthquakes and fault displacements occur every 200 years. Fault in photograph is on drainage divide between two major rivers, but lies within river valleys over most of its course, passing through several potential dam sites (see Fig. 26)

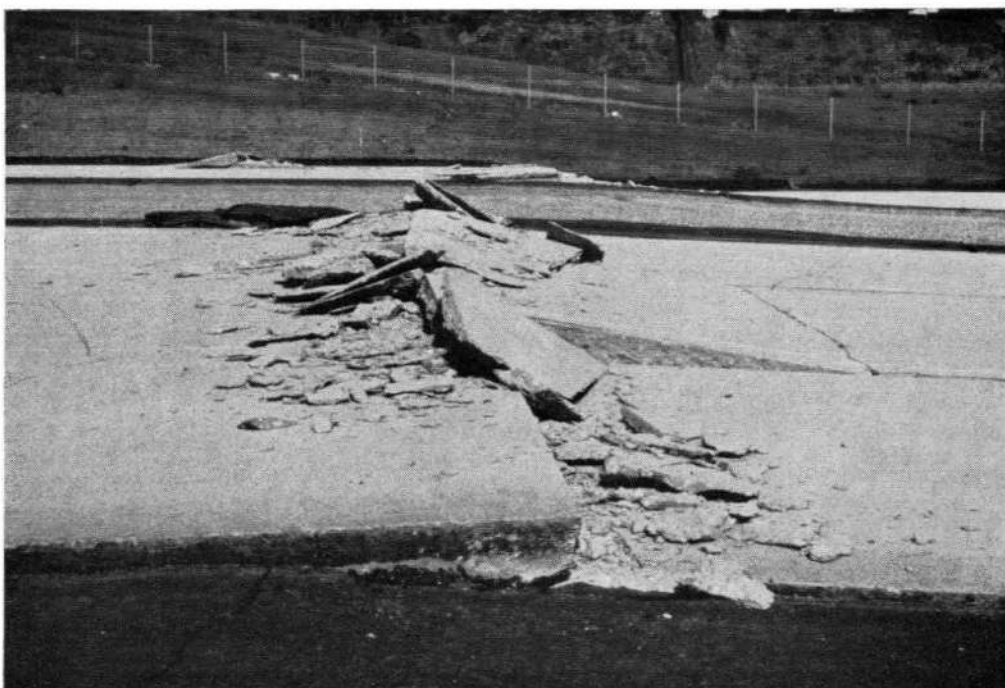
Fig. 24. 1971 San Fernando, California thrust fault break passing through concrete pavement showing buckling resulting from shortening of a distance between points on opposite sides

Thrust faults. These involve vertical displacements caused by horizontal compression. The distance between points on opposite sides of the fault decreases as a result of the displacement (Fig. 24). The fault planes tend to have a shallow inclination (dip) from the horizontal—typically 20–40°. Because of the shallow dip, thrust fault traces tend to be sinuous in plan view through hilly terrain. Many major mountain systems of the world are bounded by thrust faults, such as the Andes and Himalayas, and most of the world's great earthquakes have been caused by thrusting in the oceanic trenches where the ocean floor is being thrust beneath the continental edges. The great 1964 Alaska earthquake and the 1960 Chile earthquake are typical results of breaks on such fault systems.

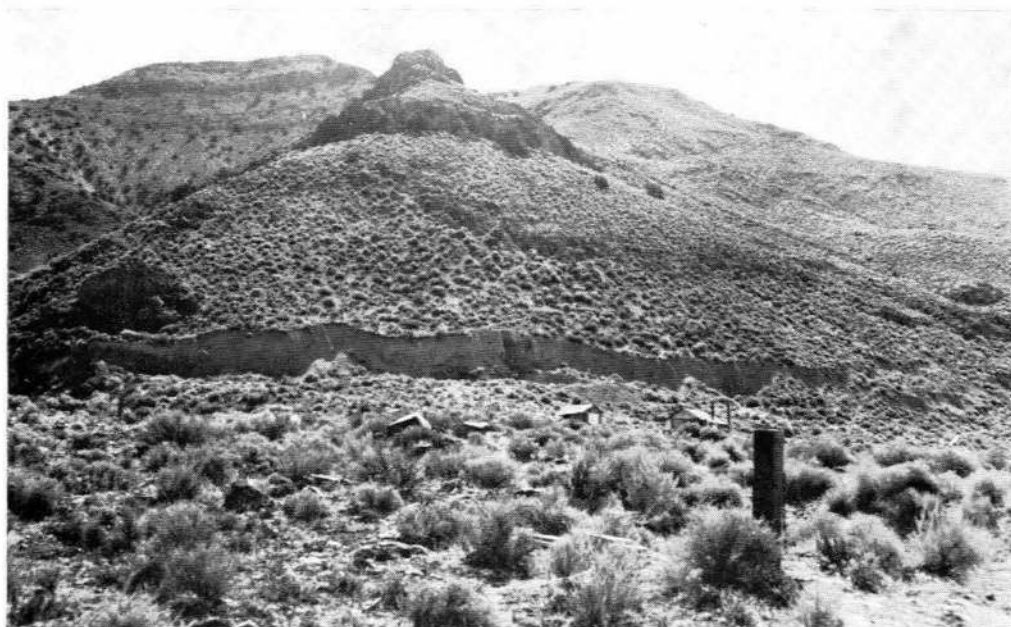
Fig. 25. 1963 photograph of 1915 break on the Pleasant Valley Fault (normal fault) Nevada. Fault scarp is exceptionally well preserved in the arid climate

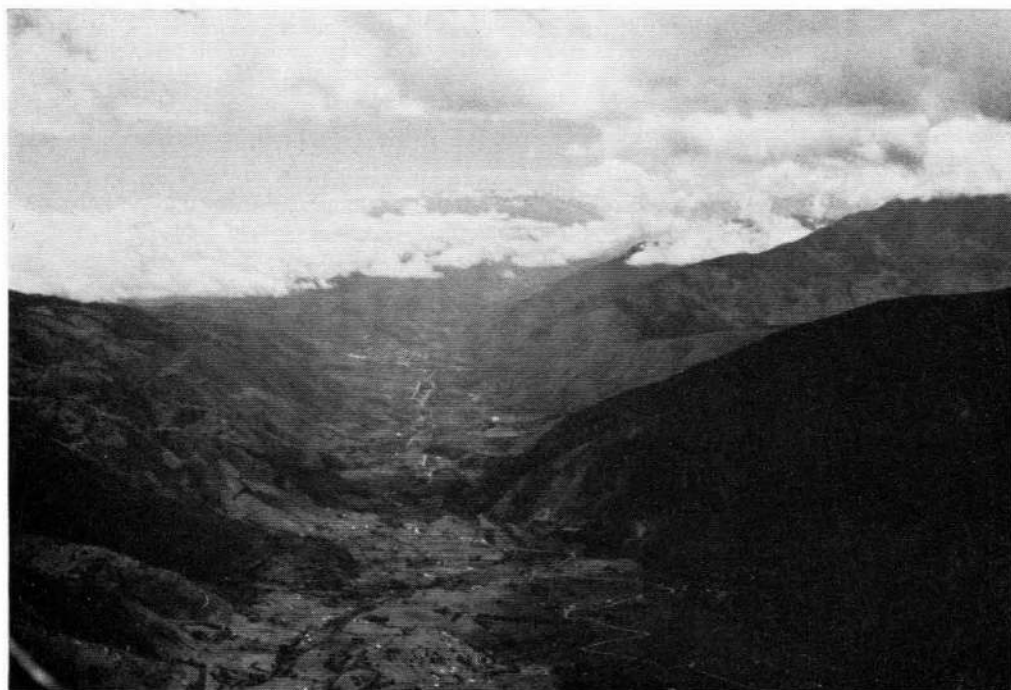
Fig. 26. Main rift valley of Boconó Fault, Venezuela (master strike-slip fault) with length of at least 500 km, looking northeast from Lagrita towards Merida in the far distance

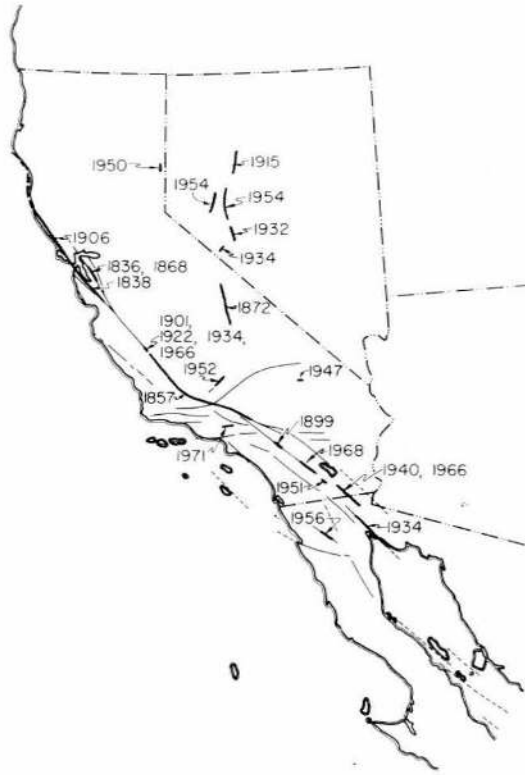
Fig. 27. San Andreas and associated fault zones in California, Nevada and northern Mexico. Zigzag lines show where surface of ground was broken during historic earthquakes and the dates of the breaks

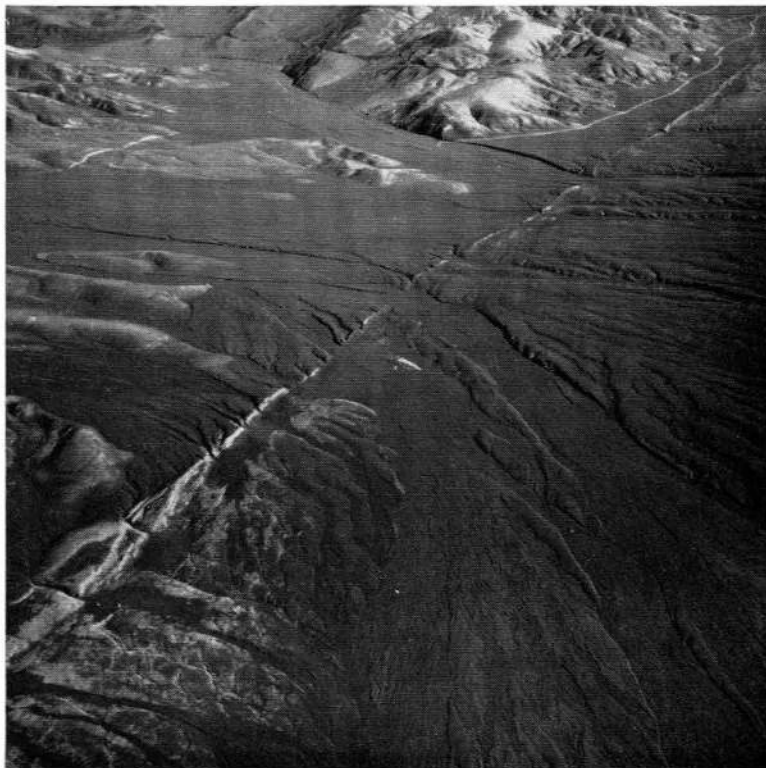
Fig. 29. Atacama Fault near Antofagasta, Chile. No historic breaks are recorded on this fault but geologic evidence that it has offset all but the youngest alluvium indicates conclusively that it is active

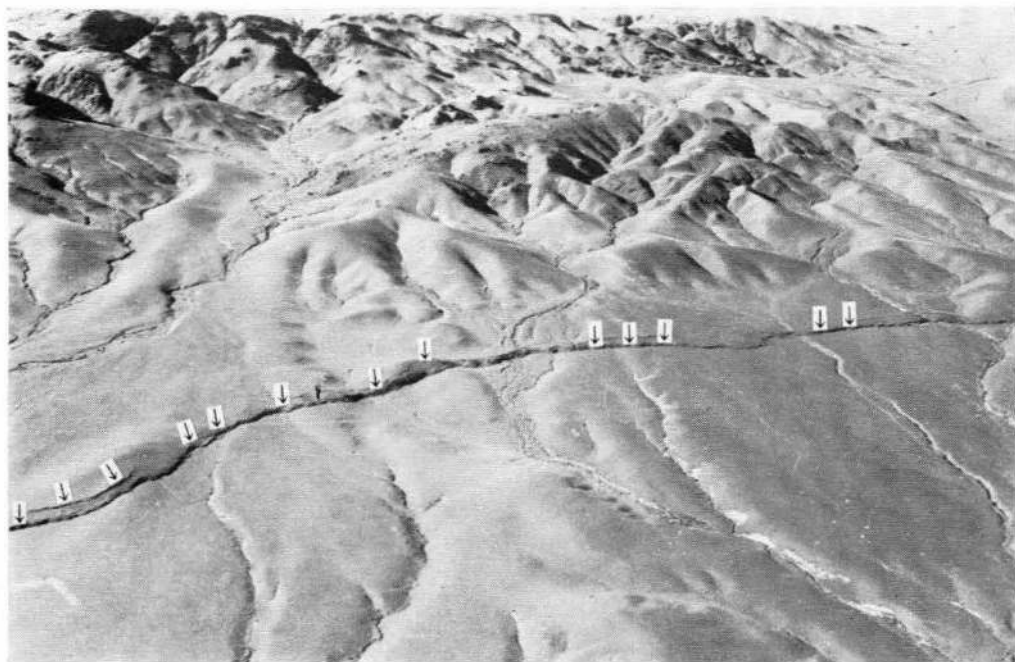
Fig. 30. Scarp (arrows) of 1957 Gobi-Altai earthquake ($M=8.3$) in Mongolia. Average fault break displacement in area of photograph was 5 m horizontal component and 5 m thrust component

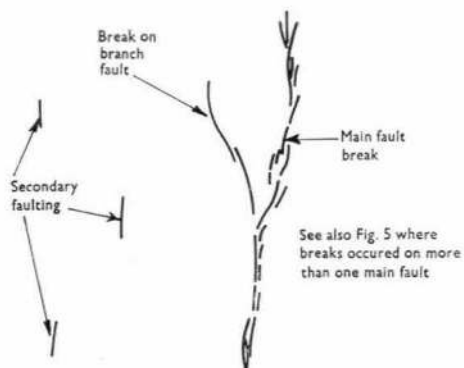
Fig. 31. Schematic relations among breaks on main, branch and secondary faults (after Bonilla, 1967)

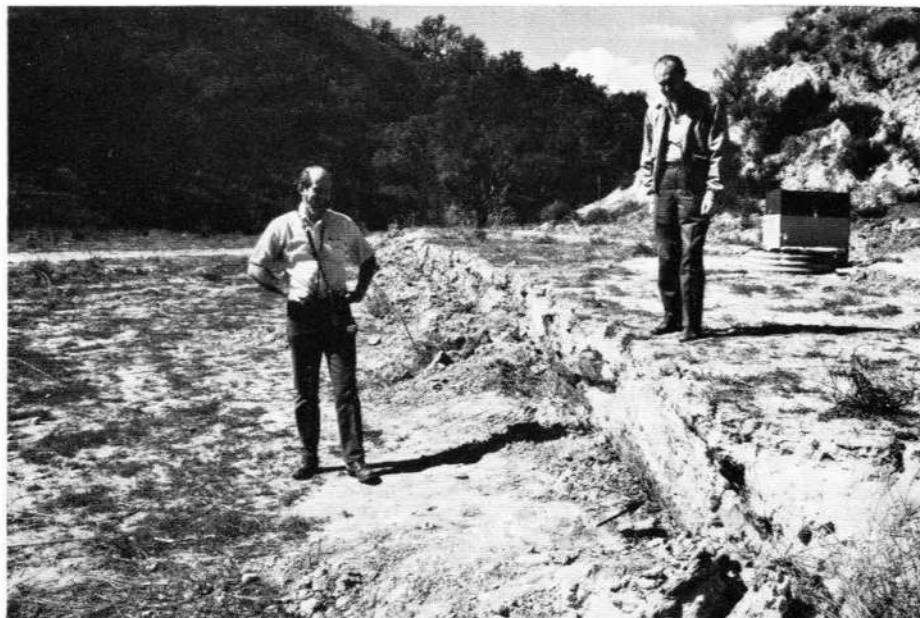
Fig. 32. Thrust fault that broke during 1971 San Fernando, California earthquake ($M=6.4$). This is a secondary fault in the upthrown block, about 1 km from main fault break. Fault plane dips about 60° with the horizontal (black arrow in lower right hand corner)

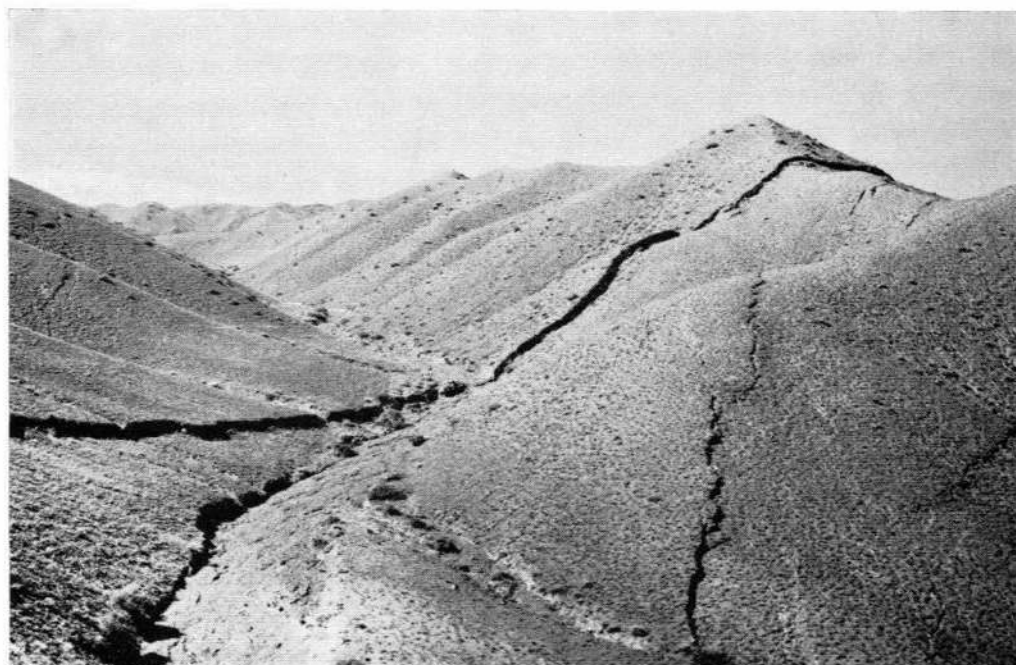
Fig. 33. Break on a secondary normal fault with a displacement of about 1.0 m during the 1957 Gobi-Altai earthquake, Mongolia ($M=8.3$). Several branch faults are broken on the downthrown block

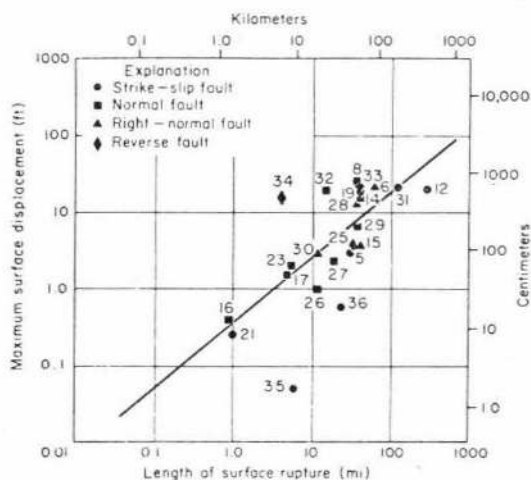
Fig. 34. Rough correlation between length of break and maximum relative displacement of ground on opposite sides (after Bonilla, 1970; numbers on chart refer to individual faults in the Bonilla tabulation)

The displacements have ranged from only a few millimetres to a maximum of the order of 10 m. The largest fault displacement known during a single earthquake is about 11 m, which was the vertical displacement on the Chedrang fault reported by Oldham (1899) at the time of the 1897 Assam earthquake ($M=8.7$). The largest corresponding horizontal displacement is 8.8 m, measured at the Bogdo Fault after the great 1957 Mongolian earthquake ($M=8.3$) (Florensov and Solonenko, 1963). Still larger movements have been associated with regional deformation during large earthquakes, such as changes of elevation of more than 14 m at the 1899 Alaskan earthquake ($M=8.5$) (Tarr and Martin, 1912), but the maximum observed displacements across discrete fault lines are believed to be those above. There is no reason to think that they will not be exceeded as more intensive observations are made in the future, although the fact that earthquakes appear to have a maximum magnitude of about 8.9 implies that there is also an upper limit to the amount of fault displacement that is credible during a single earthquake.
