Potentially active faults in dam foundations

J. L. SHERARD,* L. S. CLUFF† and C. R. ALLEN‡

The Paper contains information on existing dams founded on active faults, a summary of pertinent lessons learned from study of historic fault breaks and fault mechanisms, recommended practice for evaluation of active faults, and opinions concerning design of dams on active faults. While a dam site with an active fault should be avoided if possible, if a reservoir is vitally needed and a better site is not available, it is reasonable practice to construct a conservatively designed embankment dam. Concrete dams on active faults, or near some major active faults, are not advisable. For evaluation of fault activity, geological studies usually must be carried a considerable distance from the dam site, a departure from recent past practice. Experience of the last few years with many fault studies indicates that thorough geological investigations with modern techniques will usually provide sufficient evidence to allow a judgement on the activity or inactivity of a fault.

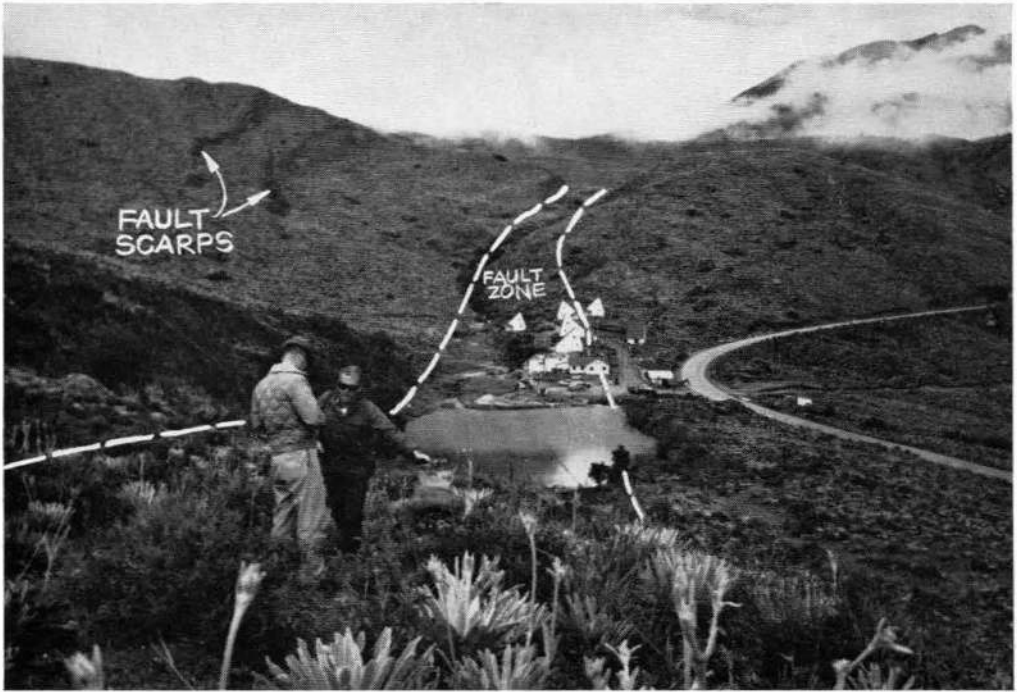
Fig. 36. A typical sag pond in closed depression along the Boconó Fault in Venezuela, a 'master' (strike-slip) active fault. Note ancient scarps of breaks on secondary faults on hillside to left of main fault trace. Note also notch in ridge line in far distance, a common manifestation of highly active faults

Most of these surface features, which are usually first identified on air photos, can also have other geological origins. For example, outcrops of hard rock beds can create linear ridges very similar in appearance to fault scarps, but the difference can be readily determined from field studies. Similarly, closed depressions and ponds are sometimes created along lineaments by limestone solution. Except for limestone solution, however, there are very few actions of nature except recurrently moving faults which create closed surface depressions more rapidly than they are filled in by deposition (Fig. 36). Closed depressions are very common on active strike-slip and normal faults, and occasionally are found along thrust faults.

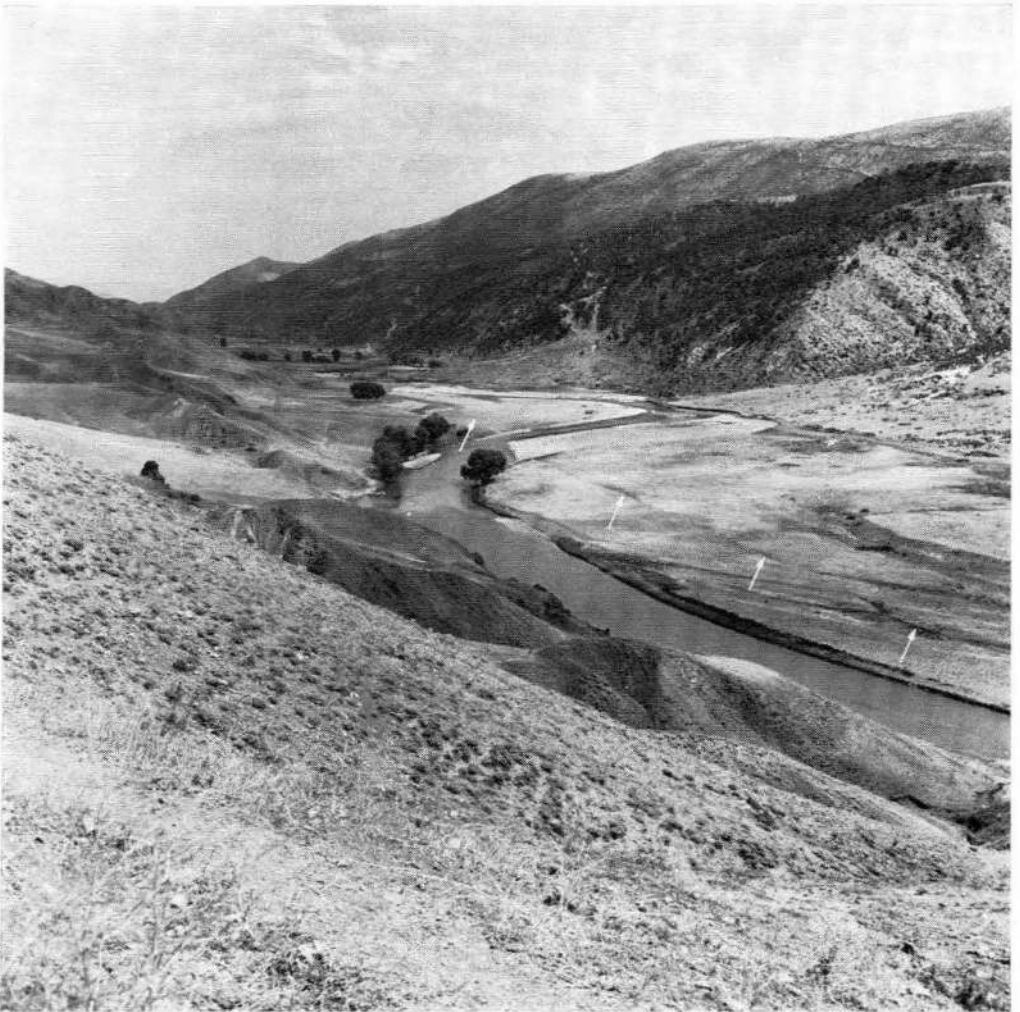
Fig. 37. Major river valley eroded along an active strike-slip fault, typical situation at many dam sites: Soganli River Canyon, Turkey, following the North Anatolian Fault. The four white arrows indicate the remnant of the last fault break during the 1944 Bolu earthquake ($M=7.6$). The photograph was taken 25 years after the last fault break. The fault is recognizable because of a subtle scarp which remains in the flood plain and the fact that the fault passing up through the river alluvium is evidently acting as a groundwater barrier. The last movement on the fault was predominantly strike-slip and about 1.5 m

Groundwater barriers in alluvium are a peculiar phenomenon of active faults. For reasons not well understood faults passing through alluvium commonly become less pervious than the adjacent alluvium by inclusion of soil fines. The resultant higher ground water table on one side of the fault commonly causes a different type of vegetation. Occasionally lines of trees grow along the line of the fault, perhaps because of the different soil along the fault as well as the higher ground water. Figure 37 shows an example (taken about 25 years after the last displacement) of an active fault trace in recent river alluvium identified both because it is a groundwater barrier and because a trace of scarp remains.

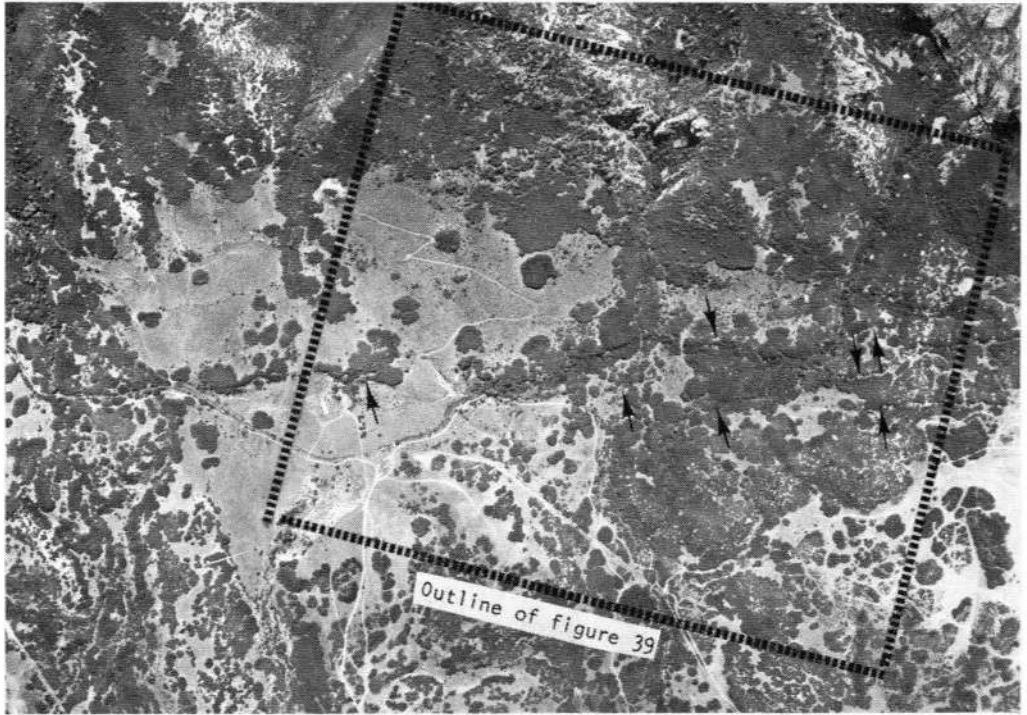
Fig. 38. Conventional air photograph showing a section of the main Wasatch Fault in central Utah, a 'master' normal fault which has not broken in historic time but is obviously active from much geologic evidence. The fault is shown by the black arrows (after Cluff and Slemmons, 1972)

Figures 38 and 39 illustrate the effectiveness of low sun angle photography during studies of the major active (normal) fault which bounds the west edge of the Wasatch Mountains, at a

site near Salt Lake City, Utah. Fig. 38 is a conventional vertical photograph of a section of the fault. Fig. 39 is a vertical photograph of the area outlined in Fig. 38. Fig. 38 was taken at approximately midday. Fig. 39 was taken at approximately 09.00 h, catching longer shadows. The example of Figs 38 and 39 is not extreme. In some cases, ordinary photographs may show almost no evidence, whereas the faults stand out clearly on low sun angle photographs (Fig. 40).

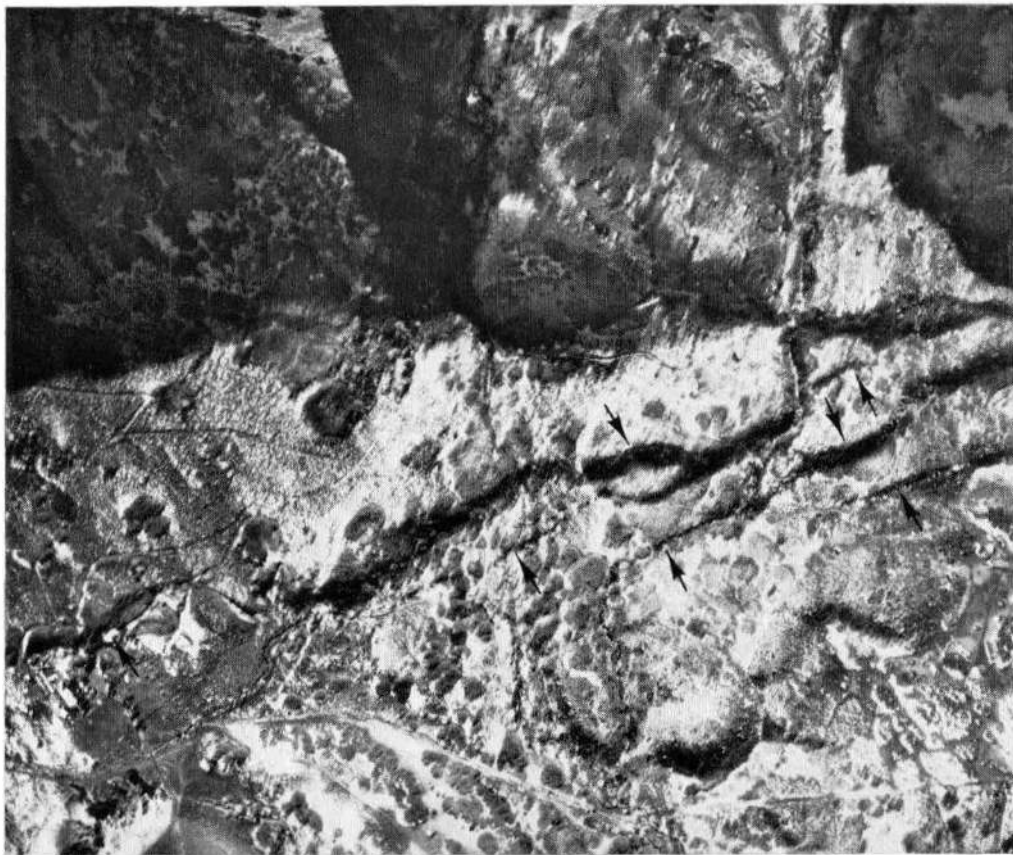
Fig. 39. A low-sun-angle photograph of the area included in the central square of Fig. 38, with the arrows in the same locations, showing how much more clearly the fault scarp can be seen (after Cluff and Slemmons, 1972)

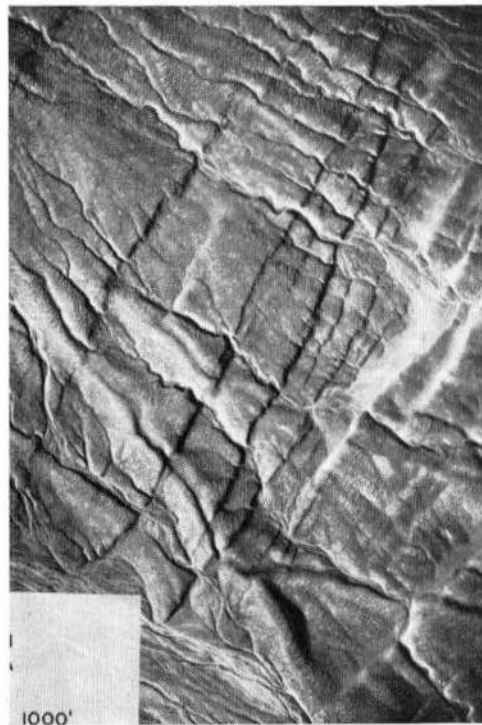
Fig. 40. Series of parallel active faults, Fish Lake Valley, California, about 500–1500 ft apart, showing the use of low-sun-angle photography. Some of these fault scarps are less than 50 cm high and would not be seen in photographs taken at midday

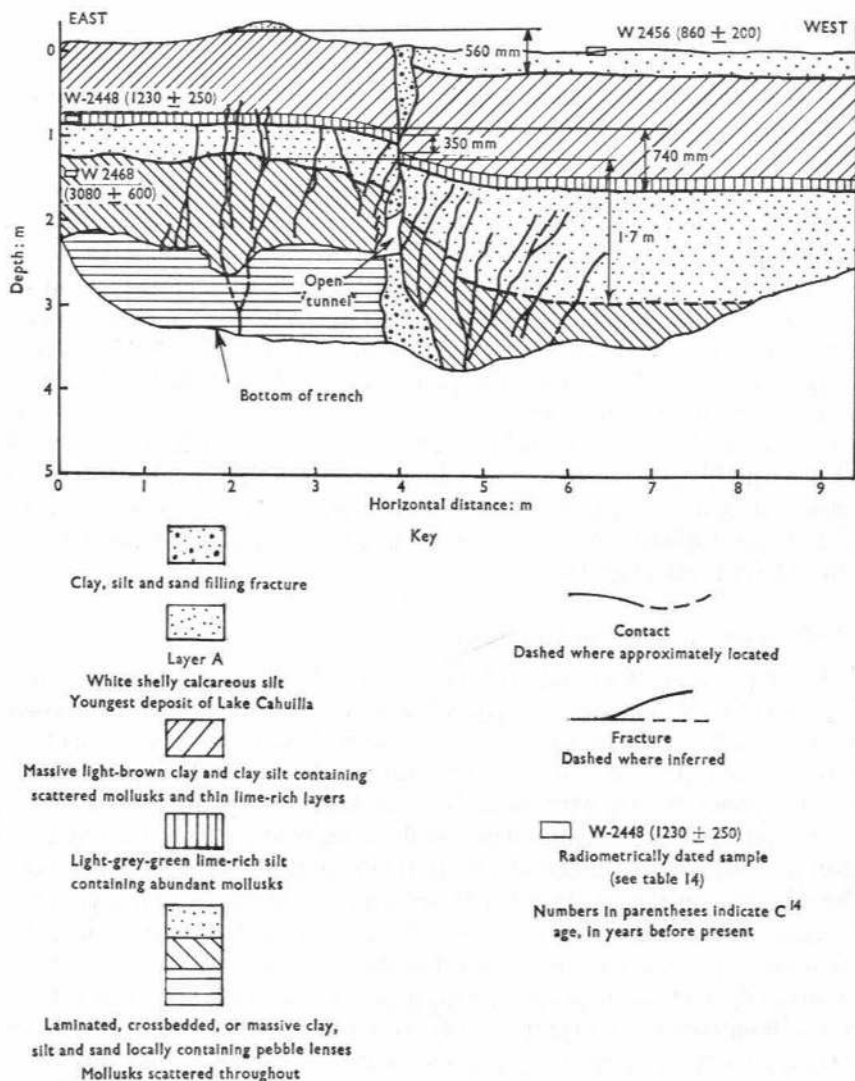
Fig. 41. Diagram from Clark *et al.* (1972) showing wall of trench excavated across one branch of the fault causing the 1968 Borrego Mountain earthquake in California ($M=6.4$). The 1968 earthquake is represented by the small displacement of the ground surface, and deeper and older strata (note carbon-14 ages) are offset by progressive amounts. The relationship suggests that earthquakes of effective magnitude of the 1968 event have occurred about once every 200 years for the past 3000 years

It is not uncommon in the walls of test trenches for clear evidence of several recurrent fault displacements to be exposed, as indicated by the fact that deeper, older deposits are offset greater amounts by the fault than the younger surface deposits. For example, in a current investigation in Nicaragua, not considered unusual, evidence has been found in a number of test trenches that surface deposits less than 10 000 years old have been displaced 2–5 times by faulting at different times. Similar situations have been the subject of several careful scientific investigations. An example is the study by Clark *et al.* (1972) of the Coyote Creek Fault (southern California) in which analysis of evidence seen in the walls of test trenches indicates recurrent displacements of recent geological surface deposits at intervals of 150–200 years during the past 3000 years (Fig. 41).

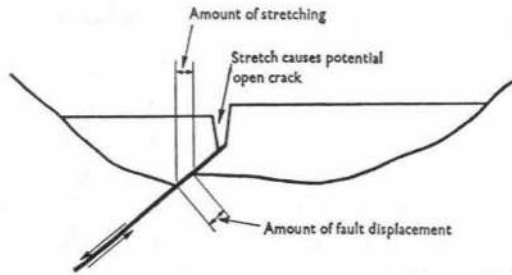
Fig. 42. Displacement of normal fault can stretch dam

First, the direction of fault displacement relative to the longitudinal dam axis can be as important as the magnitude of the displacement. Particularly, inclined normal faults striking parallel with the river whose displacement would probably tend to cause portions of the dam on opposite sides to be pulled apart could result in a wider initial crack than other types of fault movement (Fig. 42).

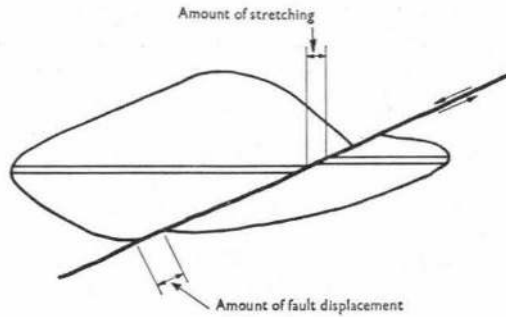
Fig. 43. Displacement of strike-slip fault can stretch dam

Displacements on thrust faults (and on some strike-slip faults) result in compression on the shearing surface. However, displacement on a vertical strike-slip fault which strikes at a small angle with the dam axis (Fig. 43) could also conceivably elongate the dam and cause potentially larger cracks than similar magnitudes of fault displacements in other directions.

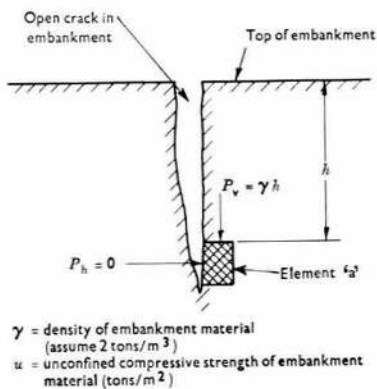
Crack can only remain open if $u > P_v = \gamma h$
 Maximum depth of open crack = $h_{max} = \frac{u}{\gamma}$
 For typical cohesionless soil: $0 \lesssim u < 5 \text{ tons/m}^2$ *
 and $h_{max} < 5/2 = 2.5 \text{ m}$
 For typical compacted clay cores: $20 < u < 40 \text{ tons/m}^2$
 and h_{max} generally ranges from 10 to 20 m
 * Assuming small cohesion from capillarity or small content of fines

Fig. 44. Theoretical maximum depths of open cracks in embankments

For an open crack to exist in an embankment, it is necessary for the embankment material comprising the wall of the crack to have sufficient unconfined compressive strength to prevent the crack from closing. The mechanics are shown in a simplified fashion in Fig. 44. If we assume an open crack in the embankment with approximate depth h , the vertical stress P_v existing on the horizontal plane forming the top of the small shaded element a must be approximately the weight of the column of overburden with height h and density γ . As the crack is open and there is no horizontal stress on the side of element a ($P_h=0$). Hence, the crack can only remain open if the unconfined compressive strength U of embankment element a exceeds P_v . Otherwise element a will fail in compression and the crack must close. As shown in Fig. 41, the maximum depth to which a crack can be sustained open without collapsing is $h_{max}=U/\gamma$. For cohesionless zones, $U=0$, and no crack can be sustained. For typical compacted fine-grained soils commonly employed for the impervious cores of earth dams, the unconfined compressive strength is generally in the range between 20 and 40 t/m², and γ is of the order of 2 t/m³. From these rough figures we can see that open cracks can be sustained in the cores of embankment dams to depths of the order of 10–20 m, below which the crack walls must collapse and close the crack, at least in the absence of internal fluid pressure in the crack. Hence, for high dams it is difficult to imagine that large open leakage channels could exist in the core at depths below the crest exceeding about 30 m.

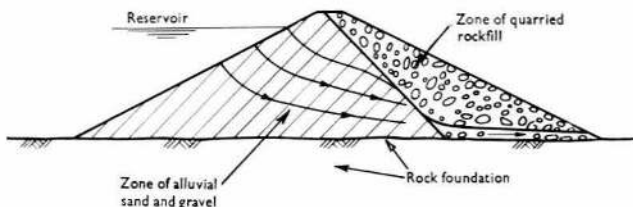
Fig. 45. Simplified illustrative example showing the two main elements of an embankment dam providing fundamental safety against foundation fault displacement

The dam which has fundamental, unquestionable safety against abrupt rupturing caused by foundation fault displacement has two main elements. First, the cohesionless transition zone and second, the coarser rockfill zone downstream. Fig. 45 shows a simplified illustrative example of an embankment dam which consists only of these two elements, with an upstream zone of alluvial sand and gravel and a downstream zone of rockfill, with no impervious core. The leakage through such a dam would be fairly high relative to other dams, but it would be a completely safe dam.

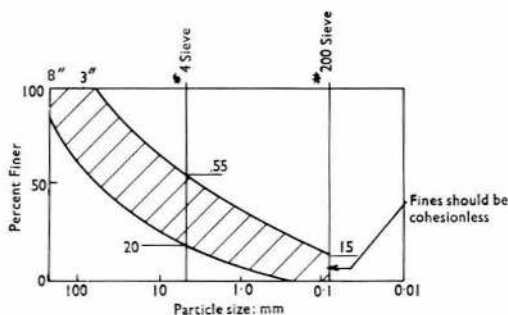
Fig. 46. Range of gradation of well-graded, coarse sand-gravel mixtures considered to be especially suitable without processing for thick transition zones

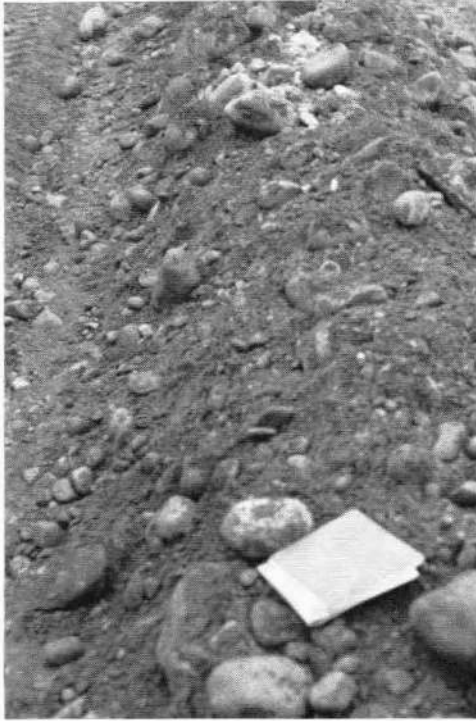
Fig. 47. Typical natural alluvial sand-gravel mixture meeting the gradation of Fig. 46. Thick zones of material of this general nature, used without processing, constitute good, self-healing and internally stable transitions
