# Quality of visual sewer inspection data: the need for a new coding system?!

Jojanneke Dirksen, Arjan van der Steen, Jeroen Langeveld, François Clemens

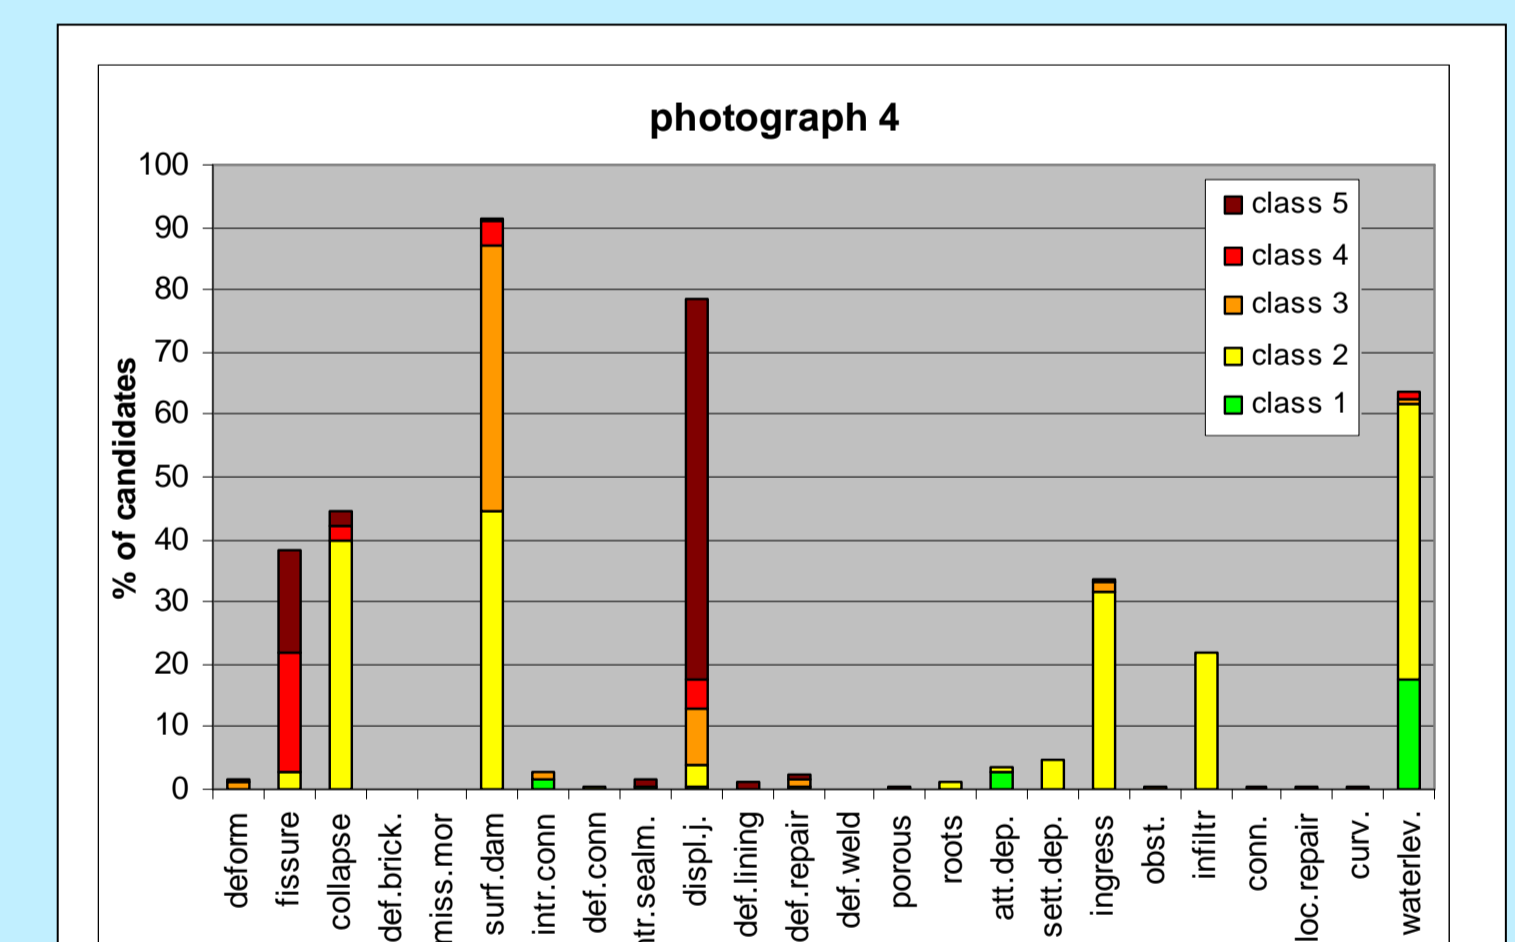
Photograph 4 shows a sewer with a crack on the soffit and bottom of the pipe. Two thirds of the candidates recognized this crack and described it as a fissure (36%), collapse (26%) or both (18%).
