Rail Surface Defect Detection and Analysis Using Multi-Channel Eddy Current Method Based Algorithm for Defect Evaluation

Keywords Rail surface defect · Eddy current testing · Natural defect · Defect sizing · Multi-channel eddy current equipment

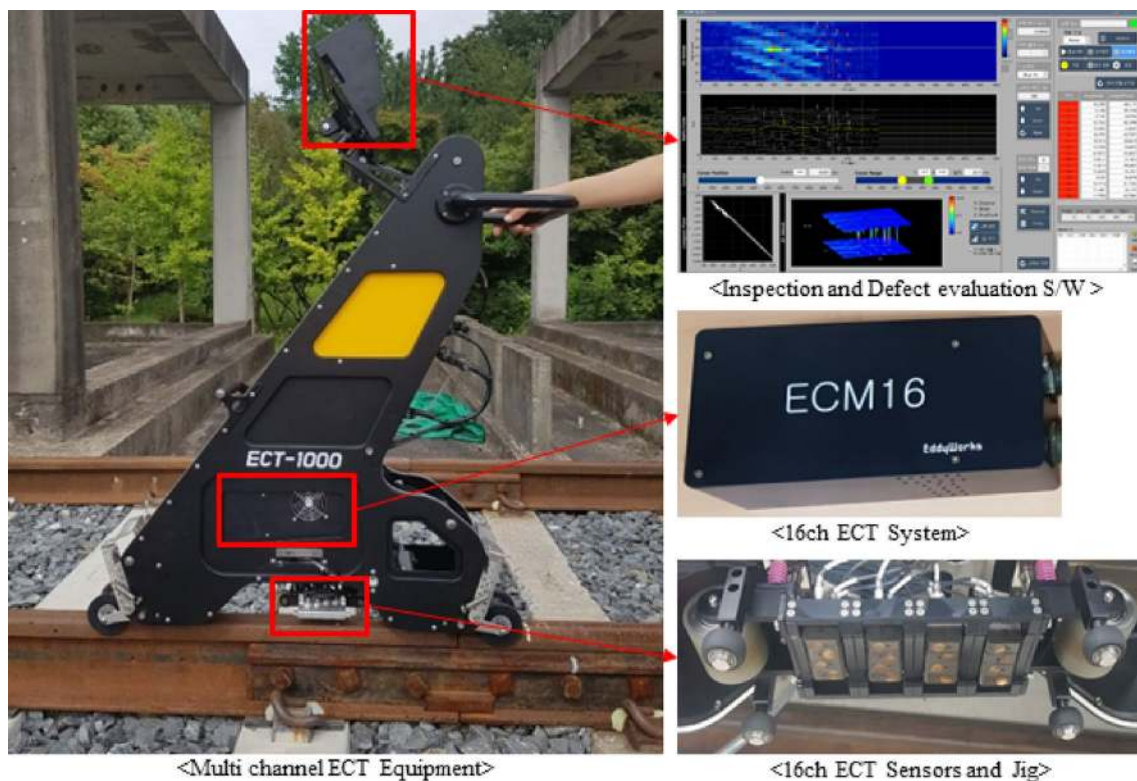
Fig. 1 Configuration of the multi-channel eddy current equipment

Figure 1 shows the multi-channel eddy current inspection equipment, which is placed on top of the rail and scans the rail surface as the operator pushes the equipment forward. The equipment is composed of the eddy current system, 16 channel sensor jig, inspection and analysis program, and main power system. The eddy current system inputs the voltage and frequency necessary for the operation of the sensors and performs processing and storage of the acquired signal and the encoder signal. The inspection and analysis program is composed of calibration, 2D, amplitude, Lissajous plane, 3D, and defect sizing. The 2D image, amplitude, and Lissajous plane are displayed in real-time during the inspection, and the location and approximate size of the defect can be identified. Accurate information on the defect can be obtained from the estimated defect length, width, and depth results through the 3D image and defect sizing, which utilize the location of defect detection and data after completion of the inspection. The 16 channel sensor jig has four wheels that act as a guide along the side of the rail for stability when the equipment is placed on top of the rail, and each sensor has a suspension system to maintain uniform lift-off when the equipment is placed on top of a nonuniform rail surface due to deterioration. The sensor arrangement is 4*4 and ceramic pads of the same 0.5 mm thickness were attached at the bottom of the sensors to prevent damage to the sensors. The main power system provides power to the eddy current system and display panel.

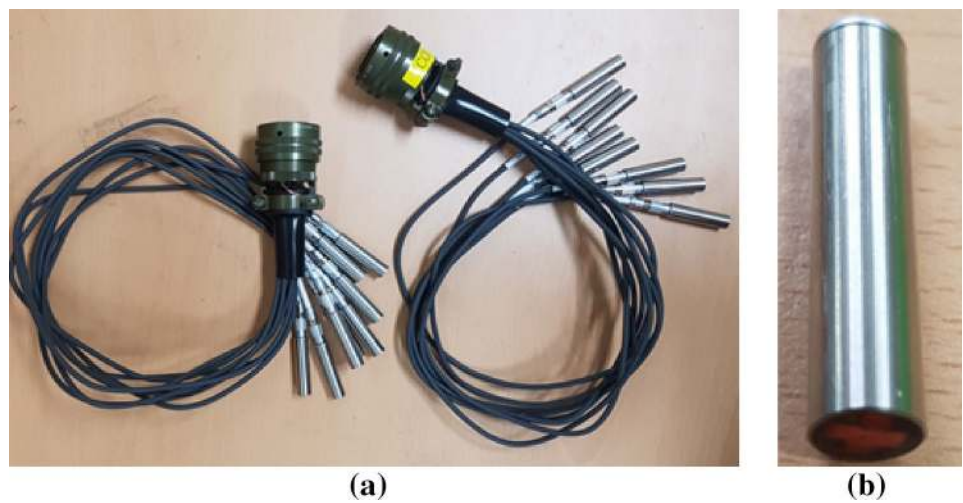
Fig. 2 Multi-channel eddy current sensor: **a** 16ch eddy current sensor and **b** plus (+) point sensor

Figure 2a shows the sensors of the eddy current inspection equipment. As can be seen in the figure, the sensors are divided into two groups with eight channels each and they are connected to the eddy current system. Each sensor was manufactured as connector types for convenient repair. Figure 2b shows the plus (+) point sensor, which is a differential sensor fabricated in a plus (+) shape where each layer is wound in a crisscrossing manner. The differential sensor is composed of two receiving sensors, and each received signal is simultaneously affected and cancelled out, resulting in the output signal level of 0. Hence, they are not significantly affected by lift-off and noise, and

defect detection in the circumferential and axial directions are possible [15, 16]. The sensors have an external diameter of 8 mm, wire diameter of 0.1 mm, total of four layers, operating frequency of 300 kHz, applied voltage of 7Vpp, and lift-off of 1 mm. Additionally, the intervals between the left and right sensors were 0.16 mm and the intervals between the forward and behind sensors were 3 mm.

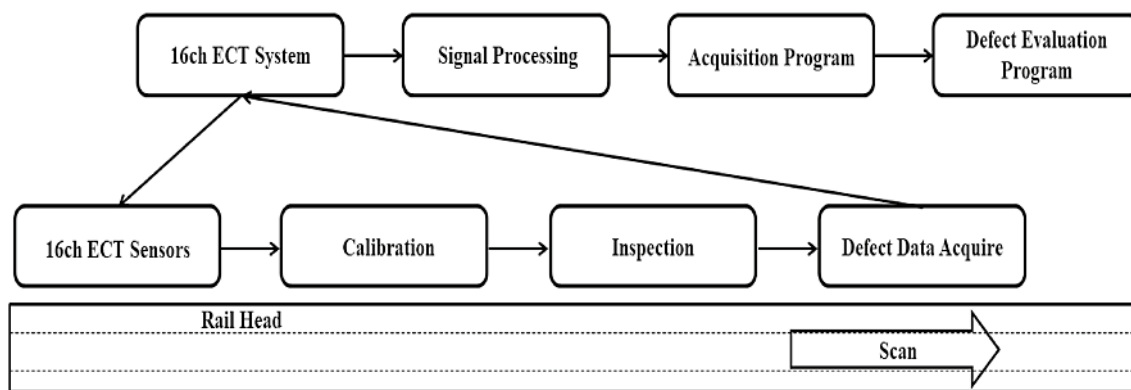
Fig. 3 Schematic of the ECT system

Figure 3 shows a schematic diagram of the process all the way to the defect evaluation using the data obtained from the eddy current system from scanning the rail. Excitation of the ECT sensor is carried out through the frequency and voltage inputted from the 16ch ECT system. The sensor

produces a magnetic field using the excitation, and after calibration to maintain uniform sensitivity, the target rail is scanned for inspection and data are acquired through the ECT system. The acquired raw data undergo signal processing to obtain information regarding defects using the 16ch signal, 2D image, and Lissajous plane, which appear in real time through the acquisition program. Also, the sizing of the defect is conducted including the length, width, and depth of the defect through the 3D image and defect evaluation algorithm for accurate defect analysis. Approximate sizing of defects during use is possible in the development equipment, and for precise analysis, it is possible through the developed defect evaluation algorithm program after defect detection is completed.

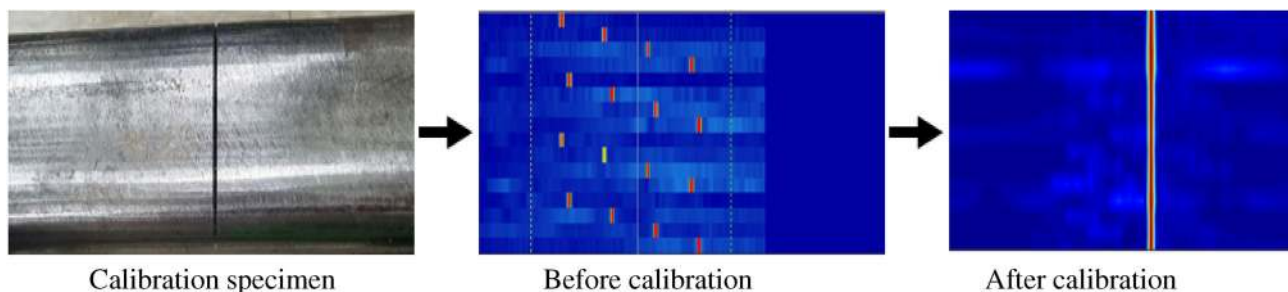
Fig. 4 Calibration method of 16ch ECT sensors

Figure 4 shows the calibration method of the 16ch eddy current sensor and a slit defect of 1 mm width and 3 mm depth was made cutting through in the direction transverse of the rail head surface. Before calibration, defects appear like the sensor arrangement, and since the plus point sensor is made by hand, the 16 resistors are not the same, so there is a difference in sensitivity. Therefore, by using the balancing and calibration functions in the program, the sensitivity

of the sensor is made the same. After calibration, it appears the same as the shape of the defect, and it can be seen that the sensitivity of the sensor is the same with the red line in the middle. Calibration test specimens of varying rail sizes (50 K, 60 K, UIC60) were prepared and data were recorded after calibration. Thus, calibration does not have to be performed for every inspection as the calibration data for the corresponding rail that are stored in advance can be loaded and used.

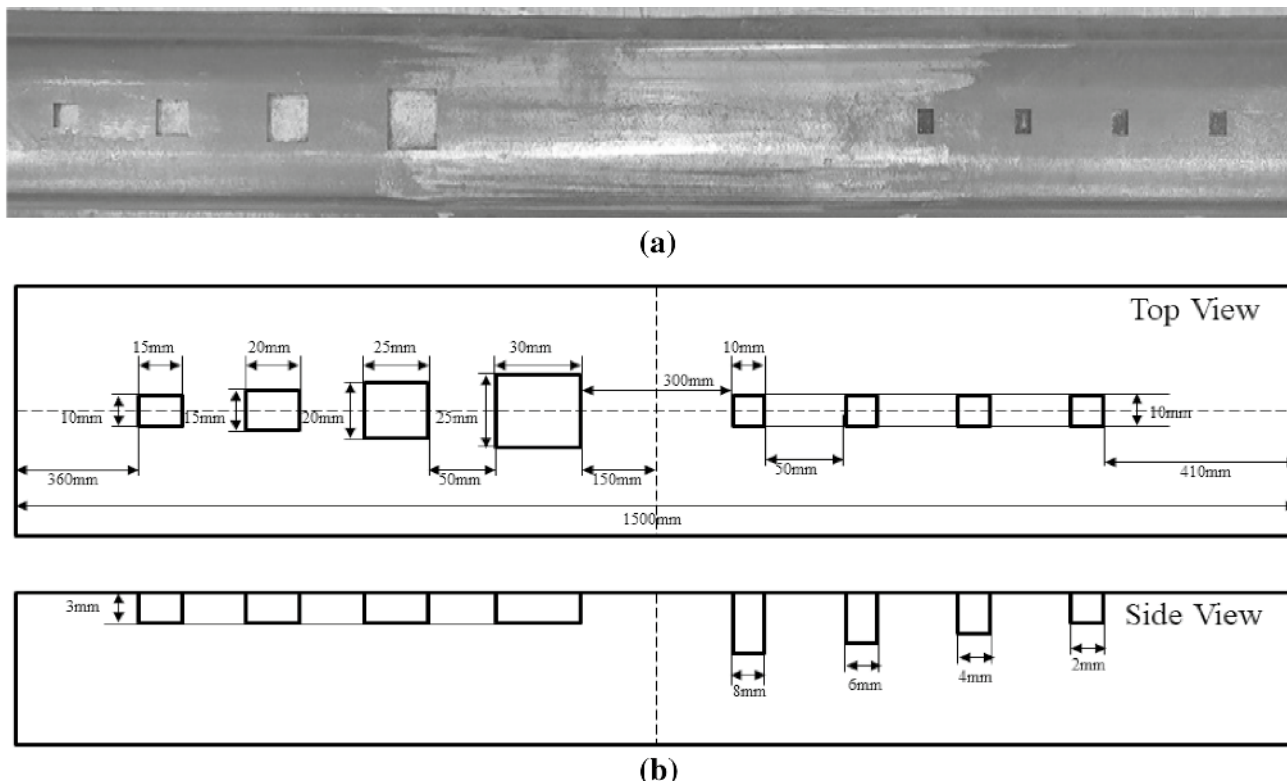
Fig. 5 Squats artificial defects (UIC60): **a** artificial defects picture and **b** defect size

In order to check the applicability of the defect evaluation algorithm, 8 artificial defects in the shape of a rectangle with different sizes and depths were manufactured on the UIC60 rail used in high-speed craft as shown in Fig. 5a. As shown in Fig. 5b, the four defects on the left had the same depth but varying vertical and horizontal dimensions while the four defects on the right had the same dimensions but varying depths that increases in 2 mm intervals. The defects were fabricated at locations at least 360 mm from the edges on both sides in order to prevent the edge effect. The defects were distanced 50 mm apart from each other for accurate analysis of the detection signal. The test specimens with

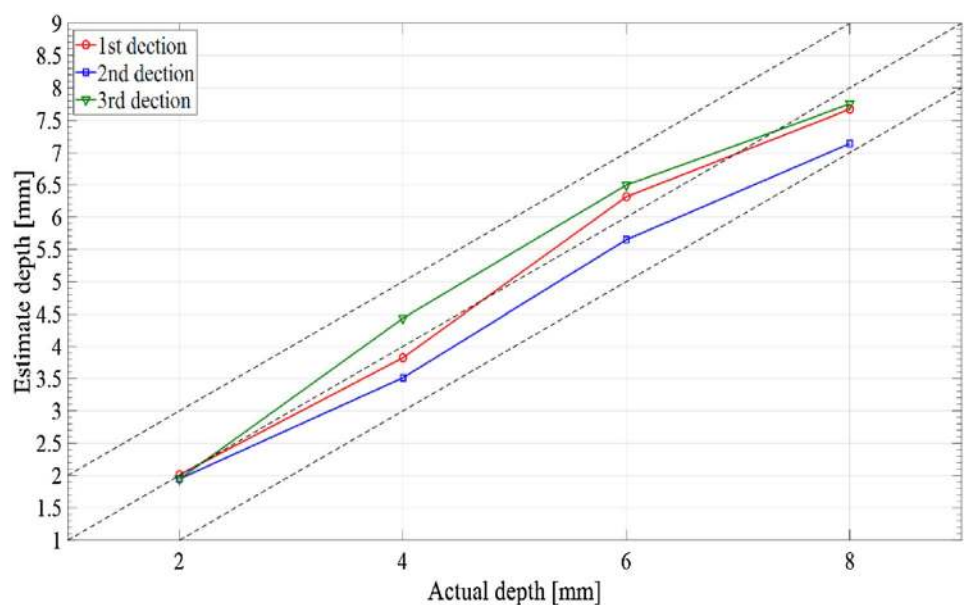
Fig. 8 Depth sizing

As shown in Fig. 8; Table 2, the average depth sizing results obtained from the three measurements were approximately 1.97, 3.92, 6.15, and 7.52 mm, and the maximum errors were approximately +0.01 and -0.05 mm for 2 mm, +0.43 and -0.49 mm for 4 mm, +0.5 and -0.35 mm for 6 mm, and -0.86 mm for 8 mm. Also, the calculated error ranges for the average values were found to increase as the defect depth increased. Therefore, the estimated error range increases due to the decrease in sensitivity as the depth increases, and hence the maximum estimated depth was determined to be 8 mm for the developed equipment.

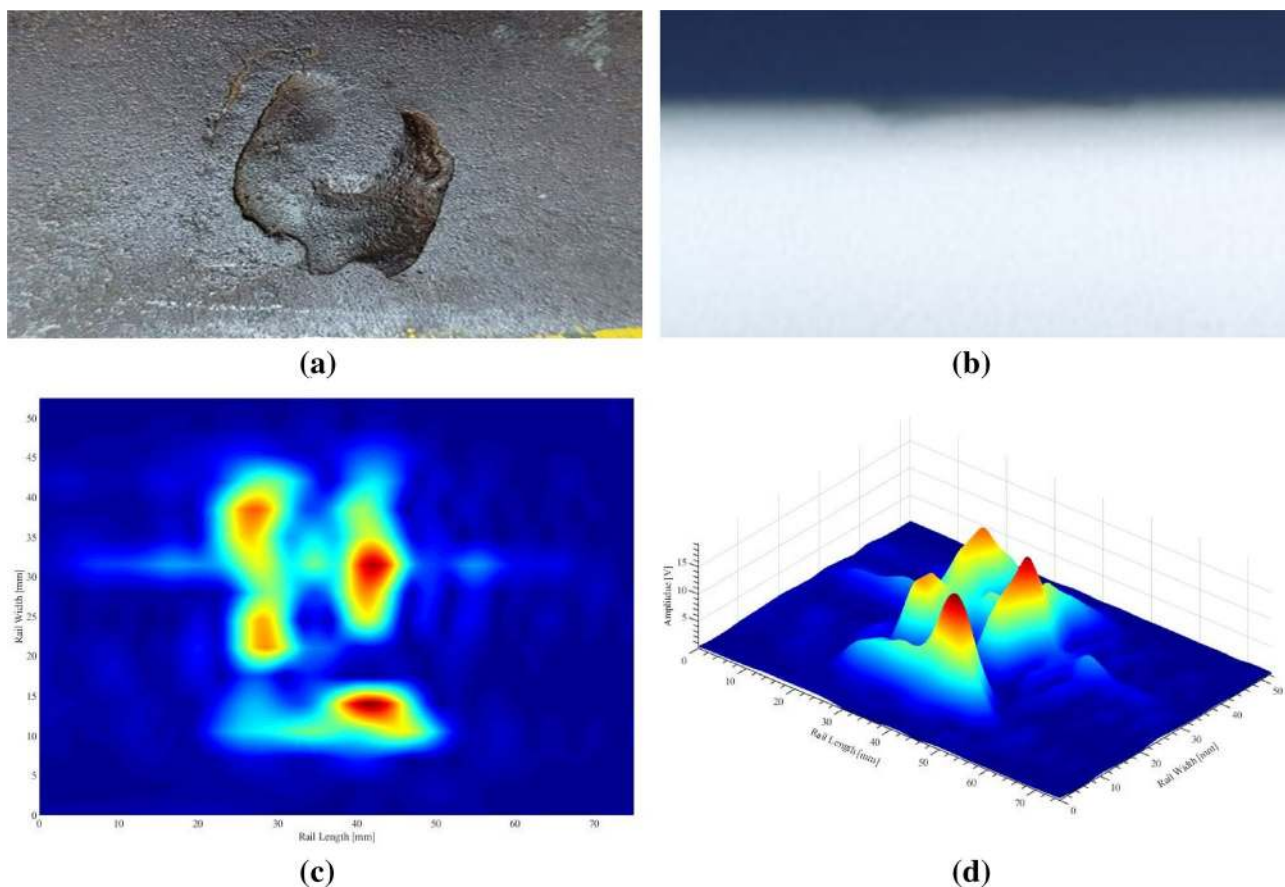
Fig. 10 Inspection of the second natural defect: **a** natural defect, **b** RT image, **c** 2D image, and **d** 3D image

approximate size of the defect and its location were ascertained from the 2D image of Fig. 9c; however, it was difficult to distinguish the cracks. The 3D image was obtained as shown in Fig. 9d to accurately identify the shape of the defect where the amplitude revealed that each end of the defect was deep with the lower part being the deepest. The upper crack was not visible but the lower crack was observed through the peak next to the area with the highest peak in the width direction. Table 3 shows a comparison of the actual defect size, RT size, and estimated size obtained from the developed equipment. The actual width of the defect was approximately 30 mm whereas it was measured as around 29 mm through the RT method and 27.99 mm using the eddy current inspection device; for the actual defect length, the RT method resulted in a measurement of around 14 mm, matching the actual length, while the measurement using the eddy current inspection device was around 13.44 mm. For the defect depth, the RT method resulted in a measurement of around 3 mm and the eddy current inspection device returned a value of around 4.09 mm. Except for the defect width, the error was roughly +1 mm. Figure 10a shows a shelling defect shaped like a horseshoe, and from the side view image of the defect in Fig. 10b it can be observed that

the left side is deeper and trapezoidal in shape. The rough shape and size of the defect could be inferred from the 2D and 3D image of Fig. 10c, d but because it was not similar to the actual shape of the defect, information on the defect through this 2D and 3D image was not sufficiently reliable. The reason why the 2D and 3D images do not match the actual defect is that the threshold was set so that only defects of 2 mm or larger can be read in the acquired signal. Therefore, defects with a depth smaller than 2 mm did not appear in the 2D and 3D images, so they did not match the shape of the actual defect. Table 4 shows the measurement results of the defect size. The RT and eddy current inspection equipment measurements for the length and width of the defect were approximately 1 mm and 2 mm greater than the actual measurements, respectively. With regard to the defect depth, the RT measurement was around 3 mm while

the eddy current inspection equipment measurement was around 2.1 mm. The error range of the eddy current inspection equipment was thus measured to be about ± 2 mm. Figure 11a shows a shelling defect in the shape of an X on the rail surface, and the side view of Fig. 11b was similar in shape to that of Fig. 10b. The 2D image of Fig. 11c also showed an X shape, similar to that of the actual defect shape. In addition, it was confirmed that there were additional defects below the defect center. In Fig. 11d, when the depth of the defect is compared, as can be seen from the RT image of Fig. 11b, the amplitude at the bottom of the defect in the left width direction is the highest, so it can be seen that it is deeper than other parts. Comparing the defect length measurement results in relation to the actual defect length in Table 5, the RT measurement was around 22 mm and the eddy current inspection equipment measurement was around 22.12 mm. For the width, the RT measurement was around 29 mm and the eddy current inspection equipment measurement was around 28.31 mm. The eddy current inspection equipment measurement was closer to the actual length compared to the RT measurement result. With regard to the defect depth, the RT measurement was about 2 mm and the eddy current inspection equipment measurement was about 2.57 mm. The measurement results of the eddy current inspection equipment for the three natural defects showed that the error range was largest for the width and the

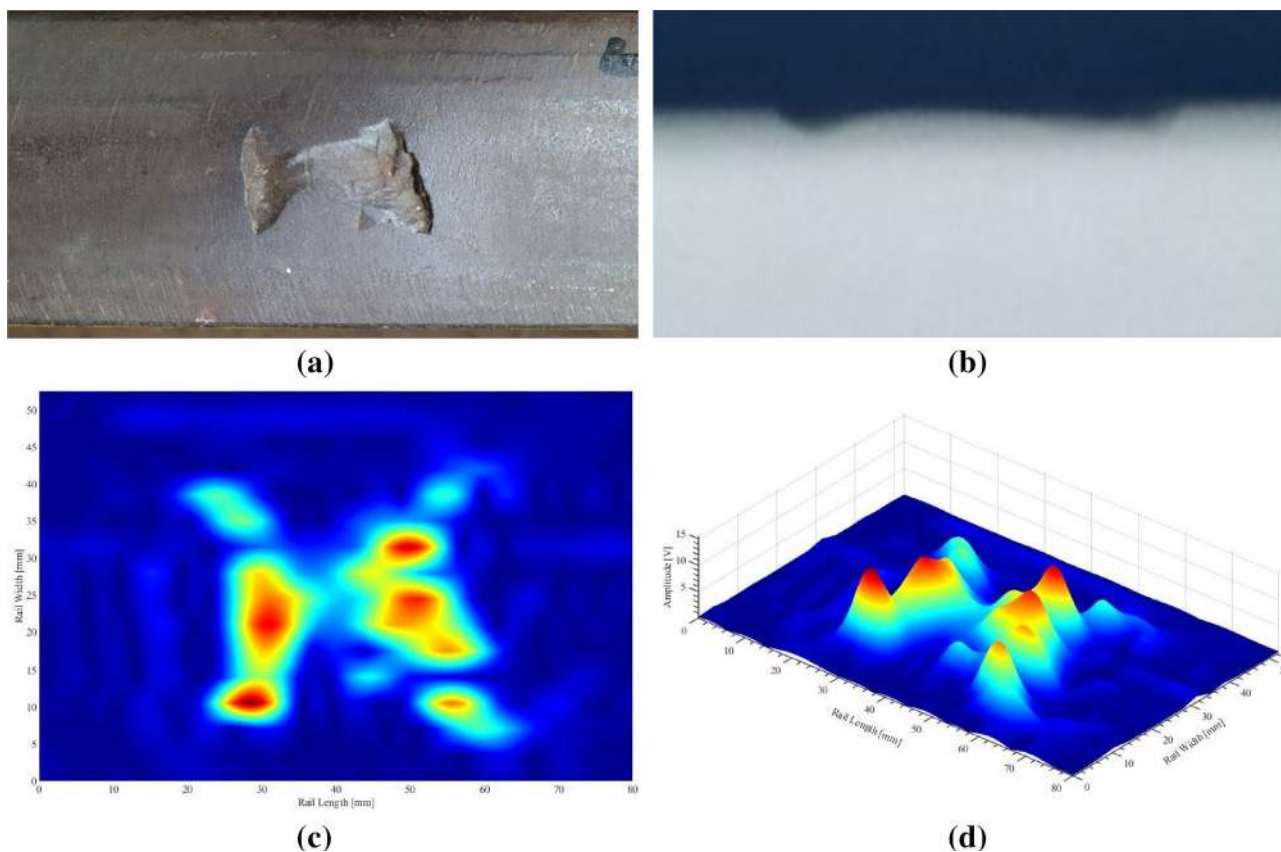
Fig. 11 Inspection of the third natural defect: a natural defect, b RT image, c 2D image, and d 3D image

error range of maximum + 1 mm and minimum + 0.31 mm for the length were measured excluding the defect of Fig. 11a. The error range of maximum + 1.09 mm and minimum + 0.57 mm was measured for the depth.

method results and eddy current inspection equipment results were compared with each other. For the width, the error range of the eddy current inspection equipment was around + 2 mm excluding the defect of Fig. 11a while the error range was within around + 0.5 mm excluding the defect of Fig. 10a. For the depth, the error range was at the most around + 1 mm, in contrast to the RT measurement results. The feasibility for practical use was determined using the maximum error range of the defect and the accuracy of the 2D and 3D images based on the natural defect inspection results. The developed equipment was developed to avoid dependence on overseas rail defect detection equipment, and it is equipment that prioritizes user convenience through repeated field application experiments.
