# **Red River Waterway, Lock and Dam No. 4**

## **Report 2**

## **Navigation Alignment Conditions**

## **Hydraulic Model Investigation**

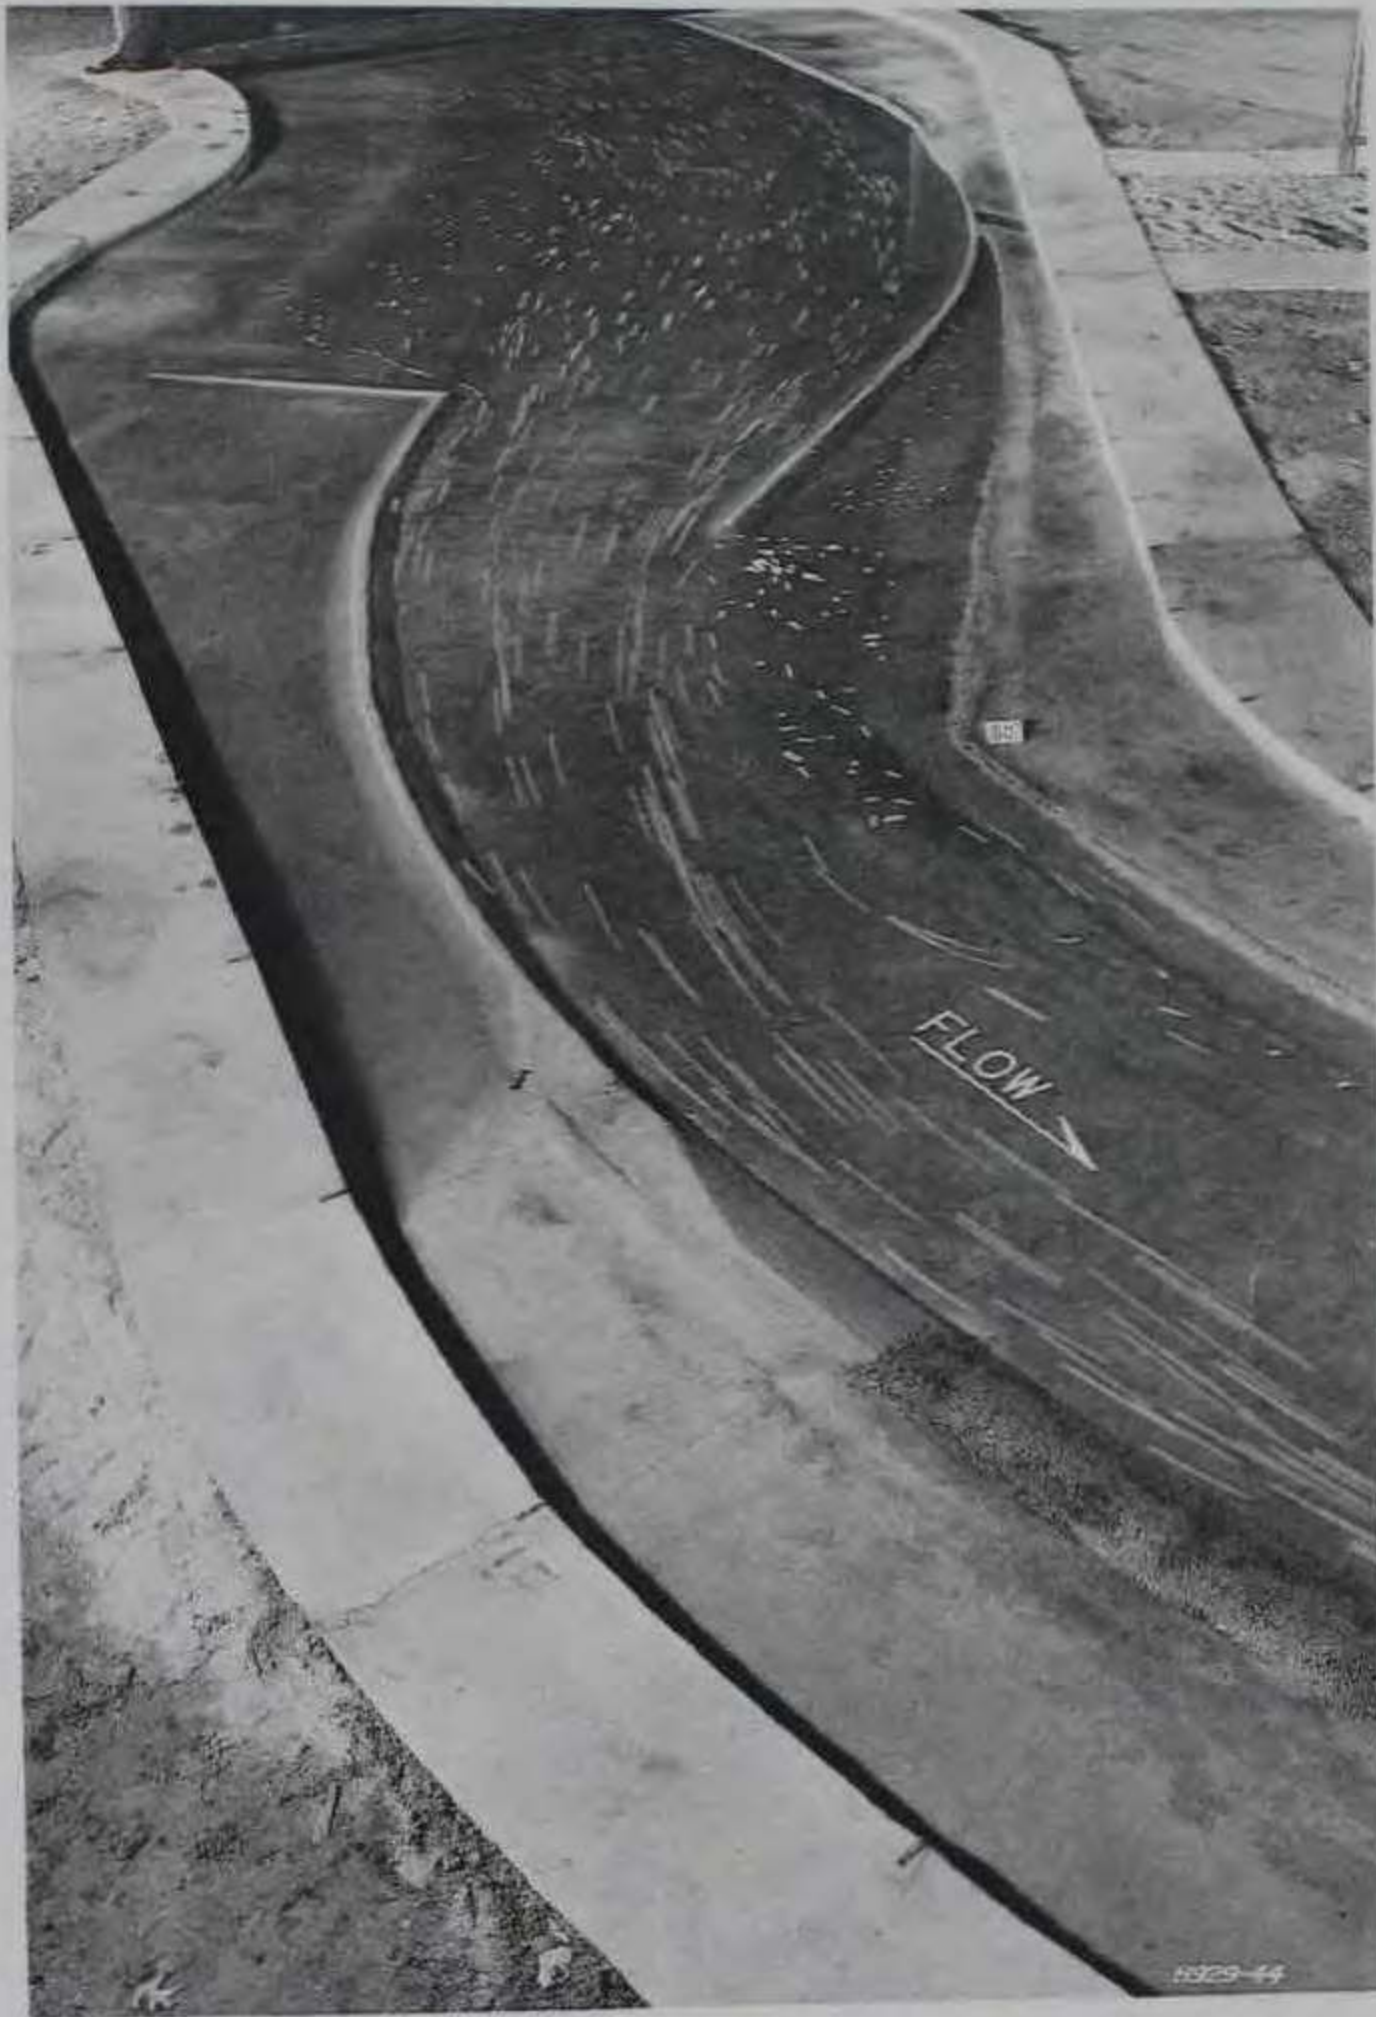
Photo 1. Plan B, looking upstream, discharge 60,000 cfs. Confetti showing surface current patterns entering and through Piermont cutoff

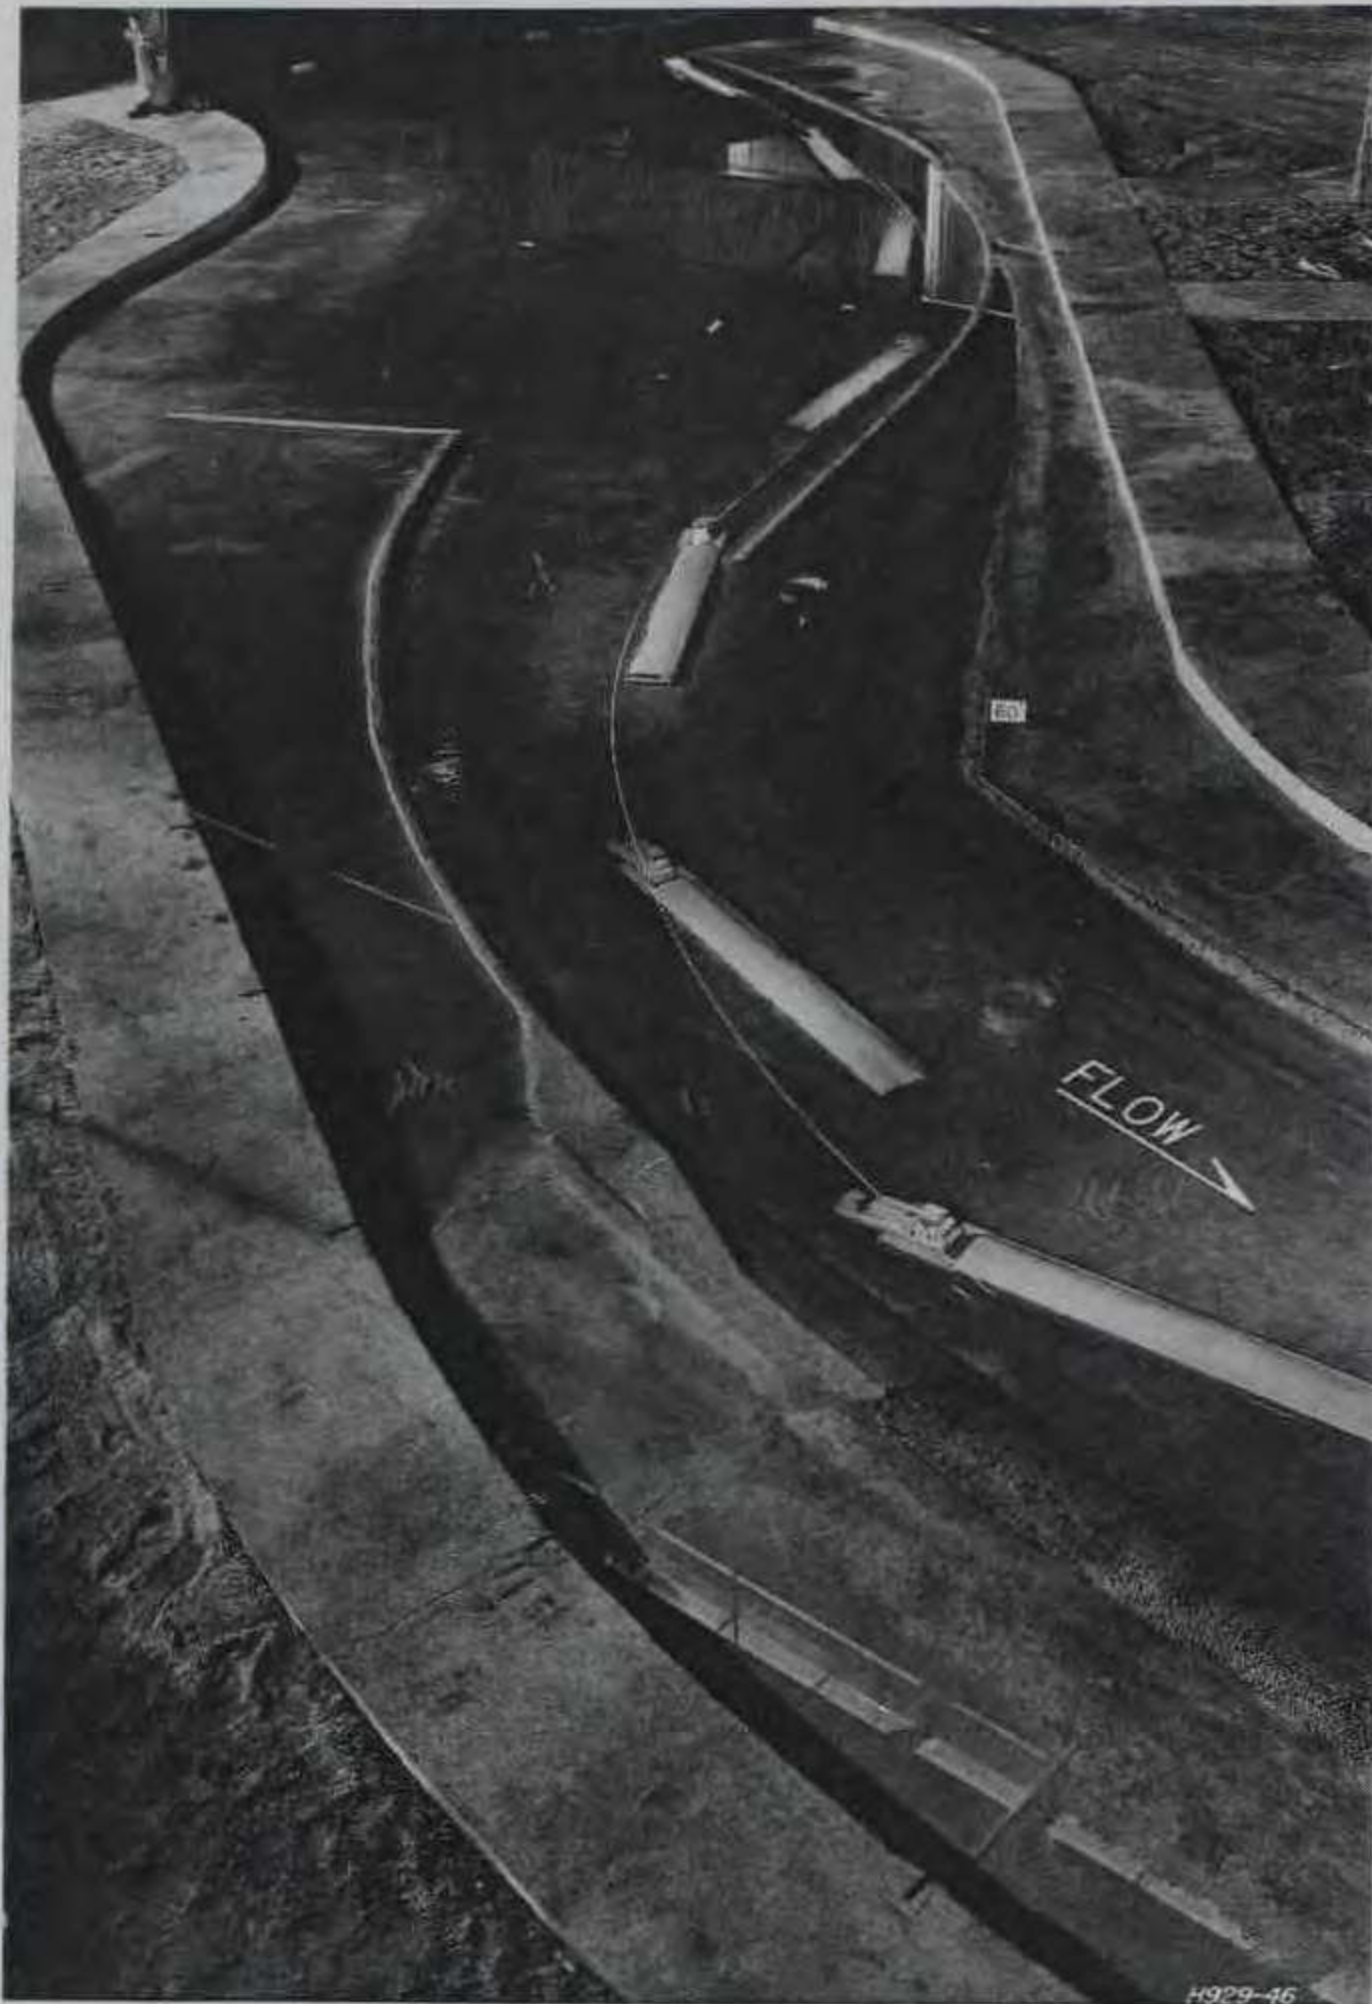
Photo 4. Plan B, looking upstream, discharge 60,000 cfs. Path of down-bound tow entering Piermont cutoff. Note tendency for tow to be confined against right descending bank

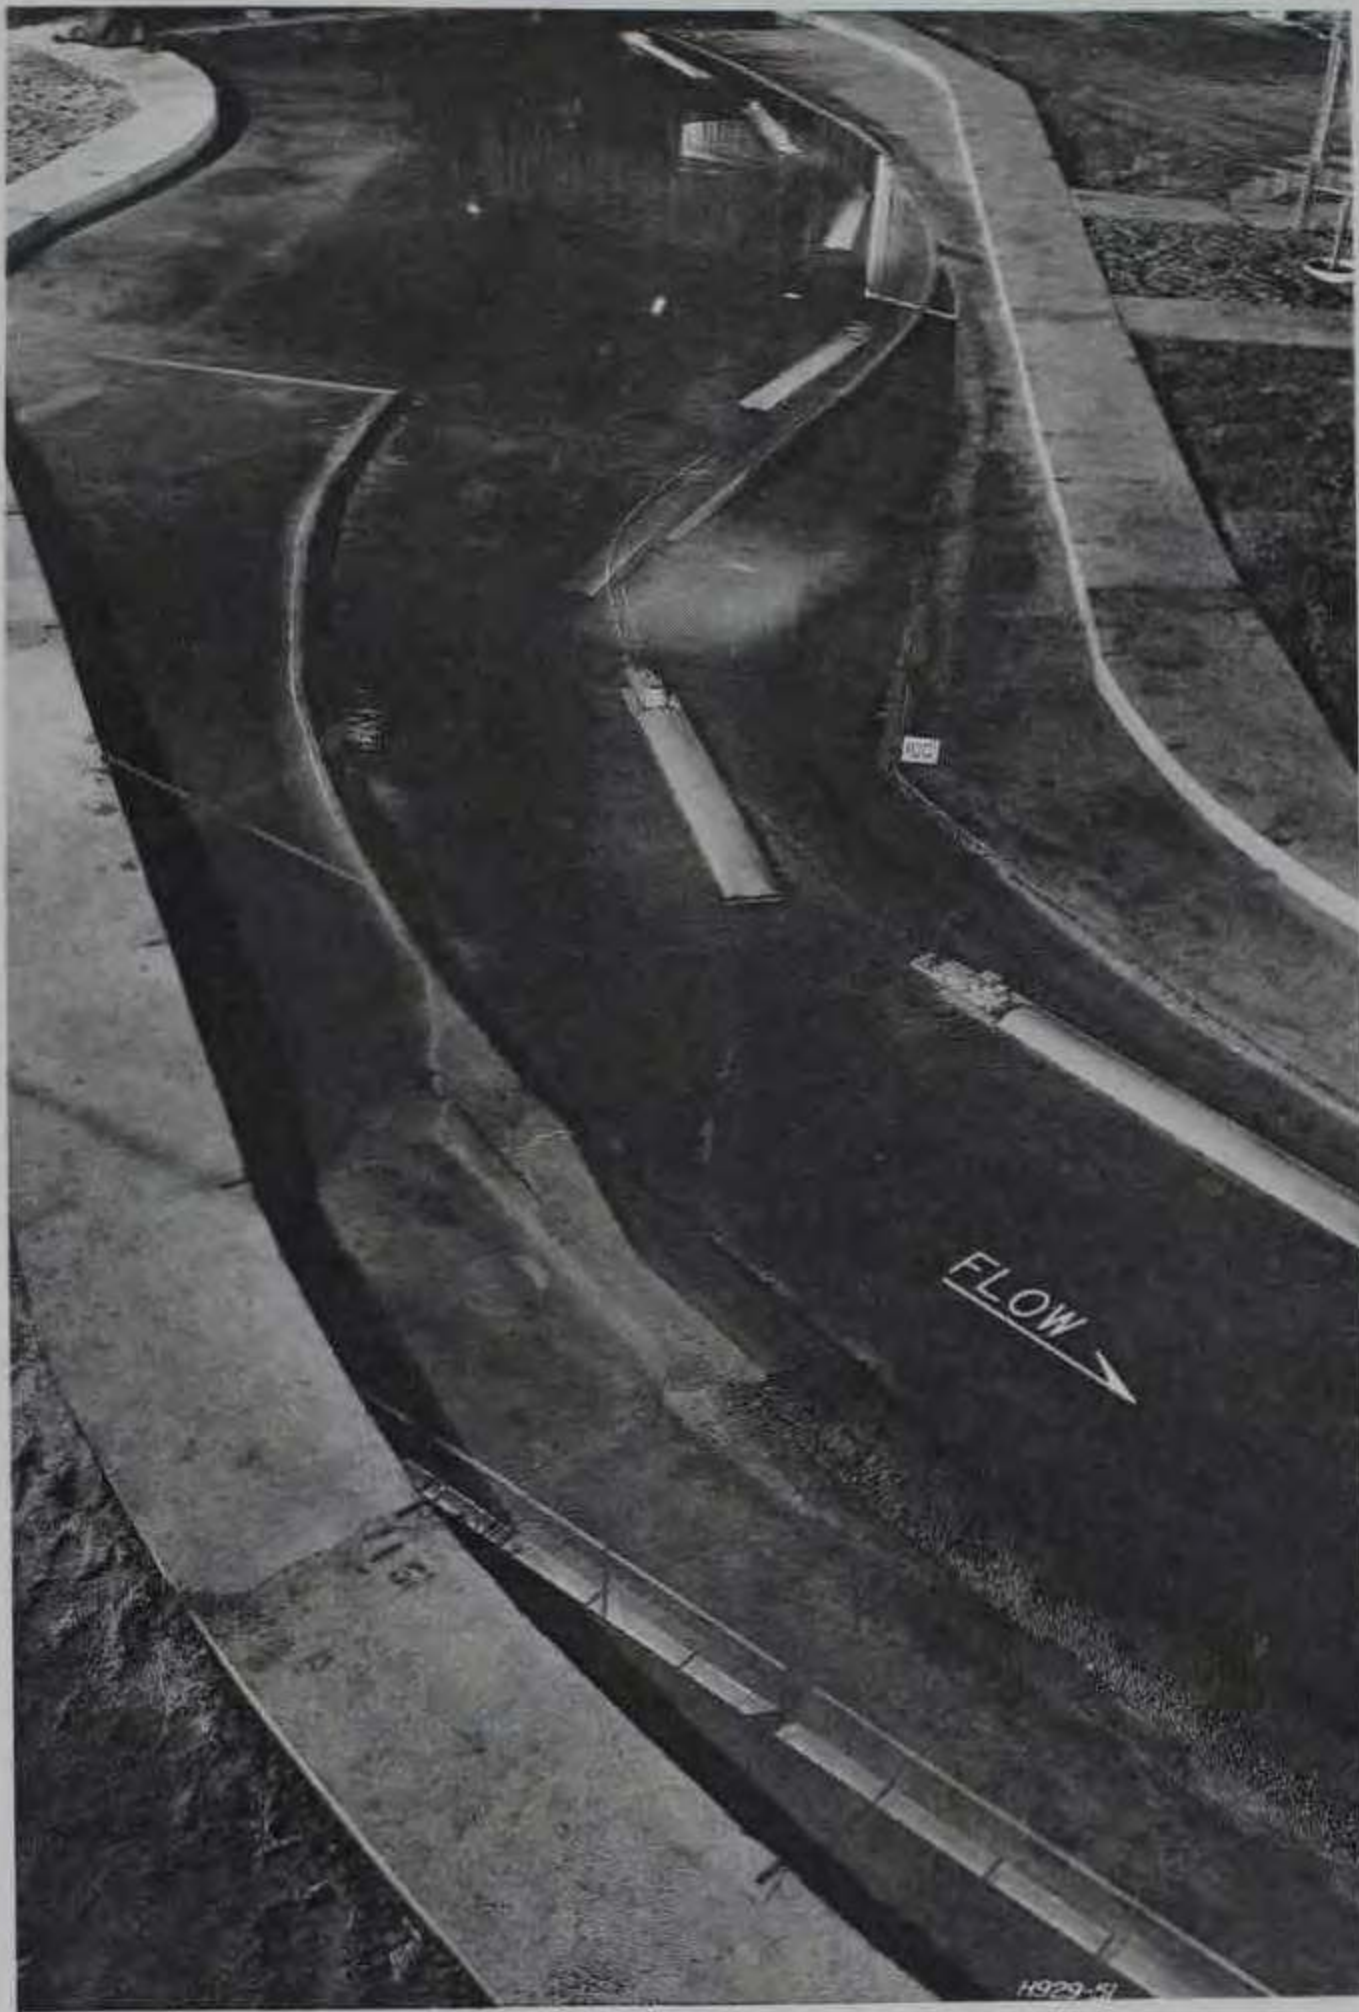
Photo 5. Plan B, looking upstream, discharge 100,000 cfs. Path of down-bound tow flanking into Piermont cutoff

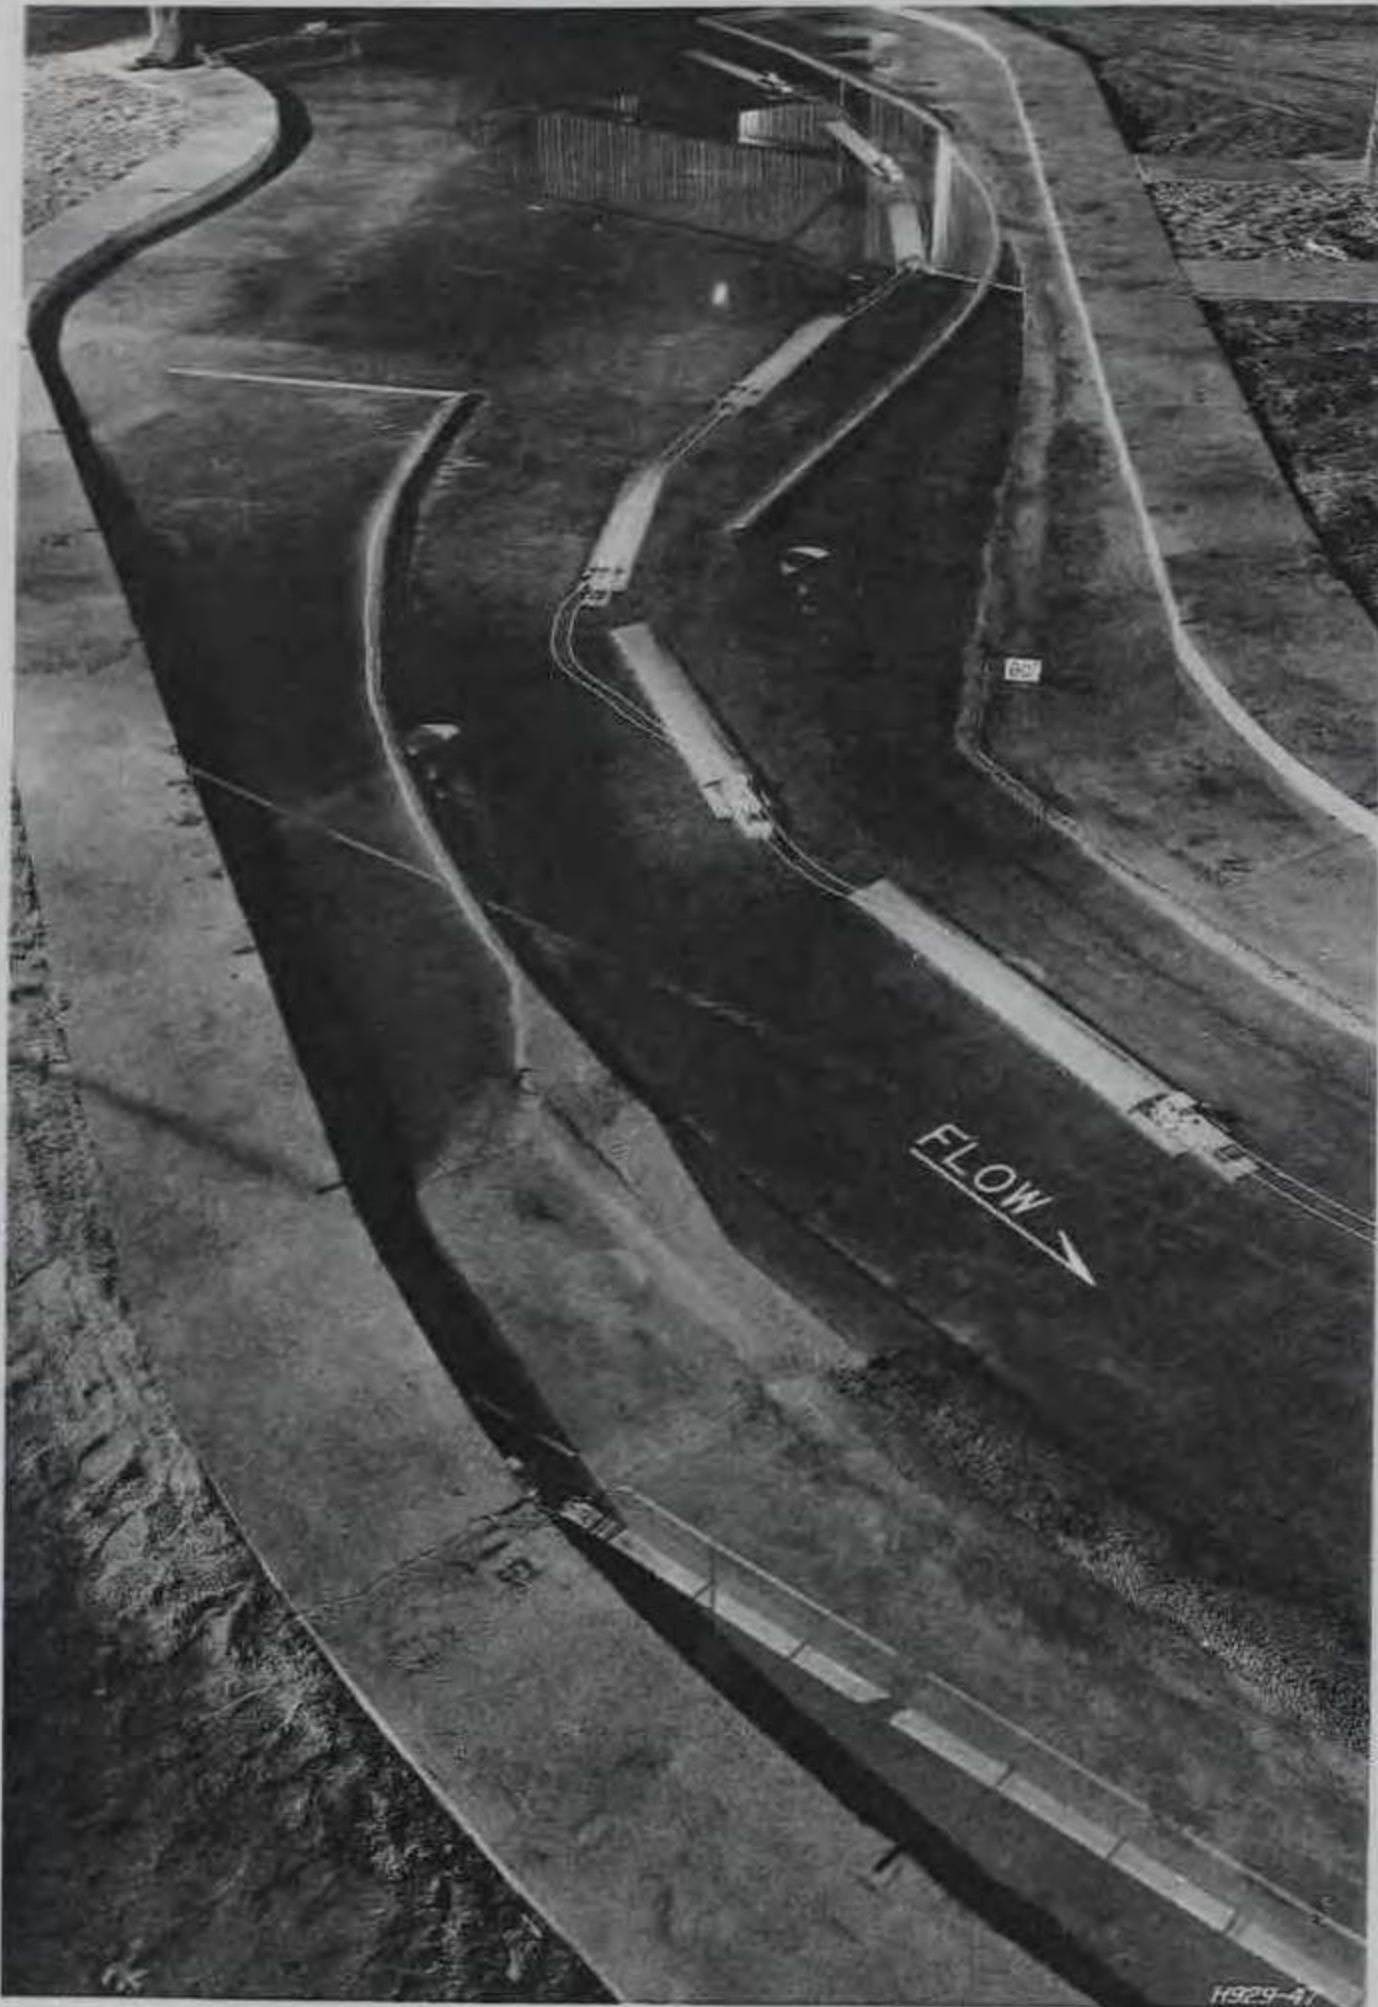
Photo 6. Plan B, looking upstream, discharge 60,000 cfs. Path of upbound tow leaving Piermont cutoff. Note maneuvering near end of Bull Revetment

No major difficulties were indicated for upbound tows navigating through the bendway, but it should be noted that considerable maneuvering was required to move through the constriction at the upstream entrance to Piermont cutoff because of the alignment of currents through this reach (Photo 6).

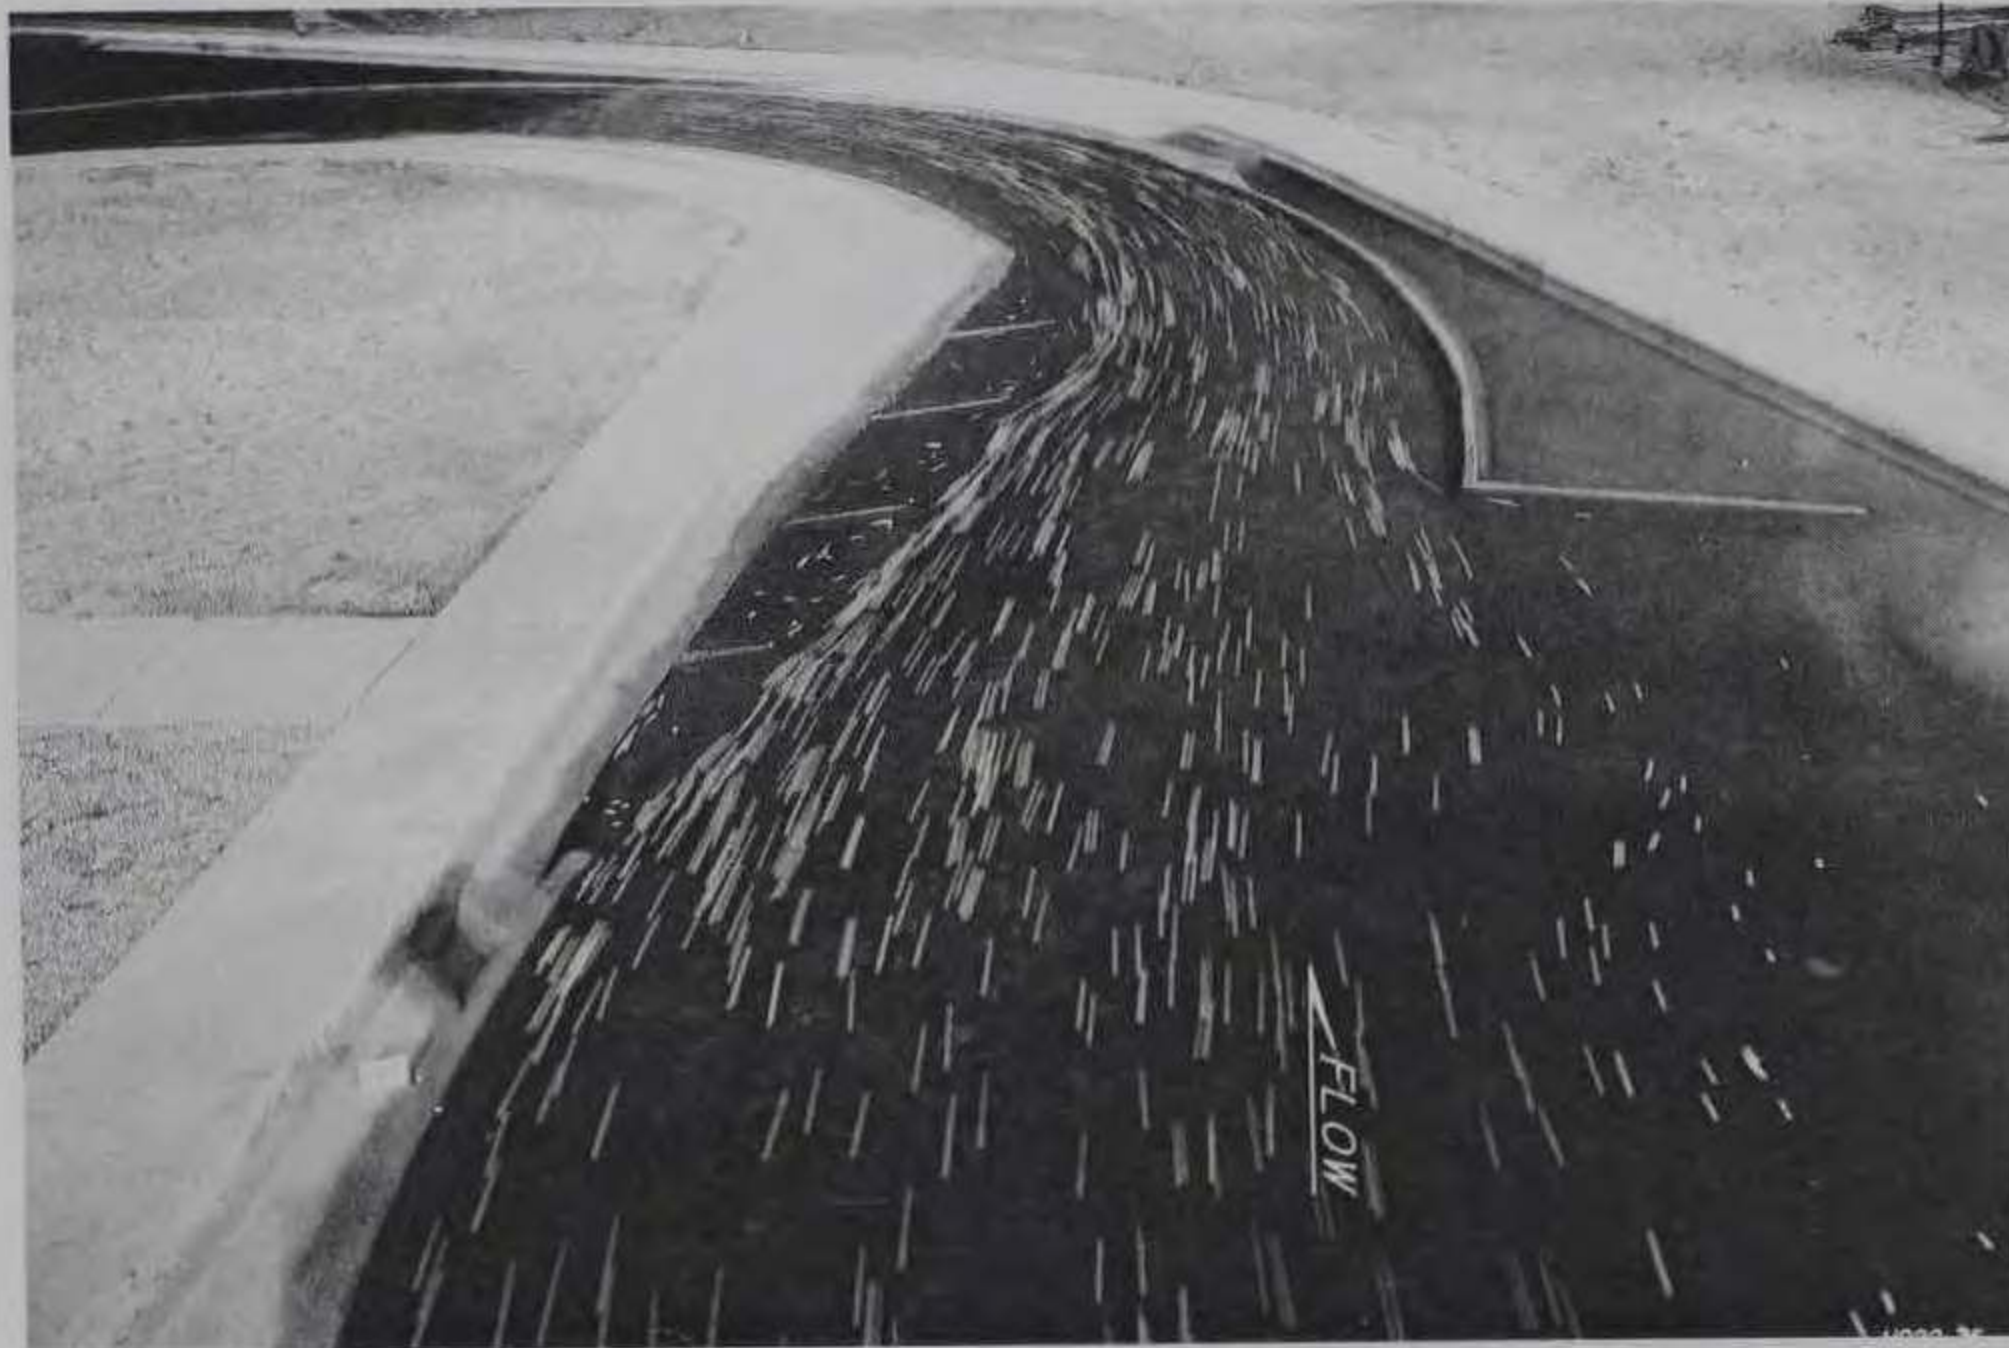
Photo 11. Plan C, looking downstream, discharge 80,000 cfs. Confetti showing surface current patterns entering and through Piermont cutoff

to 9.1 fps with riverflows of 20,000 and 134,000 cfs, respectively. In this reach, a reduction in the maximum velocity of the current of about 2.0 fps was observed when compared to Plan B. There was very little difference in current alignment and velocities through the cutoff. The flow appears to be more uniformly distributed at the upstream entrance to the cutoff; however, the flow was still concentrated toward and along the right descending bank of the bendway (Photo 11).

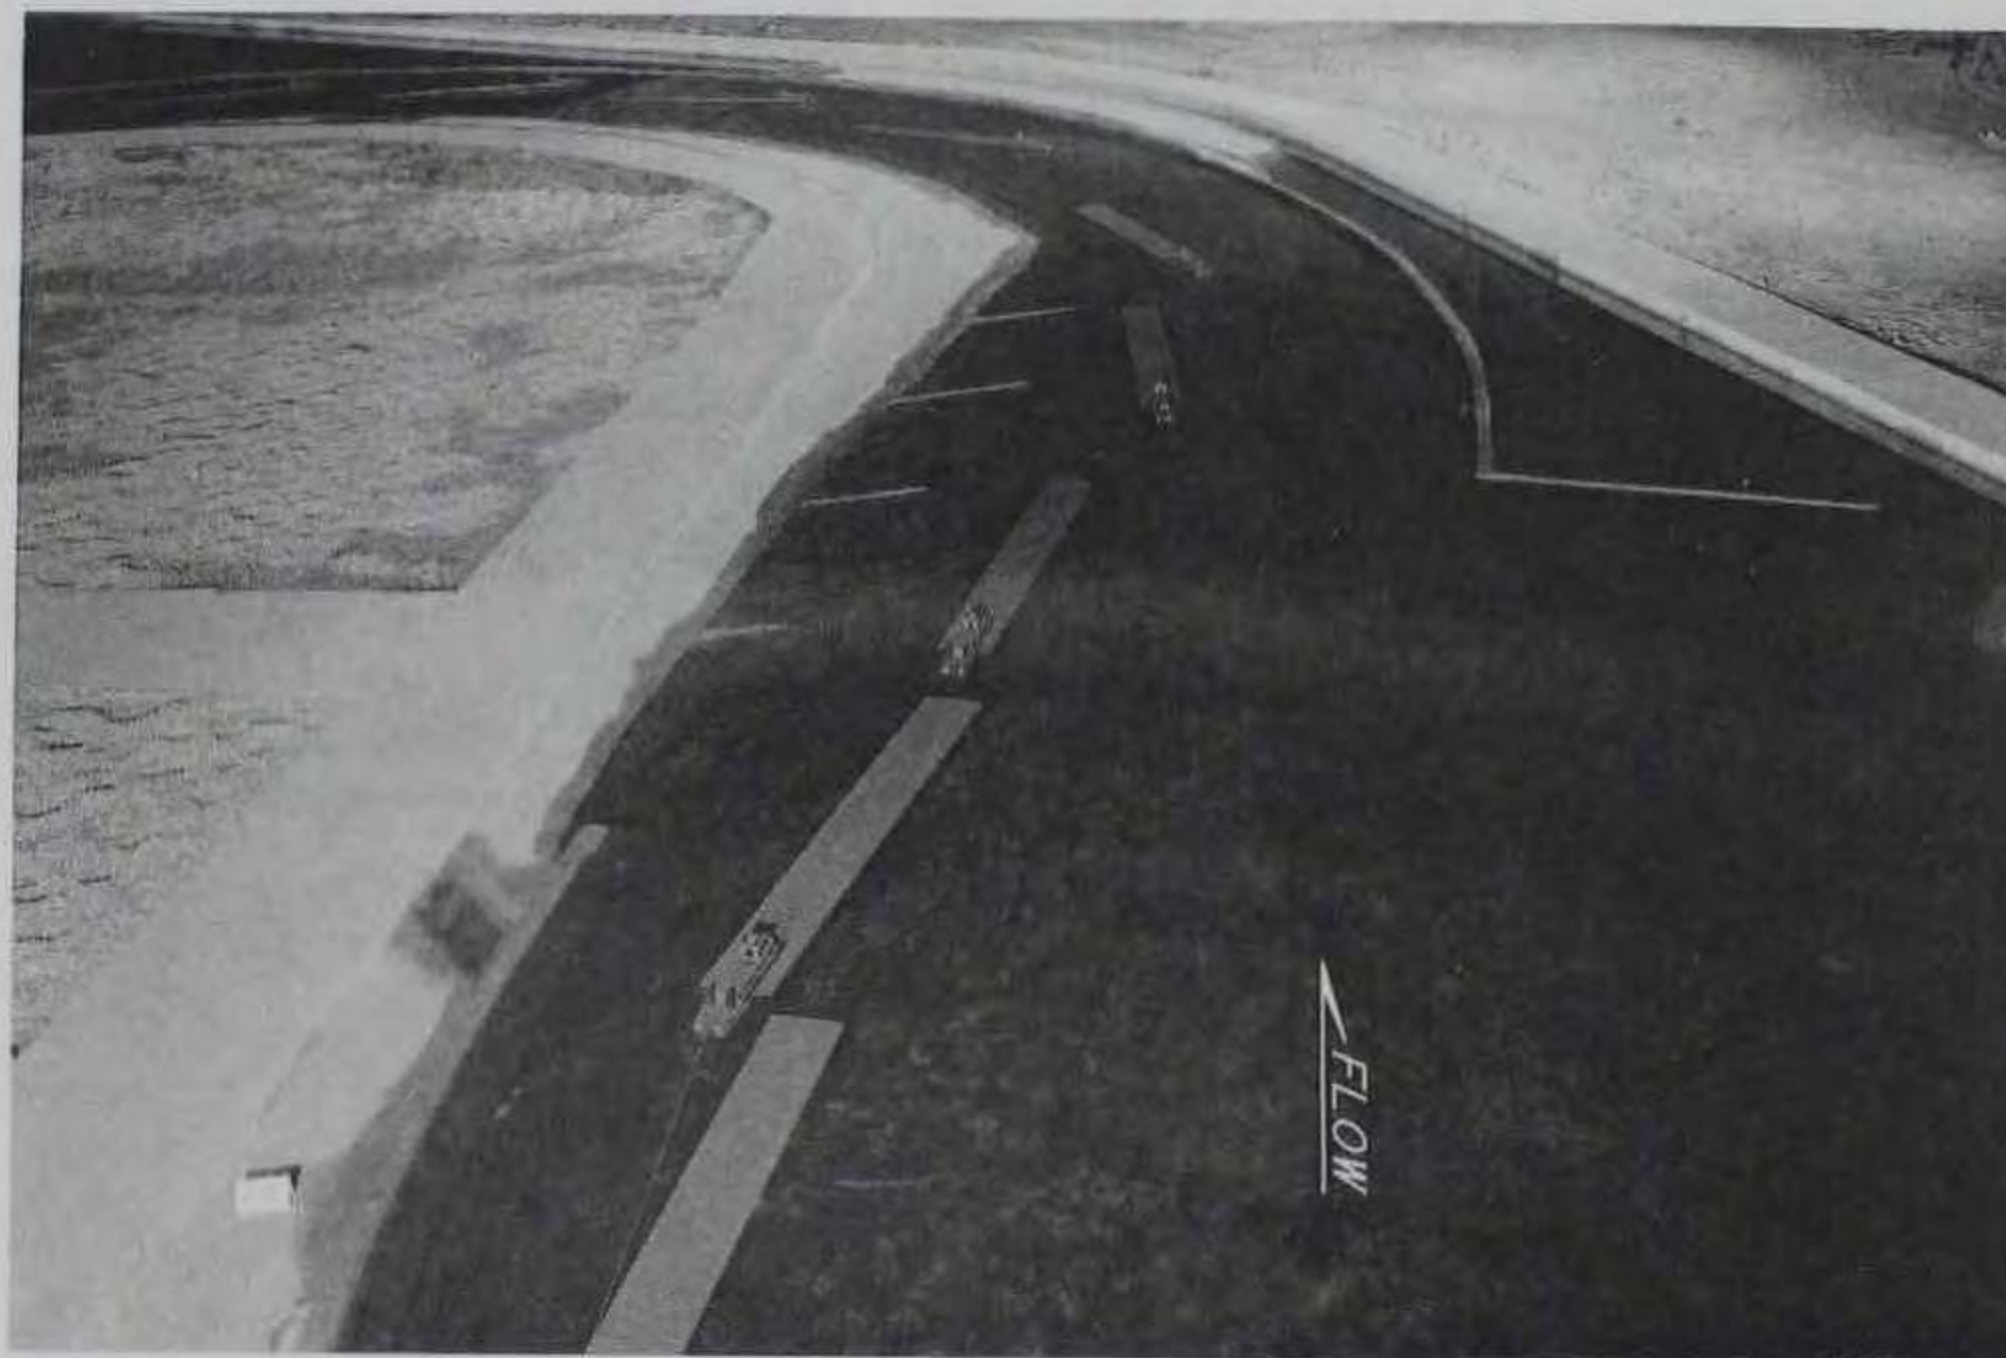
Photo 12. Plan C, looking downstream, discharge 60,000 cfs. Path of downbound tow driving past four spur dikes and into Piermont cutoff

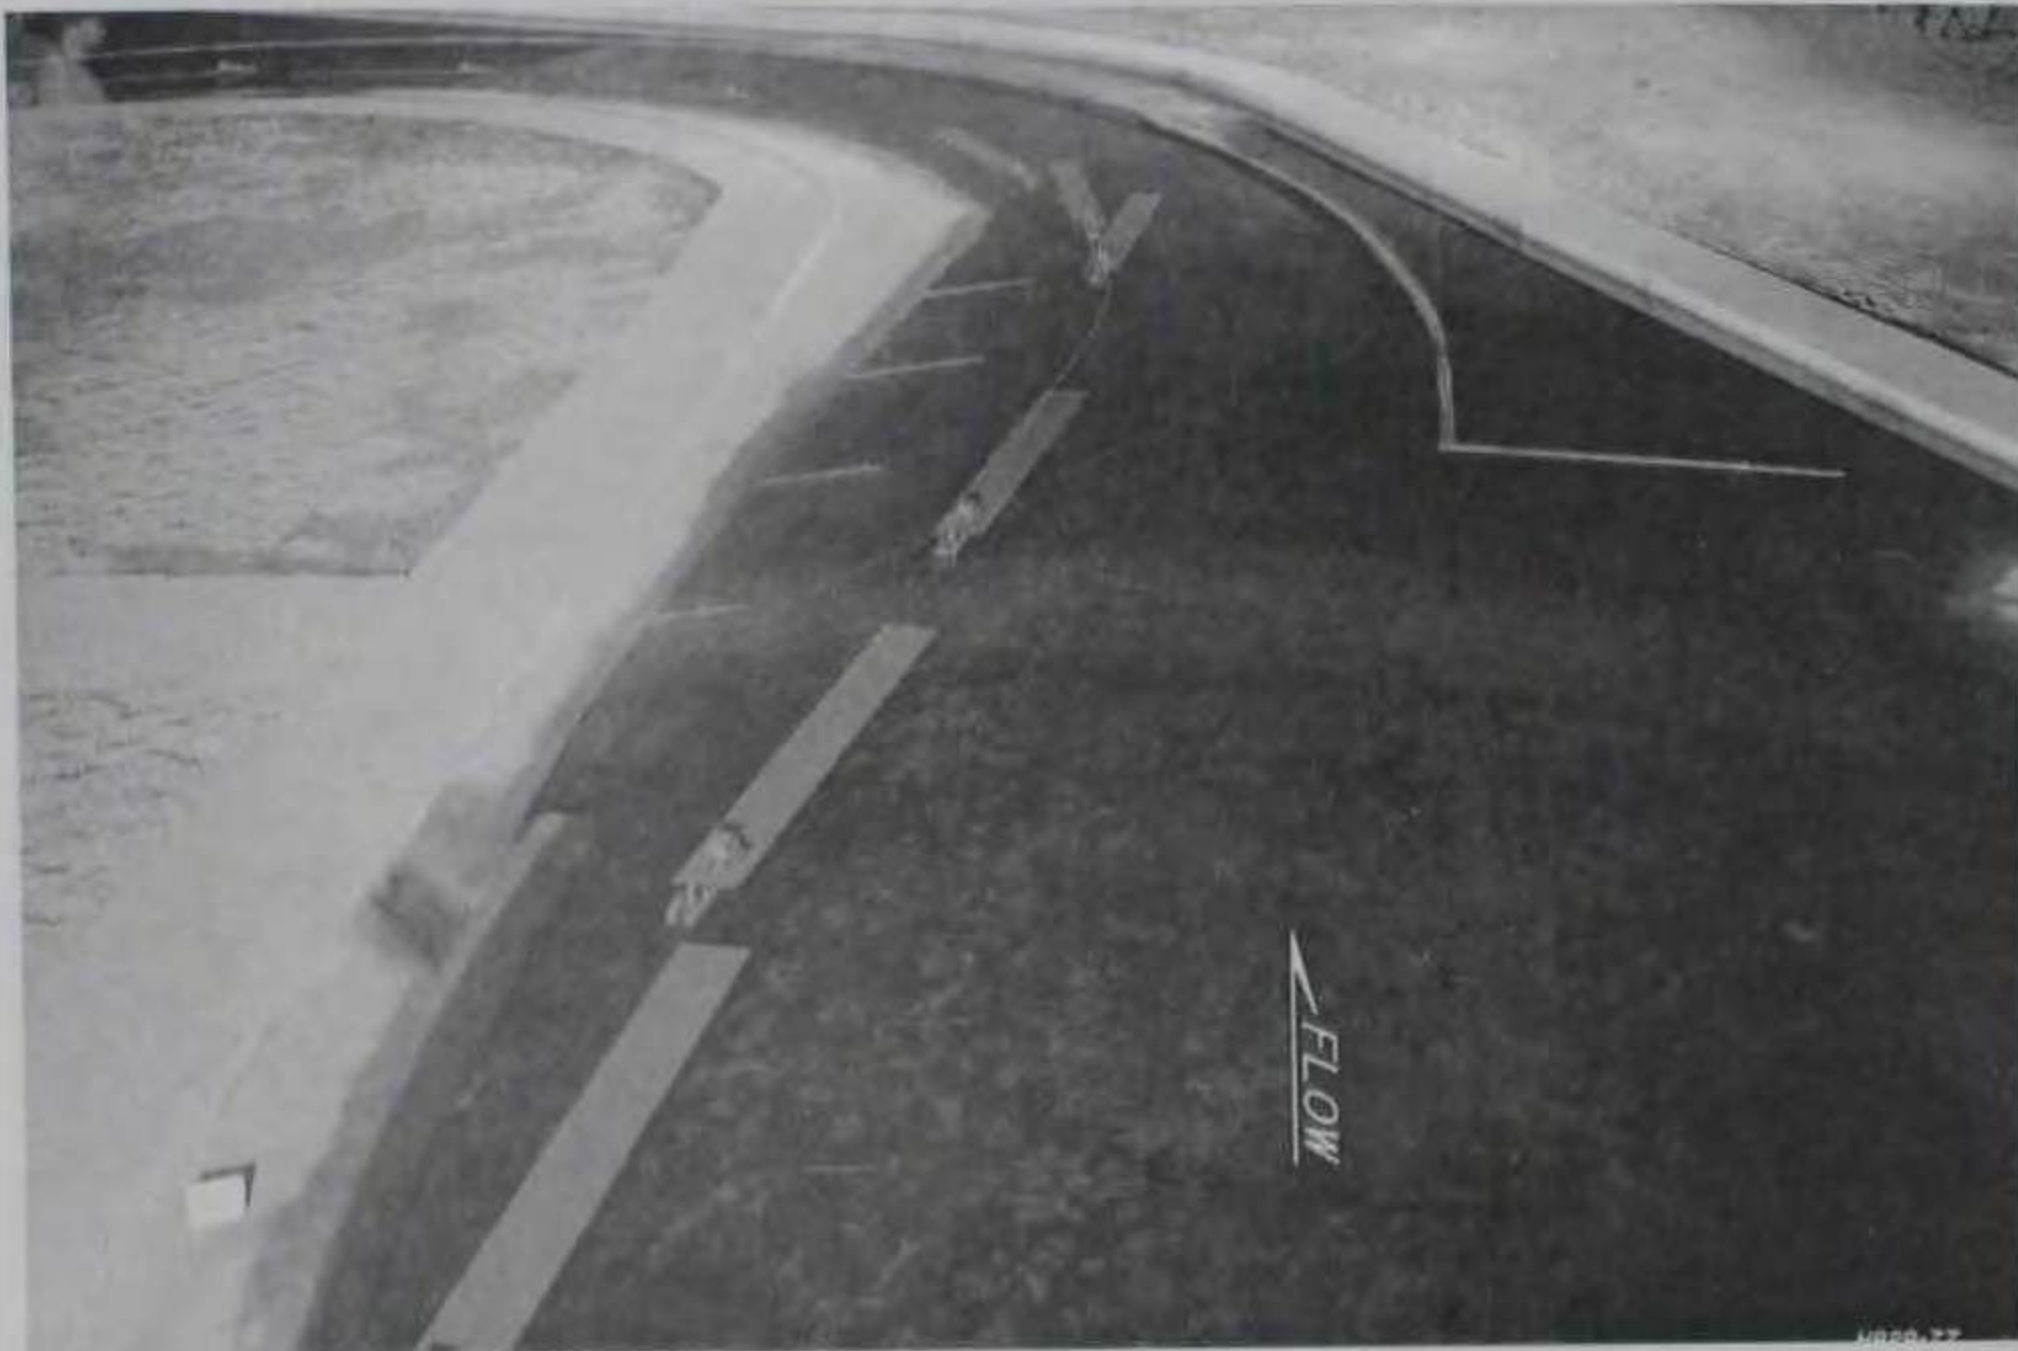
Photo 13. Plan C, looking downstream, discharge 80,000 cfs. Path of downbound tow flanking past four spur dikes and into Piermont cutoff. Note that tow is positioned to inside of bend

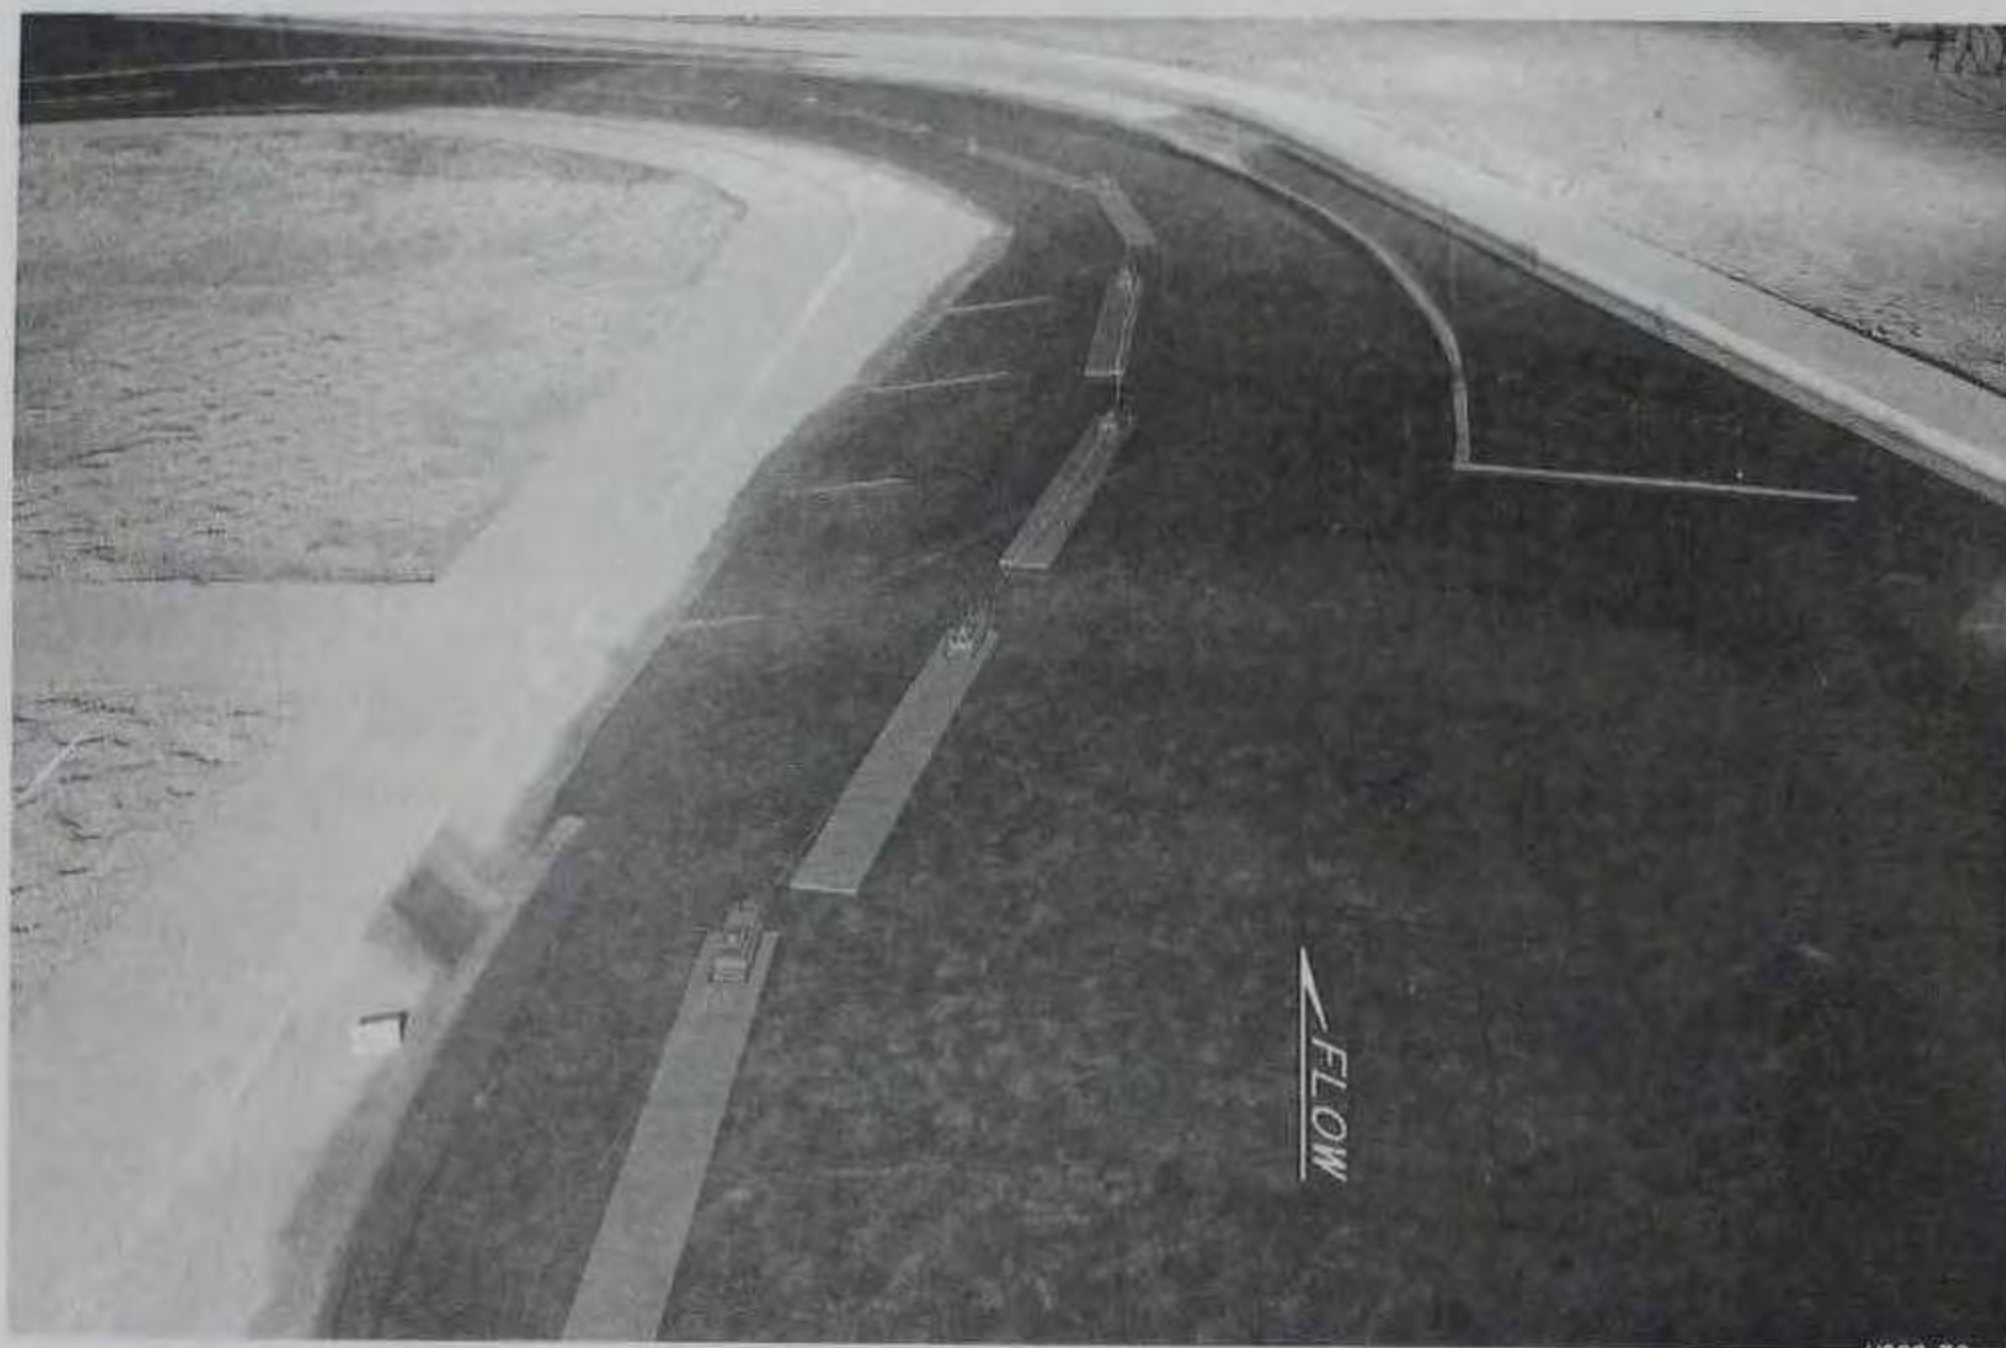
Photo 14. Plan C, looking downstream, discharge 80,000 cfs. Path of upbound tow leaving Piermont cutoff

Navigation conditions for upbound tows navigating Piermont cutoff were satisfactory with all riverflows. However, it should be noted that some maneuvering was required at the upstream entrance of the cutoff (Photo 14).
