# **Red River Waterway, Lock and Dam No. 4**

## **Report 2**

## **Navigation Alignment Conditions**

## **Hydraulic Model Investigation**

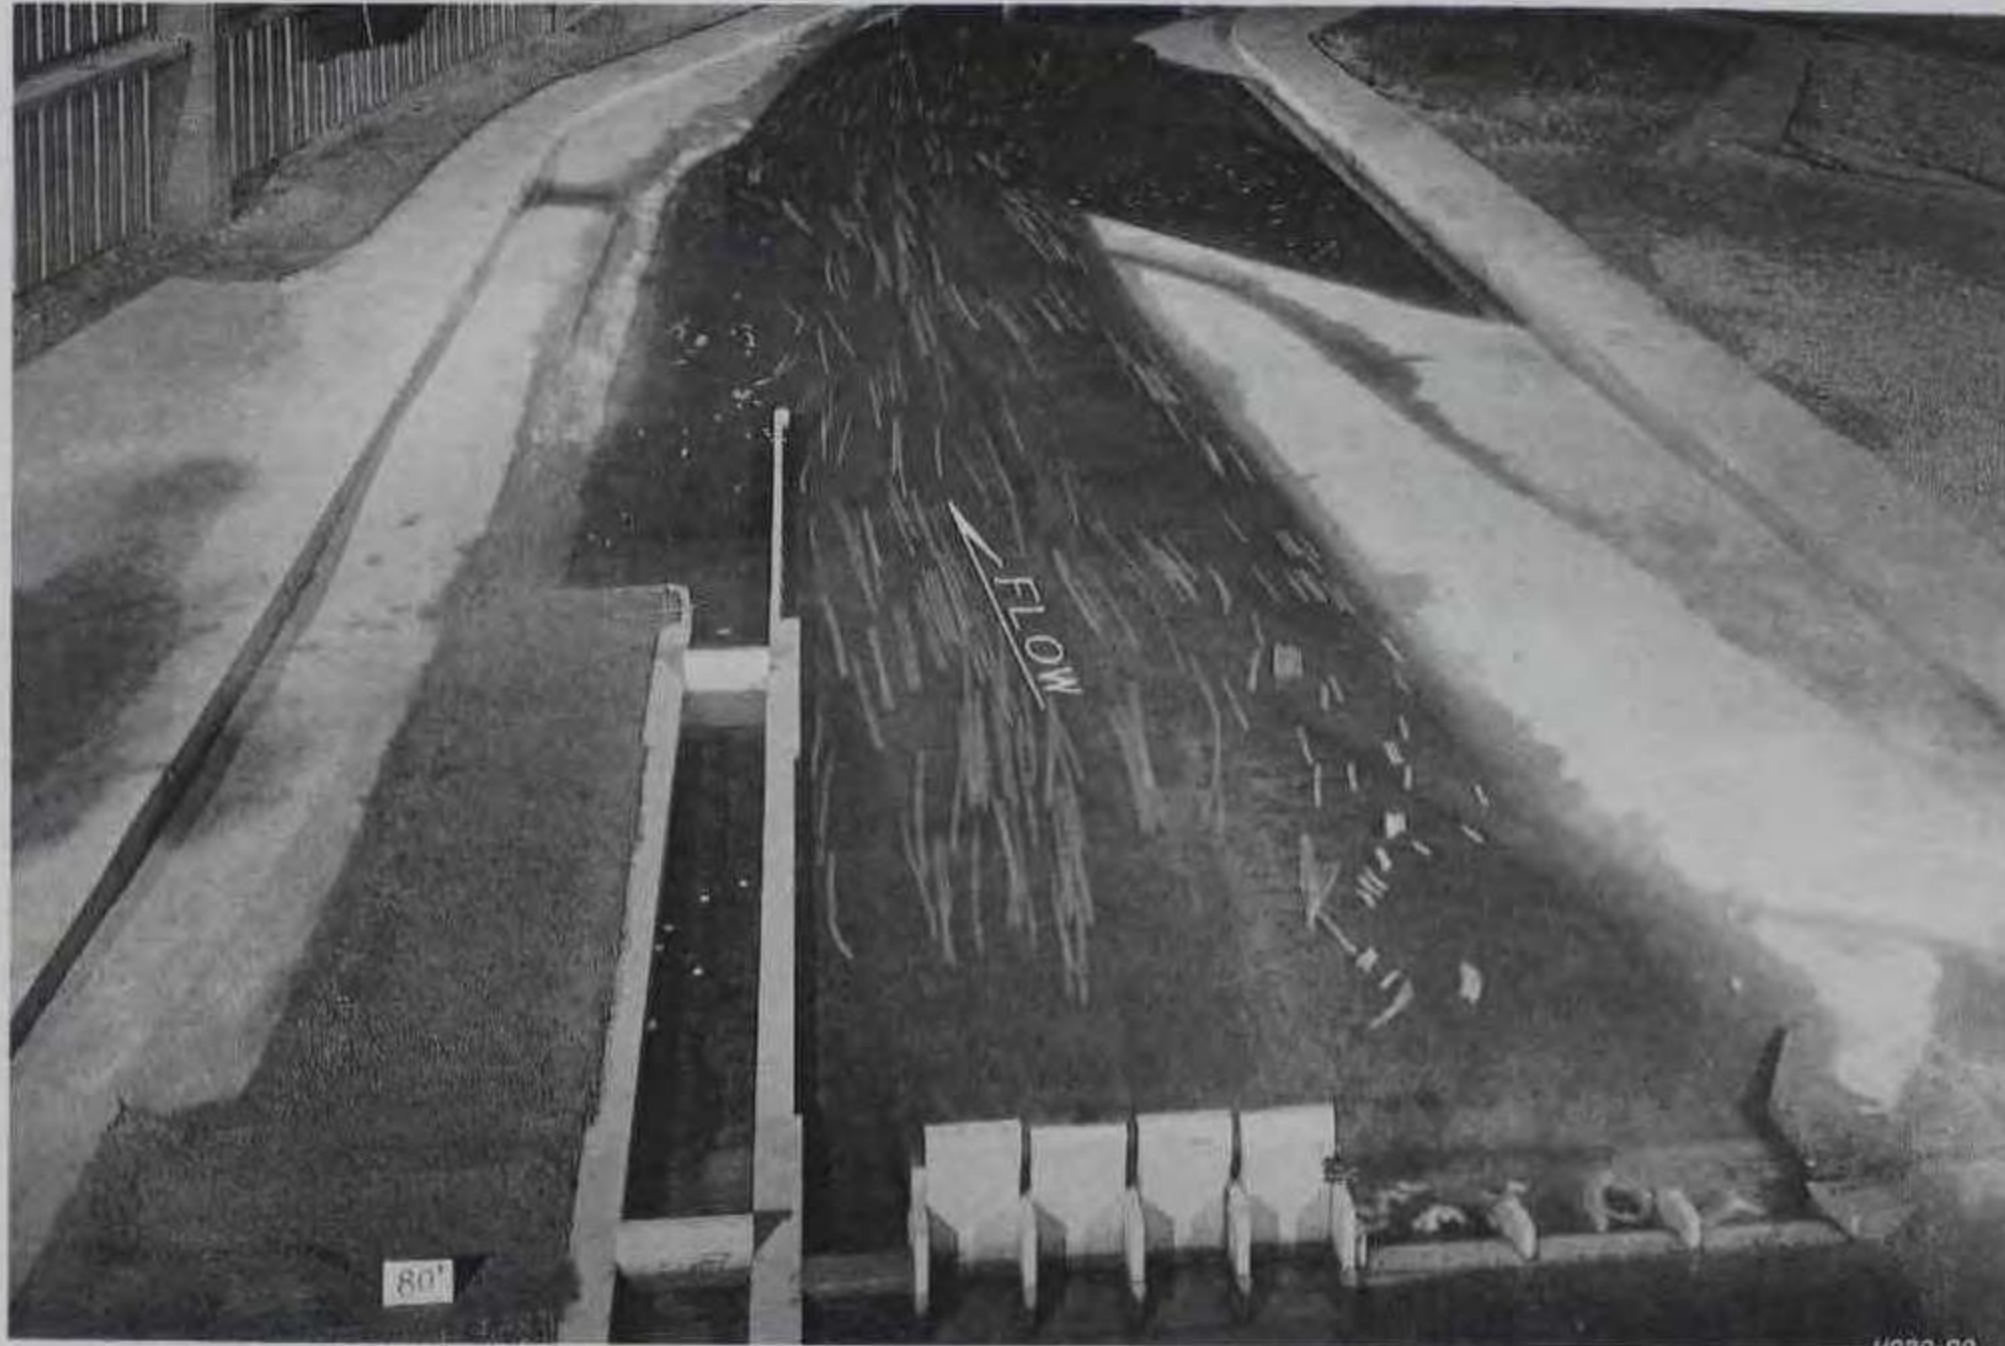
Photo 16. Plan C-1, looking downstream, discharge 80,000 cfs. Confetti showing surface current patterns in the lower lock approach. Note eddy downstream of guard wall

Current direction and velocity data are shown in Plates 11-15. These data indicate an overall increase in current magnitudes in the exit channel compared with Plan C. The wing dike off the downstream guard wall increased the upstream intensity of the eddy (Photo 16) in the lower lock approach by as much as 1.0 fps compared with conditions for Plan C. Current magnitudes in the exit channel appear to have increased by about 20 percent compared with those for Plan C.

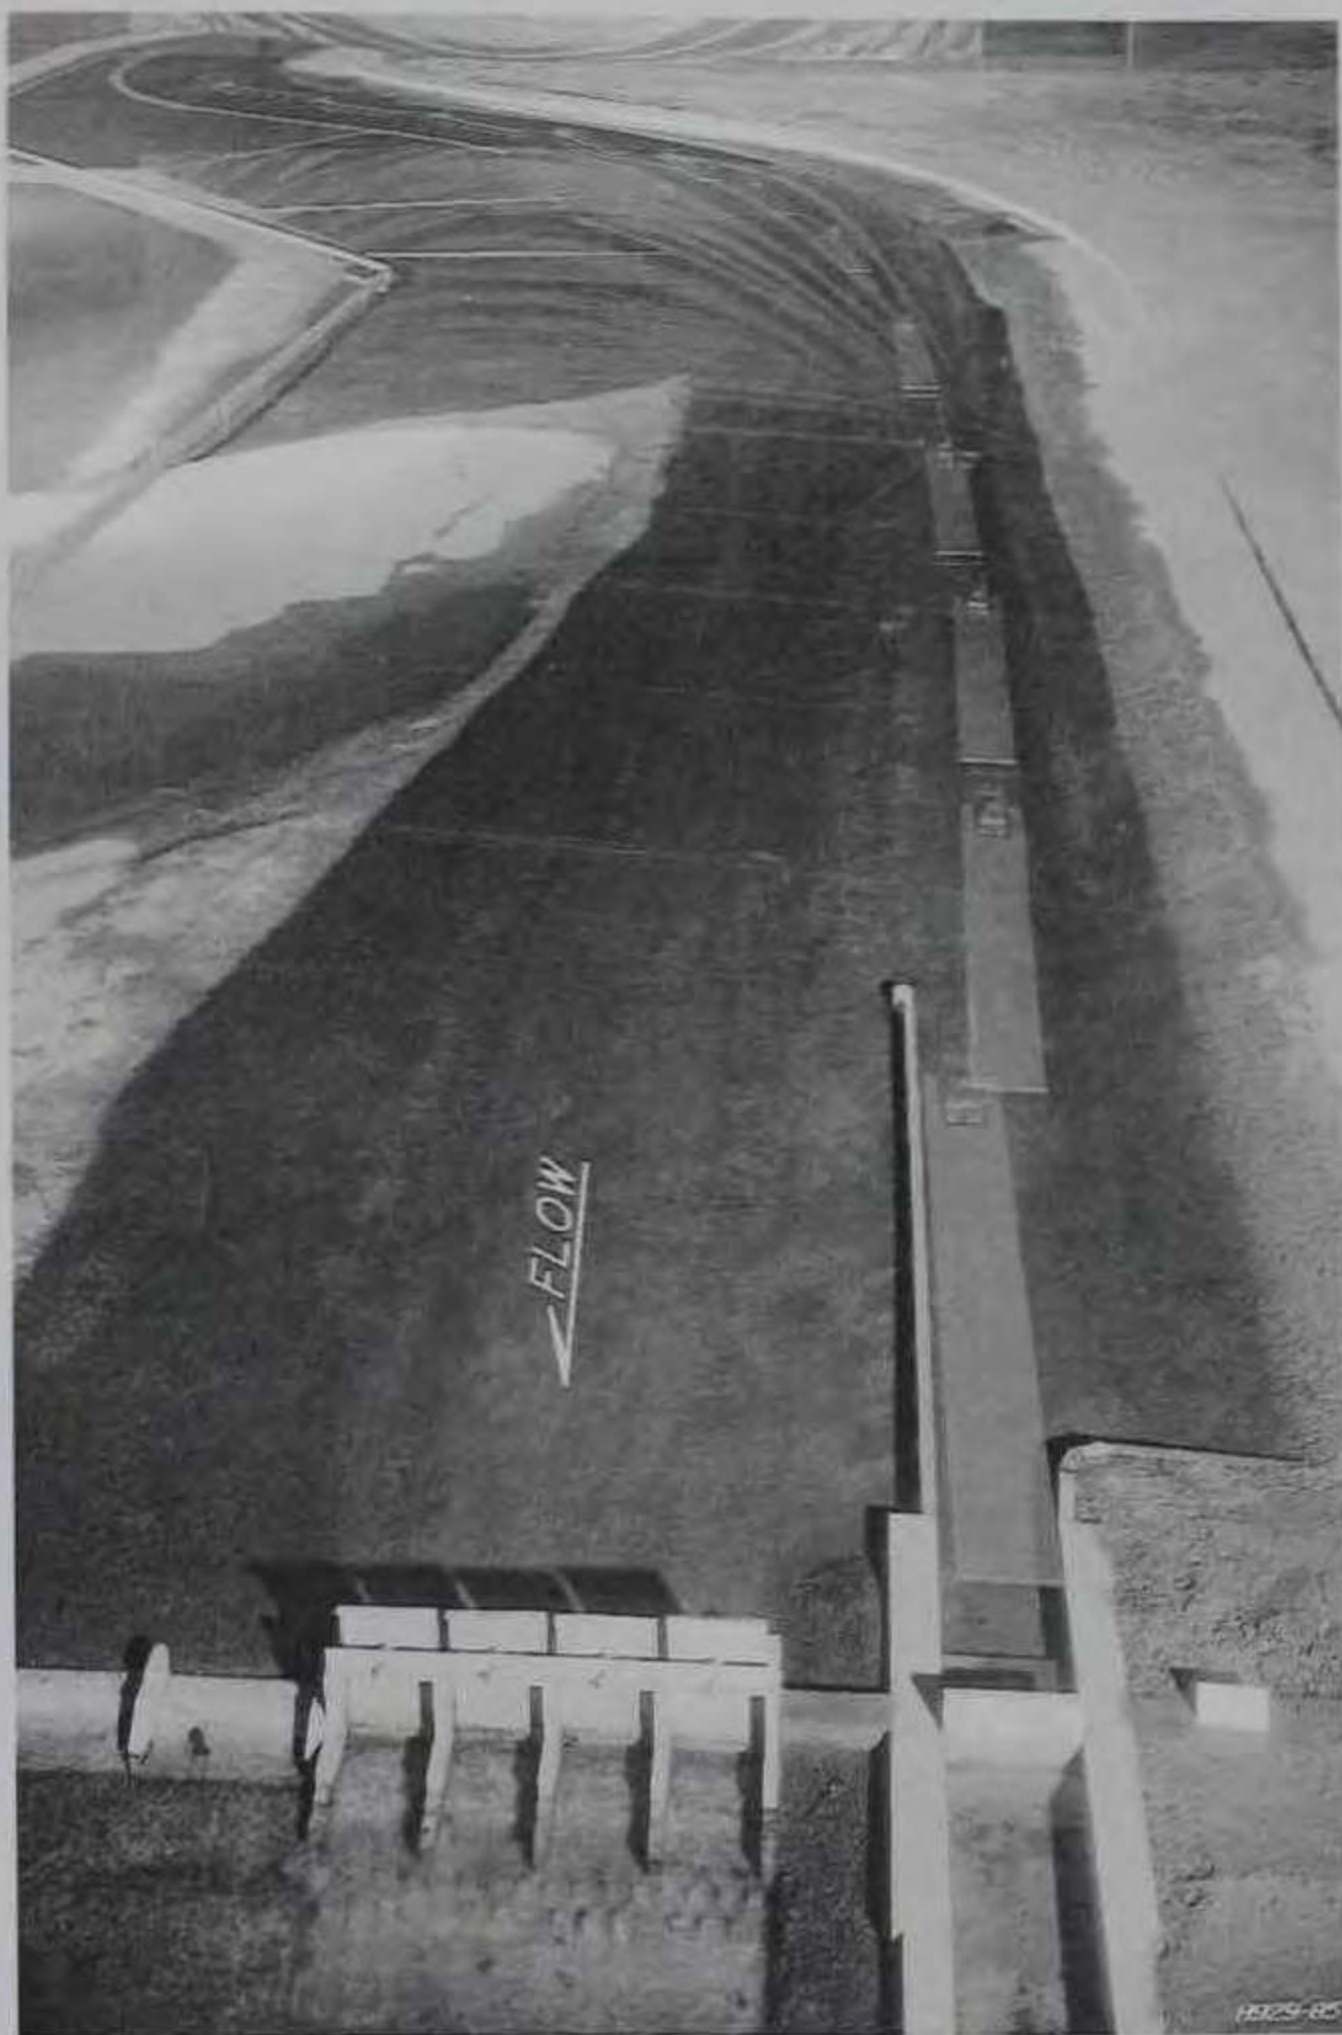
Photo 21. Plan C-2, looking upstream, discharge 60,000 cfs. Path of downbound tow entering the upper lock approach

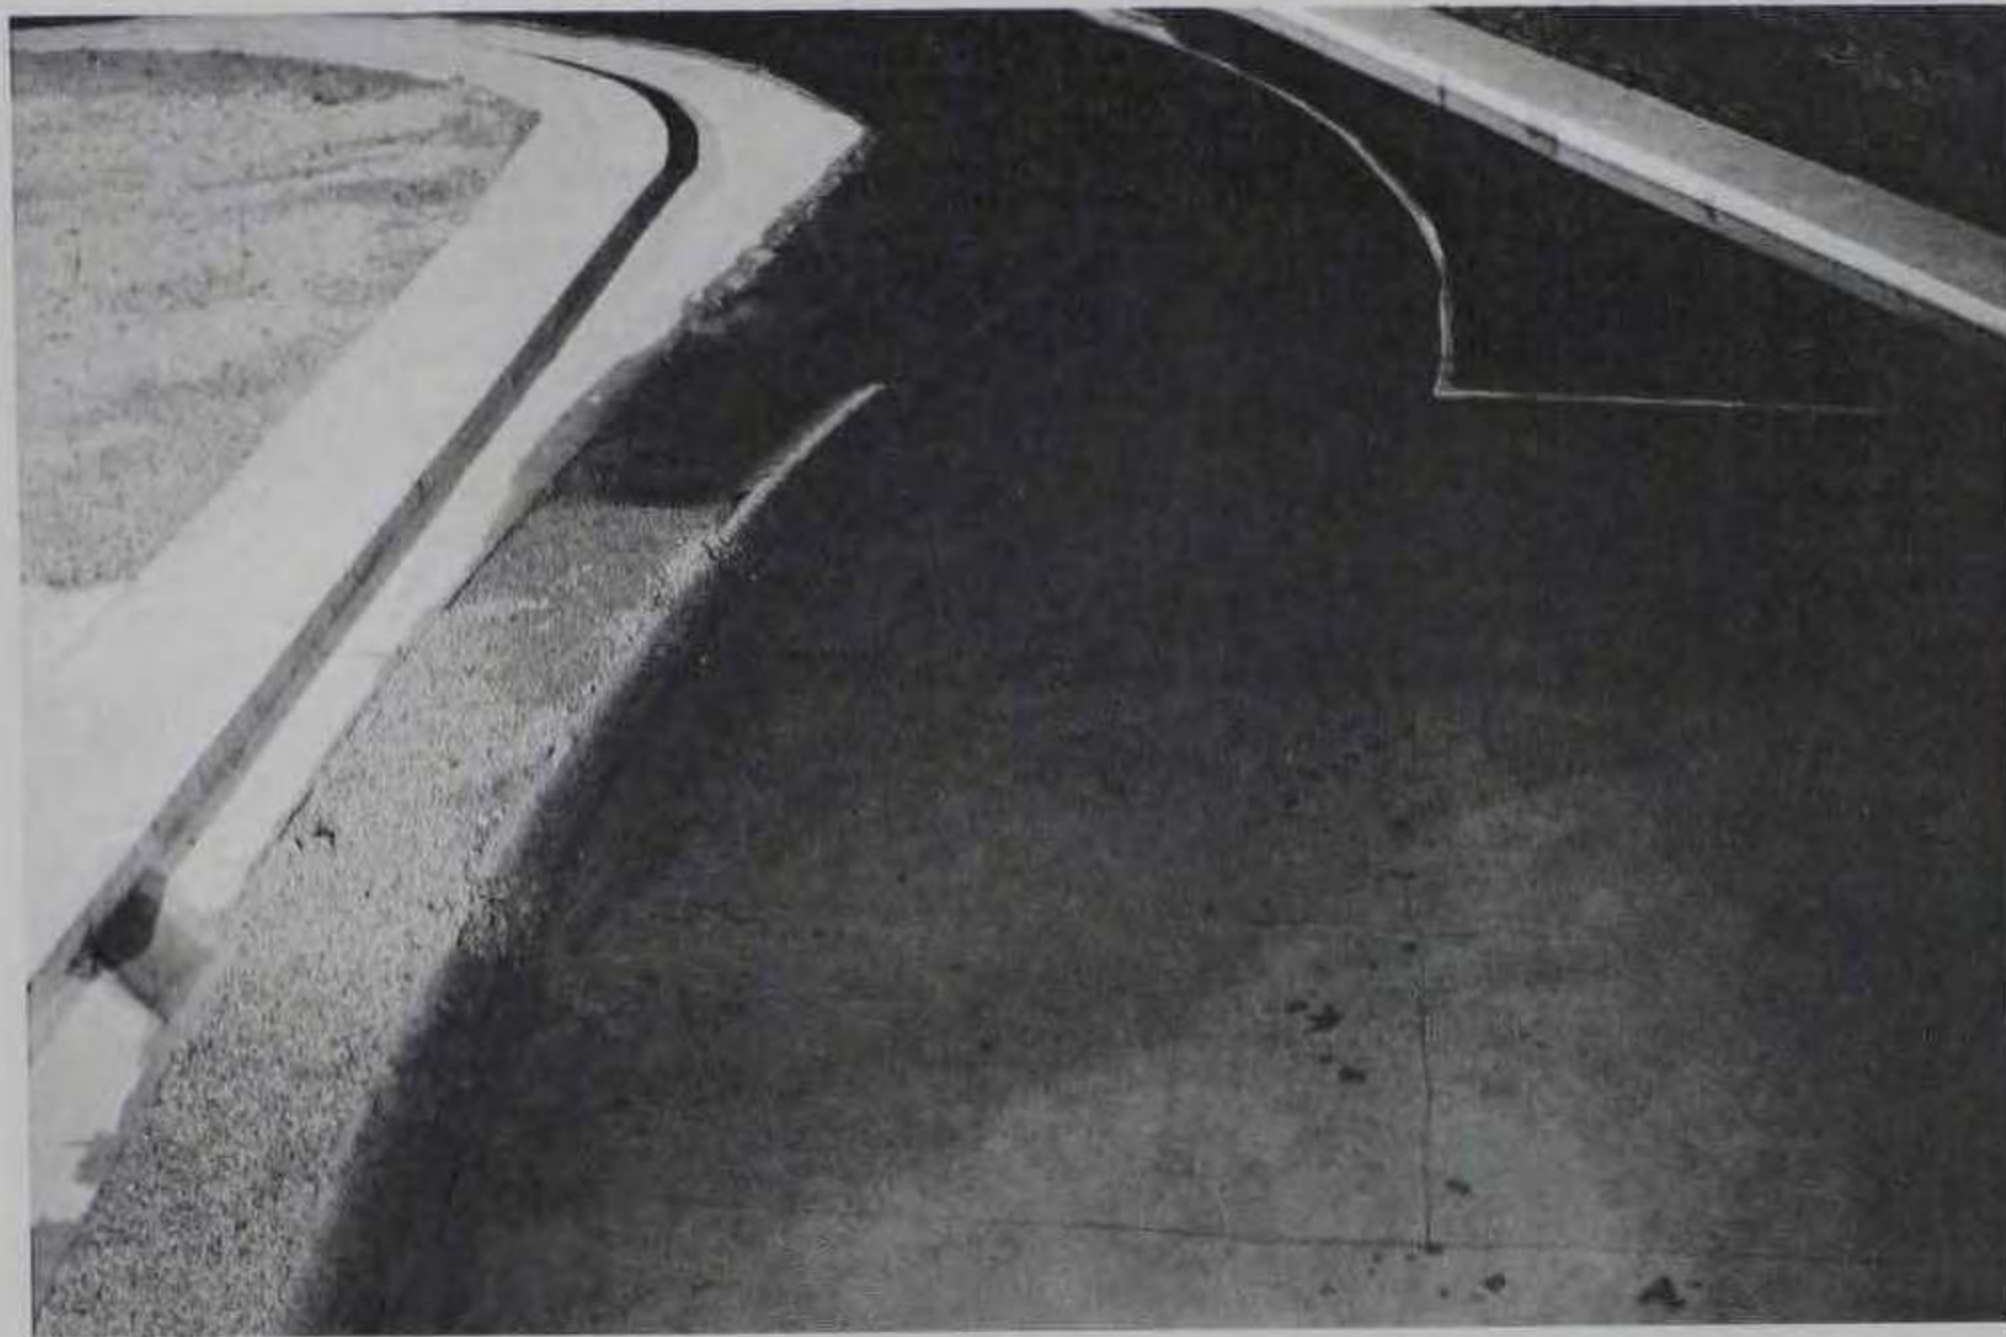
Photo 23. Plan D, looking downstream, showing Bull Revetment and the entrance to Piermont cutoff

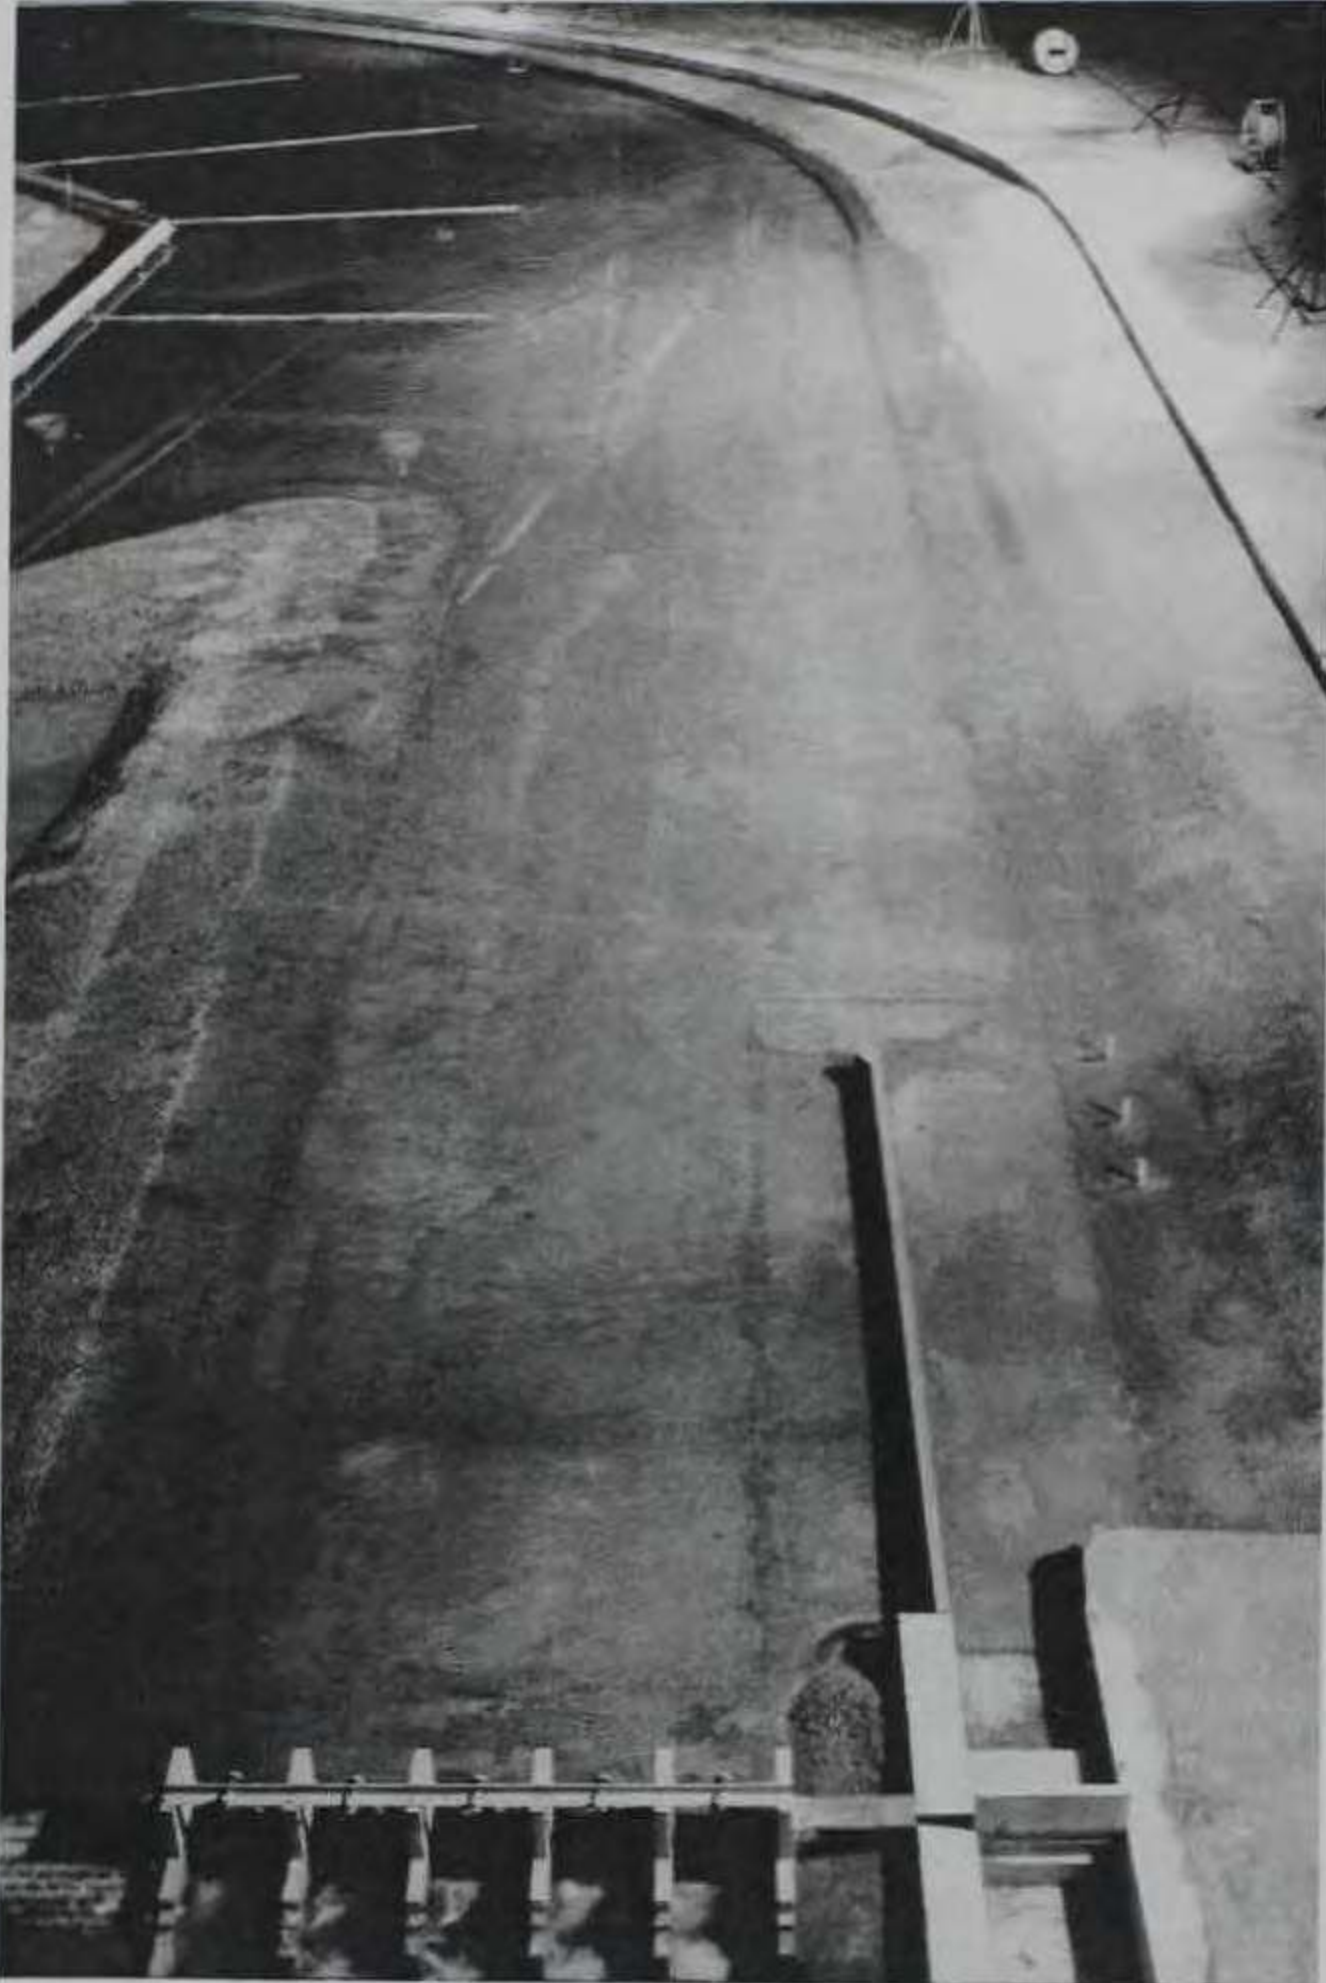
Photo 24. Plan D, looking upstream, showing the upper lock approach

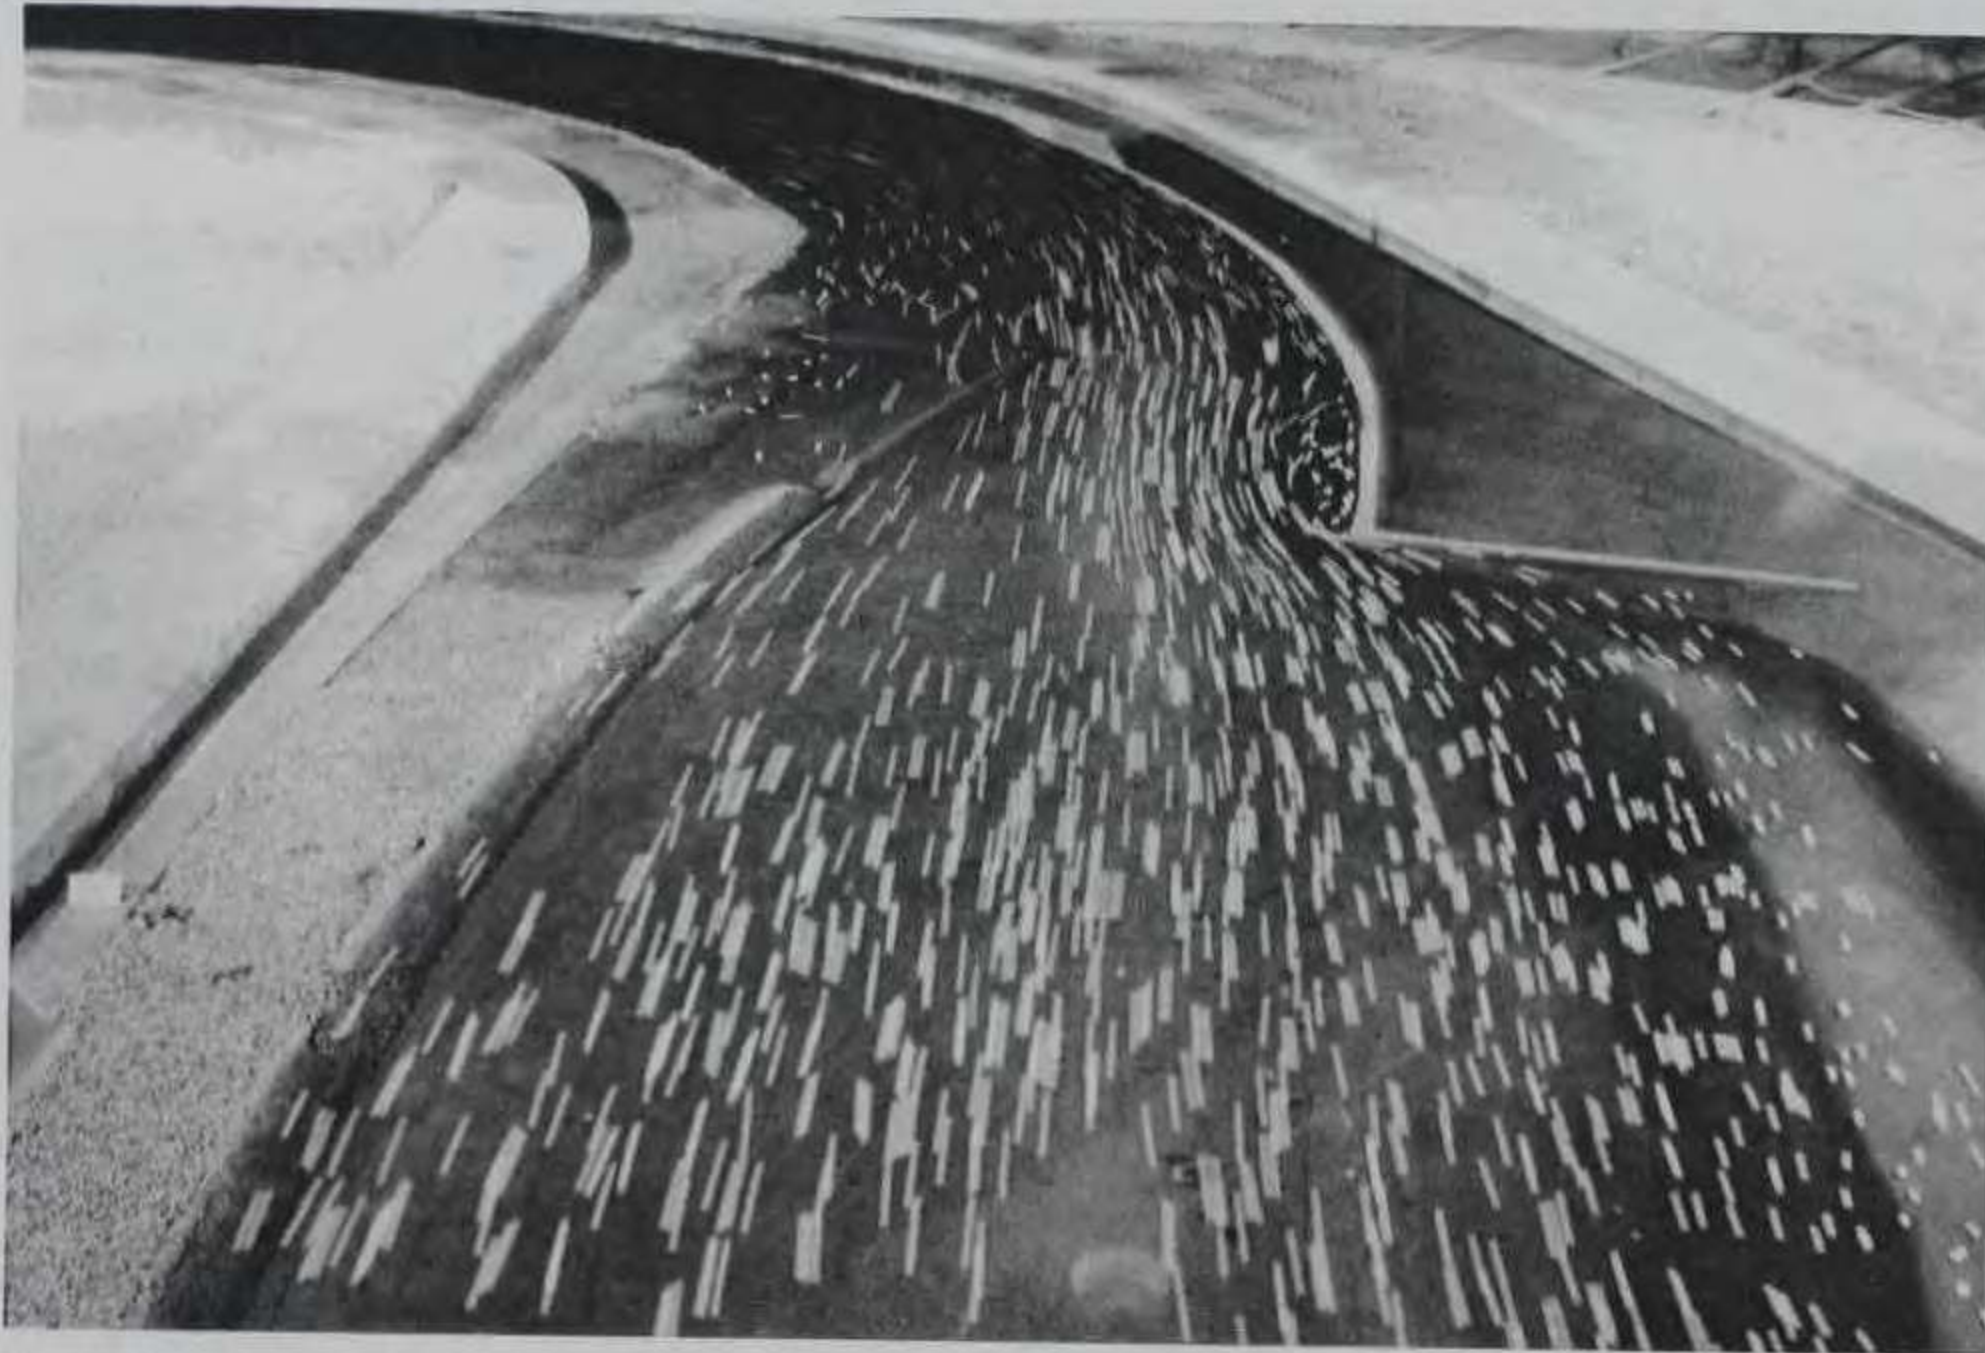
Photo 26. Plan D, looking downstream, discharge 80,000 cfs. Confetti showing surface current patterns

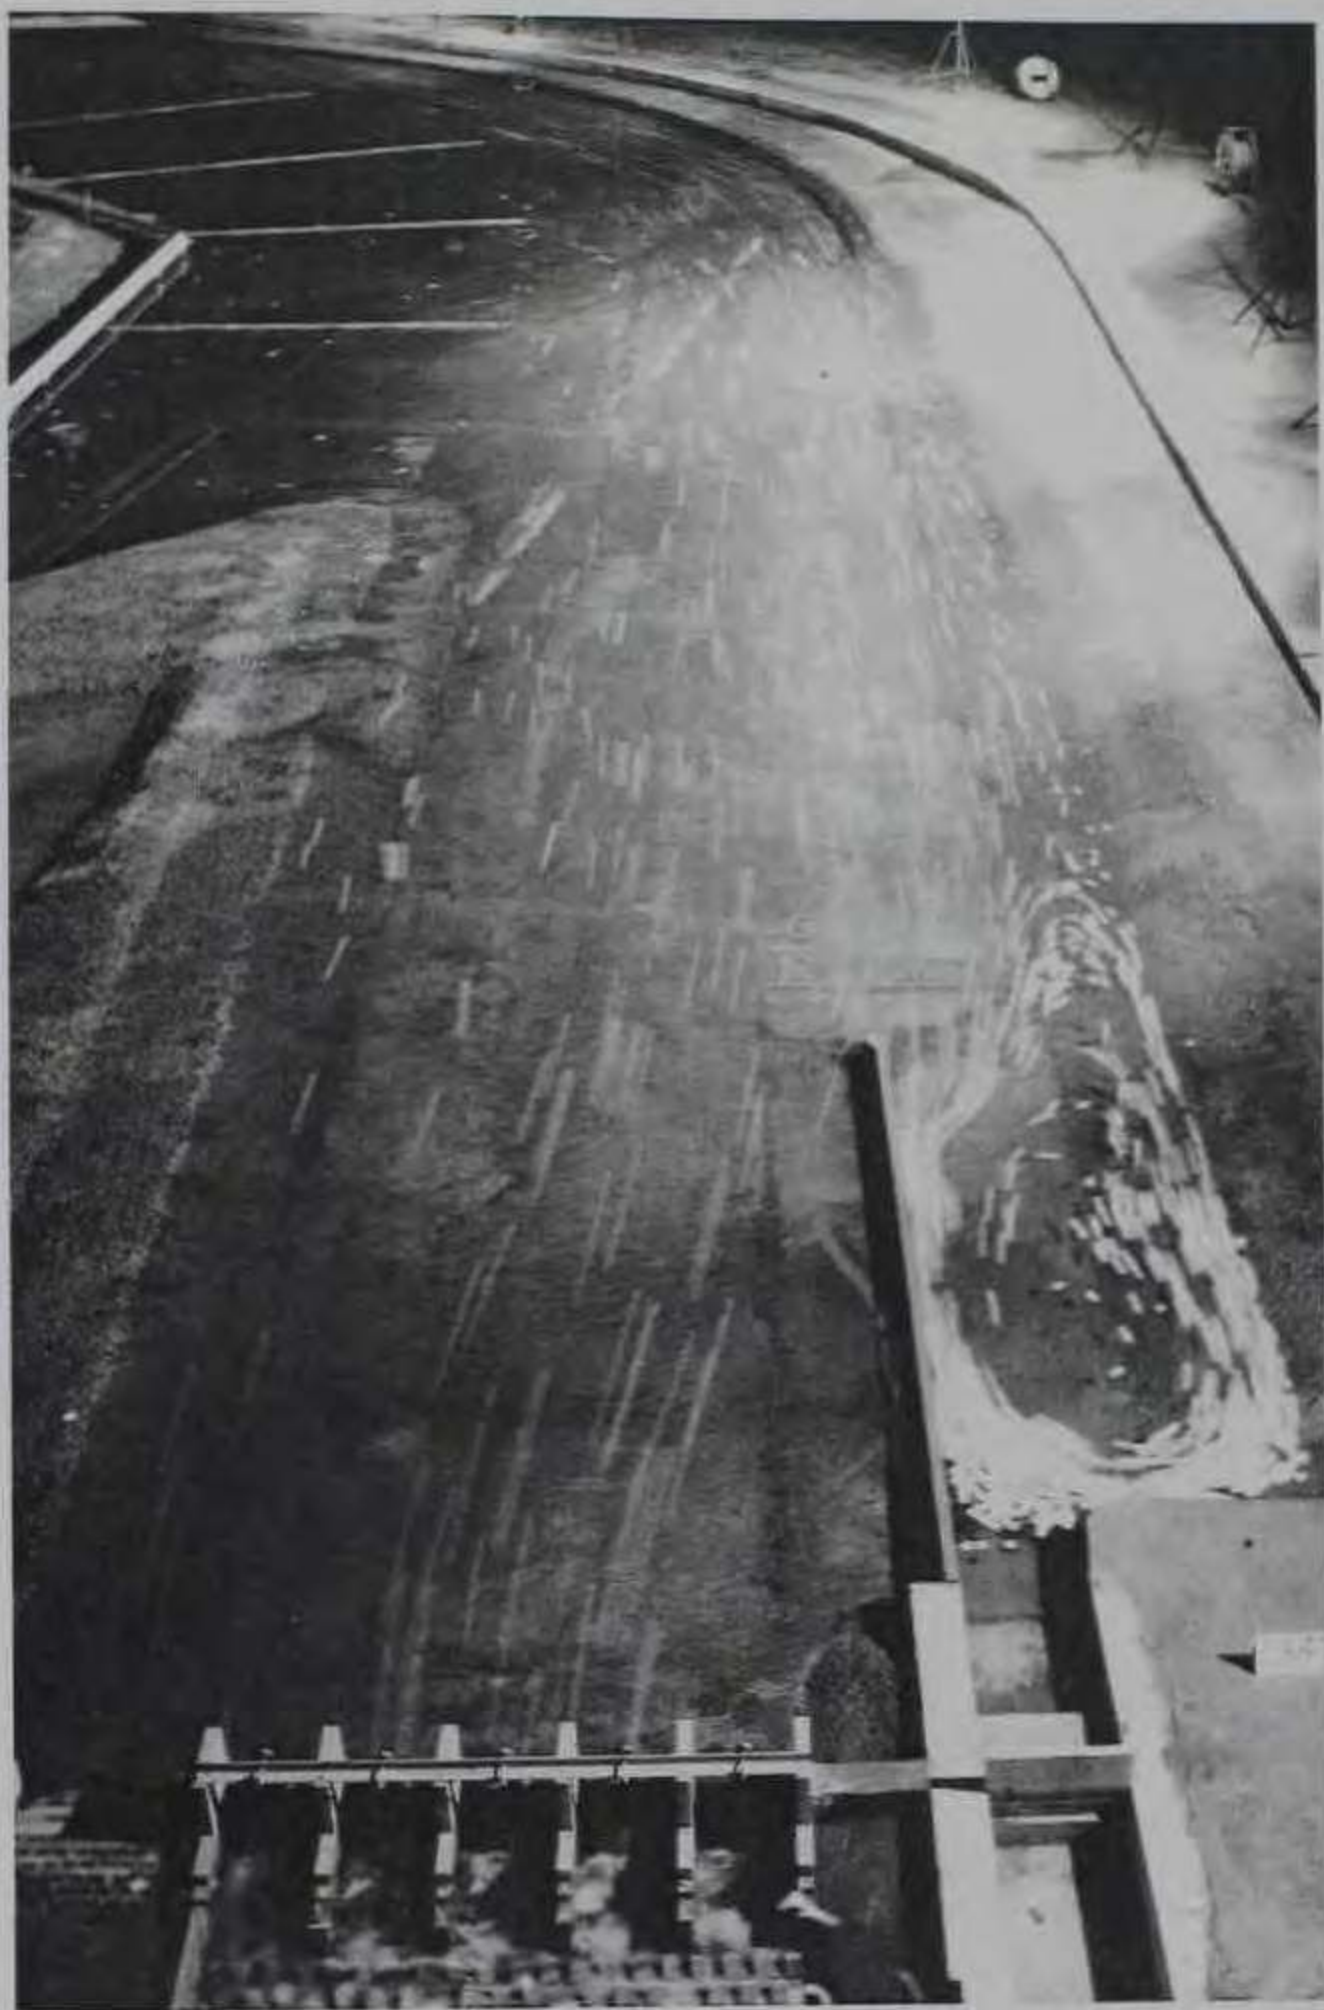
Photo 27. Plan D, looking upstream, discharge 134,000 cfs. Confetti showing surface current patterns. Note large eddy landward of guard wall

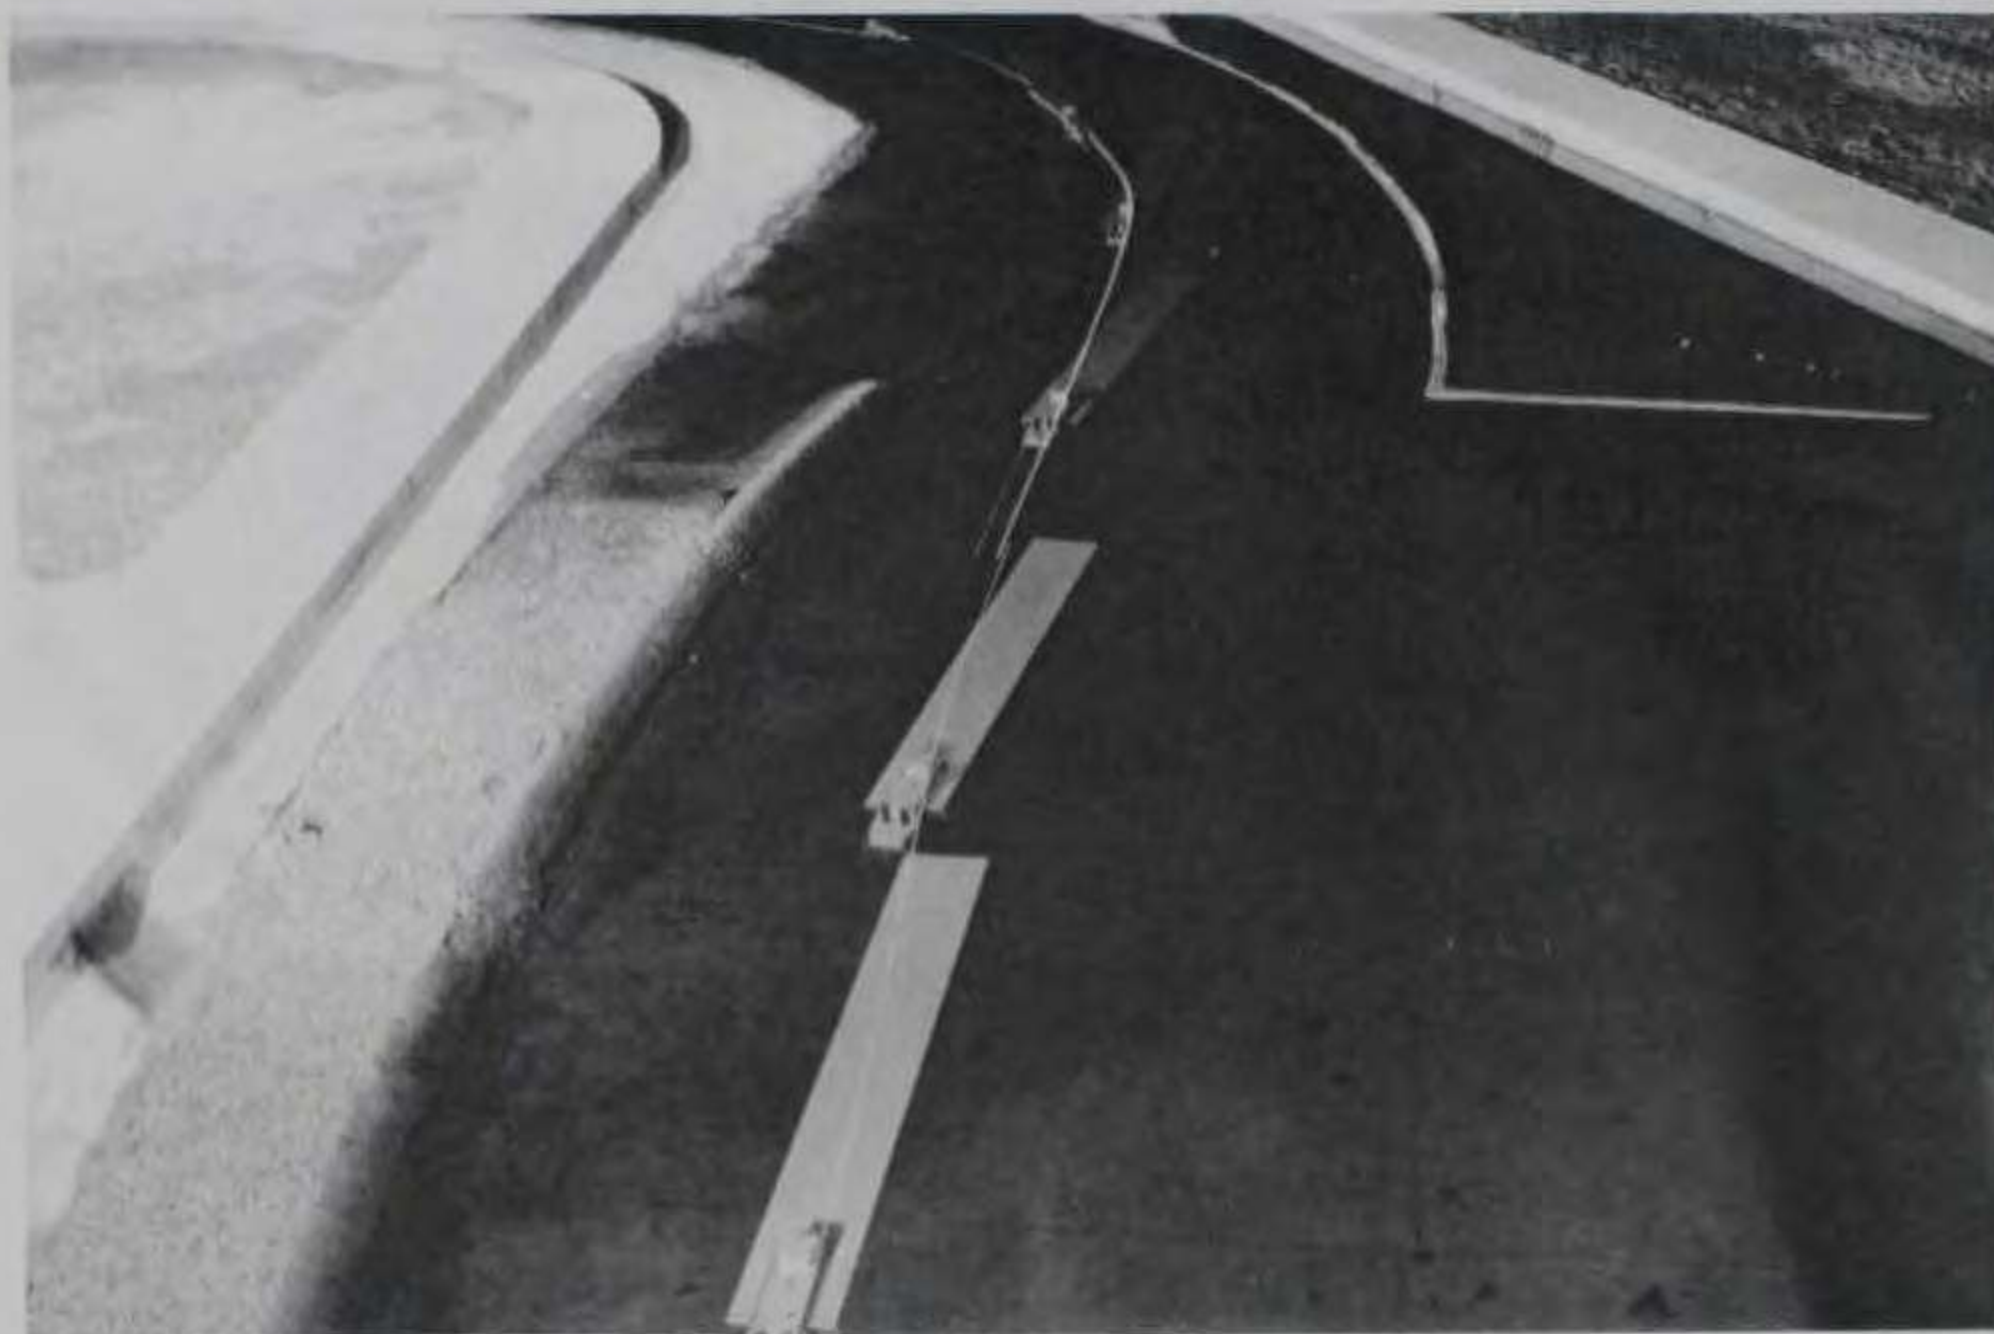
Photo 29. Plan D, looking downstream, discharge 60,000 cfs. Path of downbound tow flanking past Bull Revetment and into Piermont cutoff. Note tendency for currents to move toward submerged portion of Bull Revetment

Navigation conditions for downbound tows entering Piermont cutoff were difficult with all flows. With riverflows of 60,000 cfs and above, a flanking maneuver, as shown in Photo 29, was required to enter Piermont cutoff. The flanking maneuver was considered very difficult due to the high-velocity currents moving across the submerged portion of Bull Revetment. These currents tended to move the tow over the dike very strongly and toward the left bank (Photo 30). Downbound tows that approached Piermont cutoff more midchannel (Photo 29) were not affected as much by the currents moving over the dike. Downbound tows attempting to drive past Bull Revetment, shown in Photo 31, and into Piermont cutoff had a strong tendency to be moved toward or grounded on the right bank.

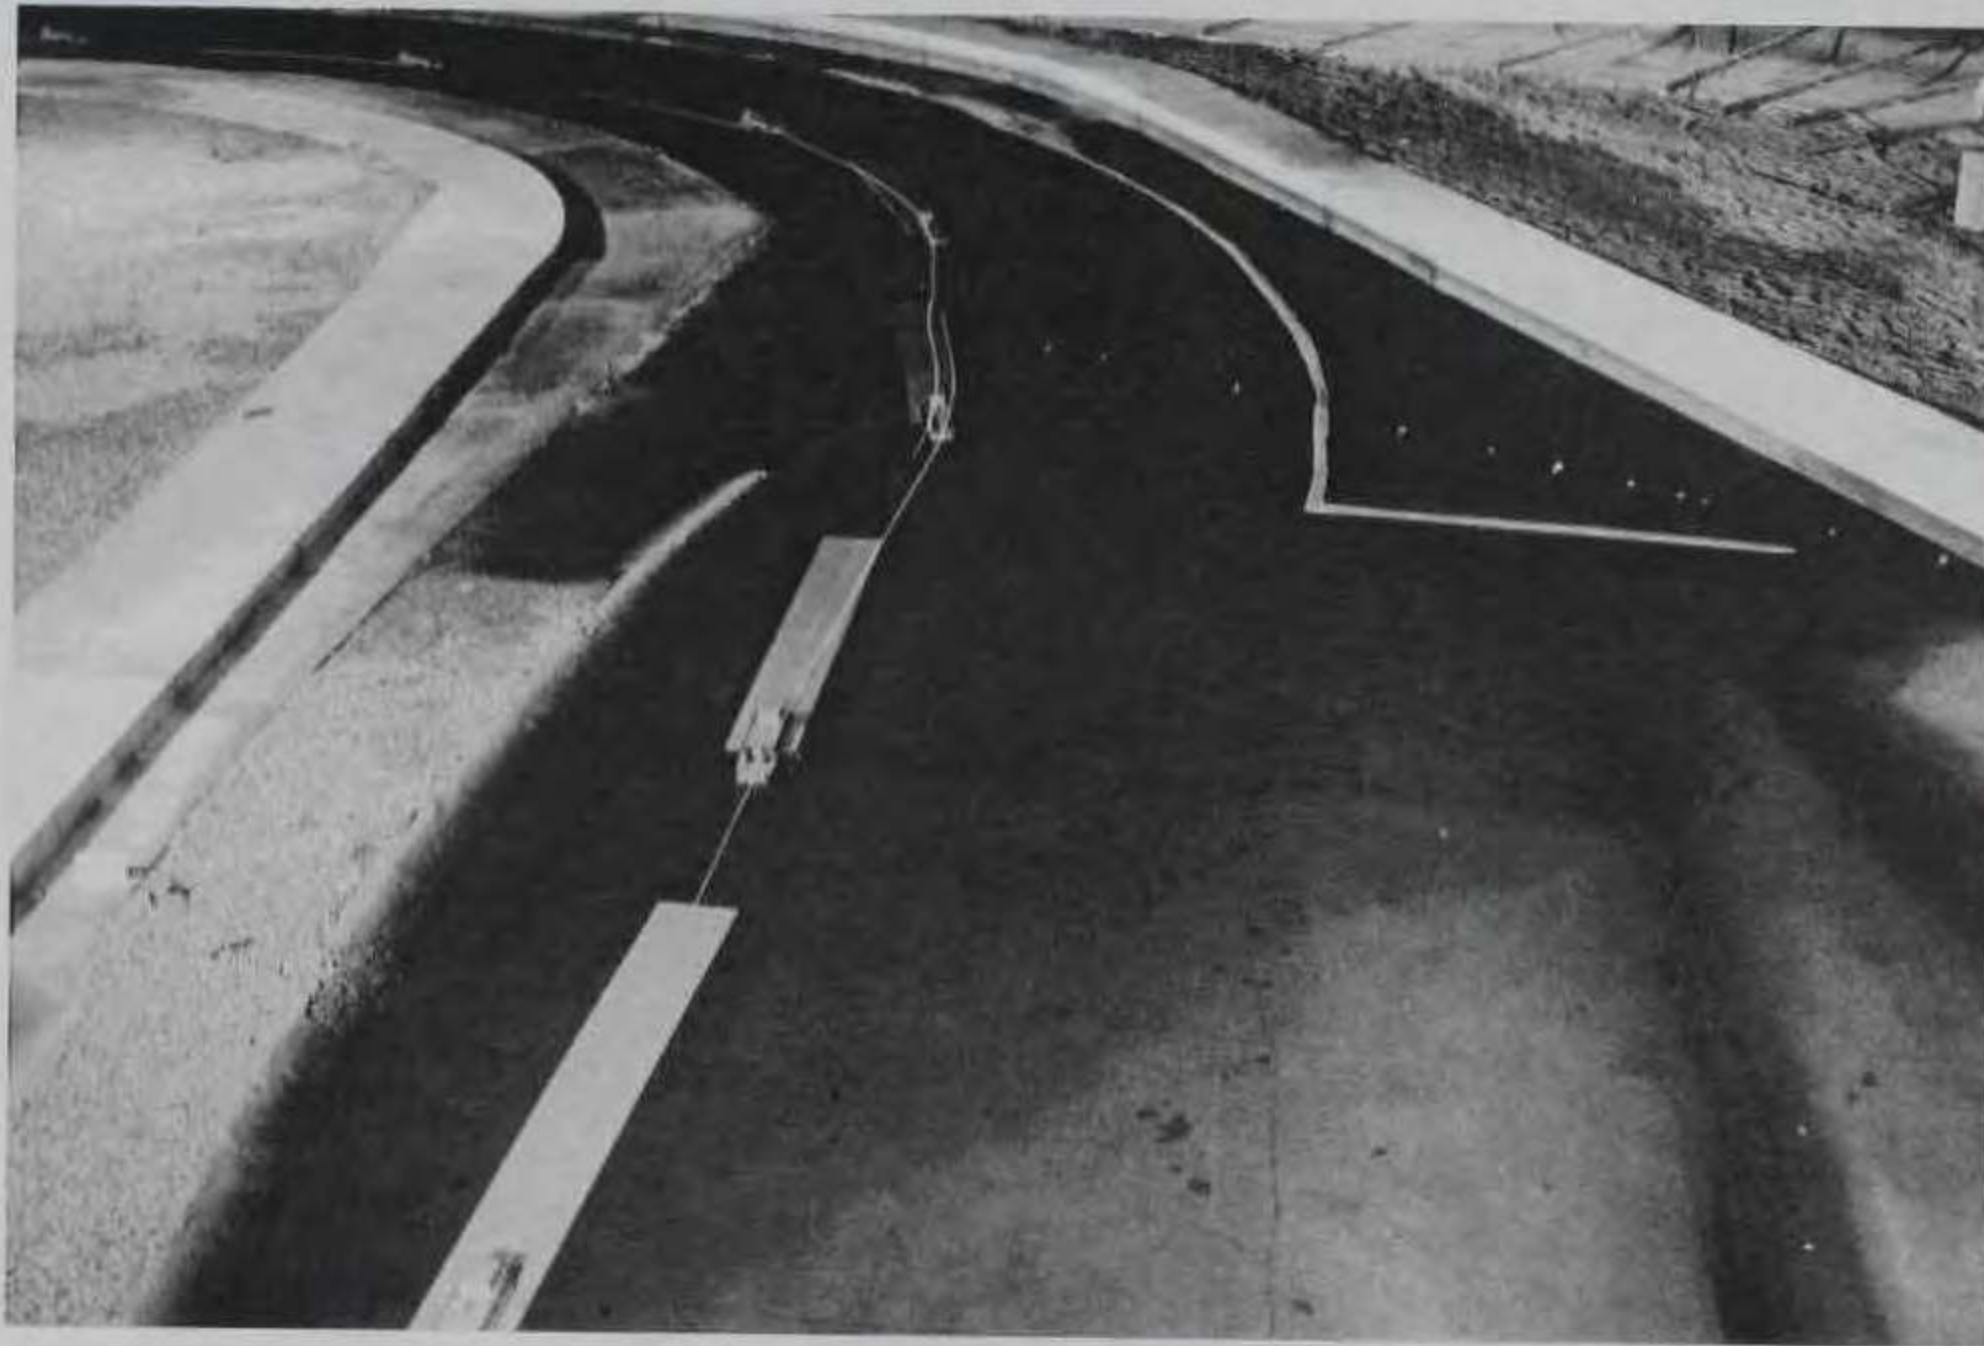
Photo 30. Plan D, looking downstream, discharge 80,000 cfs. Path of downbound tow flanking past Bull Revetment and into Piermont cutoff. Note tendency for currents to move toward left bank in vicinity of Piermont cutoff
