# **Red River Waterway, Lock and Dam No. 4**

## **Report 2**

## **Navigation Alignment Conditions**

## **Hydraulic Model Investigation**

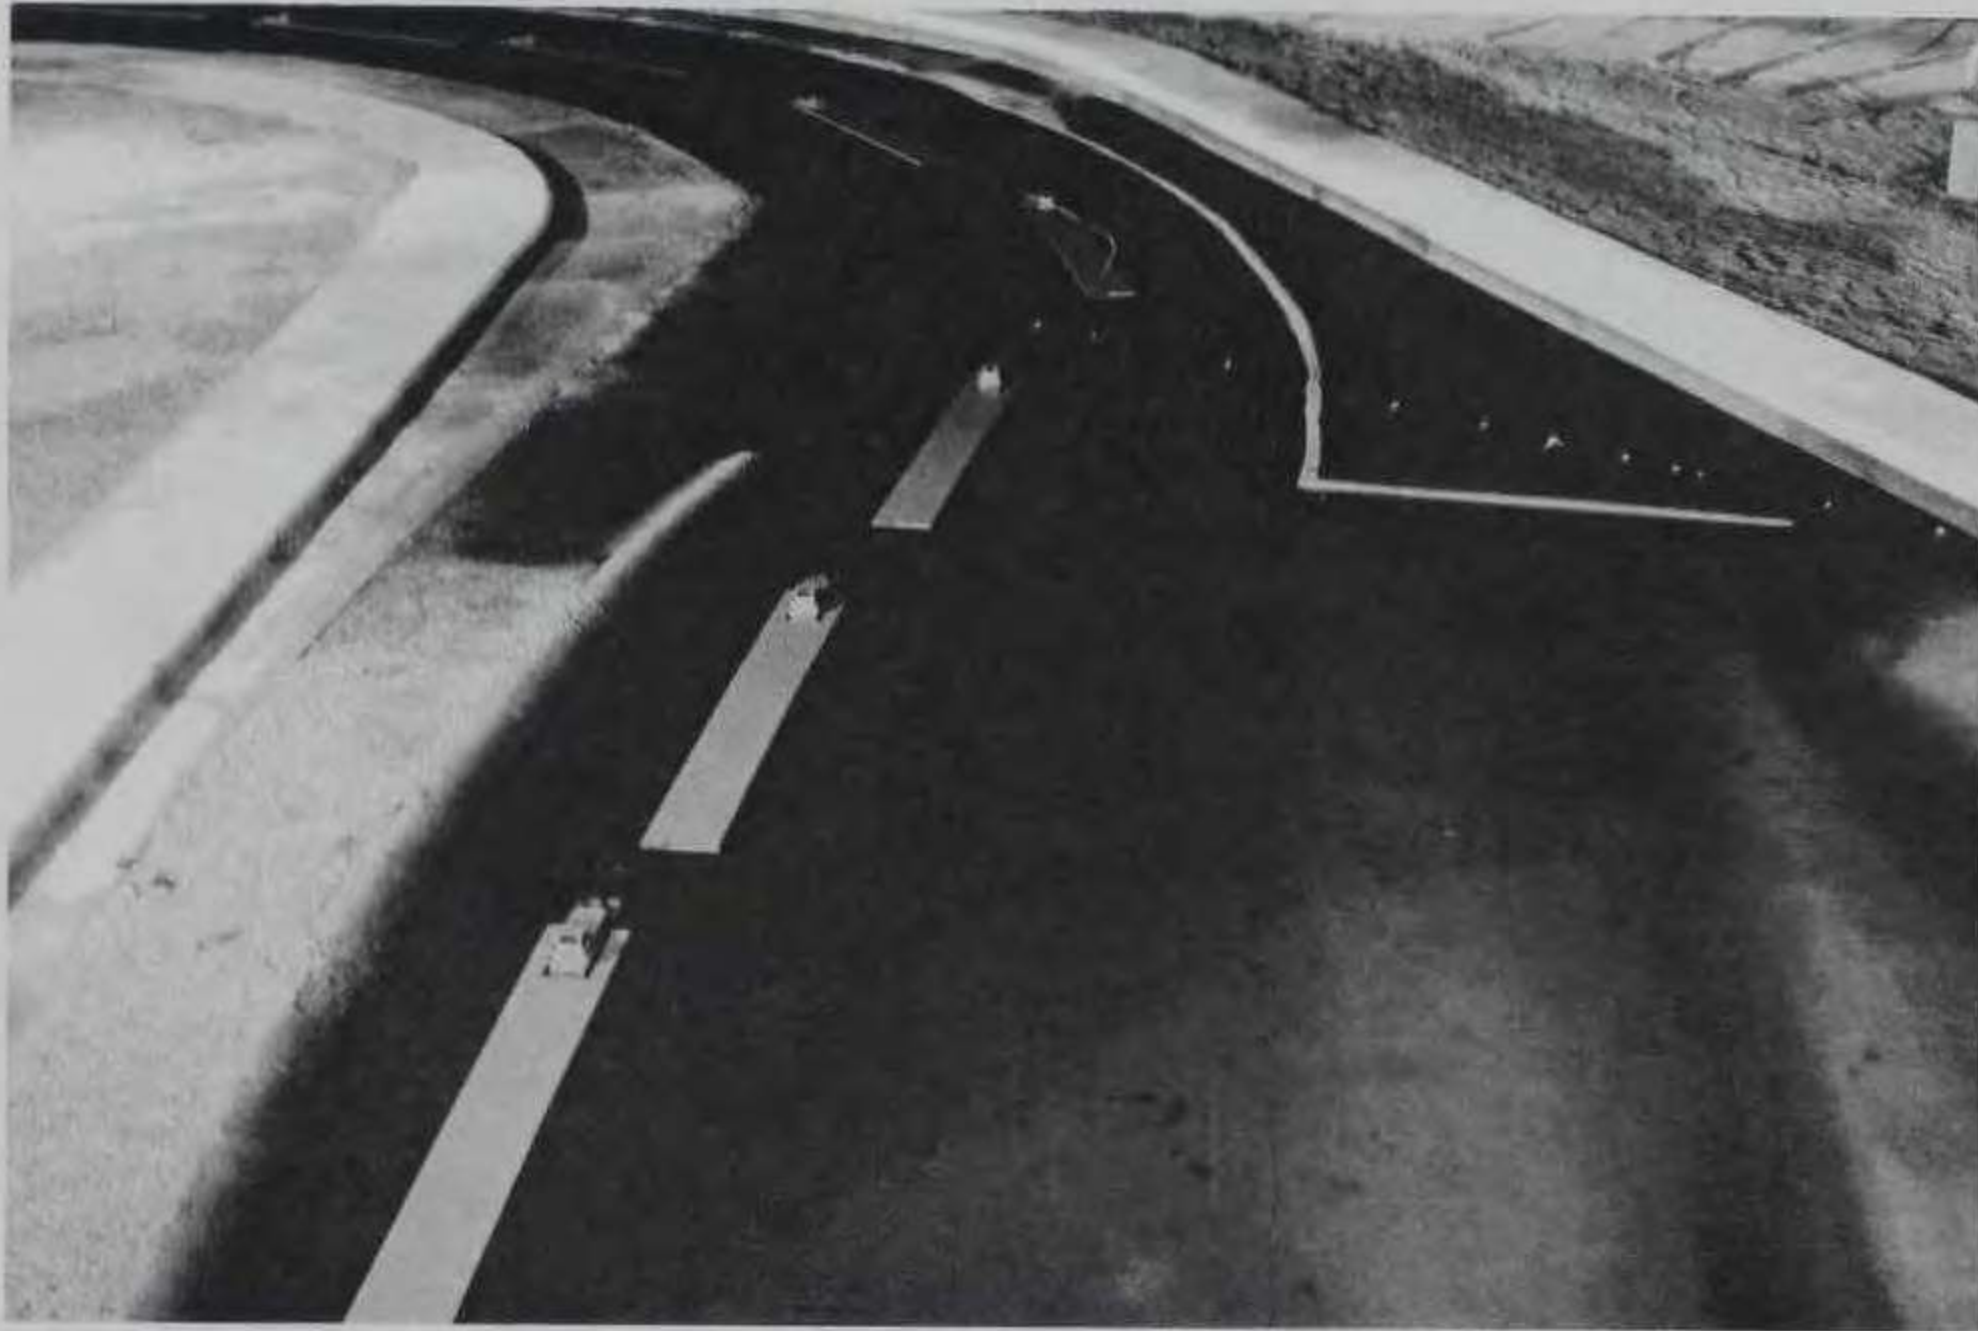
Photo 32. Plan D, looking downstream, discharge 80,000 cfs. Path of upbound tow leaving Piermont cutoff and moving past Bull Revetment. Note tendency for tow to be moved toward Bull Revetment

Navigation conditions were also difficult for upbound tows in this reach of the model. The high-velocity currents moving across the dike and the currents deflected off the right bank revetment tended to move upbound tows from midchannel toward Bull Revetment (Photo 32). Upbound tows leaving Piermont cutoff and moving upstream over the submerged portion of Bull Revetment experienced a very strong tendency to be moved toward or into Bull Revetment. An underpowered tow could experience serious navigation difficulty in this reach of the study.

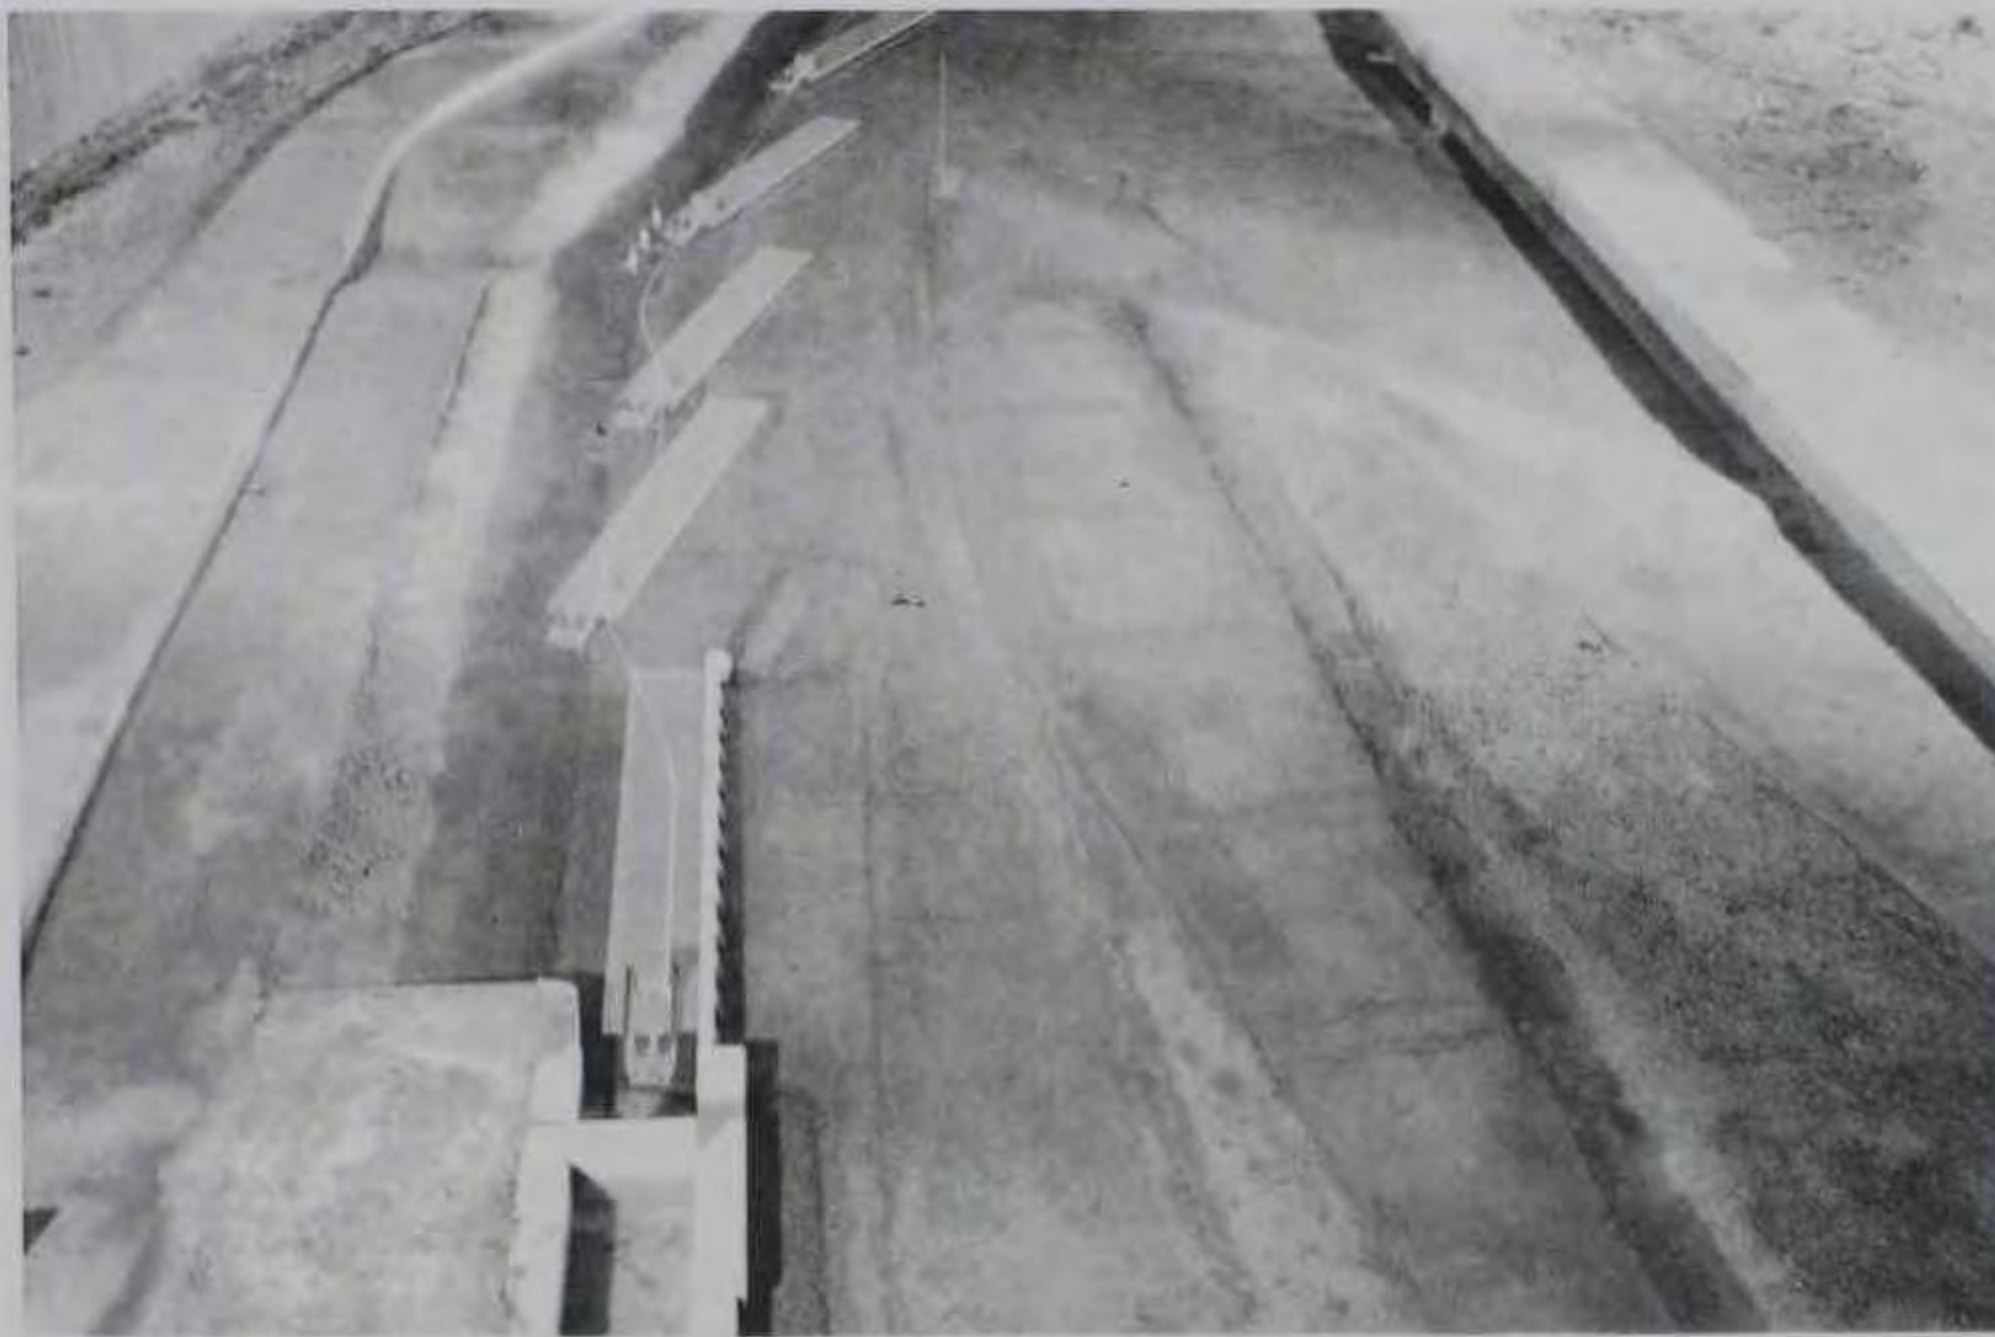
Photo 35. Plan D, looking downstream, discharge 80,000 cfs. Path of downbound tow leaving the lower lock approach. Note tendency for currents to move toward left bank and into mooring dolphins

Navigation conditions were unsatisfactory for downbound tows leaving the lower lock approach with all flows. Downbound tows leaving the lock were pushed toward or into the left bank by the flow moving across the lower lock approach (Photo 35). The mooring dolphins located about 1,000 ft downstream

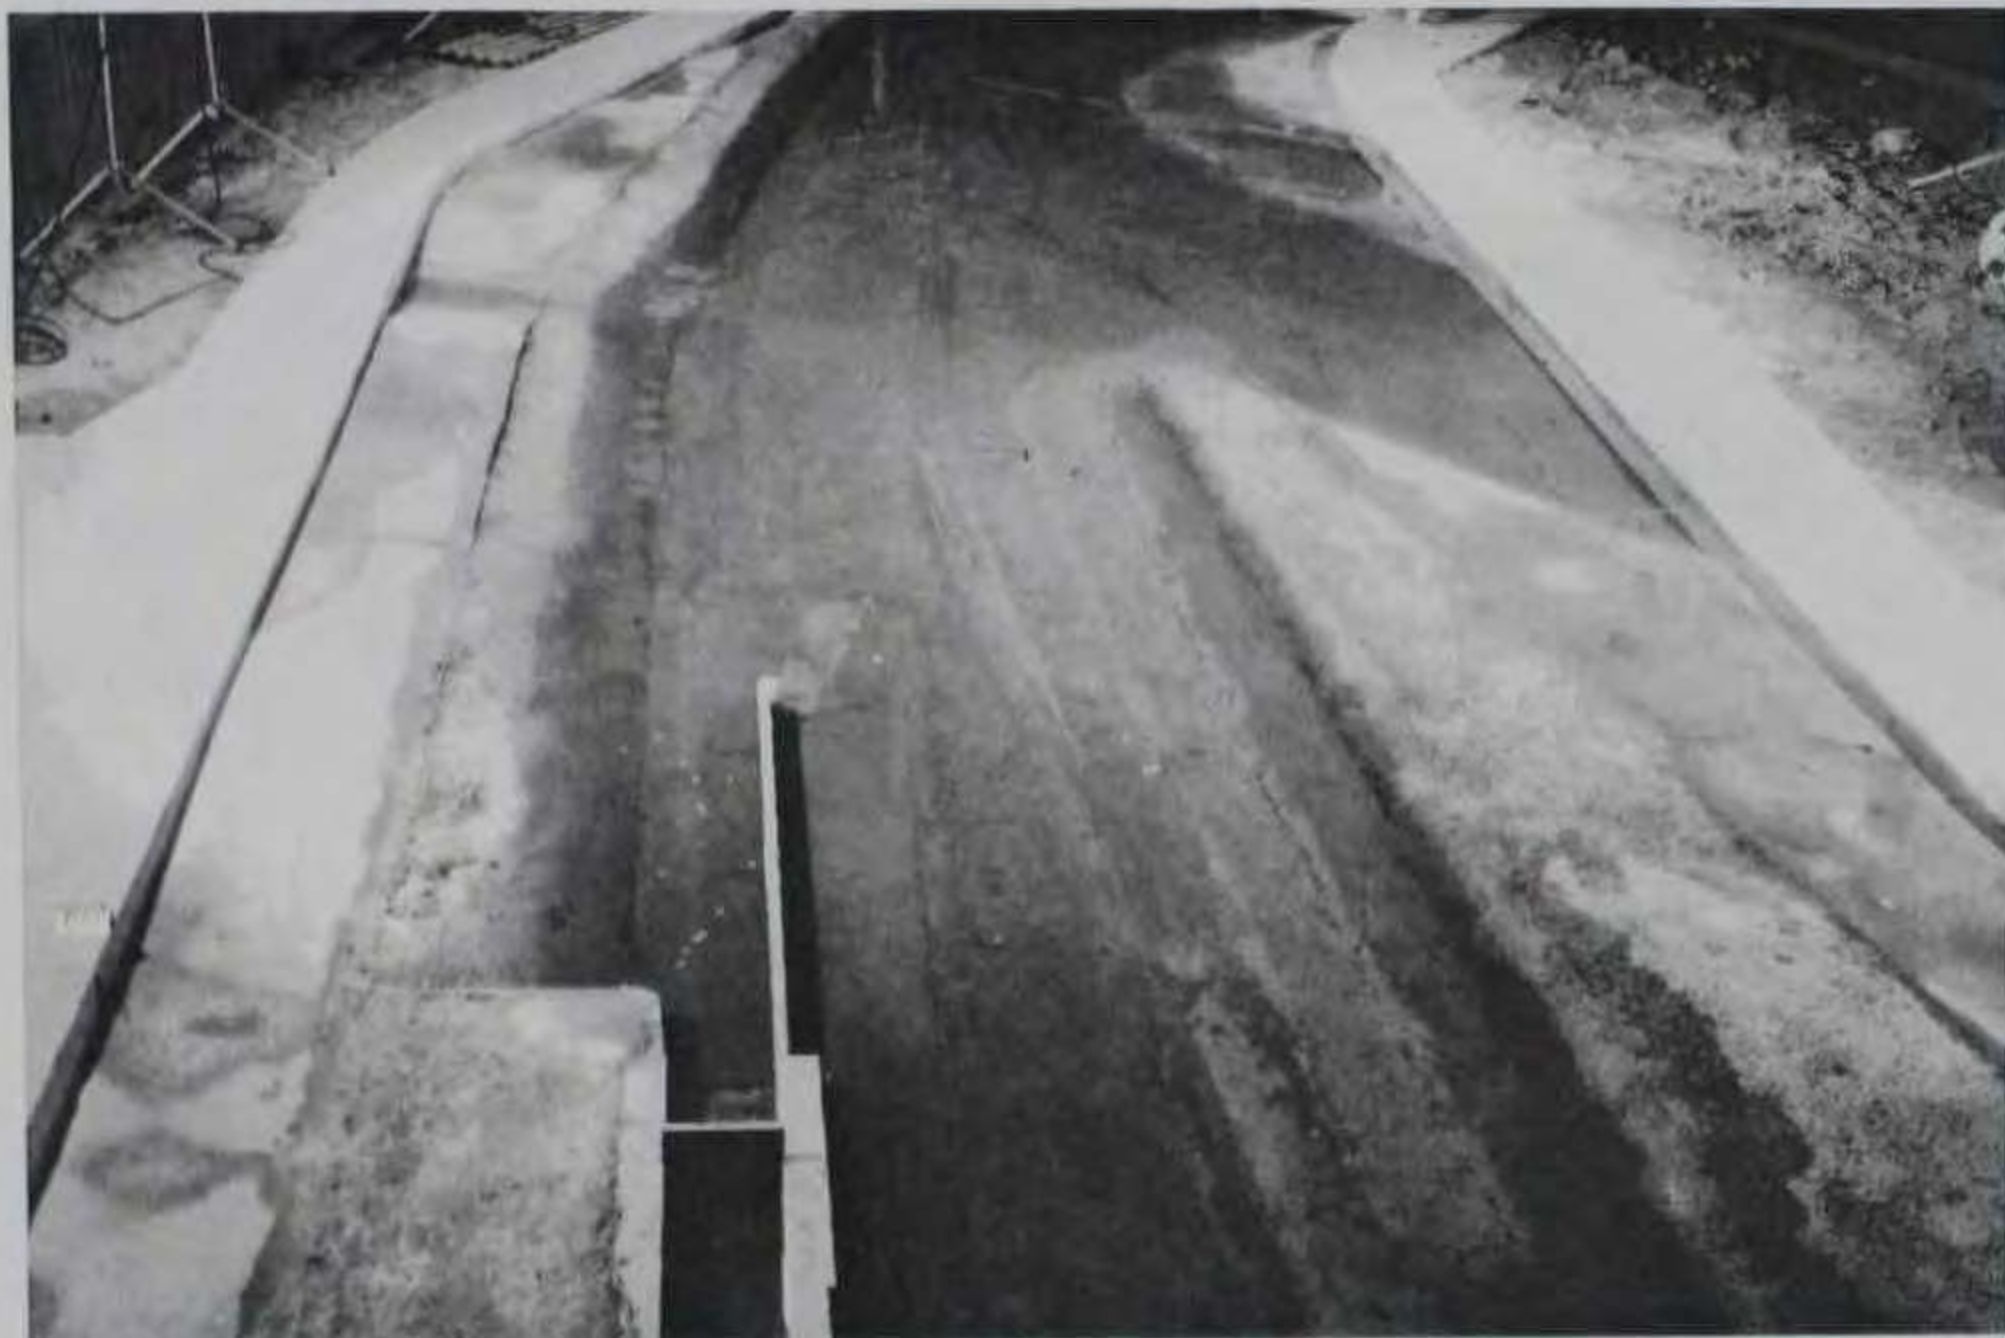
Photo 37. Plan D-2, looking downstream, showing the lower lock approach

Plan D-2, shown in Figure 14 and Photo 37, was the same as Plan D-1 with one exception. The width of the downstream overflow berm with top el 100 on the right bank was reduced to 100 ft wide, thus widening the channel. The transition from the fifth gate bay was revised to accommodate this change. The lower lock approach has a minimum width of 450 ft with bottom el 81.0.

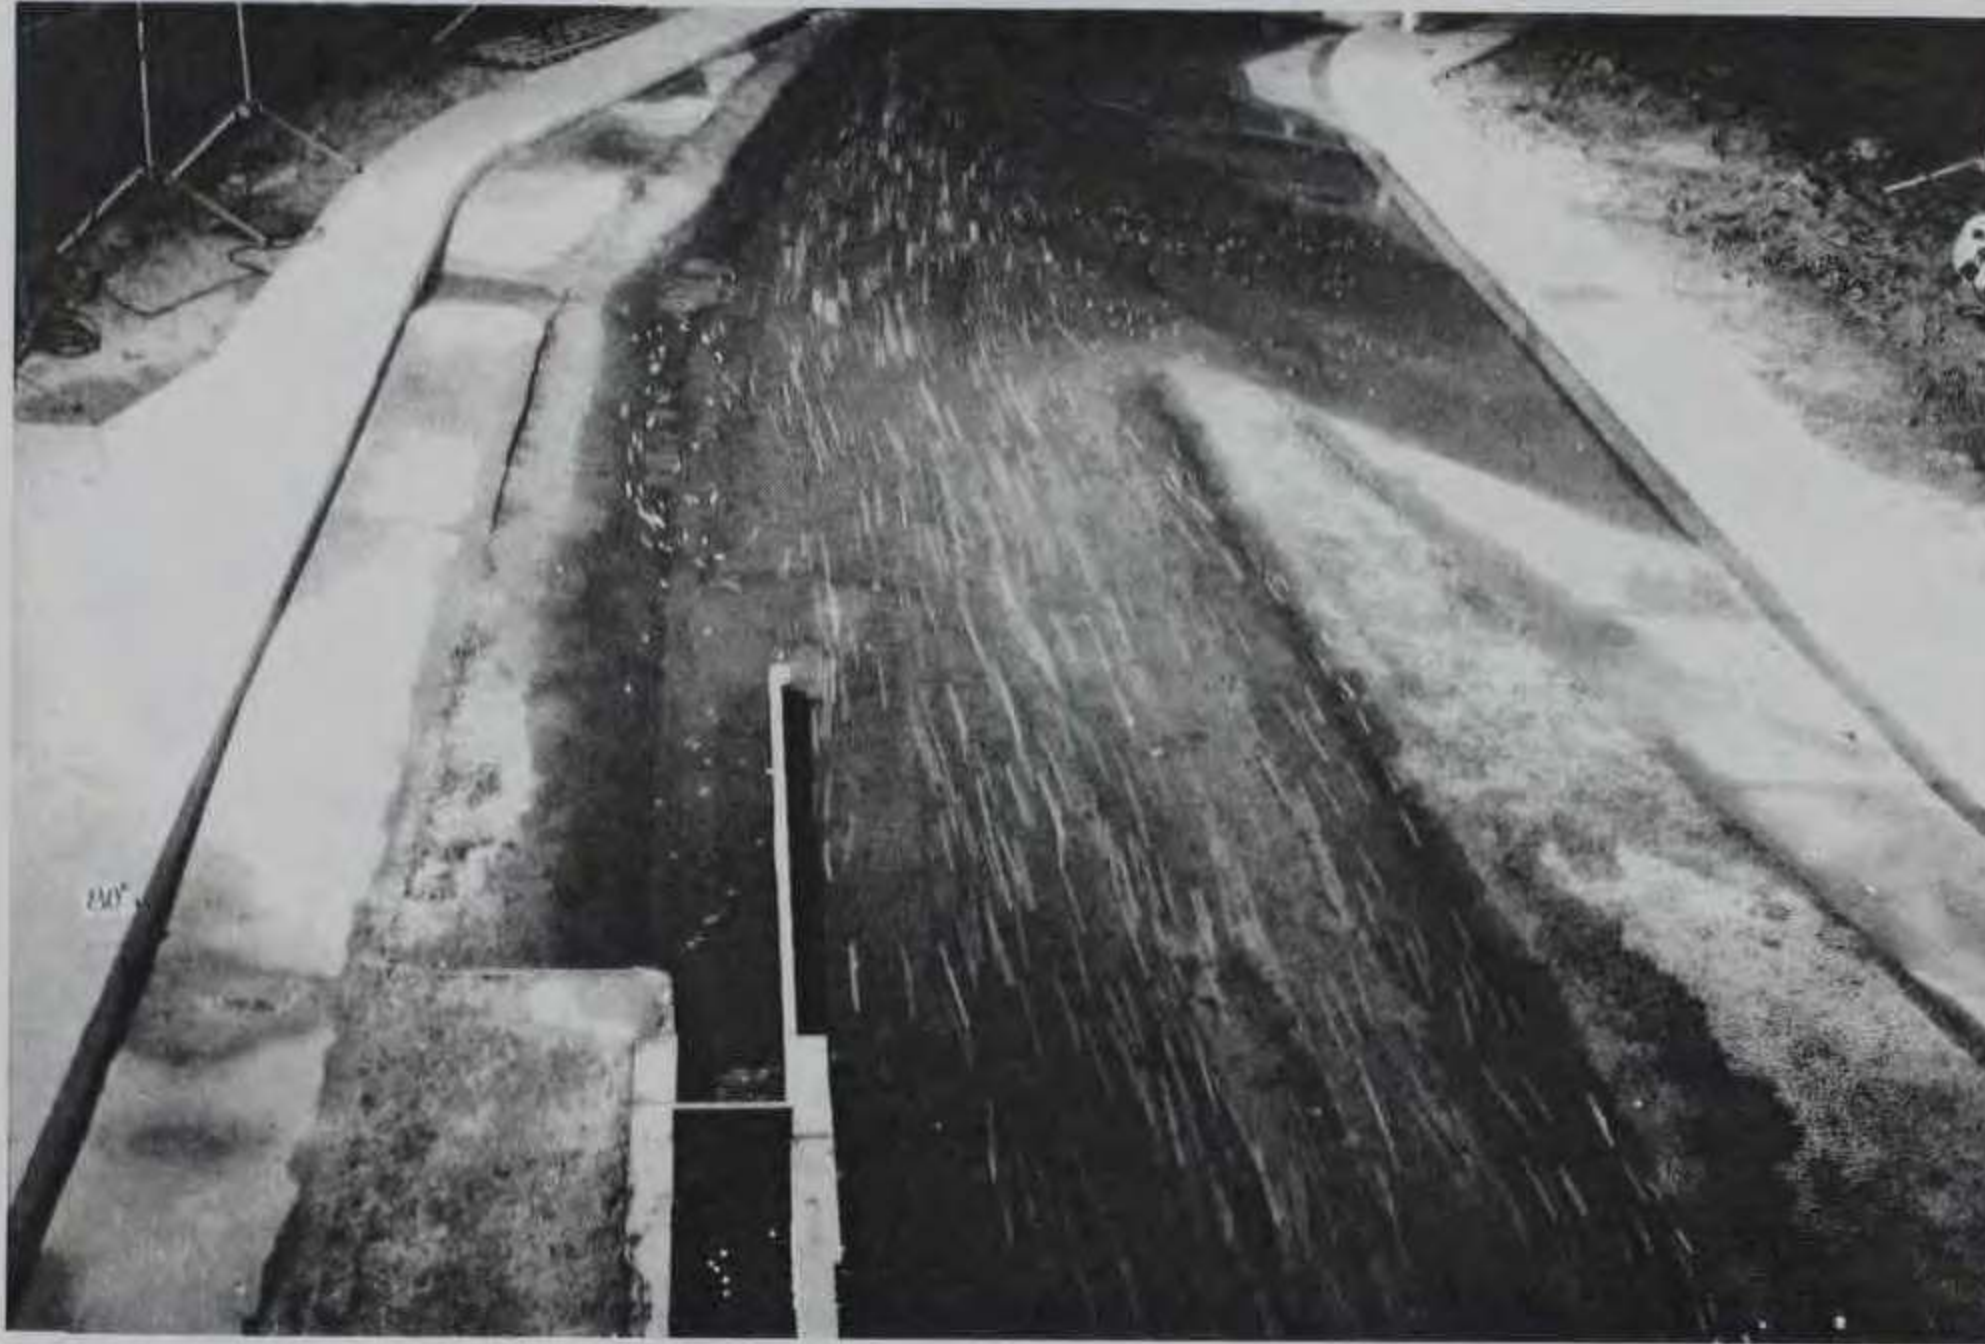
Photo 38. Plan D-2, looking downstream, discharge 80,000 cfs. Confetti showing surface current patterns

Current direction and velocity data are shown in Plates 29-33, and surface current patterns are shown in Photo 38. Current direction and velocity data indicate a 5 to 10 percent reduction in the velocity of the current in the excavated channel. The flow was more evenly distributed across the excavated channel than with Plan D-1. The intensity of the eddy in the lower lock approach was also reduced. The maximum current velocity recorded across the lower lock approach was about 5.0 fps with a riverflow of 100,000 cfs. The maximum upstream current velocity in the eddy in the lower lock approach was about 2.0 fps with a riverflow of 100,000 cfs.

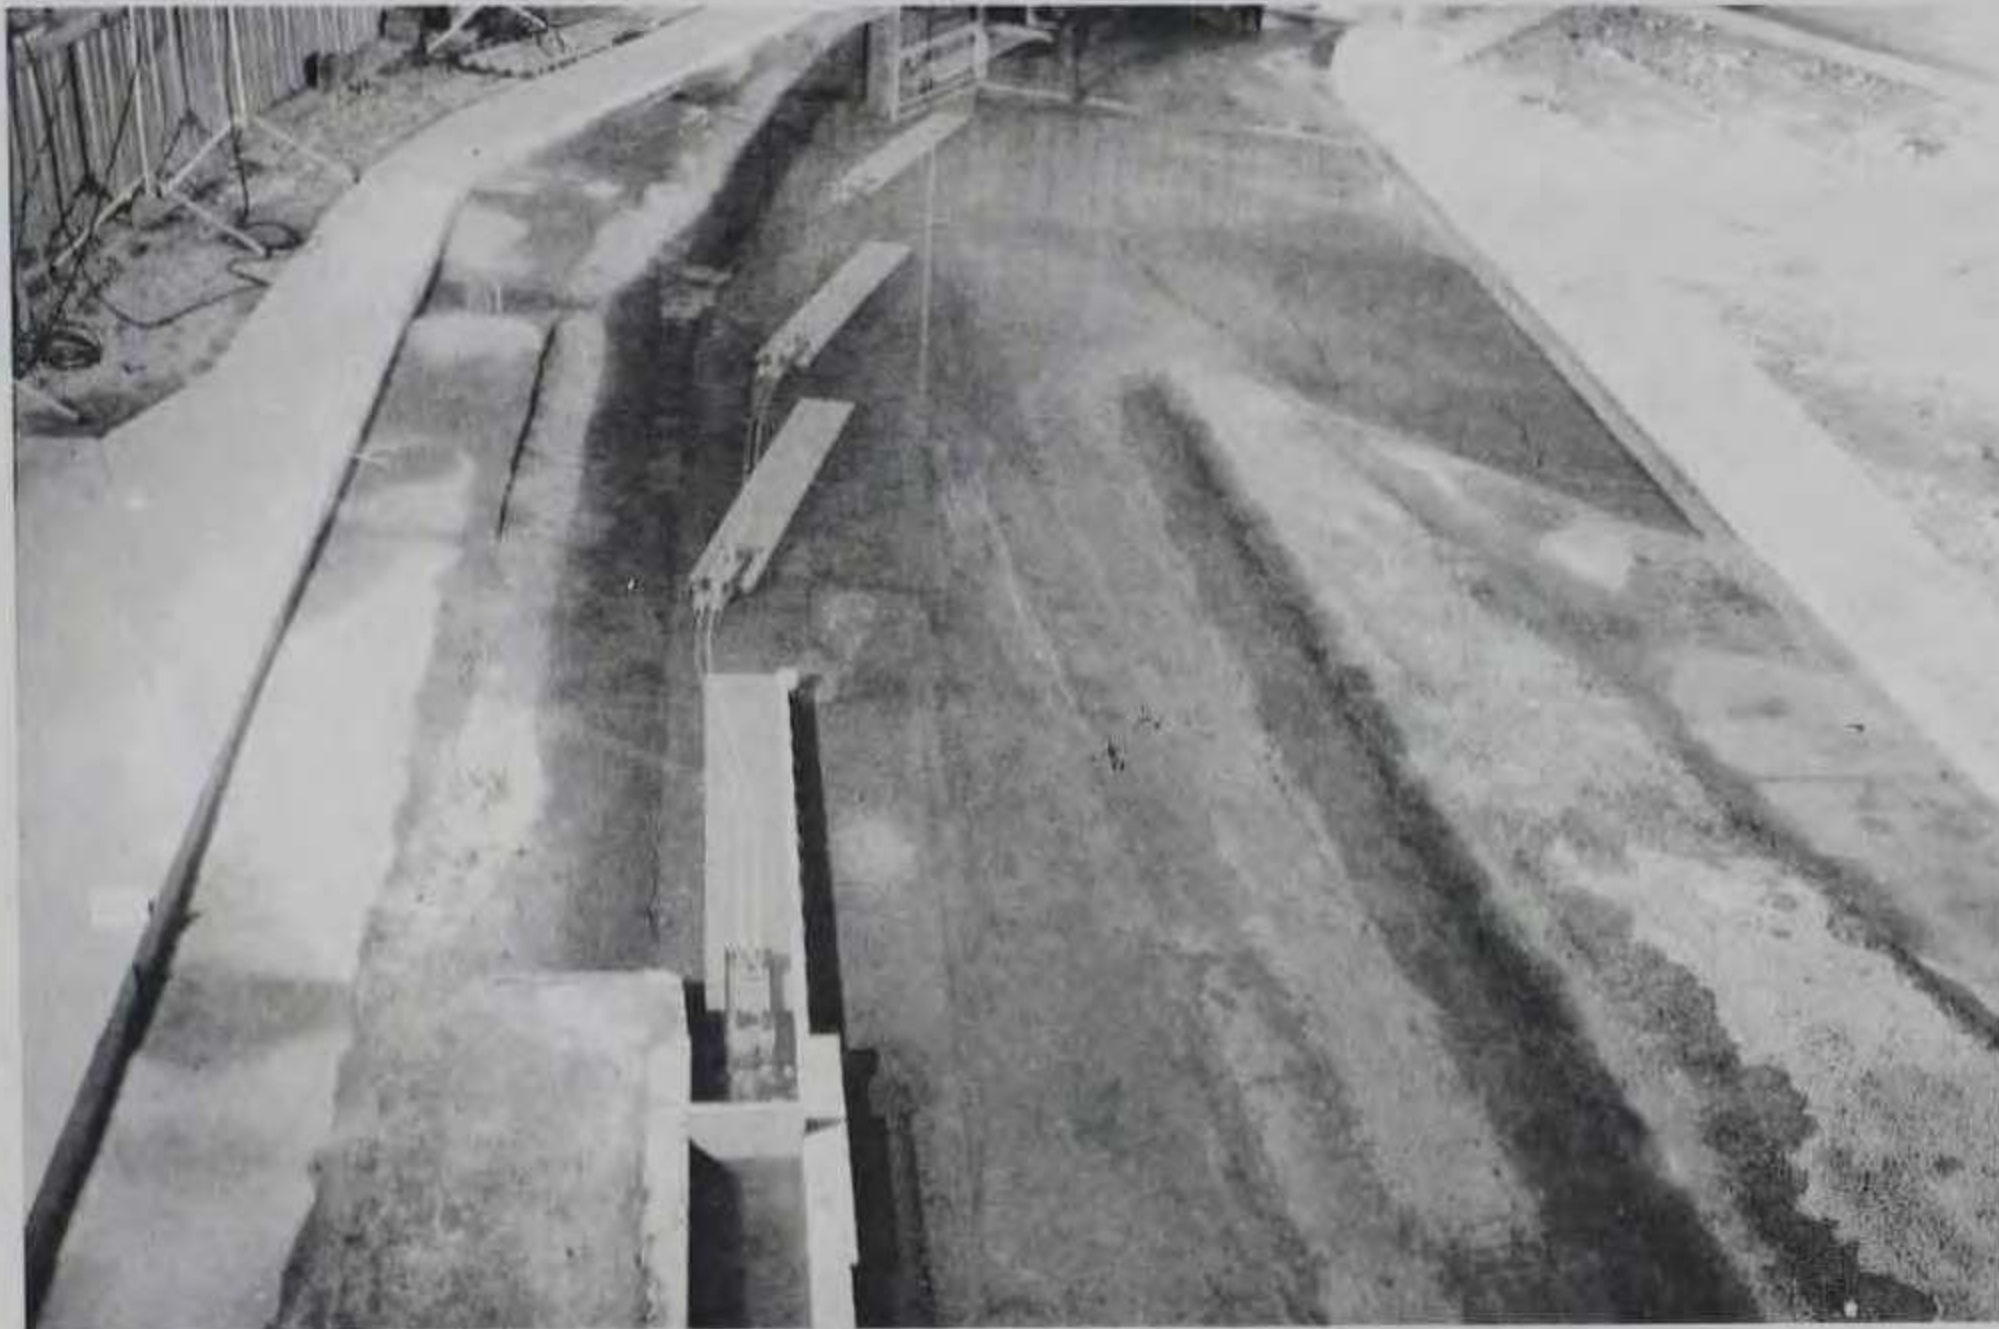
Photo 39. Plan D-2, looking downstream, discharge 80,000 cfs. Path of downbound tow leaving the lower lock approach

Navigation conditions were satisfactory and improved compared with those of Plan D-1 for downbound tows leaving the lower lock approach with all flows. Improvement was due to an overall reduction in velocities in the lower lock approach channel. Downbound tows could push out of the protection of the guard wall, take a set toward midchannel, and proceed downstream with no significant difficulties (Photo 39). Since the lower lock approach was in a slight bend, downbound tows were required to drive away from the left bank to keep from being grounded. There was a tendency for downbound tows to be moved toward the left bank.

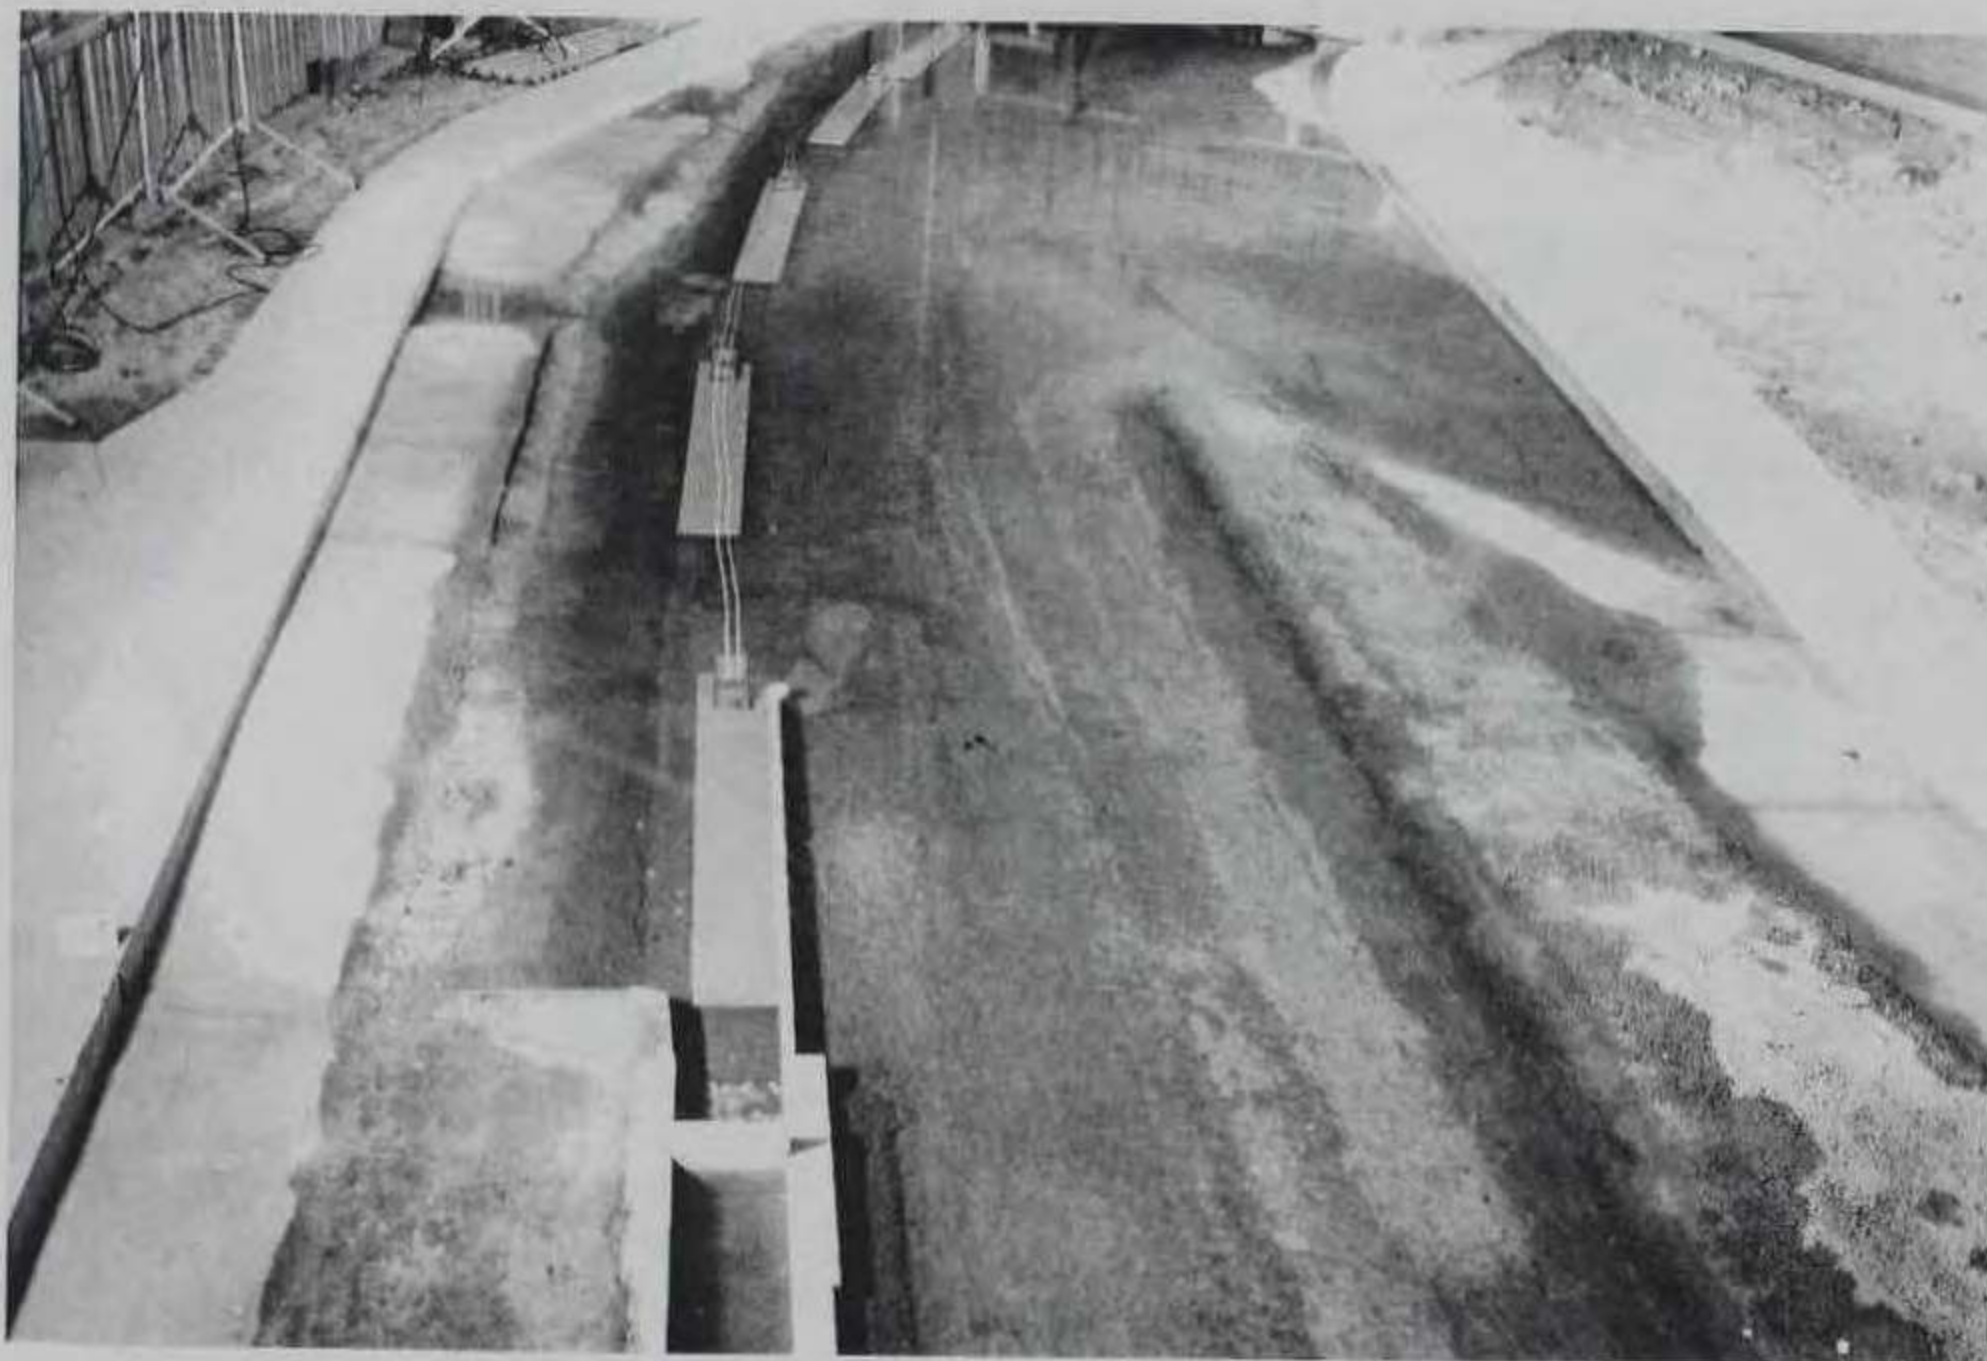
Photo 40. Plan D-2, looking downstream, discharge 134,000 cfs. Path of upbound tow entering the lower lock approach

Navigation conditions were satisfactory for upbound tows entering the lower lock approach with all flows (Photo 40). However, some maneuvering was required for upbound tows to align with and enter the lock chamber due to the eddy in the lower lock approach.

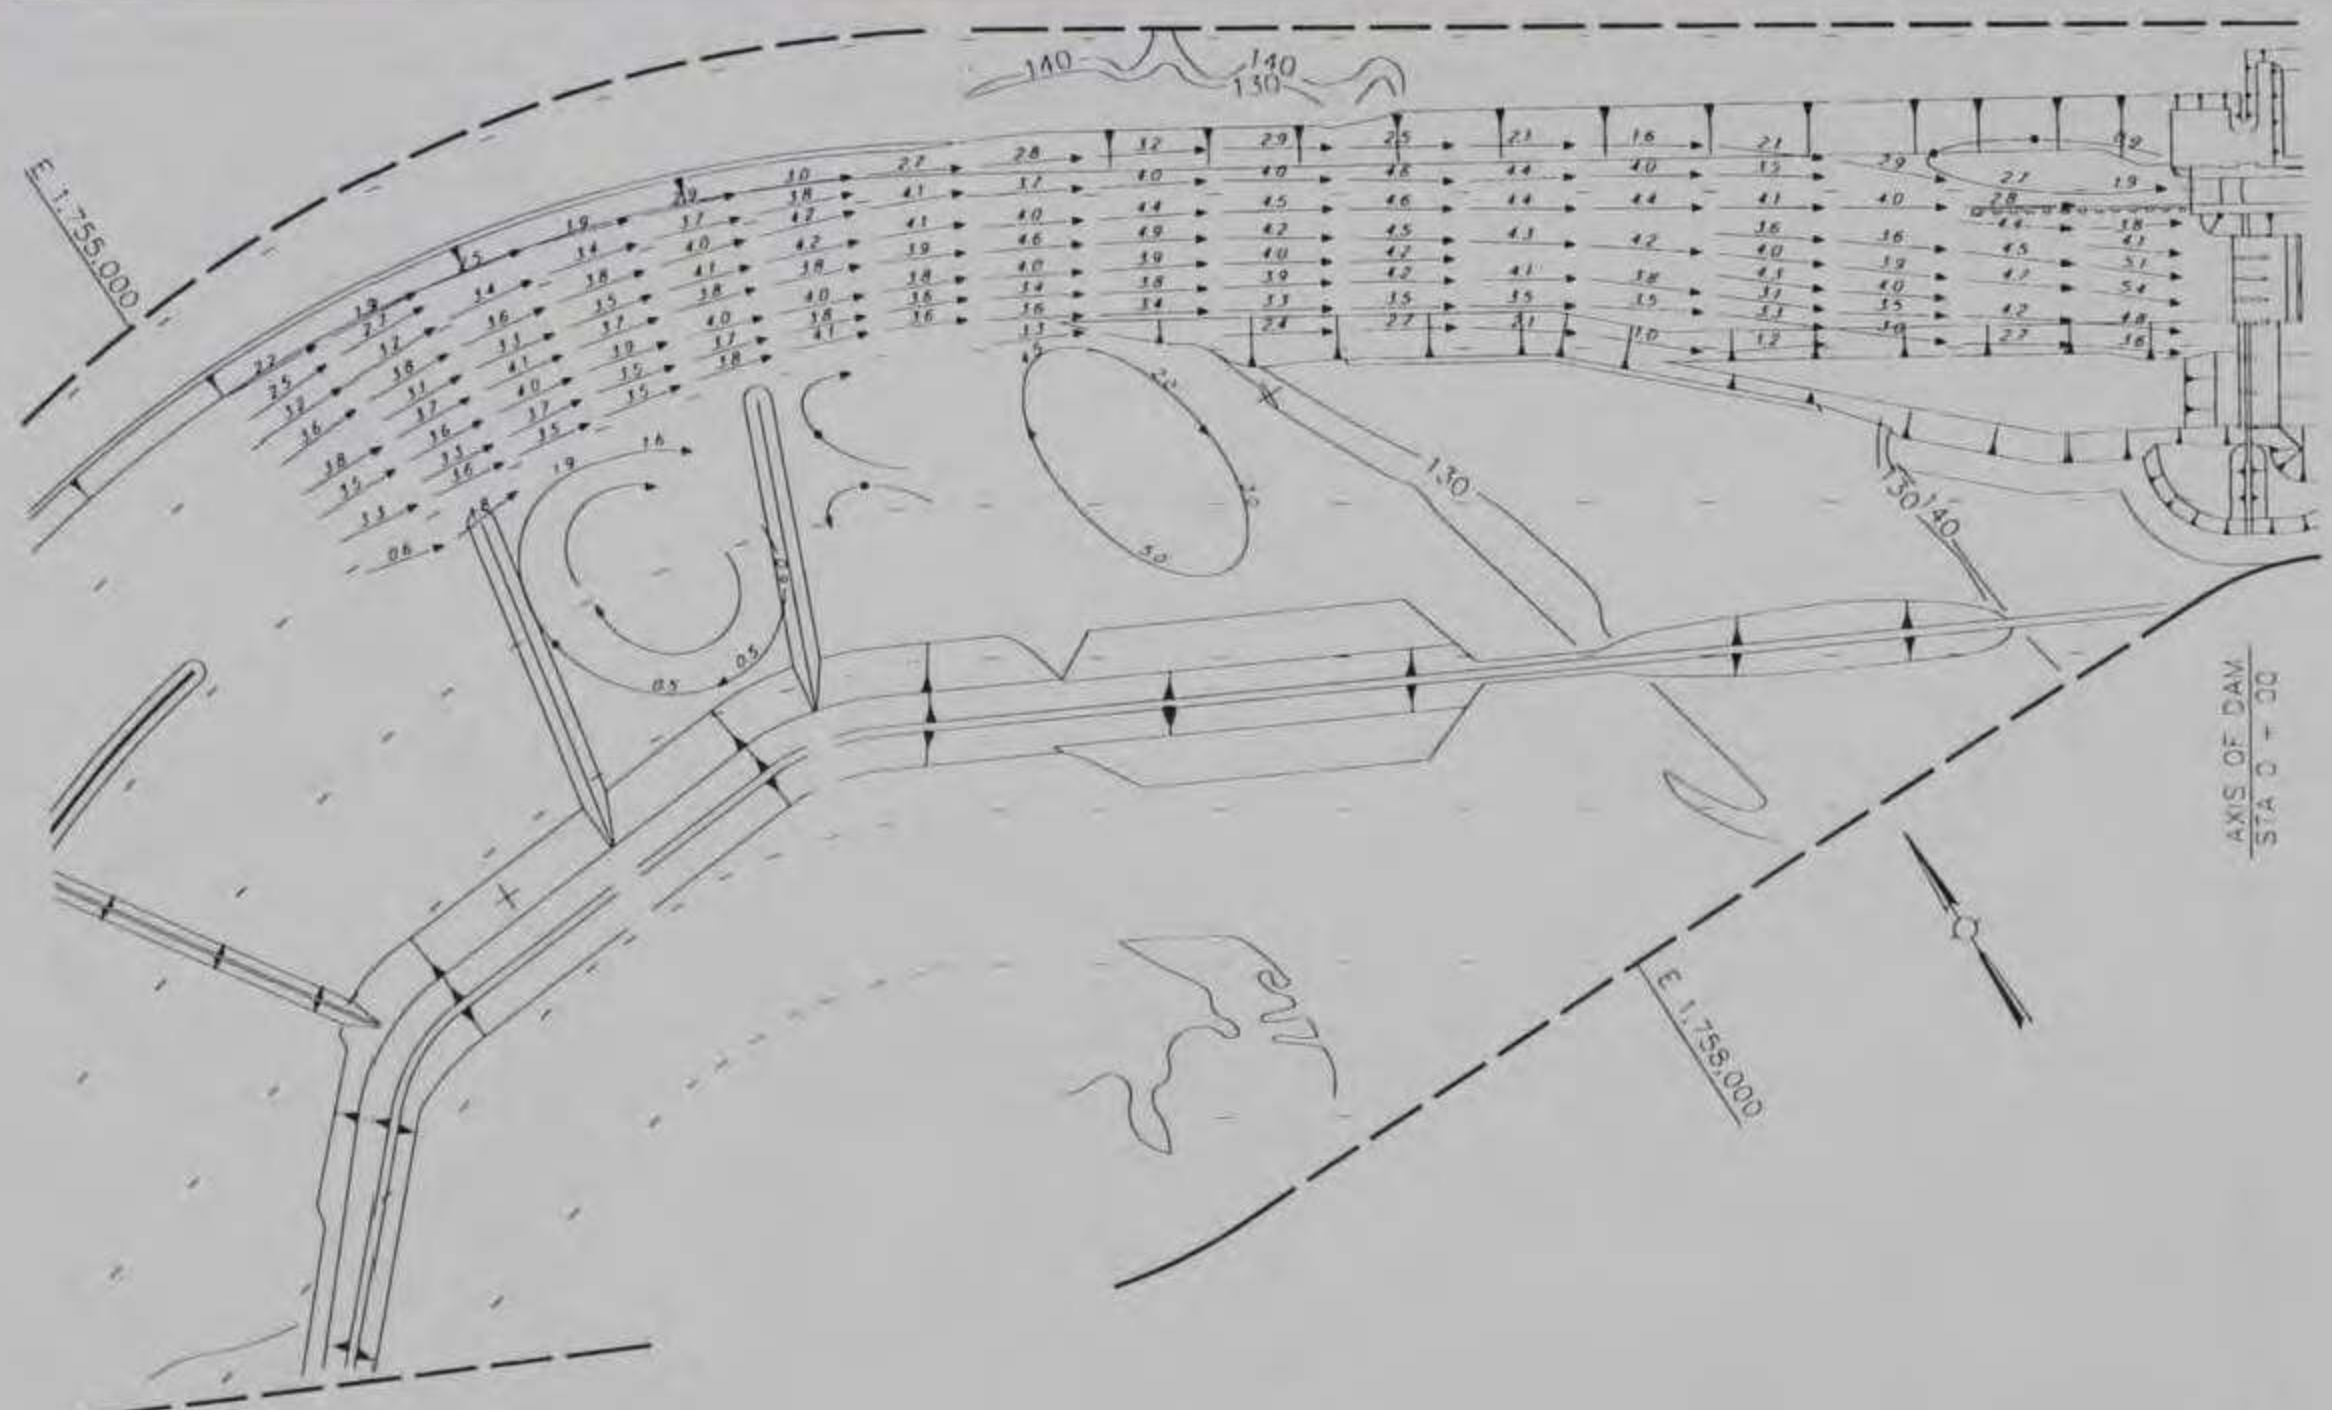
VELOCITIES AND CURRENT DIRECTIONS  
 PLAN C-2

DISCHARGE: 60,000 CFS  
 TAILWATER EL: 108.4 FT
