# **Red River Waterway, Lock and Dam No. 4**

## **Report 2**

## **Navigation Alignment Conditions**

## **Hydraulic Model Investigation**

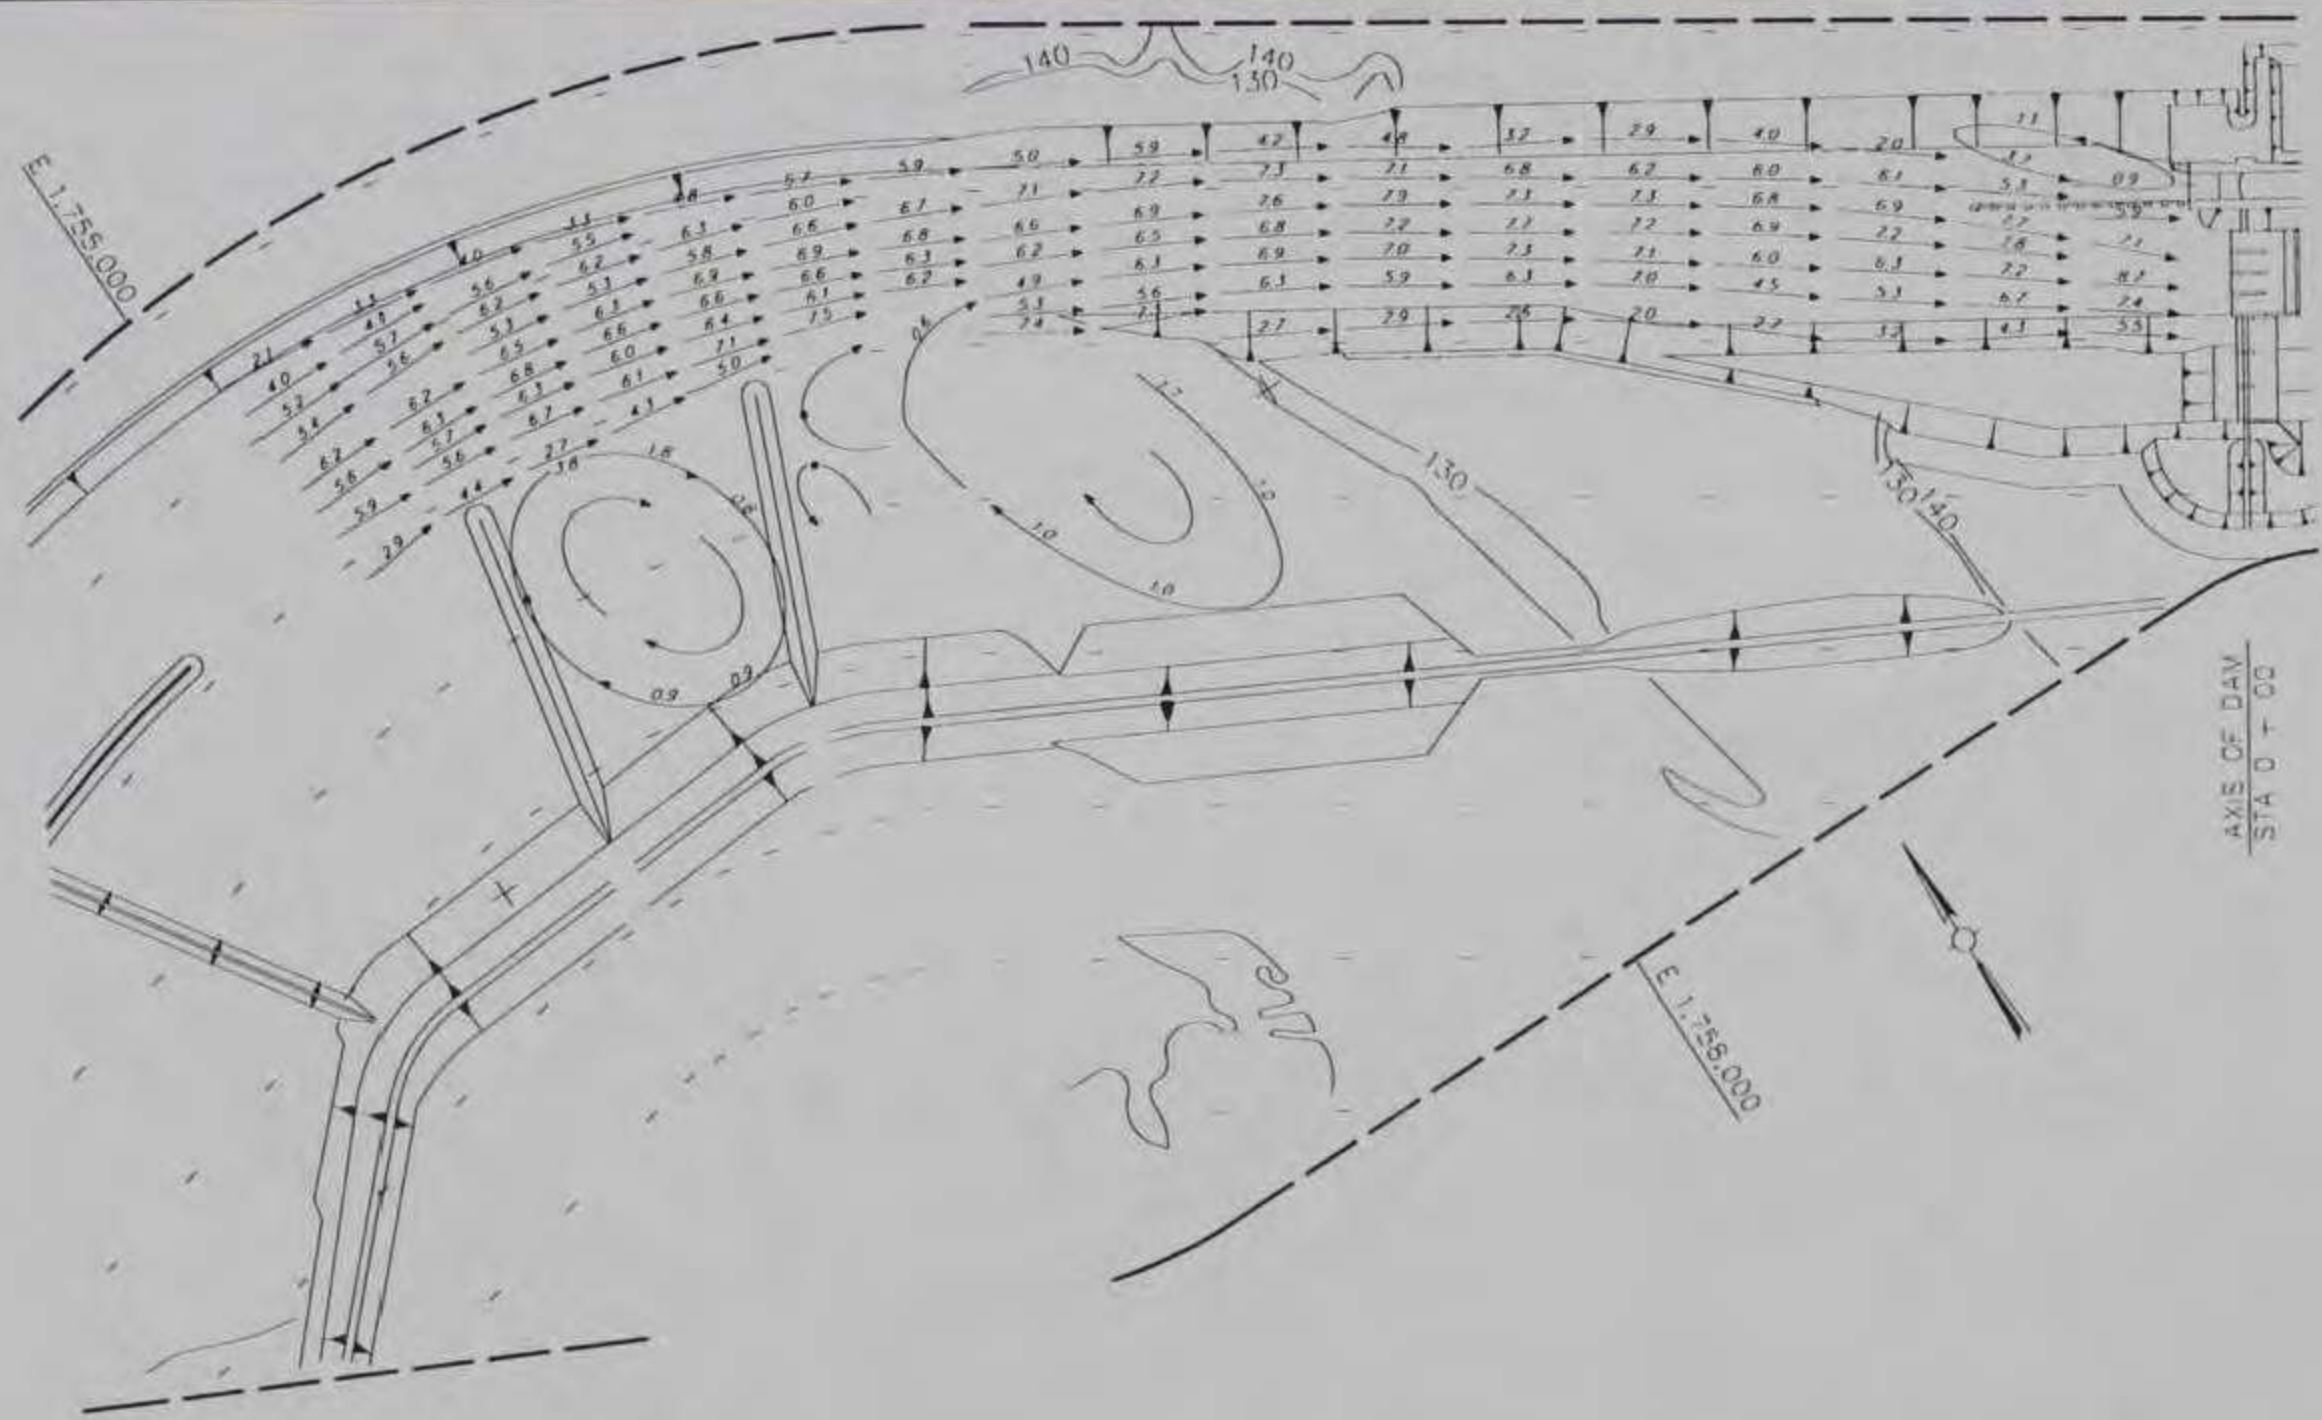
VELOCITIES AND CURRENT DIRECTIONS  
 PLAN C-2

DISCHARGE: 100,000 CFS  
 TAILWATER EL: 114.0 FT
