Repair of Damaged Steel-Concrete Composite Girders Using Carbon Fiber-Reinforced Polymer Sheets

M. Tavakkolizadeh, A.M.ASCE,¹ and H. Saadatmanesh, M.ASCE²

DOI: 10.1061/(ASCE)1090-0268(2003)7:4(311)

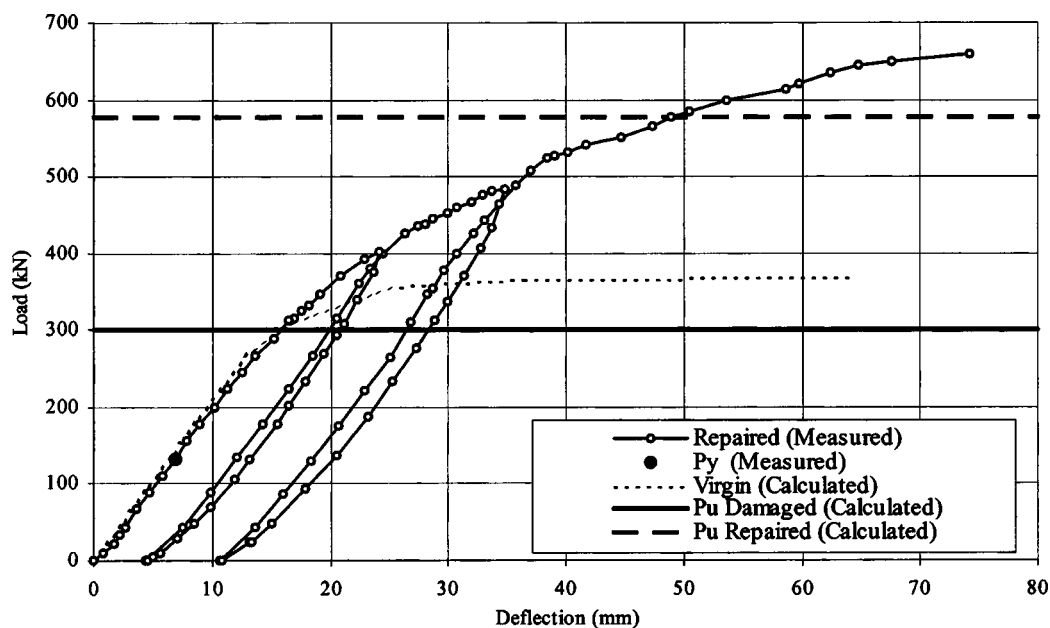
Fig. 11. Load versus deflection of girder with 50% loss in flange area and repaired with three layers of CFRP sheet

The concrete slab of the second specimen had a compressive strength of 16.6 MPa. The lower strength concrete was used to change the mode of failure to overreinforced compression crushing of concrete. As shown in Fig. 11, the load deflection response of the composite girder was initially linear with a slight curve due to transverse cracks (shrinkage). The stiffness of the girder in the elastic region was 20.4 kN/mm. The unloading and reloading in the elastic region did not show any permanent deformation or hysteresis. The behavior continued to be linear until the tension flange of the girder reached its yielding strain at 136.5 kN. The CFRP sheet was under a small tensile stress of 71 MPa, equal to 3.5% of its strength. At the load level of 245 kN, the epoxy that filled the cut started to separate itself from the steel. Continuing loading of the girder into its postelastic regime, two unloading and reloading cycles were performed at load levels of 400 and 500 kN. While both cycles showed a slight amount of hysteresis, the energy dissipation in the second cycle was more pronounced. The reloading stiffnesses were 20.2 and 18.3 kN/mm for reloading after reaching 400 and 500 kN, respectively. Debonding of the CFRP sheet from the steel girder in the midspan at the cut location (20 mm on each side) started at the load of 480 kN. The

lower stiffness in the second and third cycles was due to softening of the concrete and development of longitudinal cracks in the slab, which started to appear at the 475 kN load level. The longitudinal cracks in the slab started to widen at 530 kN and became expanded at 580 kN. The debonding in the midspan grew to 45 and 70 mm on each side of the cut at load levels of 600 and 660 kN, respectively. The concrete slab of the composite girder was almost divided into three longitudinal strips (along the edges of compression flange) at the ultimate load of 658.5 kN, when the girder deflected 74.3 mm. The tensile stress in the CFRP sheet was 1,606 MPa, equivalent to 75% of its strength. The concrete slab was under a strain of 0.0029 and clearly failed in compression. The continuation of the loading was terminated due to buckling and crippling of the compression flange and web after disin-

tegration of the slab. Tensile stress in CFRP sheets went up to 1,748 MPa before termination of the experiment. The concrete failure in compression was the clear mode of failure in this specimen, and the repairing technique clearly recovered the loss of strength and stiffness due to the loss of the tension flange. Overall, the repair technique was successful and the ultimate deflection of the girder was 1.5% of the clear span.

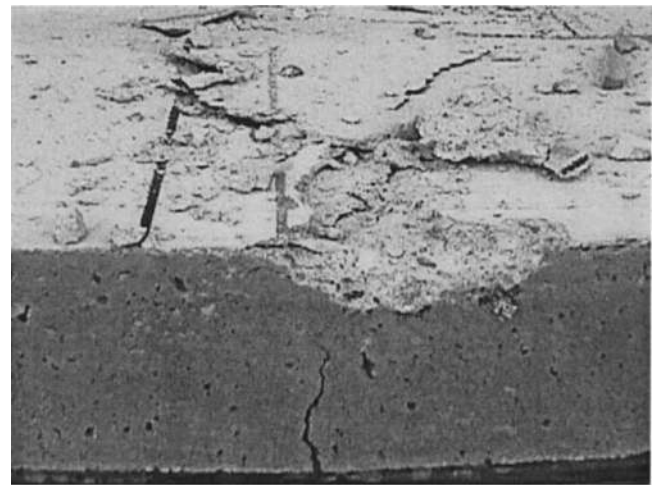
Fig. 14. Failure due to compression crushing: (a) concrete crushing; (b) flange instability

Crushing of concrete, as shown in Fig. 14(a), was the dominating failure mode for the girder made of 16.6 MPa concrete. The three-layer repair system for a girder with a 50% loss of its tension flange forced the slab to carry the maximum compressive strain of beyond 0.29% before failure. Meanwhile, the extent of damage to the slab and the widening of longitudinal cracks after failure allowed the flange and web to buckle, as shown in Fig.
