Semicond. Sci. Technol. 22 (2007) 392-395

Response of machining-damaged single-crystalline silicon wafers to nanosecond pulsed laser irradiation

Jiwang Yan, Tooru Asami and Tsunemoto Kuriyagawa

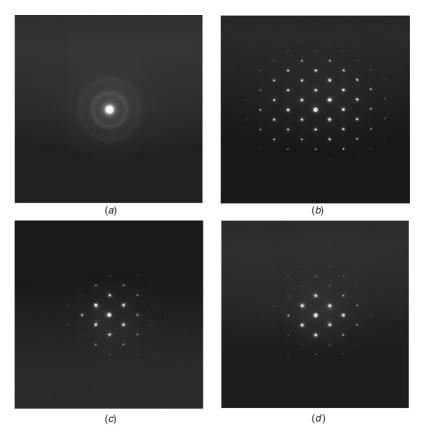
Figure 2. Selected area diffraction patterns of the individual regions marked in figure 1. In (a) the unirradiated region, only halo rings can be seen, indicating that the near-surface grey layer is amorphous. In (b) the boundary region, (c) the irradiated region and (d) the original bulk region, clear diffraction spots are shown, which demonstrates single-crystalline structures.

To further characterize the lattice structures, selected area diffraction (SAD) analysis was done with the same TEM. The diffraction area was 100 nm in diameter at a camera length of 1 m. Figures 2(a)-(d) show the SAD patterns of regions A, B, C and D, respectively, as marked in figure 1. In figure 2(a), only halo rings are shown, verifying that the grey layer just beneath the machined surface is amorphous. In figure 2(b), clear diffraction spots of [110] incidence can be seen, indicating that the boundary between the unirradiated and the irradiated region is crystalline; although dislocations can be seen in this region from figure 1. The result in figure 2(c)also shows clear diffraction spots of [1 1 0] incidence, which is completely the same as that of the original bulk region as shown in figure 2(d). Similar results were confirmed for other TEM samples under the same conditions. From these results, we can conclude that by laser irradiation the machining-damaged layer has been completely reconstructed to the original singlecrystal structure.

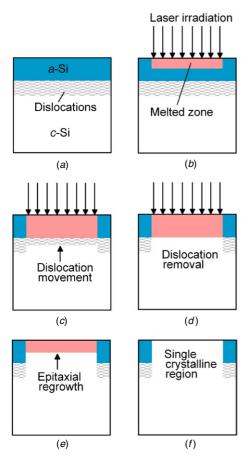
Figure 3. Schematic models of the response of a machining-damaged silicon wafer during laser irradiation. (*a*) Due to diamond machining, a subsurface amorphous layer and a dislocation layer are generated to the silicon wafer. (*b*) At the beginning of laser irradiation, a thin melted zone is formed in the amorphous layer. (*c*) The melted zone keeps growing downwards until the amorphous layer is completely melted; at the same time, the dislocations begin to move towards the liquid–solid interface. (*d*) Dislocations are completely removed before the laser pulse is over. (*e*) After the laser pulse, epitaxial regrowth begins from the liquid–solid interface. (*f*) The machining-induced damages are completely removed and the silicon wafer is reconstructed to perfect single-crystalline structure.

might occur in the present work. The microstructure change of the silicon wafer during laser irradiation is schematically shown in figure 3(a)-(f). Since amorphous silicon (a-Si) has a higher absorption coefficient of laser than the crystalline silicon (c-Si), there will be enough absorption of the laser light in the amorphous layer to form a thin liquid silicon film. The liquid silicon layer is metallic and has much higher absorption, thus a deeper liquid layer will be formed that extends into the dislocated crystalline region. Under high temperature conditions, the mobility of dislocations can be significantly elevated and the dislocations will be transported towards the solid-liquid interface, leaving a completely defectfree crystalline substrate. Then after the laser pulse, cooling will result in epitaxial regrowth from the defect-free crystalline layer. This layer serves as a seed layer to crystallize the liquid layer; thus can yield excellent crystalline perfection. The heating-cooling rate is extremely high and the recrystallization is an instantaneous process. In laser annealing, the duration of liquid silicon was estimated to be ranging from 10 ns to μ s level, depending on the laser pulse width and other conditions [11–15].

It is thought that, provided the laser energy intensity is not too high, the lattice structure reconstruction process may be a self-stopping process. In other words, the single-crystalline region has a low-absorption coefficient thus can withstand the laser pulse without damage. If the laser energy intensity is

excessively high, however, the molten silicon liquid might be boiled and splashed, leading to visible damages. The processing of machine-damaged layers of different depths can be realized by varying the laser energy intensity, pulse width, or the number of pulses.
