STATISTICAL SURVEY OF THE PATHOLOGY, DIAGNOSIS AND REHABILITATION OF ETICS IN WALLS

Bárbara AMARO, Diogo SARAIVA, Jorge de BRITO, Inês FLORES-COLEN

Abstract. This paper presents a statistical survey on the pathology, diagnosis and rehabilitation of ETICS (external thermal insulation composite system) in walls. The development of an expert-knowledge inspection and diagnosis system for this type of cladding implied the creation of classification lists of anomalies, most probable causes, diagnosis methods and repair/maintenance techniques. The collection of data through field work where the tools developed within the proposed system were applied was the basis for this statistical survey. The field work consisted of the visual inspection of 146 façades with ETICS cladding located in various areas in Portugal and aged from 3 to 22 years. The data obtained enable anomalies to be related to their causes and so conclusions can be drawn on the best way to minimize the development of the former and eliminate the latter, at the design and application stages. The study further revealed the main sensitive issues of the cladding system during its service life, highlighting the importance of a

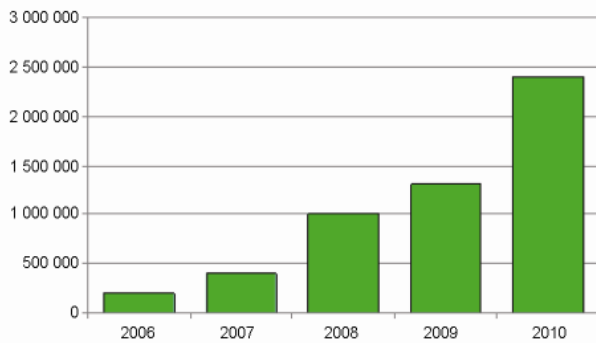
Fig. 1. Evolution of the application of ETICS (in m²) in Portugal (Duarte 2011)

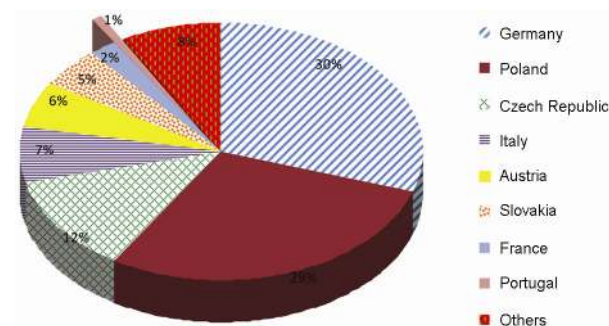
Fig. 2. Application of ETICS (in relative area) in Europe in 2008 (Duarte 2011)

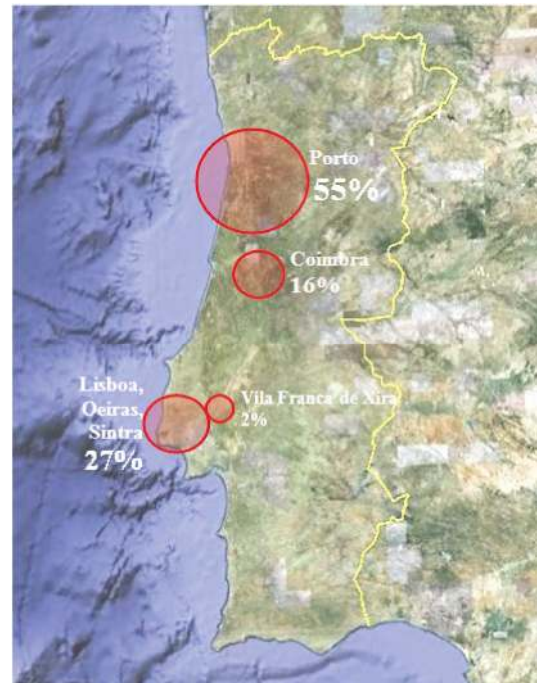
Fig. 3. Geographical distribution of the sample

The buildings inspected covered a good part of the Portuguese territory, particularly the north and centre regions (Fig. 3). Since ETICS were most frequently used in Portugal to comply with buildings' thermal comfort regula-

tions, this system is mostly found in the north, where it is cooler. That is why more buildings were inspected in Porto, approximately 19 400 m² of façade area, around the same as the total façade area inspected in the centre of the country (5 250 m² in Coimbra and 11 780 m² in Lisbon Metropolitan Area). No buildings in the south were inspected since there are far fewer buildings with ETICS there and the few there are, are relatively recent.

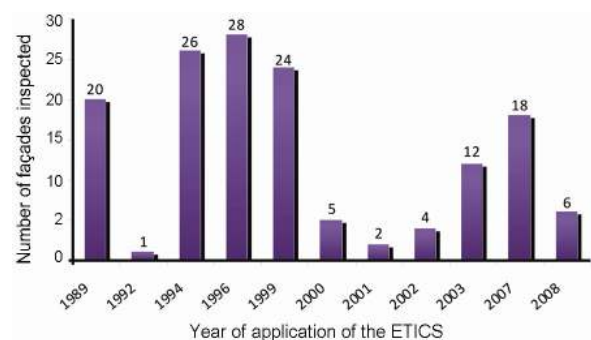
Fig. 4. Age distribution of the sample

ETICS are a relatively novel technology in the Portuguese construction sector, having only really expanded in the 1990s. The 146 façades inspected comprise ETICS applied between 1989 and 2008, thus the data collected had a considerable range of parameters. Considering that the validation of the inspection and diagnosis system should focus on the oldest possible ETICS to show their pathology, 20 façades over 20 years old were inspected, plus 84 between 10 and 20 years old and 42 less than 10 years old. Figure 4 shows the number of façades inspected by age of application of the system, giving an average of 13 years.

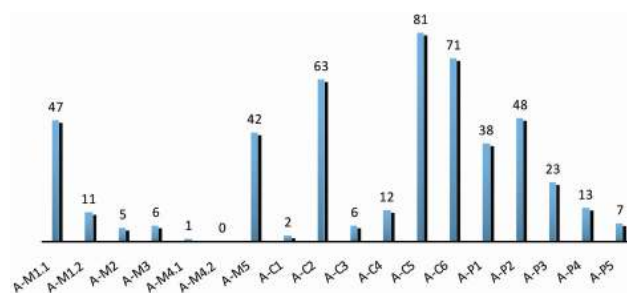
Fig. 5. Anomalies within the sample

The data for this section is represented graphically in Figures 5, 6 and 7, which cope with the contribution of each anomaly and group of anomalies within the sample.

Figures 5 and 6 indicate that the commonest anomalies are **A-C5** – *Biological growth* (present on 55.5% of the façades inspected), **A-C6** – *Other colour changes* (48.6%) and **A-C2** – *Runoff marks* (43.2%). All three commonest anomalies belong to group **A-C** – *Colour/Aesthetic anomalies*, which is not usually associated with dire consequences in terms of thermal capacity.

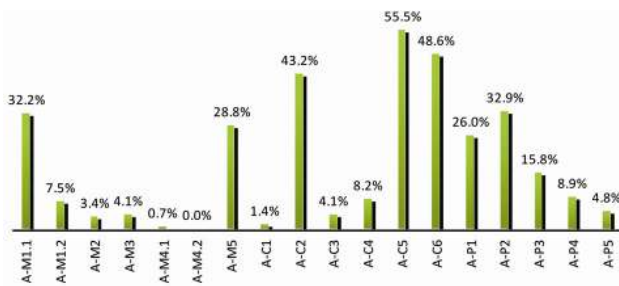
Fig. 6. Incidence of the anomalies in terms of probability of occurring in a façade

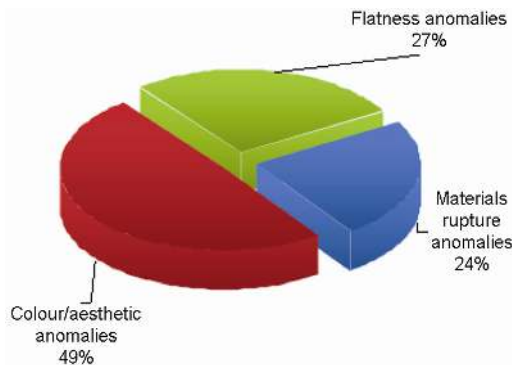
Fig. 7. Contribution of each anomaly group to the grand total of anomalies detected

This is why this group of anomalies has a higher incidence relative to the other groups, as seen in Figure 7.

The graphs further show that group **A-M** – *Materials rupture anomalies* is the least frequent in the sample (24% of the total). No case of loss of adherence of the whole system and only one of partial adherence loss were detected in the sample (anomalies **A-M4.2** and **A-M4.1**, respectively). This is a positive finding since these anomalies represent the worst scenarios of ETICS' defects and have very severe consequences for the thermal behaviour of the building. However, according to French statistics based on insurance companies' reports relative to 211 anomaly examples in ETICS between 1979 and 1985 (Freitas 2002), the incidence of loss of adherence of the whole system was 12% and of partial adherence loss was also 12%, indicating much higher incidence than found in this study, even though the French study is much older (ETICS' reliability has improved over the years). It is concluded that the non-observance of loss of adherence

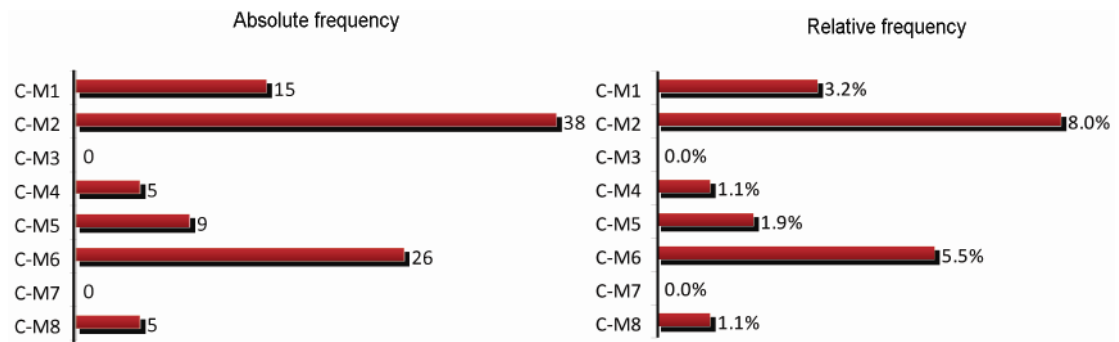
Fig. 8. Absolute and relative incidence of materials selection errors

Figure 8 concerns the causes related to materials selection, with an overall contribution of 9% to the grand total of causes. Though it would be reasonable to regard these defects as design errors, by setting them apart it was possible to highlight problems specific to the materials. Causes **C-M2** – *Inadequate protection against micro-*

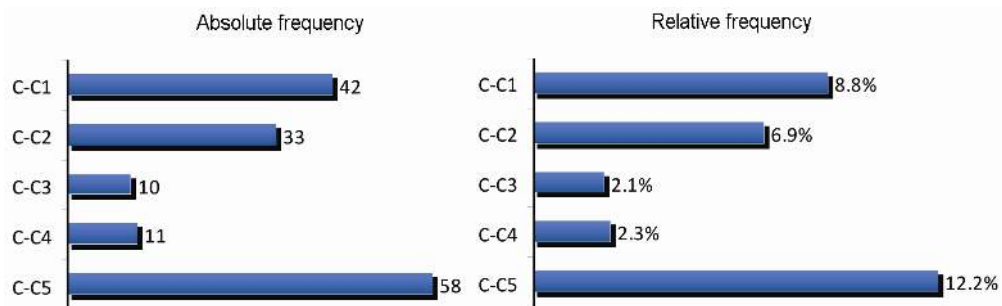
Fig. 9. Absolute and relative incidence of design errors

Figure 9 shows that cause **C-C5** – *Inadequate design of sills, flashings or on the ground-floor* has the highest incidence in the group, and has been attributed (as direct or indirect cause) to 58 anomalies in the 146 façades. As a matter of fact this error was associated several times with the development of regular water runoff paths that lead to efflorescence and the growth of micro-organisms due to water accumulating on the wall. In other cases the non-existence of tail-ends led to various anomalies. The second most frequent cause in the design errors group was **C-C1** – *Insufficient thickness of the base coat*. Even though the appropriate thickness of each coat is stated in the European technical approval guideline for commercially available ETICS (ETAG 004 2000), lower values are often specified at the design stage, especially for the base coat, which leads to an overly thin coat (1 mm). Sometimes the thickness is omitted and application criteria are dictated by the applicators. The main consequence is the subsequent susceptibility of the system to impacts and perforations that expose the inner coats. In some cases the glass fibre grid was exposed instead of being embedded in the base coat, because the latter was too thin. It is also important for the designers to strengthen the reinforcement, especially in areas subjected to tensions that cause cracking, such as window openings and corners. Cause **C-C2** – *No reinforcement* was related to 33 cases of cracking. Causes **C-C3** – *Deficient interface between the system and other elements* and **C-C4** – *No primary coat* were the least frequent within the group, with a total of 10 and 11 attributions, respectively. Figure 15 shows that design and application causes (called “initial stages”) prevailed over the other groups as causes of materials rupture anomalies and flatness anomalies. This reveals the sensitivity of the system to the planning and application tasks.

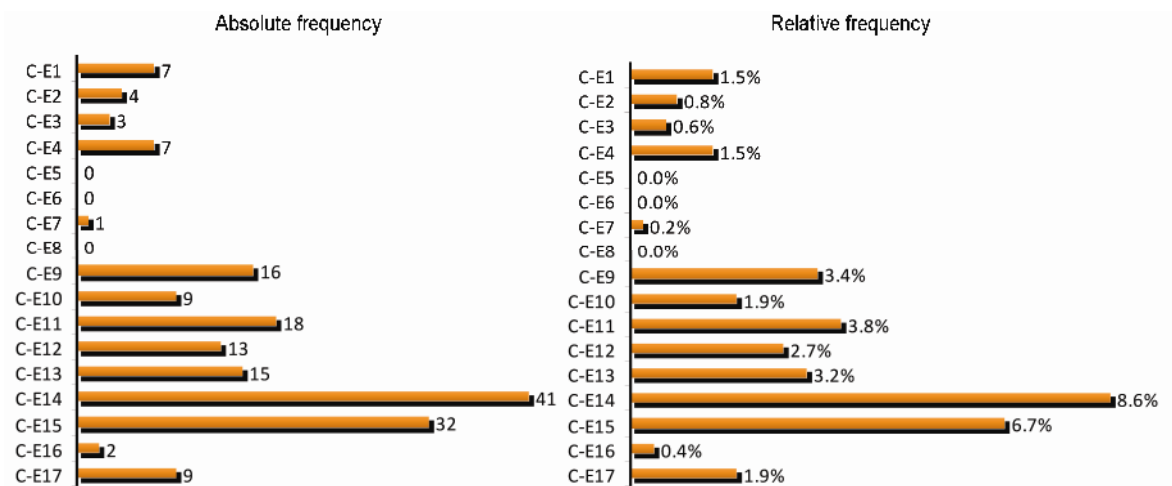
Fig. 10. Absolute and relative incidence of application errors

The application errors group accounts for 16% of the overall causes in the sample, with special emphasis on cause **C-E14** – *Deficient overlapping of the finishing coat*,

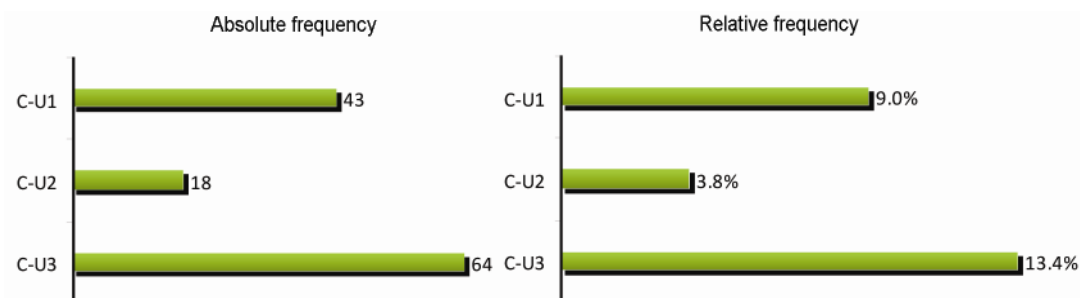
Fig. 11. Absolute and relative incidence of maintenance errors

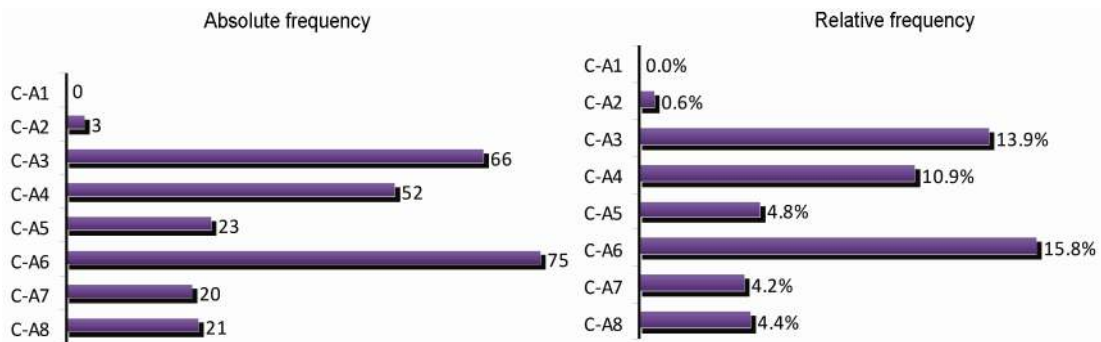
Fig. 12. Absolute and relative incidence of environmental actions

In Figure 12 causes **C-A6 – Surface condensation damp** and **C-A3 – Rain action** stand out, because they come second and third in terms of frequency of attribution in the whole sample. In fact these two causes are directly related to the commonest anomalies since they propitiate the development of micro-organisms, the adhesion of dirt to the wall and the formation of water runoff marks. Another sensitive aspect of this system is thus highlighted – the propensity of the façade to suffer long periods of damp, thus allowing the related anomalies to develop.

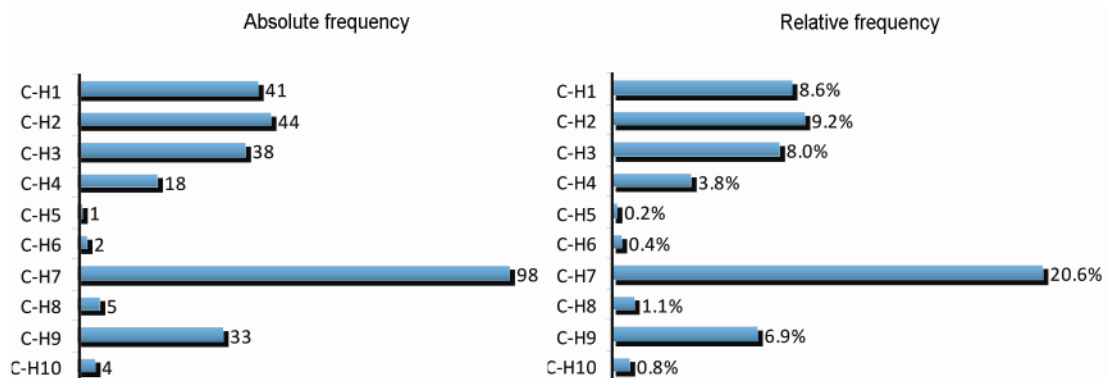
Fig. 13. Absolute and relative incidence of external mechanical actions

The cause considered to be at the root of anomaly development most often was **C-H7 – Dirt build-up (dust)**, with a grand total of 98 occurrences. In fact the accumulation of dust particles or pollution can be associated with a variety of factors, including very rough cladding, atmospheric pollution/particles driven by wind/rain, the boundaries between areas of different flatness or any situations resulting from the façades getting wet, and this cause is thus directly or indirectly related to various anomalies.

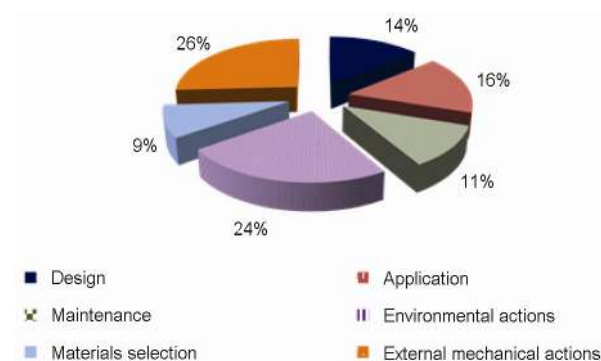
Fig. 14. Contribution of each cause group to the grand total of causes attributed

Figure 14 shows that group **C-H – External mechanical actions**, which includes the causes mentioned, accounts for the greatest proportion of all causes registered with 26% of the total. Similarly group **C-A – Environmental actions** represent 24% of the grand total of causes attributed. The causes within this group can be associated with the climatic conditions during application of the system and with subsequent in-service actions. The

Figure 14 shows that 39% of the anomalies in ETICS can be prevented by proper design, application and choice of materials, especially the materials rupture anomalies and the façade flatness anomalies. It is also concluded that implementing a plan of periodic inspections and maintenance helps to prevent early degradation from environmental and external mechanical actions during the service life, with special emphasis on the control of colour changes.

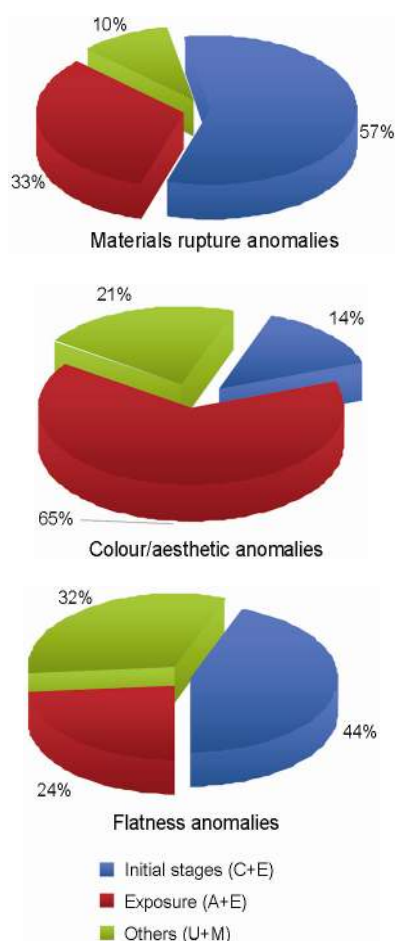
Fig. 15. Contribution of each cause to each anomaly group

The data that relates to the contribution of each cause to all the anomalies observed is found in Figures 8 to 13, where each figure corresponds to a group of causes. Figure 14 shows the contribution of each group to the set of anomalies in the sample. Figures 15 and 17 represent the contribution of the groups of causes, divided in terms of "initial stages" (design and application), "exposure" (environmental and external mechanical actions) and "others" (the other groups).

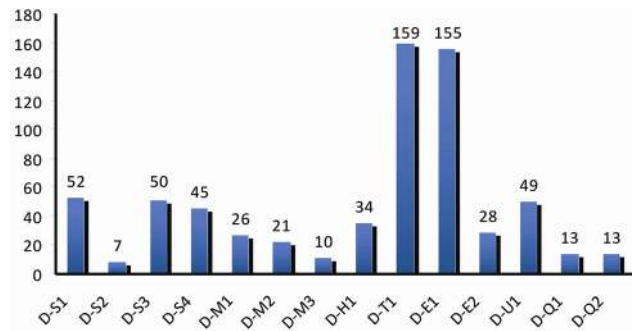
Fig. 16. Recommended diagnosis methods within the sample

Figure 16 shows the number of times each test was recommended, with a grand total of 662 diagnosis methods for the 146 façades, and Figure 17 gives the incidence of each method relative to the 476 anomalies. There are more tests than there are anomalies since all except anomaly **A-C4** – *Graffiti*, to which no specific method was assigned, could need the coupling of various *in situ* tests for a complete diagnosis.

Among the diagnosis methods recommended, **D-T1** – *Infrared thermography* and **D-E1** – *Contact moisture meter* are important because they are associated with the diagnosis of various anomalies and the evaluation of their causes and are therefore the most useful on site, especially when used together (also because they are non-destructive). In fact they are recommended 159 and 155 times, respectively, in both cases more than the number of façades inspected (146). This proves how useful they are to help diagnose more than one anomaly or check on their severity, with an additional advantage of the contact moisture meter in terms of costs.

Since 10% of the anomalies concern oriented cracking and an extra 2% non-oriented cracking, it is natural that the recommendations of the alternative methods to measure the width of cracks, **D-S1** – *Crack comparator* and **D-S2** – *Crack detection microscope*, make 12% of the total. Diagnosis method **D-S2** is recommended in only 7 of the 58 cases of cracking (12% of those cases). In other words in only 12% of the cracking anomalies was it considered necessary to resort to the millimetre accuracy of the crack detection microscope instead of the crack comparator (**D-S1**). The method **D-S3** – *Crack meter*, which can be used to monitor the stability of the cracks, had a similar usage frequency.

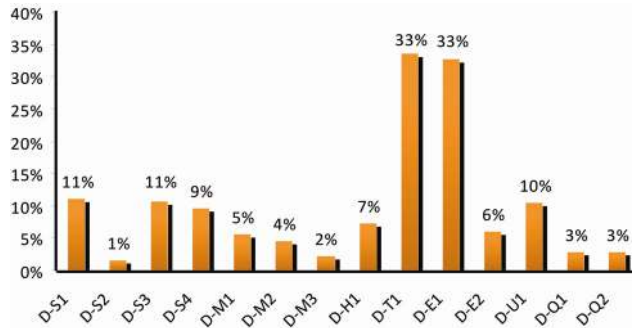
Fig. 17. Contribution of each method to the anomalies diagnosed

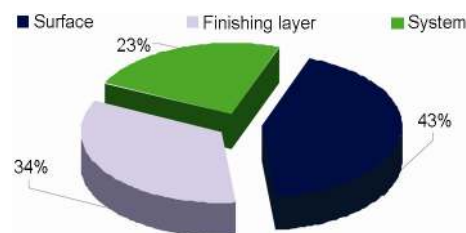
Fig. 18. Contribution of each repair technique group to the grand total of techniques prescribed

Figure 18 shows that 43% of the repair techniques prescribed belong to the group of surface techniques (**TR-A1** and **TR-A2**). They can be seen as maintenance and are directly related to the colour/aesthetic anomalies that represent around half of all the anomalies detected. On the other hand, the repair techniques concerning deeper interventions make up 24% of the universe, coinciding with the 24% of the materials rupture anomalies group, even though some of the techniques are prescribed for other anomalies, i.e. those concerning flatness deficiencies.

Figure 18 also shows that the technique **TR-A1** – *Cleaning* was the most often recommended because of the large number of colour/aesthetic anomalies, in particular leakage and biological growth. This has to do with the usually light colour of the system and lack of periodic maintenance as well as with the incorrect handling of singularities in the walls, such as sill drip edges and parapet capping, which allow biological organisms and other stains to build up on the façade.

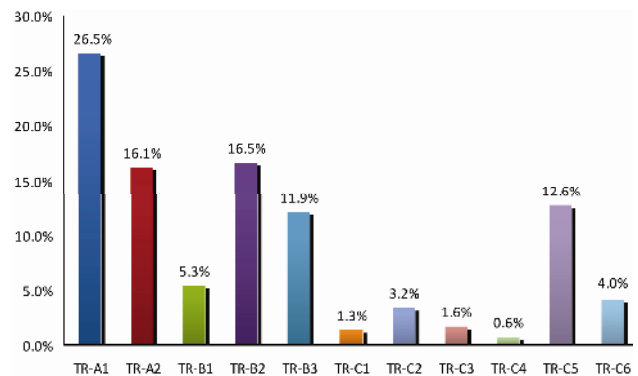
Fig. 19. Incidence of the repair techniques prescribed

Based on the data collected during the inspection campaign the frequencies of each repair technique were correlated with the various anomalies, as seen in Figure 19. The techniques aimed at repairing the anomalies and/or eliminating their causes.

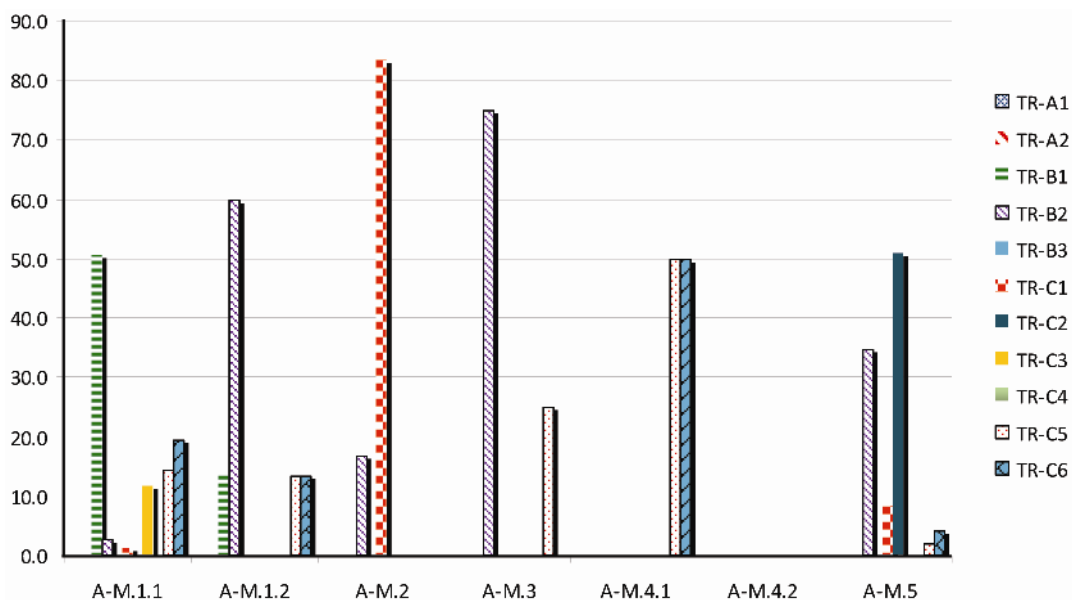
Fig. 20. Incidence of each technique to repair materials rupture anomalies

Oriented cracking (A-M1.1) was mostly solved by technique TR-B1 – Filling/clogging of cracks, and in some cases by partial/whole replacement of the system (TR-C6), usually when plates coincided with the profiles' joints. Non-oriented cracking (A-M1.2) was usually handled by technique TR-B2 – Partial/whole replacement of the finishing coat, given the superficial nature of the anomaly, though techniques TR-C6 or TR-C5 – Correction of geometrical constructive features were occasionally chosen if the anomaly was considerably extensive or resulted from an incorrectly fitted construction element (Fig. 20).

The best technique for the deterioration of the covering of reinforcement cantilevers (A-M2) was TR-C1 – Protection of protruding edges, as expected, given its specificity. For slight deterioration of the finishing technique TR-B2 – Partial/whole replacement of the finishing coat was recommended. The same technique was prescribed 75% of the times to remedy anomaly A-M.3 – Detachment of the finishing even though it was sometimes complemented by technique TR-C5 – Correction of geometrical constructive features, since replacing the finishing solves the anomaly and correcting the tail-end elements eliminates the possible cause (Fig. 20).

case resorting to back wrapping and replacement/installation of the bottom profile. The material gaps (A-M5) observed were mostly handled using technique TR-C2 – Filling of material gaps/perforations, whenever the perforation gap reached the insulation plate or the substrate (51% of cases). For more superficial gaps that only reached the reinforced mortar but did not damage the grid, partial/whole replacement of the finishing coat (TR-B2) proved to be sufficient. Technique TR-C1 was prescribed locally to treat protruding edges when the location of the material gap near the edges justified the treatment of that area and the installation of corner profiles was not considered (Fig. 20).

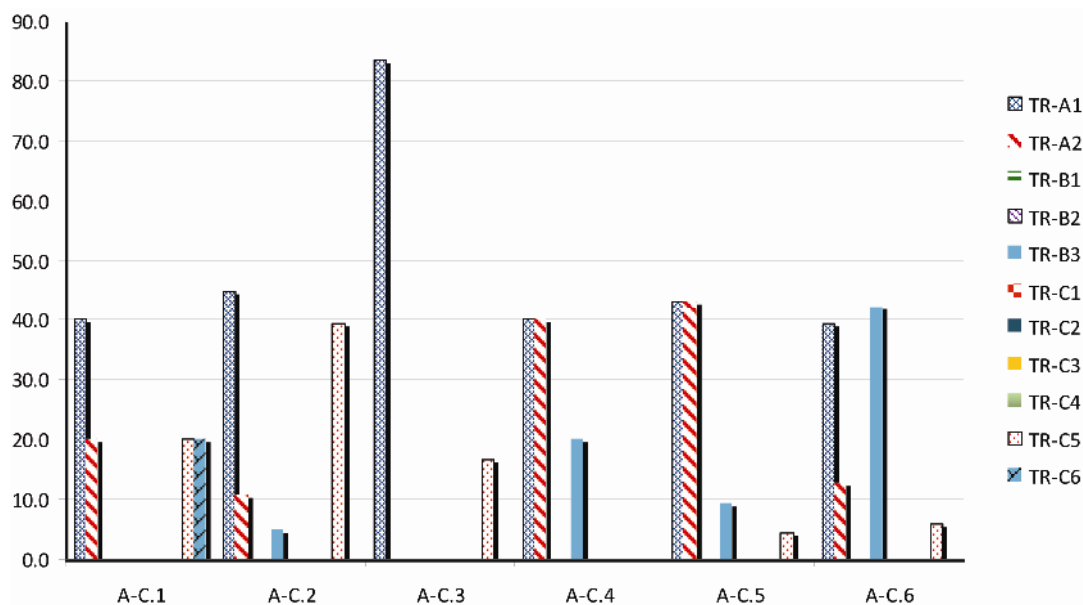
Fig. 21. Incidence of each technique to repair colour/aesthetic anomalies

A-C1 – Efflorescence and A-C3 – Corrosion stains were rare in the sample analysed, representing less than 2% in total. With the exception of a single case of efflorescence, where no deeper intervention was deemed necessary, both anomalies were solved by surface cleaning (TR-A1), in both cases over a small area, and correction of geometrical constructive features (TR-C5) (Fig. 21).

Runoff marks (A-C2) and biological growth (A-C5) represent 61% of the colour/aesthetic anomalies and 30% of all anomalies. In the first case, cleaning (TR-A1) was most often prescribed to eliminate the marks. But to eliminate the causes, correction of geometrical constructive features (TR-C5) became fundamental. As for the manifestation of micro-organisms on the system's surface, cleaning (TR-A1) and complementary application of surface protection (TR-A2) were the techniques chosen to eliminate the anomaly and prevent its recurrence. In both cases, more severe problems were repaired by painting the wall, thus justifying the incidence of technique TR-B3 in both cases (Fig. 21).

Graffiti (A-C4) strongly affects the aesthetics of a façade and is not always easy to remove. Consequently, combining cleaning (TR-A1) and the application of an anti-graffiti barrier (TR-A2), repainting the wall (TR-B3) was deemed necessary in 50% of the situations when this anomaly was detected. Depending on the characteristics, damp and dirt stains, surface decolouration, and other problems within anomaly A-C.6 – Other colour changes, were solved through simple cleaning (TR-A1). In the case of dirt stains (e.g. due to atmospheric pollution), cleaning plus the application of water repellent (TR-A2) was the technique used for runoff marks, and the application of a new finishing/painting (TR-B3) for other colour changes, especially those caused by incorrect surface repairs (Fig. 21).

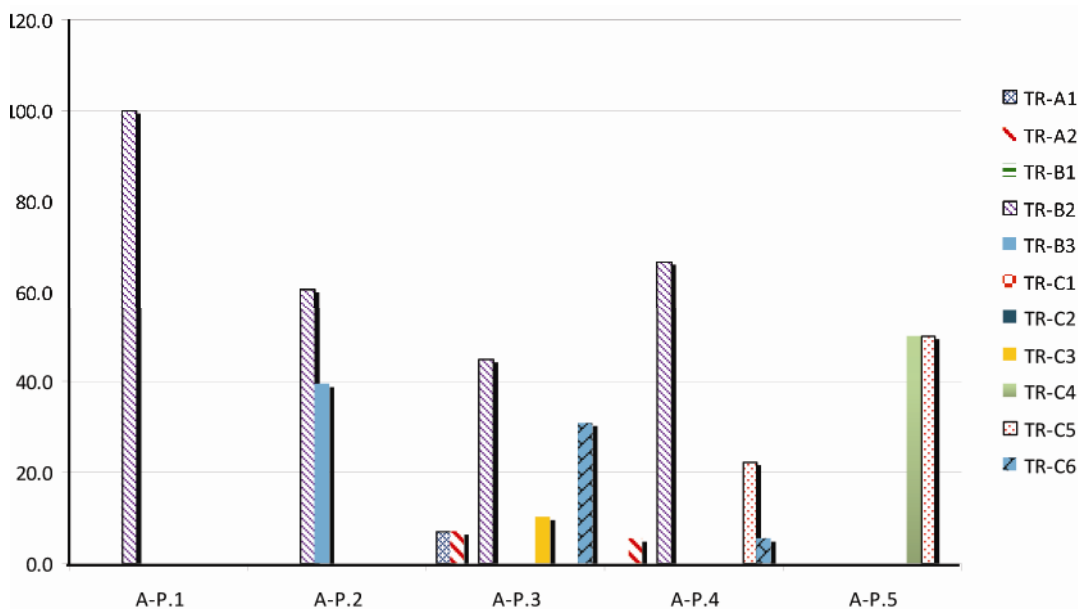
Fig. 22. Incidence of each technique to repair flatness anomalies

Flatness anomalies are mostly due to incorrect characteristics or application of the finishing coat or damage to it. Apart from swelling of the insulation plates (A-P5) which implies another level of intervention, the first four anomalies of the group require an intervention to the finishing coat, usually by partial/whole replacement (TR-B2). In fact anomaly A-P1 – Flatness deficiency was dealt with solely by this technique, which was considered sufficient given the causes established. This anomaly has a sizeable incidence (8%) and in almost all instances its origin was a deficient overlapping of the finishing coat (86%) during the system's application. Depending on the height of the scaffolding when the system was installed, it could have been applied in horizontal coats. The transition between a new coat and the previous one must ensure the greatest possible homogeneity at the level of overlapping of the finishing coat. Surface irregularities (A-P2) come from uneven texture of the finishing coat, from incorrect interventions or from small superficial material gaps. The replacement of the finishing coat (TR-B2) and the application of a new finishing on top of the existing coat (TR-B3) were the preferred techniques to rectify this anomaly (Fig. 22).
