Strategy for developing a future support system for the *Vasa* warship and evaluating its mechanical properties

Thomas Lechner^{1*}, Ingela Bjurhager² and Robert I Kliger¹

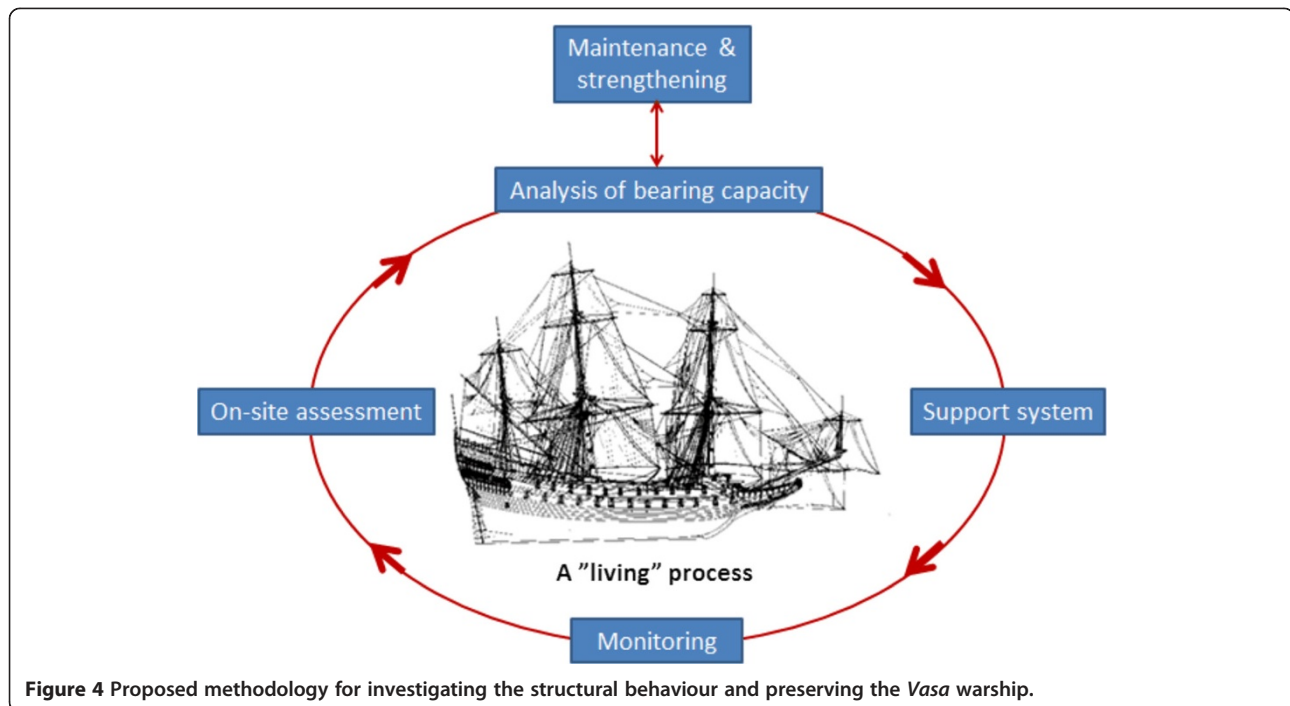
Figure 4 Proposed methodology for investigating the structural behaviour and preserving the *Vasa* warship.

A complete three-dimensional model of the warship would be of great help when it comes to creating a new support system using advanced technology in order to protect the national treasure, the *Vasa*, for the future and prevent the ship's structure deforming still further. The proposed overall methodology is illustrated in Figure 4 and consists of four steps in a "living process" with the aim of maintaining the ship in its present shape, i.e. minimising (time-dependent) deformation. These steps are:

- (1) On-site assessment of mechanical properties of the wood and description of the connections between elements
- (2) Analysis of bearing capacity by computer modelling of the ship

- (3) Choice of a new and improved support system based on the two previous steps and verification of the computer model
- (4) Monitoring the ship after installing the system

In this section, we propose a detailed methodology for the on-site assessment (Step 1, cf. Figure 4) in the
