Terahertz NDE Application for Corrosion Detection and Evaluation under Shuttle Tiles

ABSTRACT

Pulsed Terahertz NDE is being examined as a method to inspect for possible corrosion under Space Shuttle Tiles. Other methods such as ultrasonics, infrared, eddy current and microwave technologies have demonstrable shortcomings for tile NDE. This work applies Terahertz NDE, in the frequency range between 50 GHz and 1 THz, for the inspection of manufactured corrosion samples. The samples consist of induced corrosion spots that range in diameter (2.54 to 15.2 mm) and depth (0.036 to 0.787 mm) in an aluminum substrate material covered with tiles. Results of these measurements are presented for known corrosion flaws both covered and uncovered and for blind tests with unknown corrosion flaws covered with attached tiles. The Terahertz NDE system is shown to detect all artificially manufactured corrosion regions under a Shuttle tile with a depth greater than 0.13 mm.

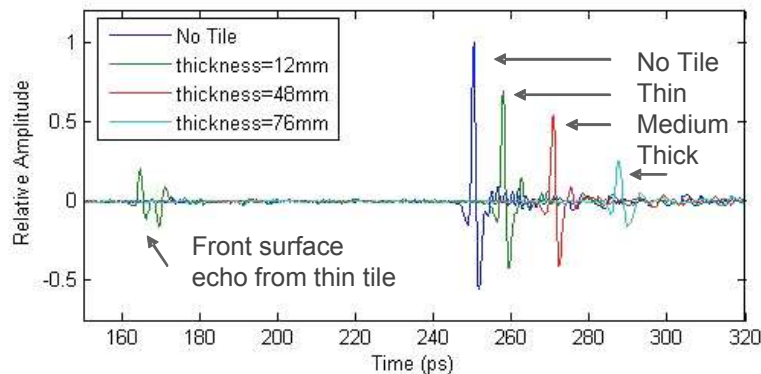
Figure 3. THz response for thick, medium, and thin and tile

To characterize the THz properties of the tiles, reflections from a metal substrate with and without an intermediary thick, medium, and thin tile were measured. These tiles are shown in figure 2. The thin tile in figure 2c was made from an originally thicker tile that was cut. Signals through each tile are shown in figure 3 along with a signal from the bare aluminum plate. These plots show the signal arrival and attenuation as a function of tile thickness. From the signals, the calculated attenuation was 3.06 dB/cm at 0.25 THz and the average wave velocity was $2.78 \pm 0.04 \times 10^8$ m/s. The real part of the refractive index for the material, calculated from the average wave velocity, was 1.08 ± 0.02 .

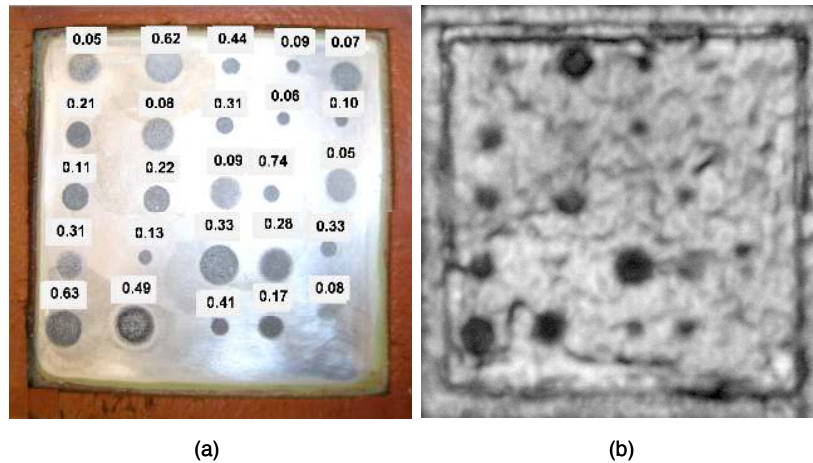
Figure 7. Panel 2, tile '745' (a) photograph of induced corrosion spots with estimated depth (mm) at each location and (b) THz amplitude image.

The second panel inspected had 17 tiles with a layout similar to the first panel. Eleven of the 17 tiles were inspected using the THz system. The remaining six tiles were damaged in previous tests. This inspection was a blind test; the personnel inspecting the panel did not know which tile covered induced corrosion. THz images of only one tile had indications indicative of corrosion. An image of this tile ‘745’ has distinctive spots that are larger than the tile related variations. This image along with a picture of the 25 induced corrosion spots (obtained after the inspection process) is shown in figure 7. Figure 7a shows the 25 induced corrosion spots and depth estimates made during manufacturing. Figure 7b shows the THz image with eight large obvious corrosion spots and another eight that are smaller and not as evident. Based on the depth measurements and a visual interpretation of the THz image, the THz system detected corrosion spot with depths greater than approximately 0.13 mm.
