TERAHERTZ NDE FOR UNDER PAINT CORROSION DETECTION AND EVALUATION

Robert F. Anastasi¹ and Eric I. Madaras²

QNDE 2005, 32nd Annual Review of Progress in Quantitative Nondestructive Evaluation, Bowdoin College, Brunswick, Maine, July 21 – August 4, 2005

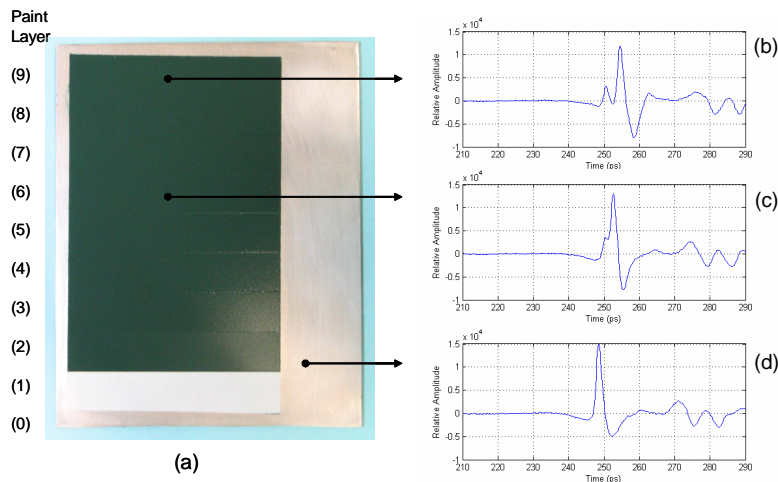
Figure 3. Paint sample (a) and (b) signal through layer-9, (c) through layer-6, and (d) on bare metal.

THz response to paint thickness was examined using a sample with a varying thickness layer of paint on an aluminum substrate. An enamel spray paint was used to paint one primer layer and eight top coat layers each approximately 25 mm wide. The bar graph in figure 2 shows the range of paint layer thicknesses on the sample. Figure 3 shows the sample, figure 3a, and THz signals at three different locations. Figure 3b shows the signal for layer-9, paint thickness 0.335 ± 0.0039 mm. In this signal, the first peak of the paint surface echo and aluminum surface echo are resolved. Figure 3c shows the signal for an intermediate paint thickness, layer-6, paint thickness 0.183 ± 0.0039 mm, the individual echoes are not fully resolved in this signal and figure 3d, show a signal from the bare aluminum surface. Using the time between the paint surface echo and aluminum echo a wave velocity in the paint was found to be 0.190 ± 0.013 ps. This corresponds to a refractive index of 1.58 ± 0.11 and a dielectric constant of 2.50 ± 0.36 .

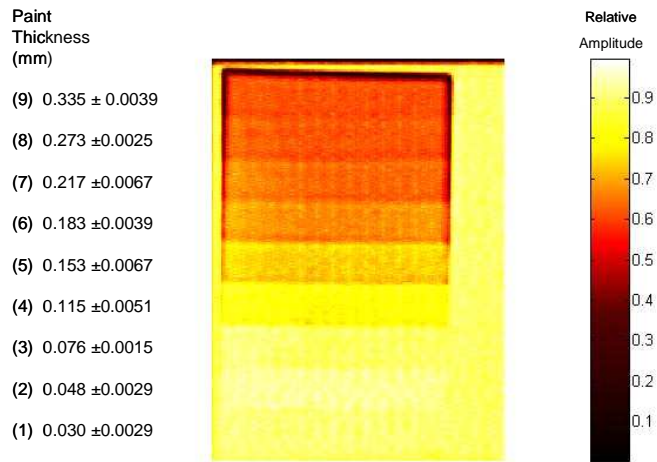
Figure 4. THz Amplitude Image (maximum signal amplitude).

A THz amplitude image is shown in figure 4. It was generated by plotting the maximum signal amplitude at each scan point as a function of gray-level. The image shows how the signal amplitude correlates to paint thickness. The darker gray or lower amplitude corresponds to thicker paint and the lighter gray, higher amplitude to thinner paint. The image also shows that paint thickness can be determined to a thickness of ~ 0.050 mm even though the individual paint surface and aluminum substrate echoes could not be resolved. The influence of the color or paint pigment was not investigated.

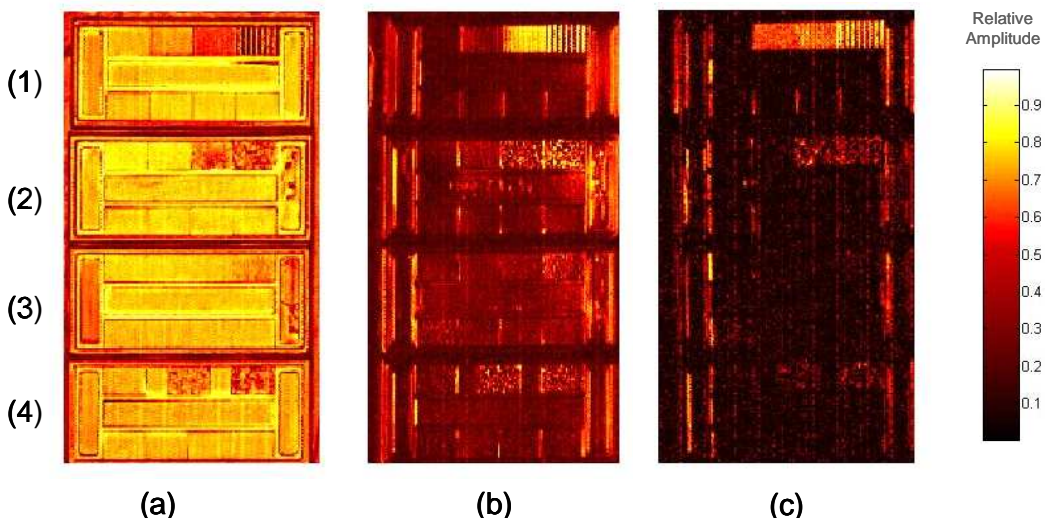
Figure 6. Comparator plate frequency images for the THz head at (a) 0 deg, (b) 10 deg, (c) 20 deg. Plate-1 is the Planning and Shaping, Plate-2 is EDM, Plate-3 is Grit and Shot Blasting, and Plate-4 is Casting.

Amplitude and frequency images were generated from the THz scan data. The frequency image was generated by applying a Fast-Fourier-Transform (FFT) to each signal in the THz scan and then taking the mean amplitude of the spectrum between 0.4 and 0.6 THz. For this data, this was the range of greatest spectral amplitude. The frequency images for 0°, 10°, and 20° are shown in figure 6. These images illustrate that for a normal inspection, figure 6a, the mean frequency amplitude is greater for the smooth areas than the roughest areas, thus the smooth areas reflect energy back to the detector while the rough areas scatter energy away from the detector. For the 10° and 20° angled inspection, figures 6b and 6c, the mean frequency amplitude is greater for the rough areas and less in the smooth areas, thus more THz energy is being detected for the rough area. To quantify the scattering shown in figure 6, an average signal power per area was calculated for the four roughest areas on the ‘Planing and Shaping’ comparator plate. This was done by calculating an average signal for each roughness area and for the total inspection areas and then computing the average signal power for each area. The roughness area result was then divided by the total inspection area result. The outcome for the four areas is shown in figure 7. This shows that the roughest area and largest angle, backscatter had the most average-signal power.

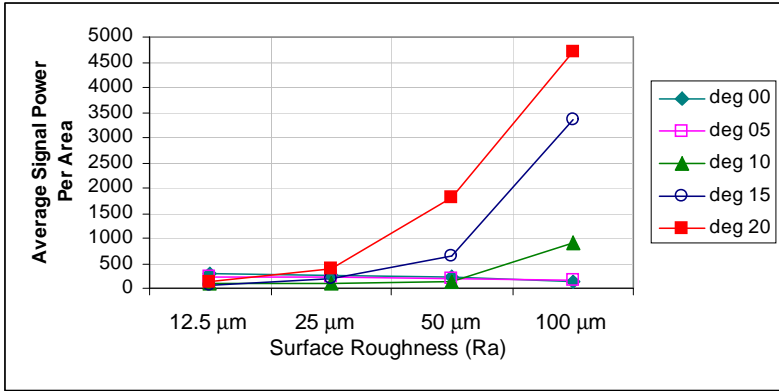
Figure 7. Average Signal Power per Area for four surface areas on the Planning and Shaping plate.

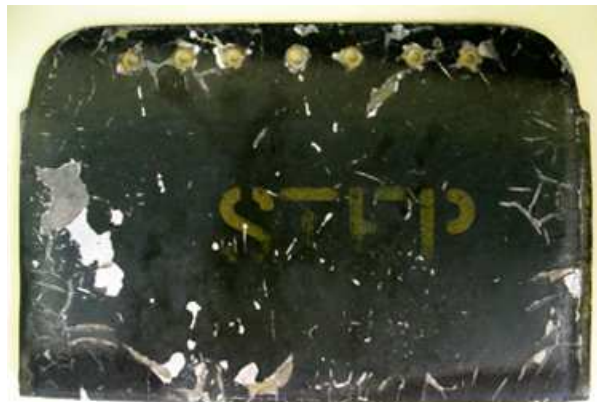
Figure 8. Chinook Fuselage Step Door is shown with flaked, chipped and cracked paint. It is approximately 20 cm by 14 cm

The Chinook fuselage step door, shown in figure 8, is approximately 20 cm by 14 cm and has areas of chipped, flaking and cracked paint. Two THz images are shown in figure 9. Figure 9a shows a maximum signal amplitude image. If the paint-thickness sample results are used as a reference then the areas of thick and thin paint can be identified by signal amplitude correlation, thus, the darker areas in the image maybe caused by thicker paint or potentially corrosion. Figure 9b, is a frequency image of mean amplitude between 0.62 and 0.68 THz, generated at a 10° angle. Using the backscatter results from the surface roughness samples, the brighter colors correspond to rougher areas and maybe potential areas of corrosion.

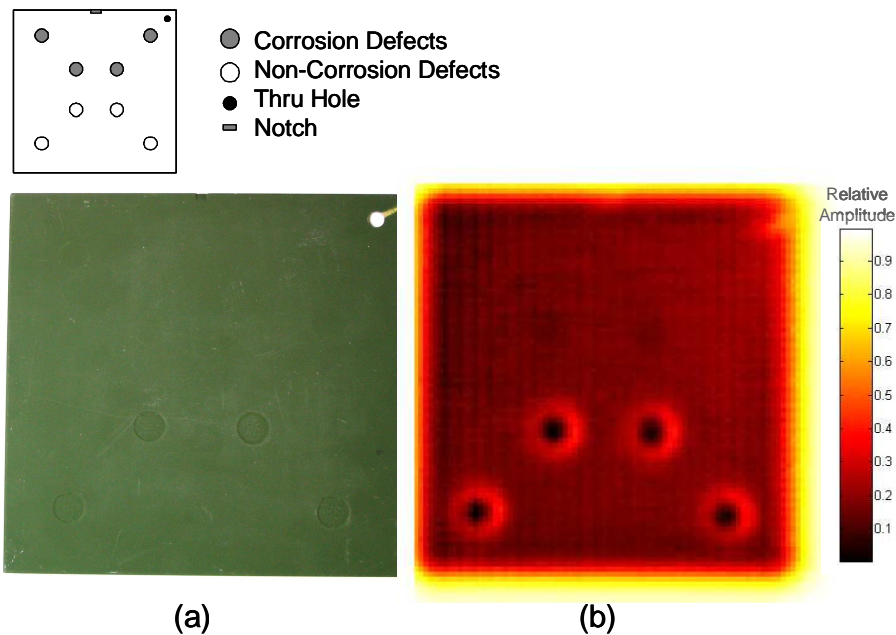
Figure 10. Corrosion sample (a) picture and (b) THz amplitude image, minimum signal amplitude from 257 ps to 273 ps.

The manufactured sample, shown in figure 10a was approximately 15 cm by 15 cm. This sample contained four corrosion areas, each 12.7 mm in diameter, produced by an electrochemical process and four flat bottom holes, 0.15 mm in depth and 12.7 mm in diameter. The sample including the corrosion spots and flat bottom holes were painted with a primer and topcoat. This paint layer was 0.06 mm to 0.07 mm thick. The flat bottom holes were visible by eye but not the corrosion spots. A THz amplitude image of the corrosion sample is shown in figure 10b. The amplitude image was generated by taking the minimum signal amplitude between 257 ps and 273 ps. In this image, the darker gray represents greater signal amplitude and the four non-corrosion defects are shown as dark spots and possible detection of the two corrosion defects are in the central area of the plate. The halos around the flat bottom holes are caused by signal interference at the edges, which distort the waveform. This same effect is seen around the outer edges of the sample. In reference to the paint thickness sample, these dark spots would correspond to thicker paint and in reference to the backscatter measurements at normal incidence, the dark areas correspond to increased scattering or rougher areas. In both cases, these spots may indicate potential corrosion.
