The effect of TiN film on low-cycle fatigue behavior of steel coated by PVD method

K. Shiozawa, L. Han

ABSTRACT

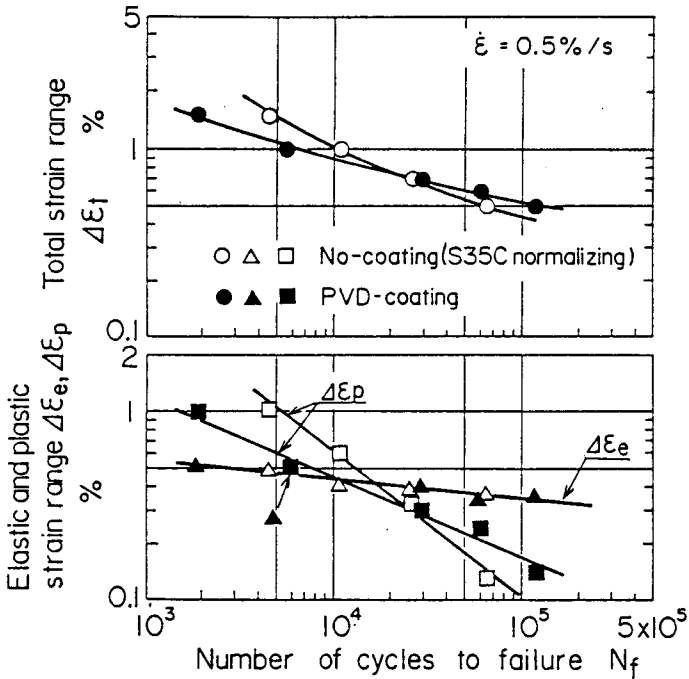
Figure 1 Strain amplitude-life curves for specimens coated with TiN by PVD method and uncoated obtained under low-cycle fatigue tests in air.

Figure 1 shows the experimental results obtained from the low-

cycle fatigue tests under conditions of controlled total strain in air. Here number of cycles to failure, N_f , was defined as the cycles at which the tensile stress amplitude of the specimen decreases to 3/4 of the maximum value. In this figure, relationship between total strain range, $\Delta \epsilon_t$, and N_f is plotted, and also the two strain range, one for elastic $\Delta \epsilon_e$ and one for plastic $\Delta \epsilon_p$, obtained from the hysteresis loops at $N_f/2$, are plotted with N_f .

It can be seen from the $\Delta \epsilon_t$ - N_f diagram that the fatigue life of specimens coated with TiN increased in the region of low total strain amplitude below $\Delta \epsilon_t = 0.7 \sim 0.8\%$, as compared with that of the uncoated one. On the other hand, fatigue life decreased for the region in high total strain range. This phenomenon is more clearly observed in $\Delta \epsilon_p$ - N_f diagram. It is speculated that cyclic deformation behavior of specimen affects the fatigue strength, because the value of the total strain range ($\Delta \epsilon_t = 0.7 \sim 0.8\%$) corresponds with the transition fatigue life, N_t , where $\Delta \epsilon_p = \Delta \epsilon_e$ in uncoated specimen. That is, at short lives, less than N_t , plastic strain predominates, and at longer lives, greater than N_t , the elastic strain is more dominant than

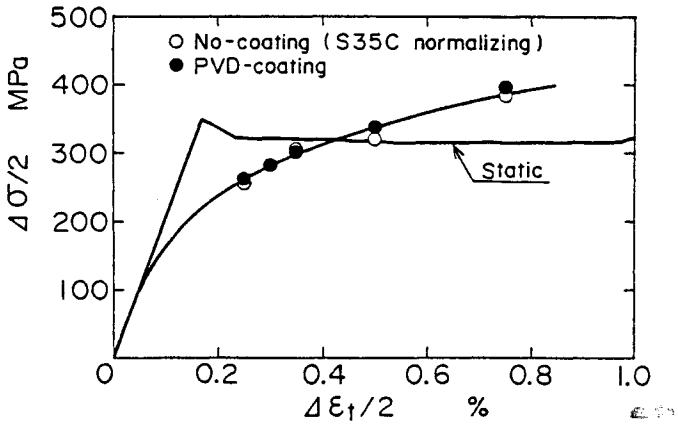
Figure 2 Experimental results of cyclic stress-strain curves compared with monotonic behavior.

Figure 2 shows the cyclic stress-strain response compared with tensile stress-strain curve, for coated and uncoated specimen. It can be seen from this figure that cyclic and monotonic stress-strain relation of coated specimen is coincident with those of uncoated specimen. Therefore, it is suggested that increase or decrease of fatigue life in coated specimen will be controlled by performance of specimen surface.

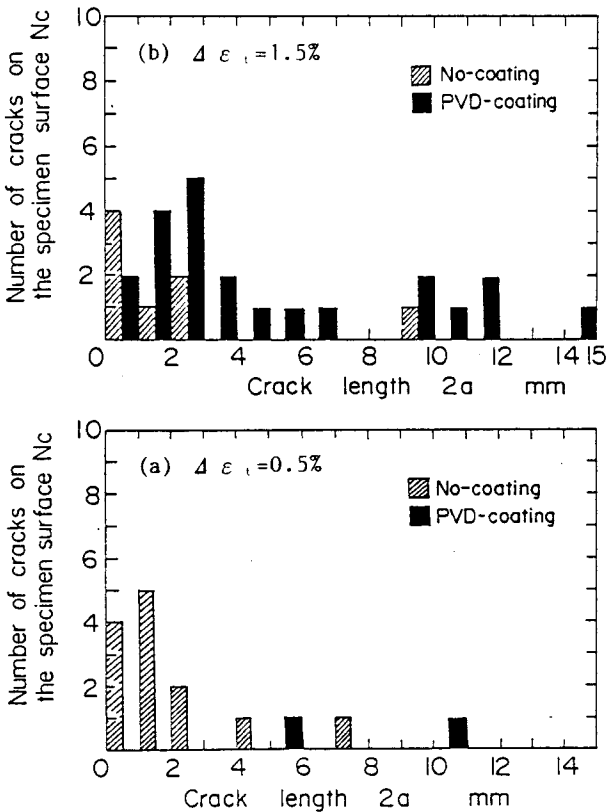
Figure 4 Experimental relationship between number of surface cracks on the specimen surface and crack length.

Many small cracks were observed on the specimen surface after fatigue test. In order to discuss the effect of coated thin film on fatigue crack initiation, number of surface cracks on the specimen surface of 8mm gauge length were counted by optical microscope of the replicas which were taken from the surface. Figure 4 shows the relationship between number of cracks and crack length. Under the testing condition of high strain amplitude level, $\Delta \varepsilon_1 = 1.5\%$, the number of small cracks on the specimen surface of coated material is larger than that of the uncoated one. On the other hand, the number of cracks is less than that of the uncoated specimen under the testing condition of $\Delta \varepsilon_1 = 0.5\%$. In this case, it is suggested that initiation of crack is constrained by hard coating film on the specimen surface, which can act as a barrier to the plastic deformation around the substrate surface. Also, it is considered that the number of surface cracks is correlated with the behavior of the rupture of coating film.
