The Longevity and Performance of Diamond-Ground Pavements

by Shreenath Rao, H. Thomas Yu, and Michael I. Darter

Research & Development Bulletin RD118

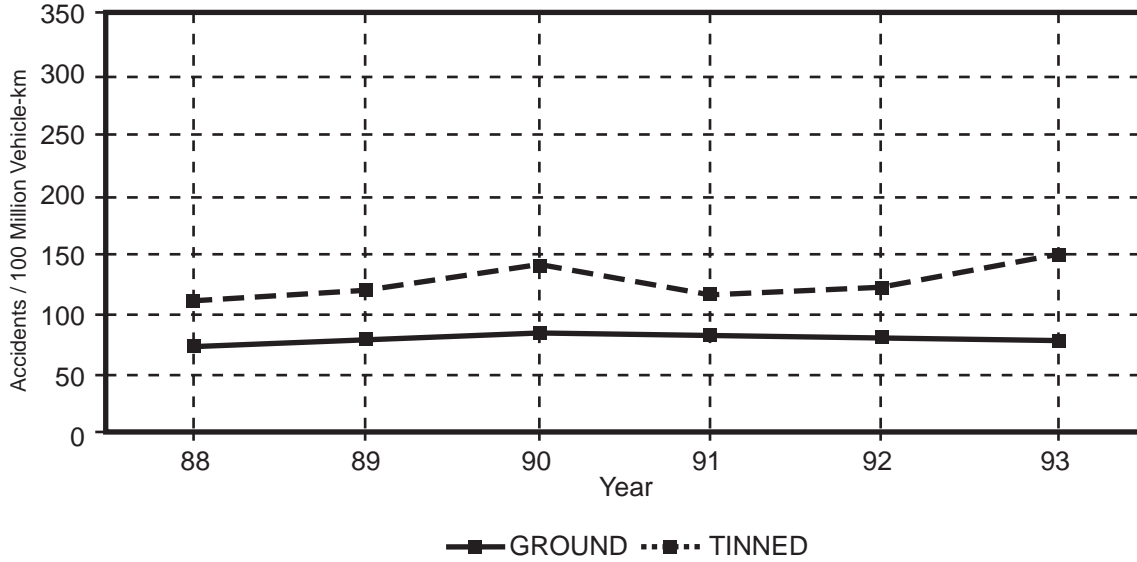
Figure 2. Accident rates between 1988 and 1993 for diamond-ground and tined pavements (Drakopoulos et al. 1998)

The overall accident rates at diamond-ground sites were 60 percent of those at tined sites. For all types of pavement, diamond-ground pavements had significantly lower accident rates than tined pavements under all conditions. Figures 2 and 3 show all condition accident rates and wet-pavement accident rates for the 6-year period. No consistent trend in the deterioration of accident rates with time was observed. In

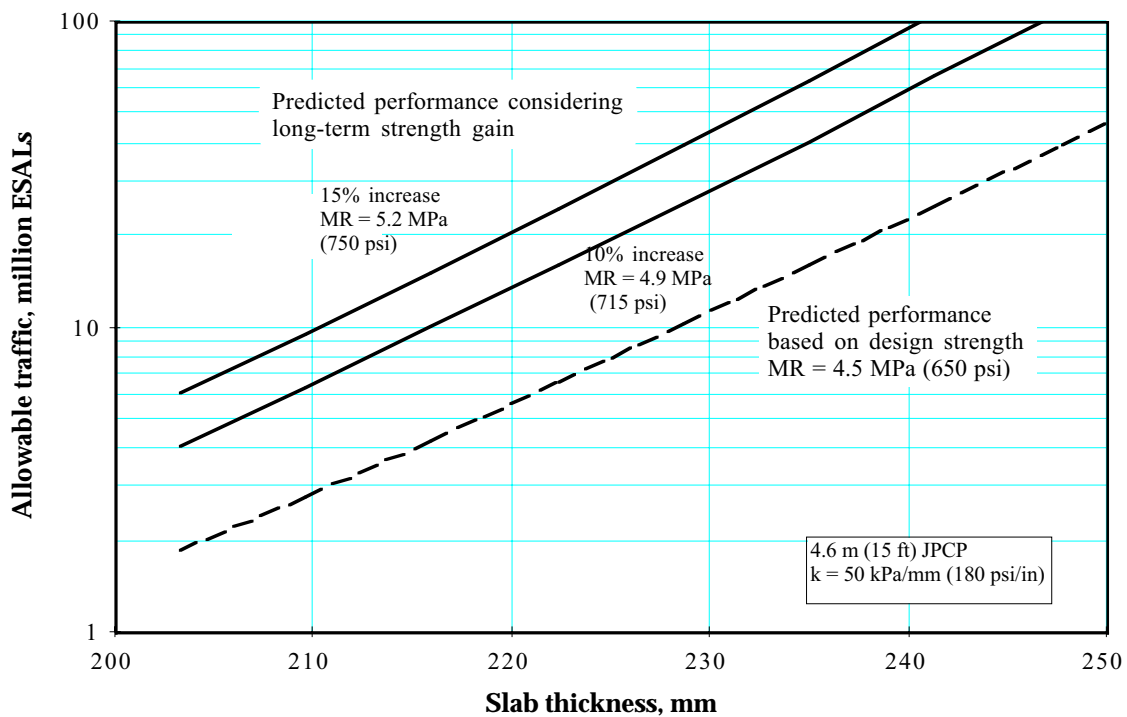
Figure 4. Effects of slab thickness and concrete strength on fatigue life of JPCP.

are shown in figure 4. The predicted fatigue life was determined using the jointed plain concrete pavement (JPCP) cracking model developed by Yu et al. (1997). Fatigue life of a pavement slab is extremely sensitive to slab thickness. A 5-mm (0.2-in.) reduction in slab thickness results in about 30 percent reduction in fatigue life if the concrete strength remains constant. However, long-term strength of concrete is significantly higher than the design strength, which is typically the 28-day strength. The strength of conven-

Figure 4 shows that with 10 percent increase in concrete strength, up to 13 mm (0.5 in.) of thickness can be removed and still achieve the design life predicted based on design strength. If the long-term strength is 15 percent higher than the design strength,

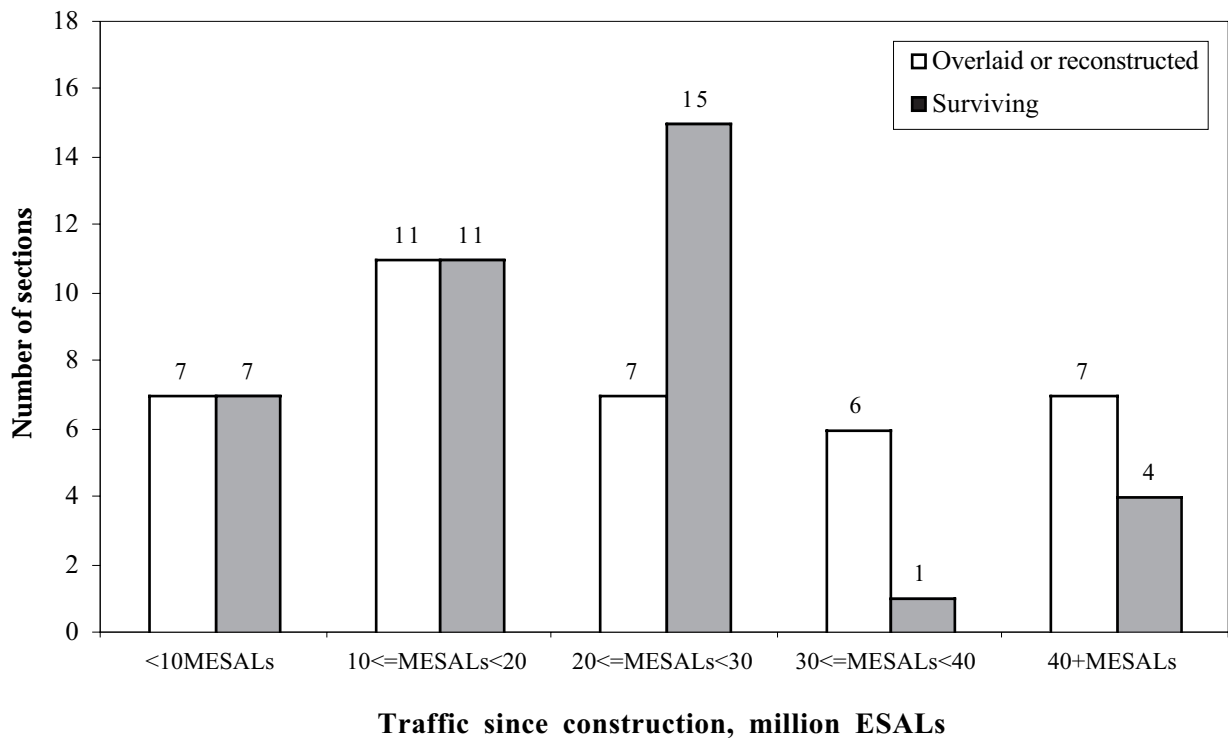
Figure 6. Distribution of traffic levels of the pavement projects for service life evaluation.

The distribution of traffic placed on these projects is shown in Figure 6. Again, good long-term performance is observed.

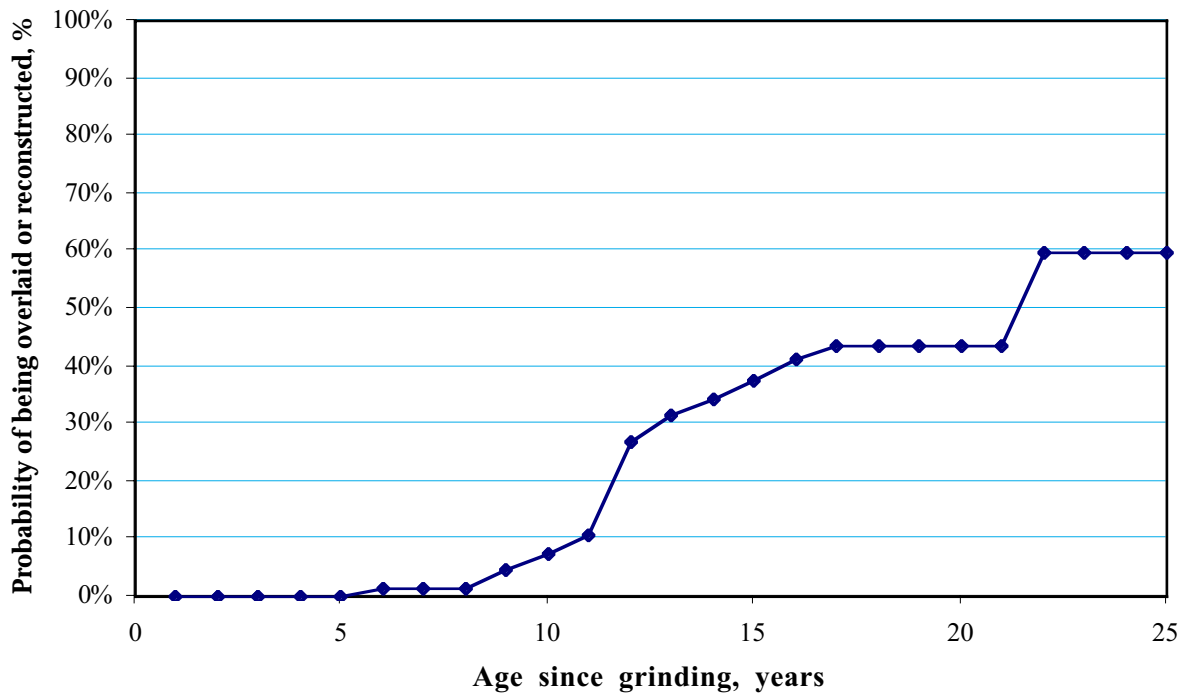
Figure 11. Survival curve showing probability of being overlaid or reconstructed vs. age since first grind for diamond-ground pavements.

Figures 11 and 12 show the probability of overlaying (or reconstructing) diamond-ground pavements after the first diamond grinding in terms of age and traffic. The probability that a diamond-ground pavement will be overlaid or reconstructed without providing at least 10 years of service or carrying 9 million ESALs is less than 10 percent.

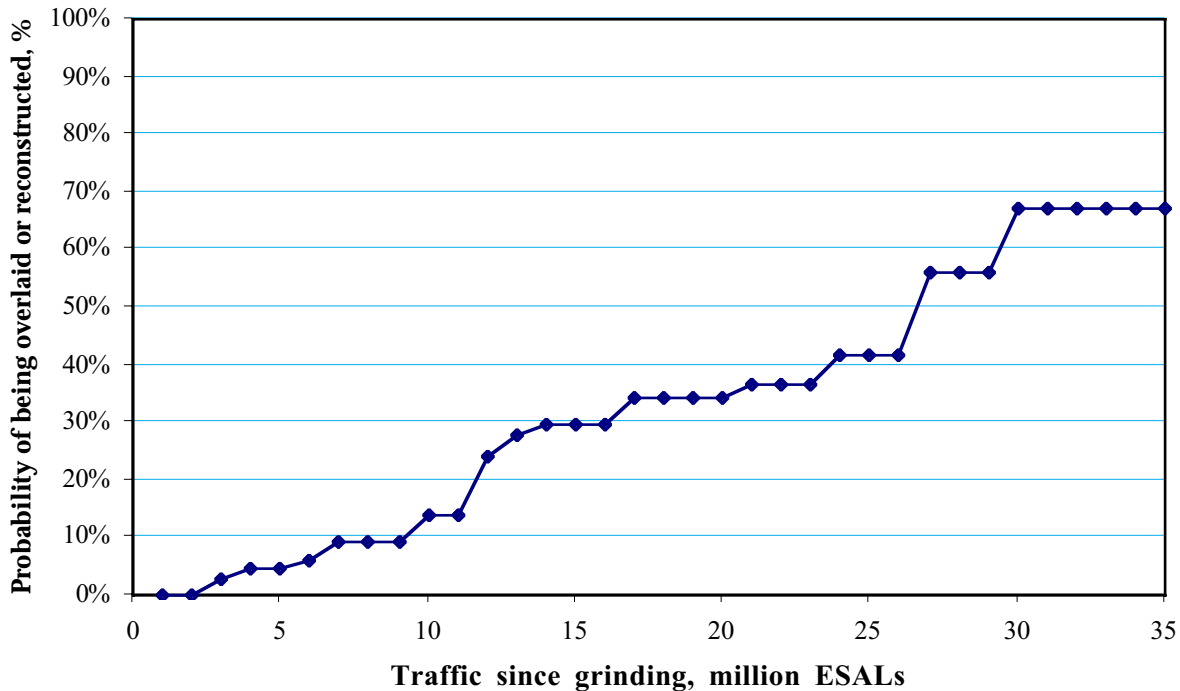
Figure 12. Survival curve showing probability of being overlaid or reconstructed vs. cumulative traffic since first grind for diamond-ground pavements.

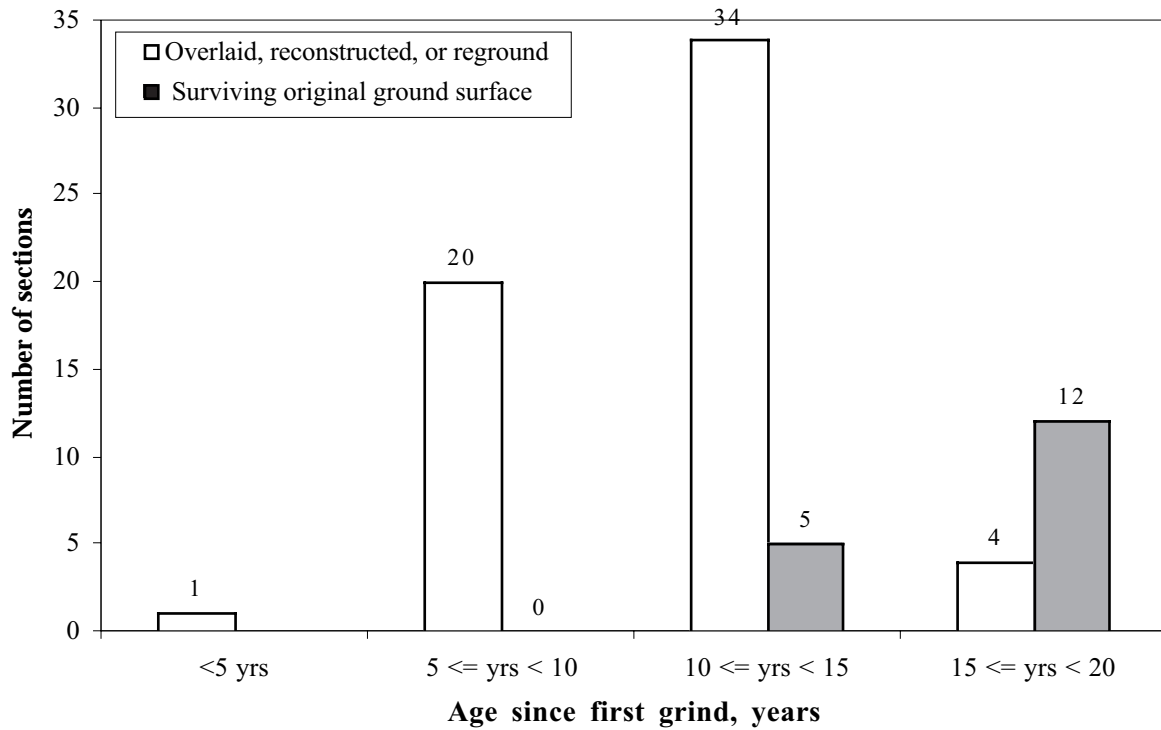
Figure 13. Distribution of pavement age since grinding to resurfacing (overlying, reconstruction, or regrounding).

Figures 13 and 14 show the survival trends of diamond-ground surfaces to regrinding, overlaying, or reconstruction.

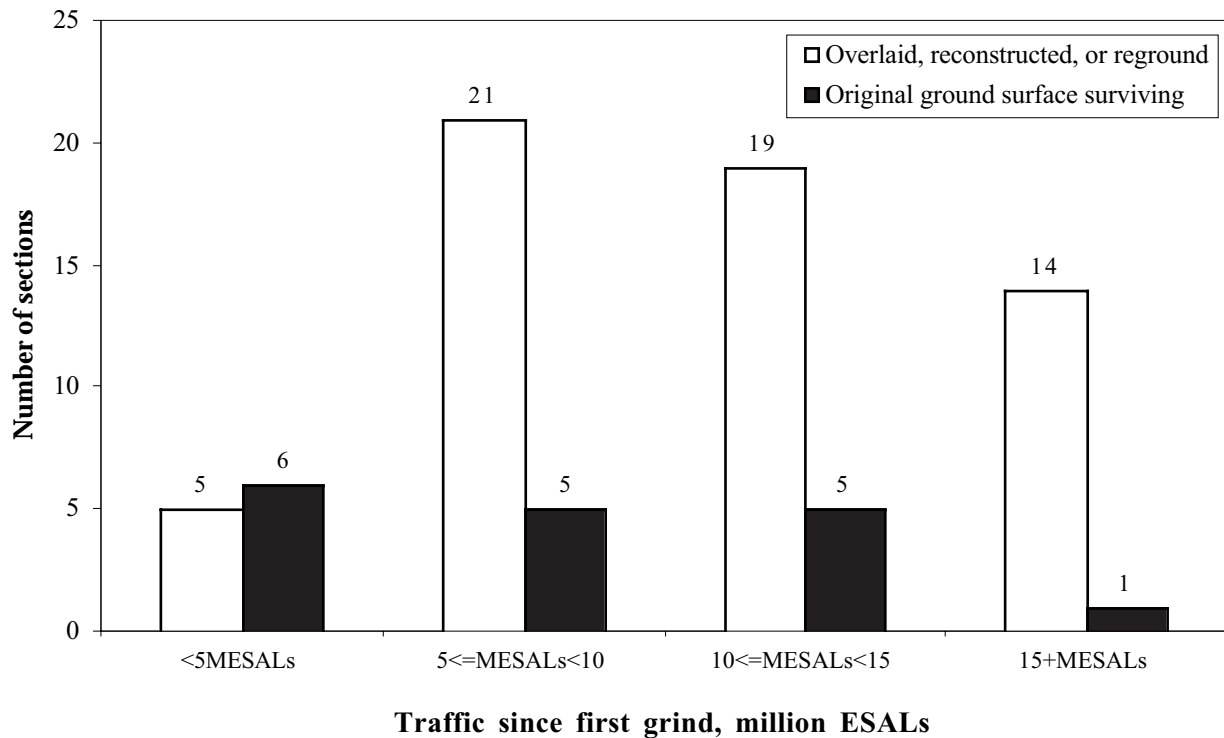
Figure 14. Distribution of traffic since grinding to resurfacing (overlying, reconstruction, or regrounding).

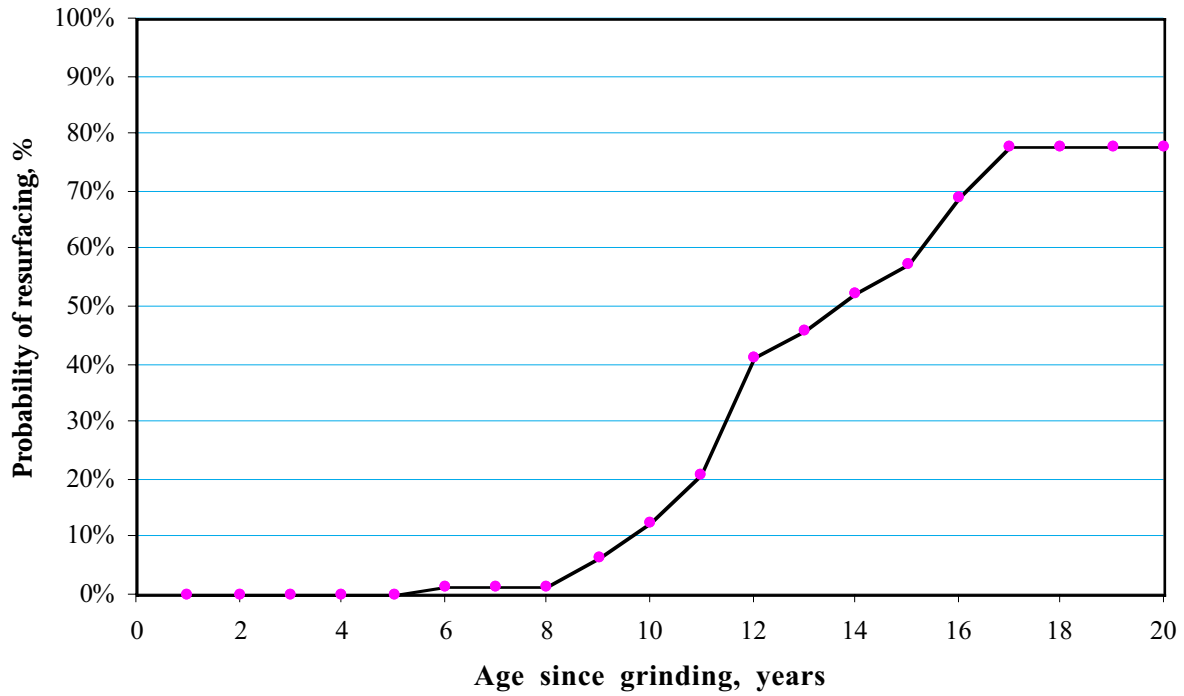
Figure 15. Survival curve showing probability of resurfacing (overlying, reconstruction, or regrinding) vs. age since first grind for diamond-ground pavements.

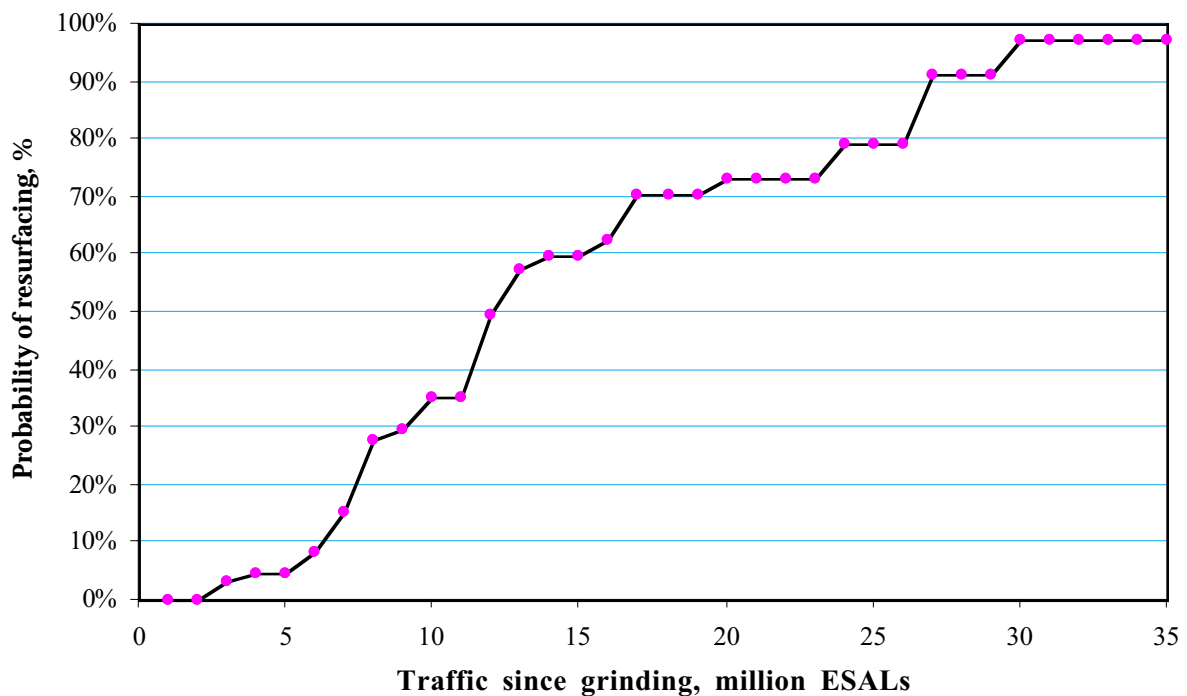
Figure 16. Survival curve showing probability of resurfacing (overlying, reconstruction, or regrinding) vs. traffic since first grind for diamond-ground pavements.

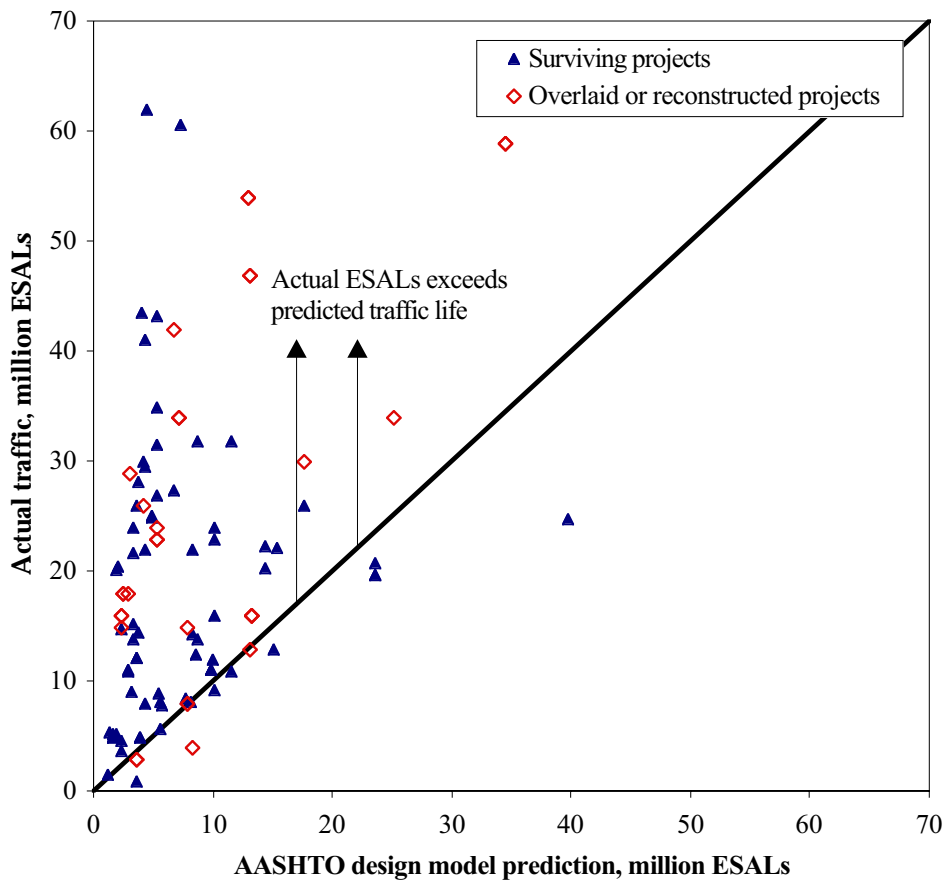
Figure 17. Actual cumulative traffic since initial construction vs. predicted traffic based on the AASHTO design procedure (50% reliability) for diamond grinding projects.

capacity for all pavements included in this study. Figure 17 shows a plot of predicted traffic based on the AASHTO procedure versus actual traffic carried by the diamond-ground pavements since initial construction. The 45-degree line shown in the graph corresponds to when the actual traffic carried by a pavement is equal to traffic predicted using the AASHTO design equations.

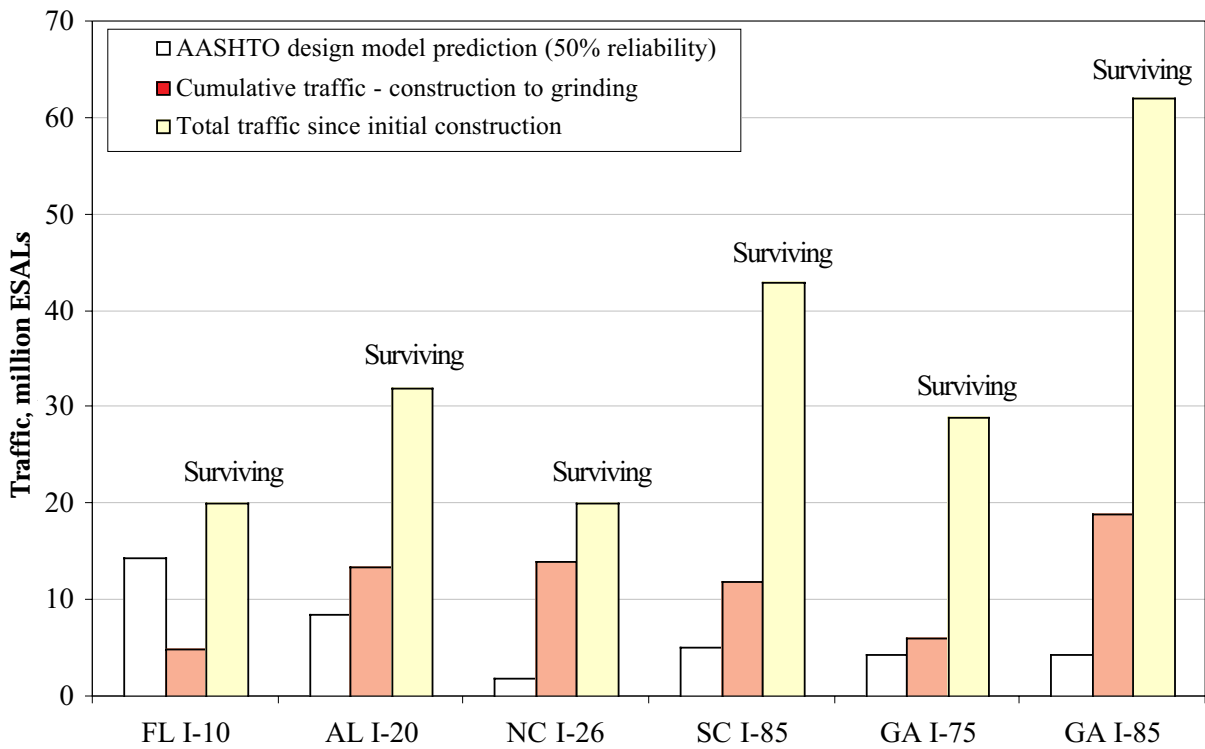
Figure 21. Predicted traffic based on the AASHTO design procedure and actual traffic since initial construction on diamond-ground projects in wet non-freeze climatic region.

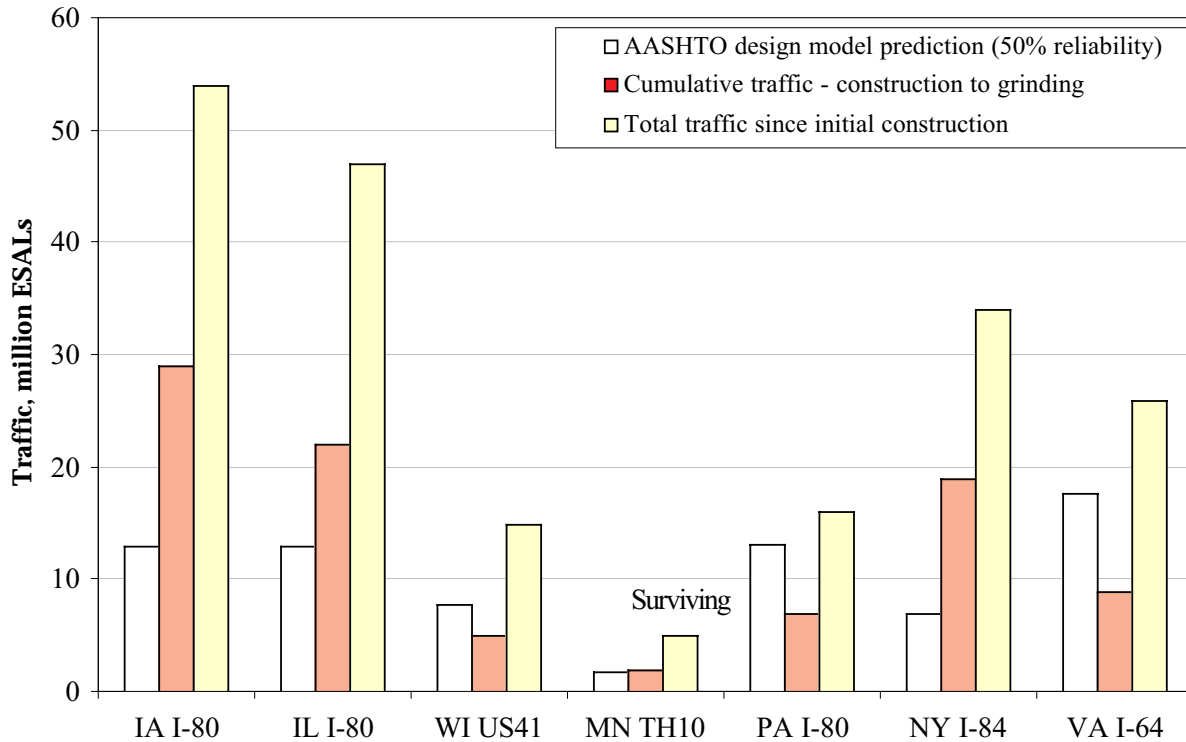
Figure 22. Predicted traffic based on the AASHTO design procedure and actual traffic since initial construction on diamond-ground projects in wet freeze climatic region.

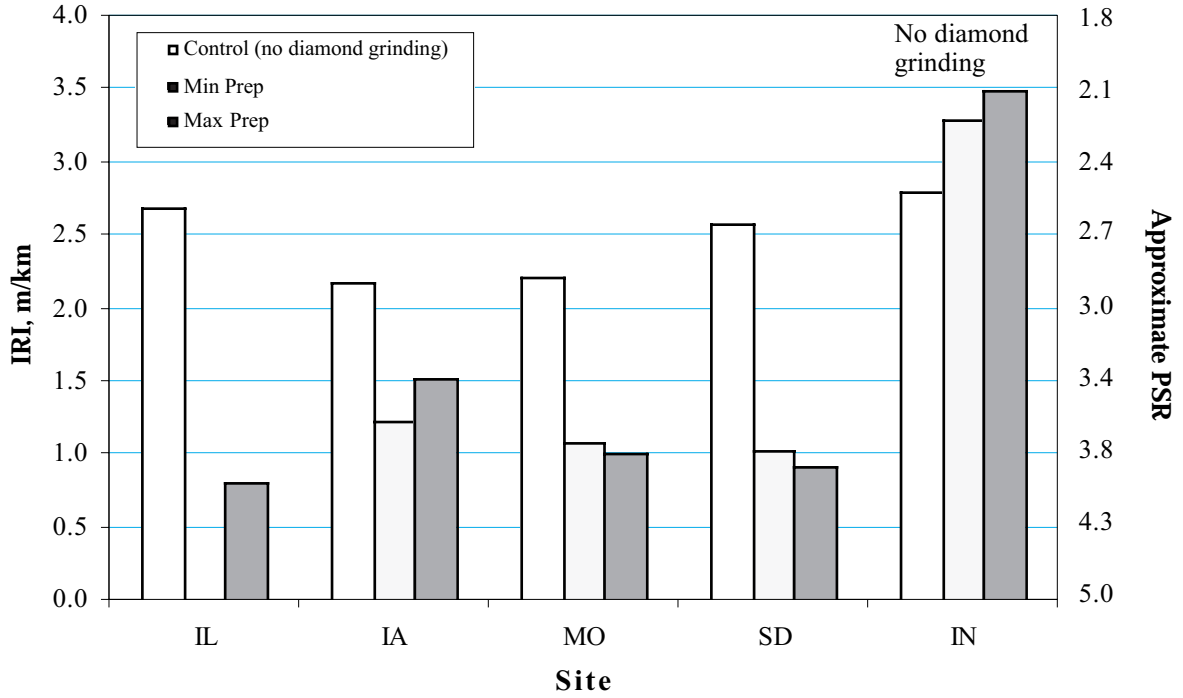
Figure 23. Immediate effects of diamond grinding on pavement smoothness.

The immediate effect of diamond grinding is a significant improvement in smoothness. Figure 23 shows a

comparison of International Roughness Index (IRI) values before and shortly after rehabilitation of SPS-6 sections. *Min Prep* and *Max Prep* refer to the following levels of CPR:

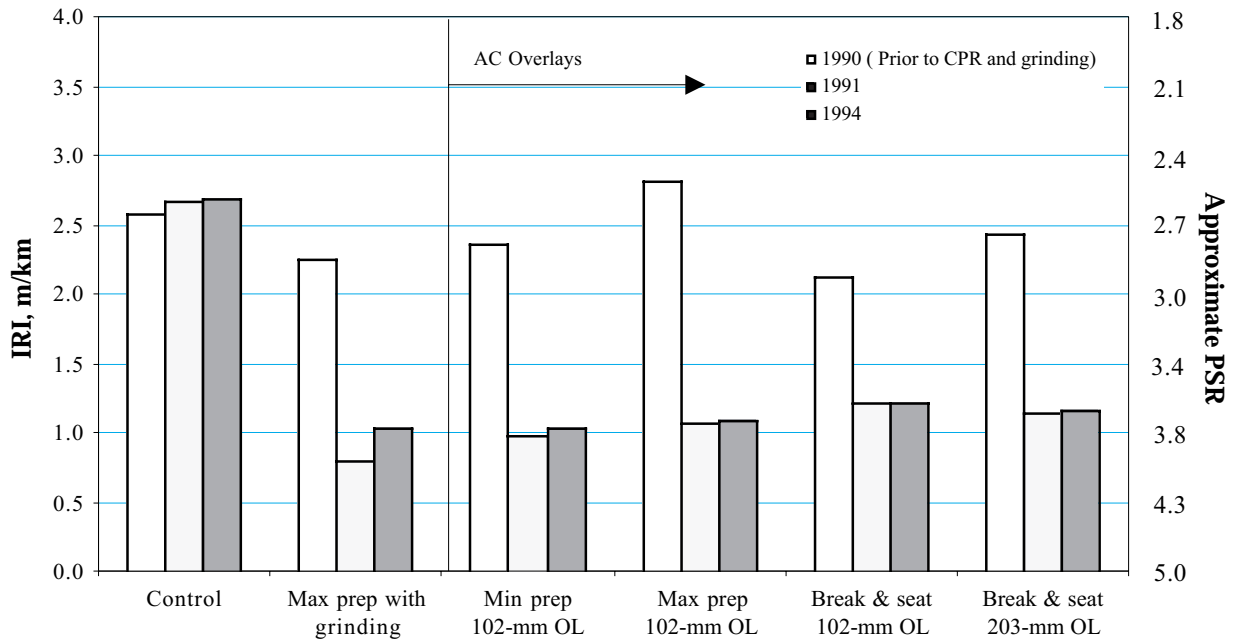
Figure 24. Smoothness performance of diamond-ground and AC overlay sections at the Illinois SPS-6 site.

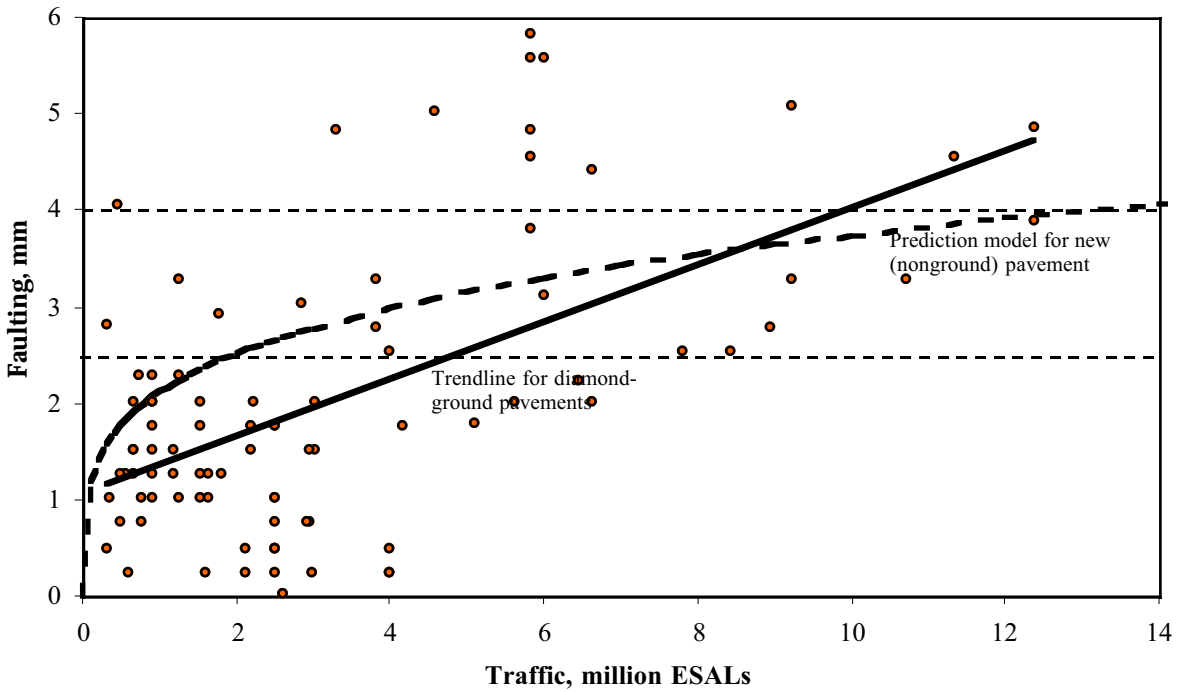
Figure 26. Faulting performance of nondoweled diamond-ground pavements.

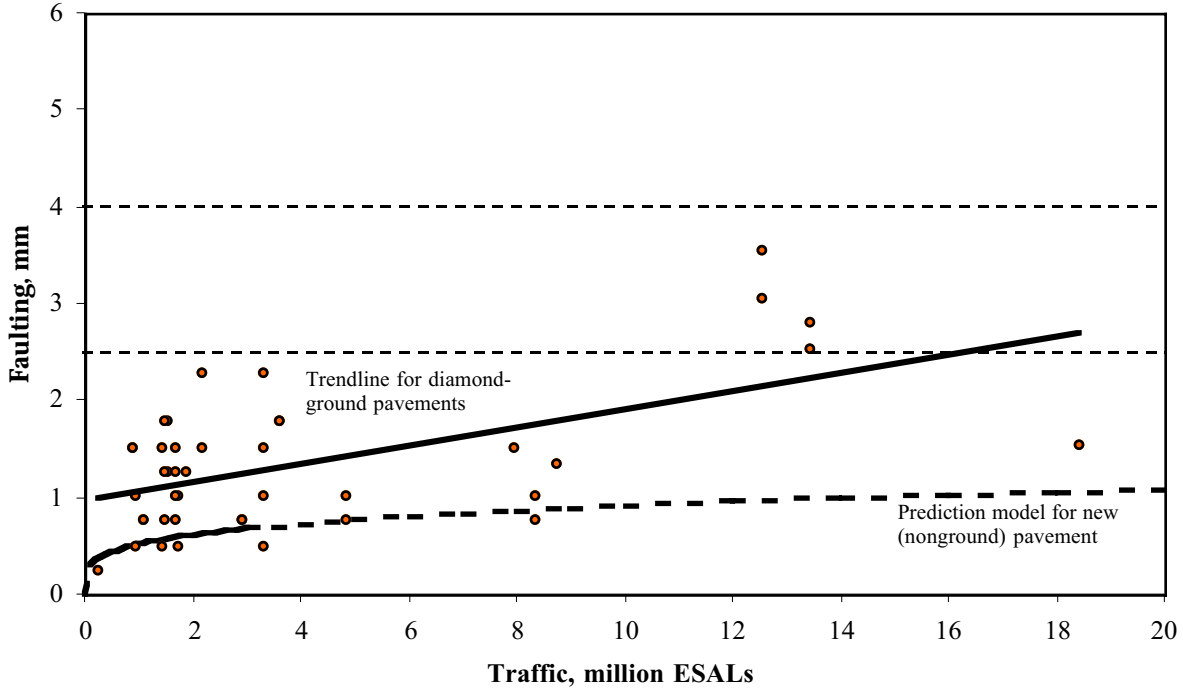
Figure 27. Faulting performance of doweled diamond-ground pavements.

Figure 27 shows that doweled diamond-ground pavements have higher faulting than predicted for new doweled pavements. The reason for higher faulting

A faulting model could not be developed for doweled diamond-ground pavements because of high variability in faulting performance. There may be numerous reasons for the high variability. Some of the sections may have developed excessive faulting because of inadequately sized dowels, loose dowels, or excessive joint opening. It is also possible that excessive faulting was not the reason for the grinding. The pavement may have been ground to improve smoothness after full-depth repairs, to level out faulted cracks, or to improve friction. Despite the variable performance, none of the doweled diamond-ground pavements developed the level of faulting that requires a corrective action. The equation of the trend line shown in Figure 27 is given by:

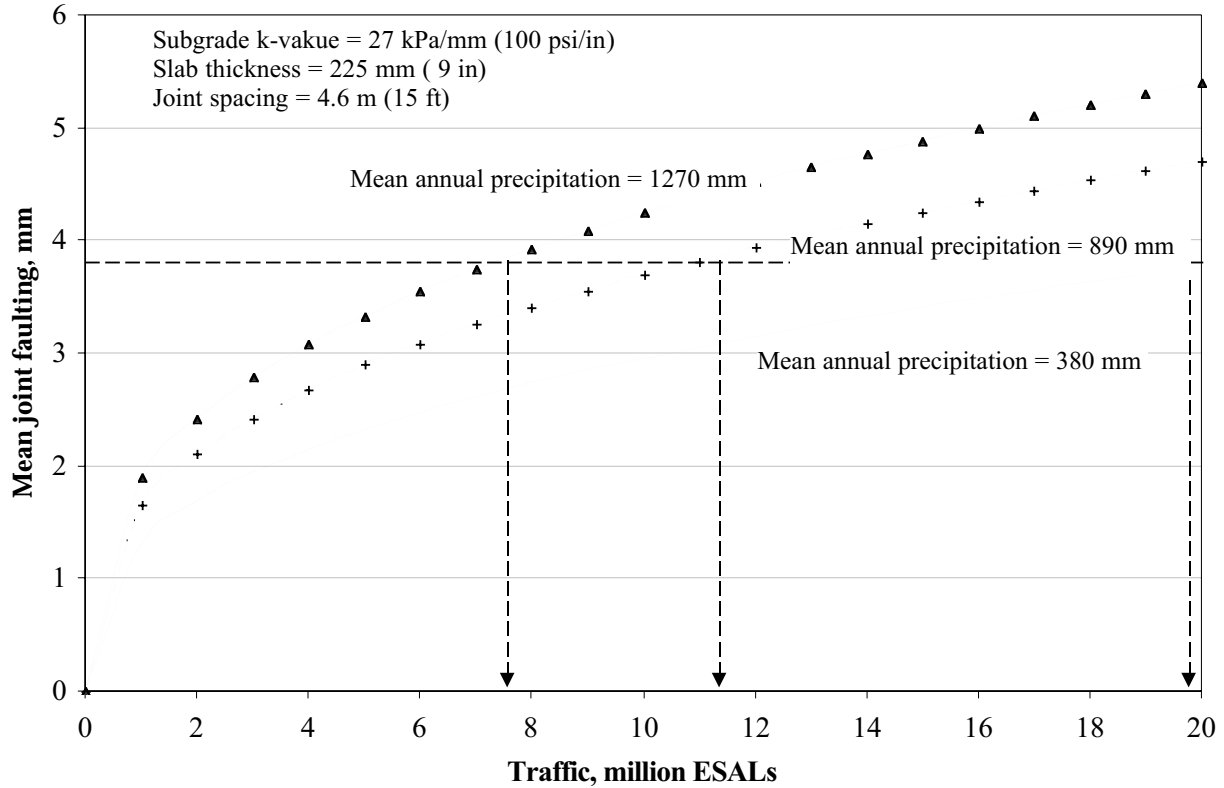
Figure 28. Effects of precipitation on nondoweled JCP faulting after diamond grinding.

Factors affecting faulting performance of diamond-ground pavements. The effect of precipitation on faulting performance of nondoweled JCP is shown in Figure 28. Immediately after grinding, nondoweled JCP shows a rapid increase in faulting and reaches 1.3 to 2.0 mm (0.05 to 0.08 in.) of faulting within 1 million ESALs. The rate of faulting decreases after 2 million ESALs. Faulting performance after diamond grinding varies significantly depending on the amount of precipitation. Pavements in dry regions (precipitation < 380 mm [15 in.]) fault to 3.8 mm (0.15 in.) after 20 million ESALs. Pavements in wet regions (precipitation > 1270 mm [50 in.]) reach this level of faulting after about 7 million ESALs.

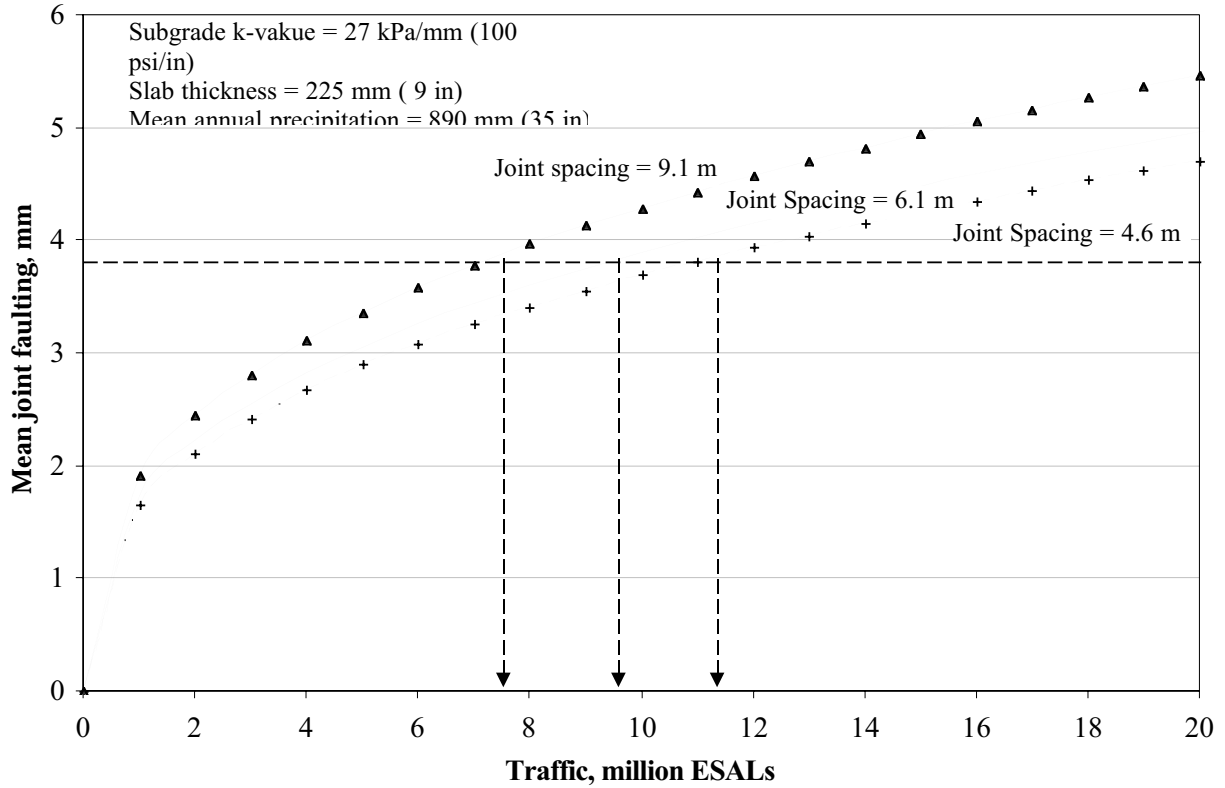
Figure 29. Effect of joint spacing on nondoweled JCP faulting after diamond grinding.

Figures 29, 30, and 31 show the effects of joint spacing, subgrade support, and slab thickness on faulting of nondoweled pavements after diamond grinding. The critical faulting level of 3.8 mm (0.15 in.) is reached after 7 to 11 million ESALs for pavements ranging in joint spacing from 9.1 to 4.6 m (30 to 15 ft). Pavements constructed on a soft subgrade ($k = 27$ kPa/mm [100 psi/in.]) reach the critical level of faulting after 11 million ESALs. Pavements constructed on a stiff subgrade ($k = 109$ kPa/mm [400 psi/in.]) reach the critical level of faulting only after 15 million ESALs. In addition, pavements with thicker slabs fault at a slower rate than those with thin slabs.

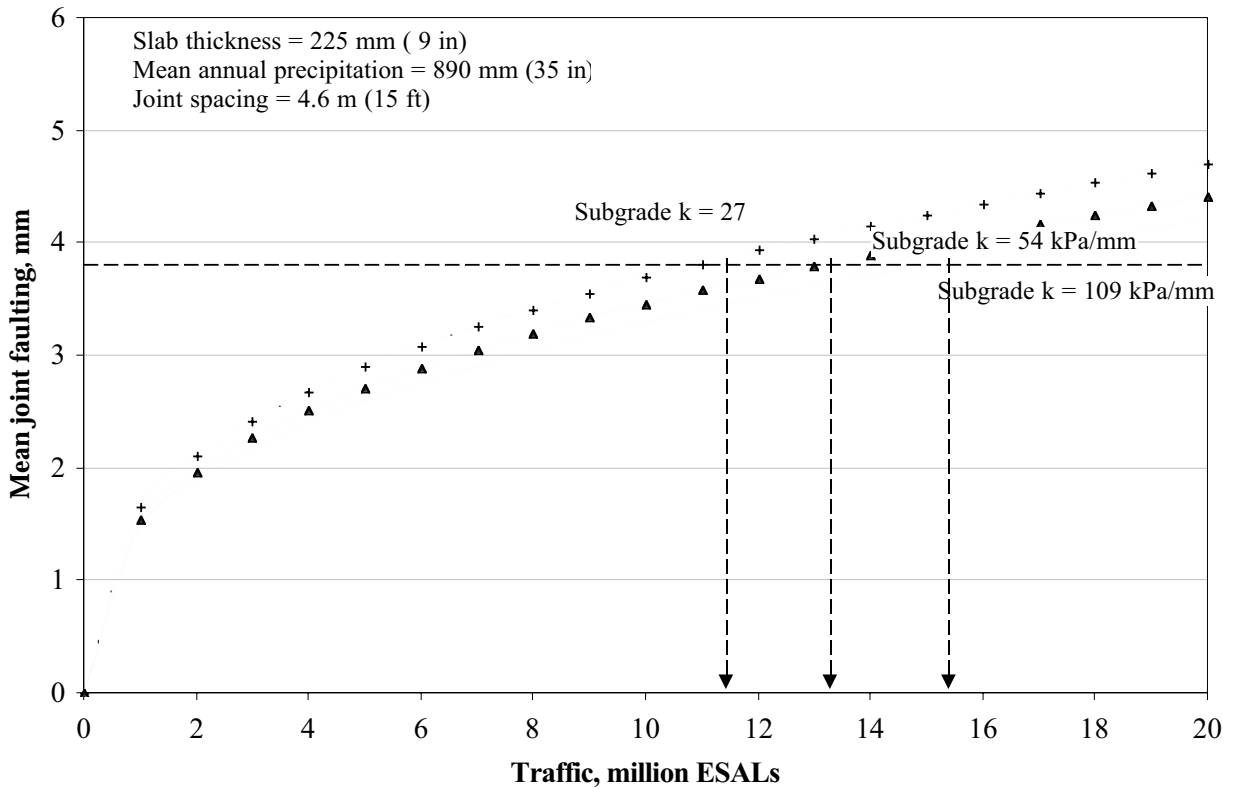
Figure 30. Effect of subgrade k-value on nondoweled JCP faulting after diamond grinding.

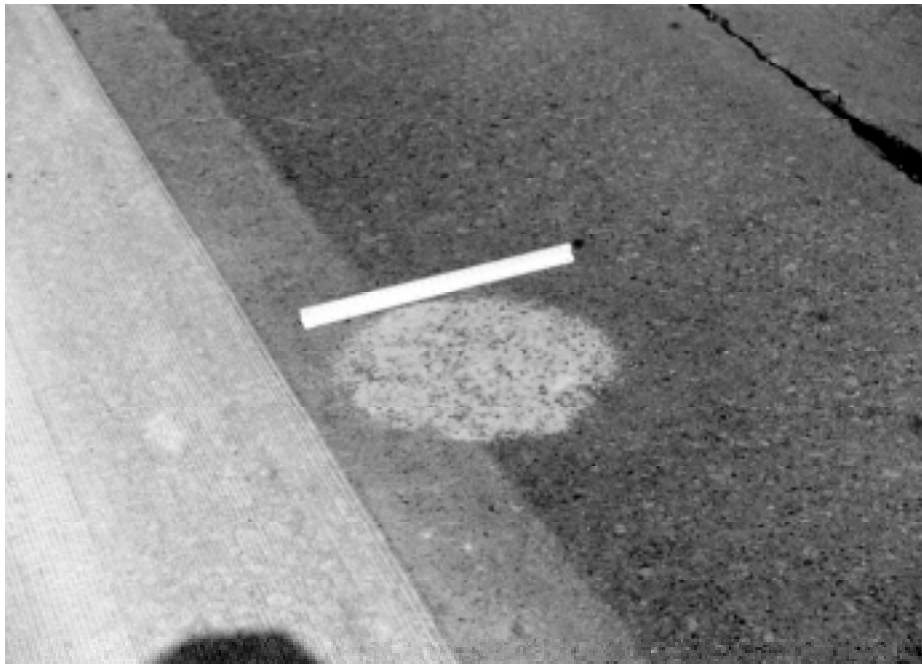
Figure 32. Sand-patch measurement for nonground pavement.

involves spreading a known volume of material (uniformly graded round glass beads) on a clean and dry pavement surface and measuring the area covered. The material spread on the surface completely fills the surface voids to the tips of the surface aggregate particles. The area covered by the material is related to the surface macrotexture, and the average depth between the bottom of the pavement surface and the tops of surface aggregate particles (the average macrotexture depth) can be determined from the known volume and the measured area. Figures 32 and 33 show the sand patch for typical ground and nonground pavements.

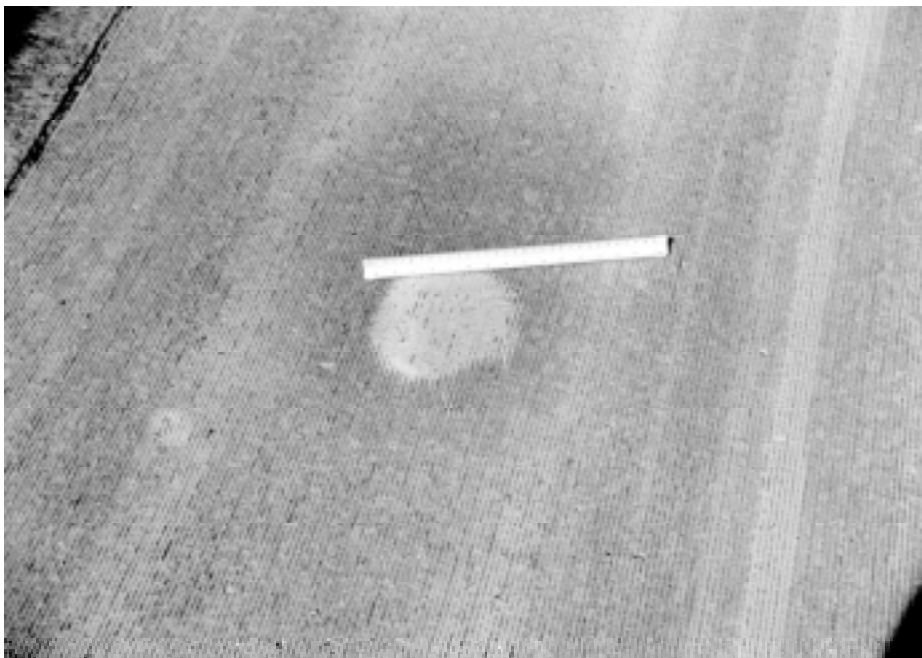
Figure 33. Sand-patch measurement for newly ground pavement.

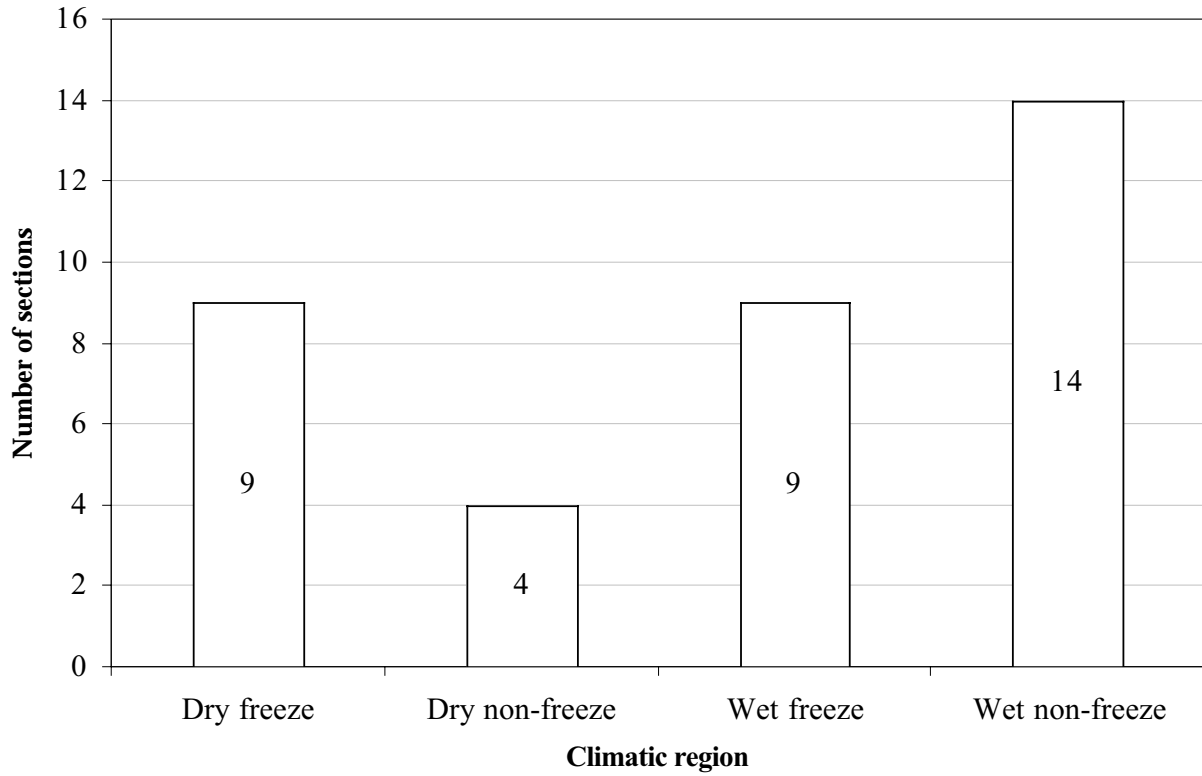
Figure 34. Climatic region distribution for macrotexture survey sections.

Sand-patch tests were conducted in the wheelpaths of 41 in-service diamond-ground pavement sections in 15 states. Five of these sections were not included in the analysis due to scaling and map cracking. Figure 34 shows the climatic region distribution for the 36 remaining sections. These 36 sections are distributed equally between the freeze and the non-freeze climatic region. Figure 35 shows the number of sections in each state where macrotexture data were collected. Table 4 shows the minimum, maximum, and average values of traffic and climatic parameters for these 36 sections.

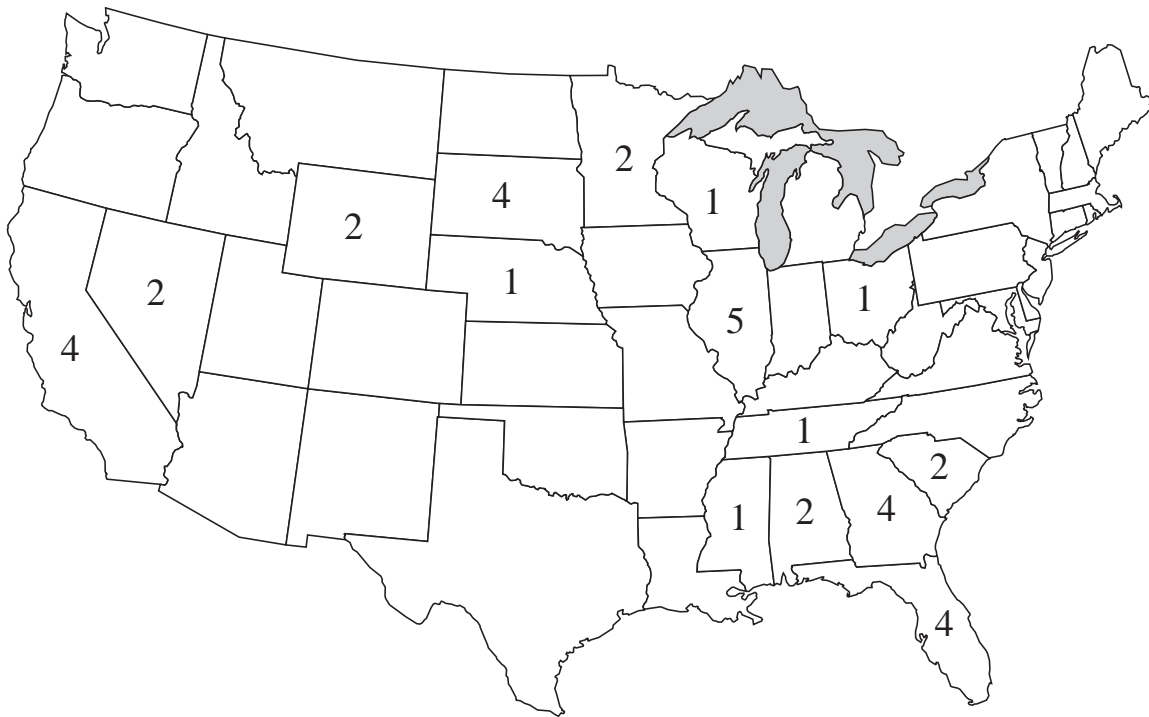
Figure 35. Distribution of diamond-ground macrotexture survey sections across the United States.

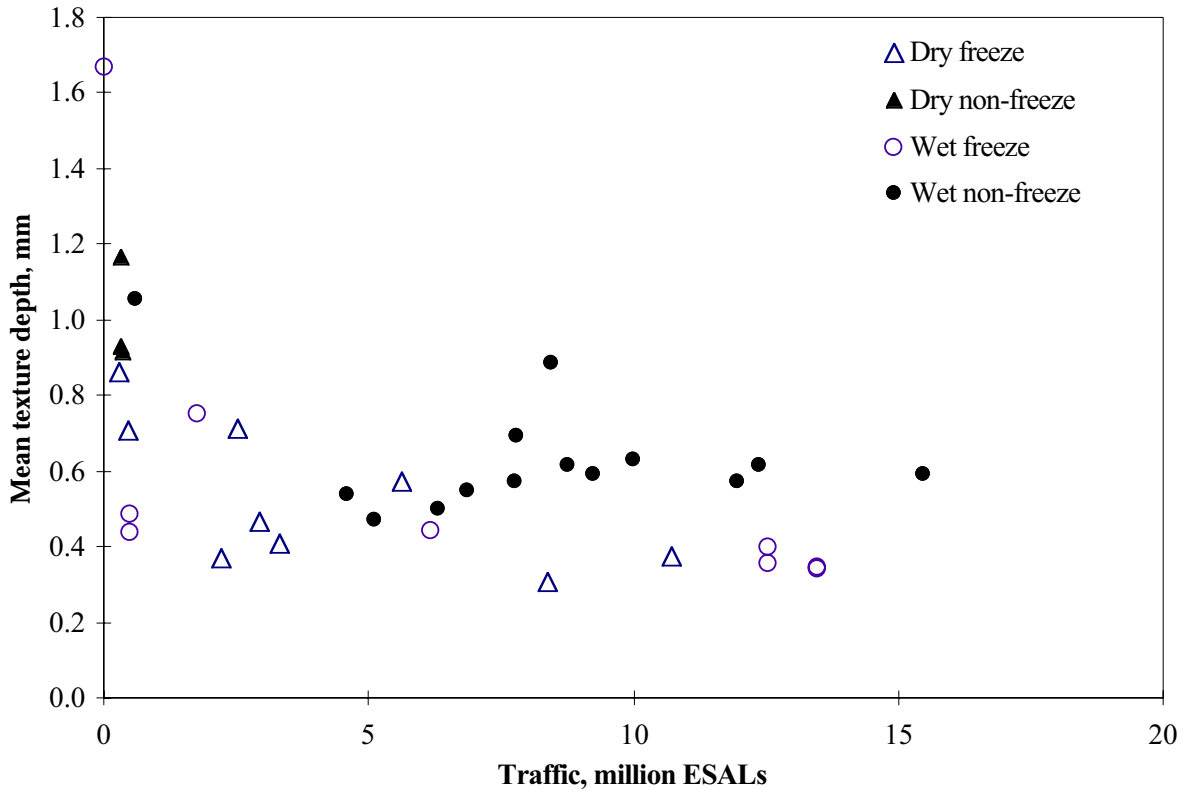
Figure 41. Mean texture depth vs. traffic since grinding, sorted by climatic region.

The mean texture depth for the 36 sections varied from a low value of 0.31 mm (0.012 in.) to a high value of 1.67 mm (0.066 in.) for a newly ground pavement. The average macrotexture value for the 36 pavements was 0.62 mm (0.024 in.), with an average age since grinding of 7.36 years. Figures 40, 41, and 42 show the measured mean texture depth versus age since grinding, ESALs since grinding, and cumulative vehicle passes since grinding, respectively, sorted by climatic

Figures 40 through 44 suggest that mean texture depth is strongly dependent on age since grinding (and, to a lesser extent, traffic since grinding). The mean texture depth for diamond-ground pavements is also evenly distributed between wet and dry climatic regions. However, many diamond-ground pavements in both the wet freeze and dry freeze climatic regions seem to have lower macrotexture than those in the non-freeze climatic regions, especially for pavements with grinding more than 8 years old. The use of winter mainte-
