The Longevity and Performance of Diamond-Ground Pavements

by Shreenath Rao, H. Thomas Yu, and Michael I. Darter

Research & Development Bulletin RD118

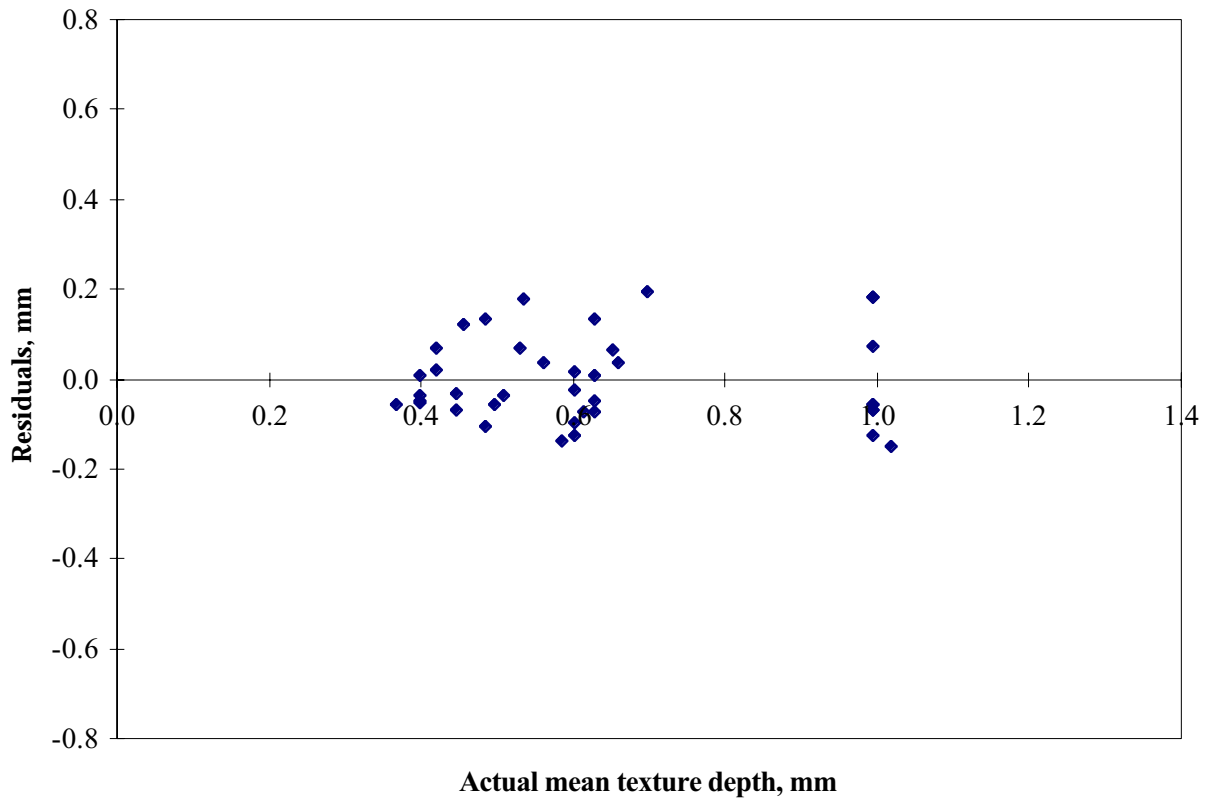
Figure 46. Residual plot for the macrotexture model.

Figure 45 shows a plot of predicted versus actual mean texture depth for the 35 pavements used to develop the model. Figure 46 shows a plot of the residuals for the regression equation. The plot is evenly distributed above and below the zero residual line, which implies that the regression equation is not biased. Figure 47 shows the variation of predicted macrotexture with age since grinding. A newly ground pavement has high macrotexture, which is typically greater than 1.65 mm (0.065 in.). Within the first 6 months after the ground pavement is opened to traffic, most of the ridges created by grinding are broken and the macrotexture falls to approximately 1.02 mm (0.04 in.). This is the starting point for the regression model. Within the first 2 to 2.5 years, the pavement macrotexture falls to 0.76 mm (0.03 in.). The rate of change of macrotexture decreases with time, and 8 years after grinding, the pavement in the freeze regions reaches a macrotexture of 0.51 mm (0.02 in.). This level is reached in the non-freeze climatic regions after 12 years. After 12 years, pavement surfaces in the freeze climatic regions have a mean texture depth of less than 0.4 mm (0.016 in.).

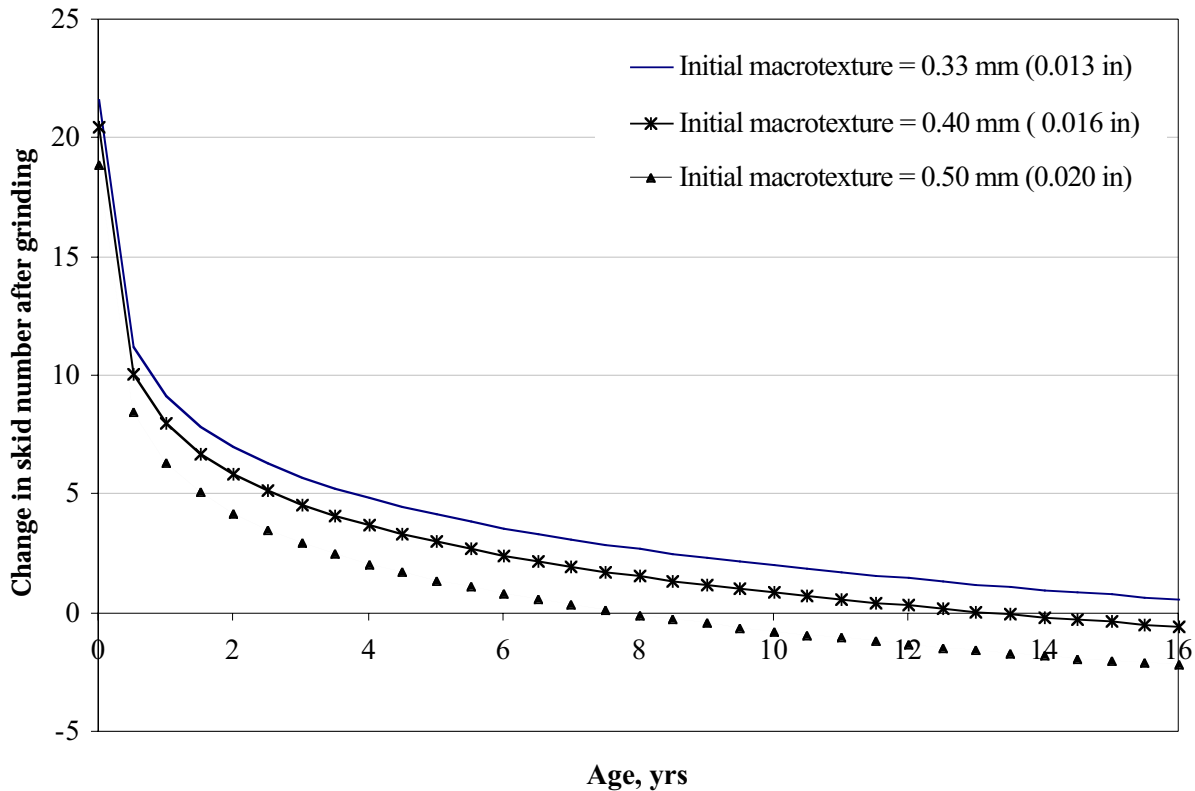
Figure 50. Change in SN50 after grinding for Highbury Avenue in City of London, Canada (Bradbury and Kazmierowski 1997).

The improvement in skid numbers following grinding is consistent with observations made by Bradbury and Kazmierowski (1997) in Canada. Skid numbers were measured at 80 km/hr (50 mph) on a diamond-ground section of the northbound lane on Highbury Avenue in the City of London. Prior to grinding, the average skid number measured was 25. Following grinding, the average skid number increased to 48. Data were collected each year from November 1989 to July 1996. Figure 50 shows the difference in skid numbers following grinding for this section. It should be noted that the skid numbers were measured at 80

km/hr (50 mph), whereas equations 13 and 14 and figures 48 and 49 are valid for skid numbers measured at 64 km/hr (40 mph). Nevertheless, the trend in figure 50 is consistent with the trend in Figure 49.
